# Effects of extreme natural events on the provision of ecosystem services in a mountain environment: the importance of trail design in delivering system resilience and ecosystem service co-benefits

Aleksandra M. Tomczyk<sup>a,b,\*</sup>, Piran C.L. White<sup>a</sup>, Marek W. Ewertowski<sup>b,c</sup>

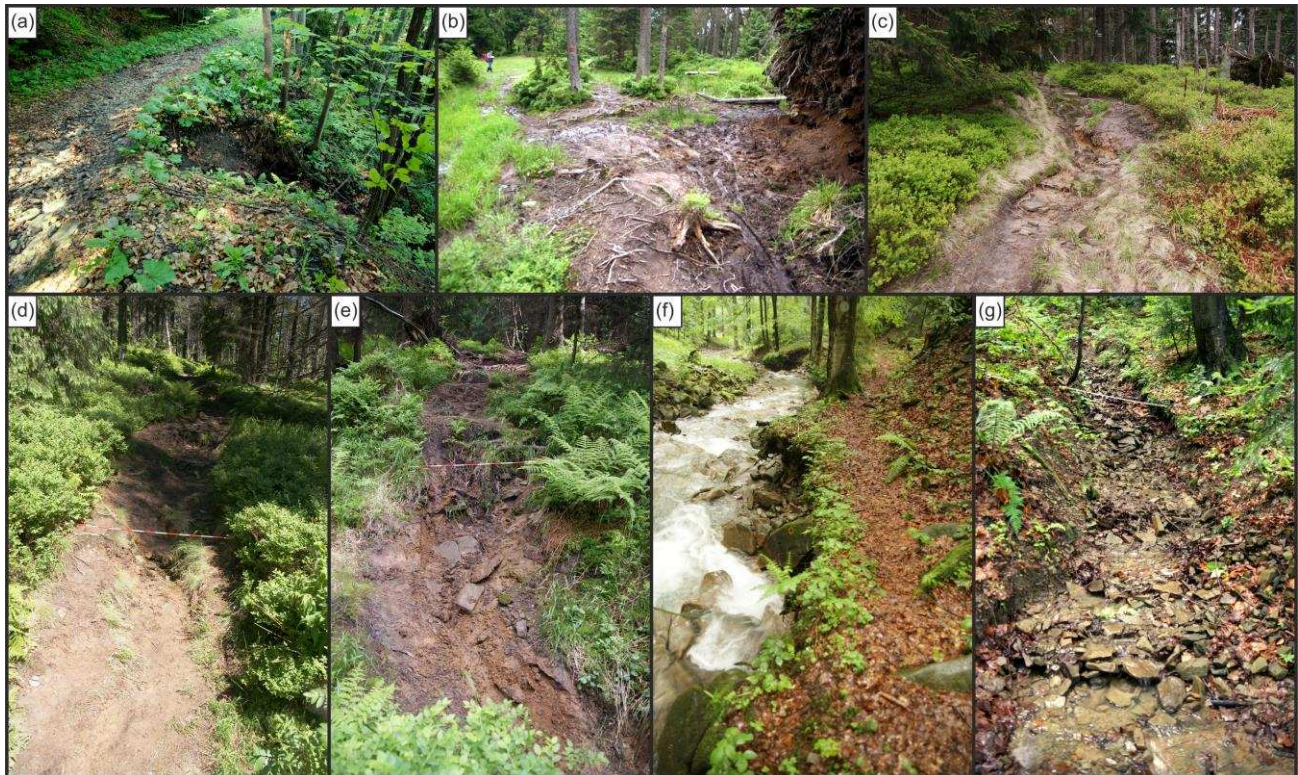
Figure 2. Examples of impacts in Gorce National Park related to the extreme rainfall event in May 2010: (a) damage to trail tread due to small landslide; (b) creation of muddy sections; (c), (d), (e) development of erosional rills destroying trail tread; (f) undercutting of trail treads by a stream; (g) increase in delivery of sediments due to soil erosion.

The intense rainfall in May 2010 caused a variety of damage within the Park area. The most important effects were the following (Fig. 2): (1) development of erosional rills on trail treads; (2) damage or destruction of bridges, culverts and water bars; (3) creation of extensive muddy sections; and (4) overall increase in soil erosion. These degradation problems created difficult and unsafe travel conditions. Visitors, trying to avoid these difficulties, started to trample trailside vegetation, leading to the additional widening of the trail tread. Moreover, in several places, alternative (informal) sections of trails were developed by users. Among other consequences of the intense rainfall were a rise in delivery of sediments into streams and retention ponds following soil erosion, and an increase in flood risk, which affected not only the Park area, but also areas downstream.

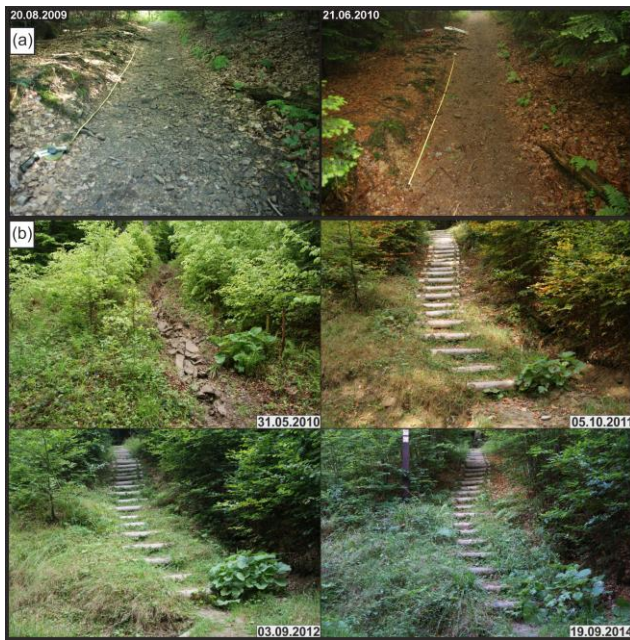
Figure 4. (a) Case study A – an example of a trail which was not damaged during the intense rainfall event which occurred in May 2010. (b) Case study B – an example of trail damage (development of an erosional rill) and the appearance of the trail after repair (scenario 2).

Scenario 1 represented the situation in which trails were properly constructed and maintained, and therefore, no significant damages occurred after the heavy rainfall in May 2010 (Fig. 4a). Moreover, trails returned to normal function almost immediately after the event (Table 1, Fig. 3). Case study A exemplified scenario 1. It was located on a ridge, in a forest. Trail slope was moderate ( $10^\circ$ ). The tread was even with natural stone pavement. The studied section had side-hill trail alignments (at  $50^\circ$  and more), that allowed natural tread drainage and minimised trail erosion. However, case study A had a low slope alignment ( $25^\circ$ ), that potentially could be difficult to drain. In case study A, proper tread drainage features such as water bars existed downslope, which helped to intercept and drain surface runoff from the tread. The trail was able to accommodate 177 users per day. As the trail was not damaged during the extreme rainfall event, the trail

Case study B illustrated scenario 2. The analysed section of trail was very steep ( $22^\circ$ ) and routed parallel to the main slope. Before the extreme rainfall, the trail was narrow, with a natural surface and no incision. The intense rainfall and subsequent surface water runoff eroded a rill, up to 0.85 m deep and up to 1.1 m wide (Fig. 4b), which created difficult and unsafe travel conditions, and forced the park managers to repair this section. In summer 2010 the rill was filled and wooden steps were installed, and visitors could use this section again safely. Shortly after the management action, as the trail was still steep and there was no trailside vegetation, surface water runoff and erosion occurred along the

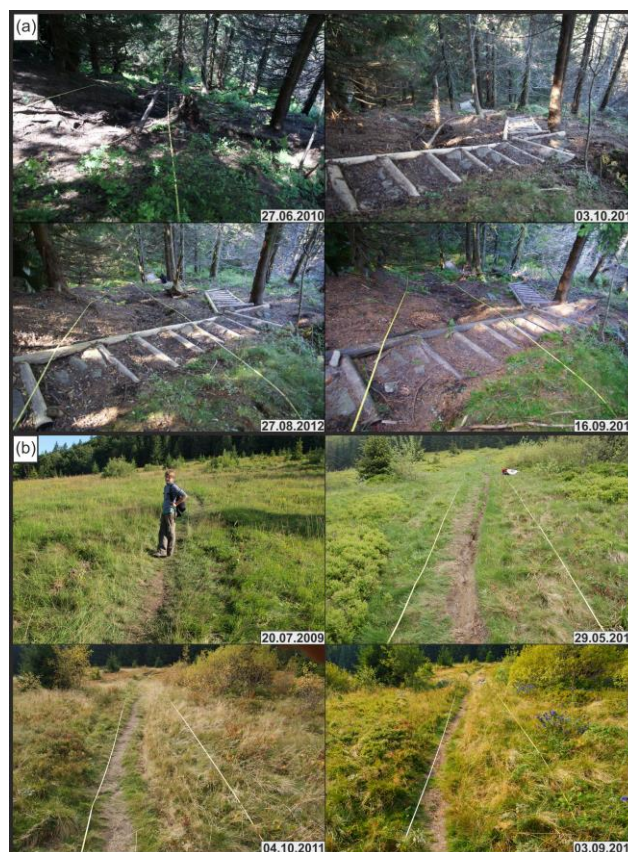
Figure 5. (a) Case study C – an example of a trail which has been degraded and repaired. The old course of the trail is marked by yellow survey tapes. After the event, new, less steep course was designed and wooden and stones steps were installed. Note that erosional processes are still active within the old route. (b) Case study D – an example of trail which was degraded and left for natural recovery. Note that before the intense rainfall event, the trail was undamaged and very narrow. In May 2010, an erosional rill developed and as a result of this, visitors created a new path (visible since 2011). During the recovery period, the grass had partly overgrown the rill; however, geomorphological processes were still active.

Case study D illustrated scenario 3. It was located in an extensive glade. Trail tread was natural, routed parallel to the prevailing slope, and trail grade was 13°. Prior to May 2010, the trail was narrow (0.6 m) and not incised (Fig. 5b). As a consequence of the heavy rainfall, erosion resulted in incision of a rill (0.4 m deep and 0.3 m wide) into the trail tread. As this caused walking difficulty, a visitor-created path arose along the damaged trail tread.

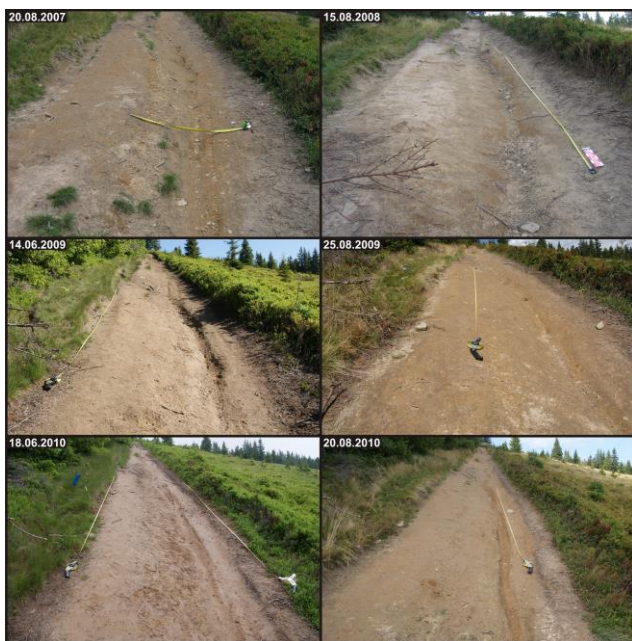
Figure 6. Case study E – an example of trail which had already been degraded before the intense rainfall event. Trail tread was uneven and wide. The extreme rainfall event caused an increase in soil erosion and the rill was deepened.

Case study E was another example of scenario 3. The analysed section was steep (16°) and routed along the edge of the glade. Trail tread was natural and directed obliquely to the prevailing slope. Prior to May 2010, it was 2.65 m wide and a small erosional rill (up to 0.1 m deep) was developed along the trail (Fig. 6). As a consequence of water runoff during the intense rainfall event, the rill was deepened.

Mean soil loss in the period of normal functioning (prior to the extreme event) was 43.4 mm (Table 1). It increased during the intense rainfall event to 52.3 mm. The trail became rougher and more prone to erosion. Hence, no natural restoration was observed. On the contrary, at this site, soil loss increased (up to 71.32 mm), and the trail section widened 0.20 m in the period 2010-2014 (Table 1).
