Liskiewicz, T [orcid.org/0000-0002-0866-814X](https://orcid.org/0000-0002-0866-814X), Kubiak, K and Comyn, T (2017)  
Nano-indentation mapping of fretting-induced surface layers. *Tribology International*, 108.  
pp. 186-193. ISSN 0301-679X

## **Nano-indentation mapping of fretting-induced surface layers**

### **Abstract**

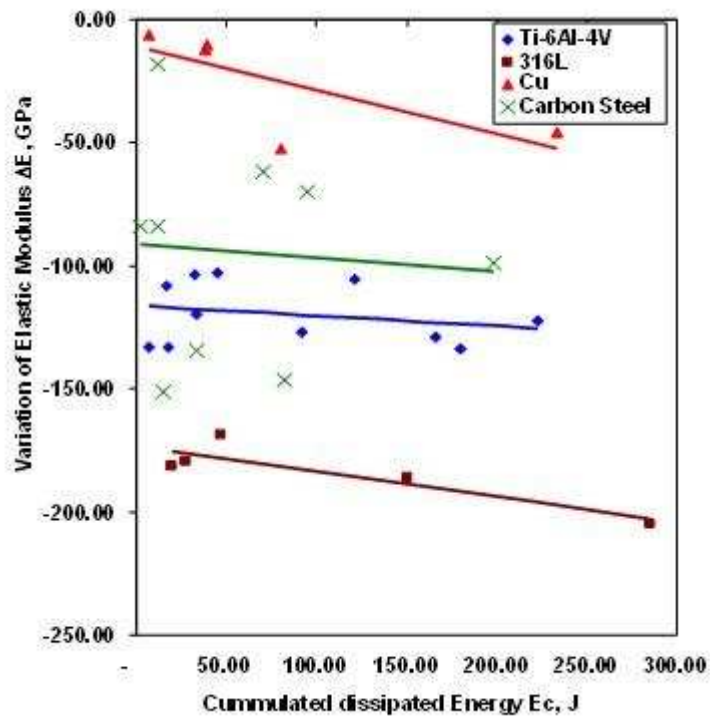
Figure 11

Fig. 11. Variation of Elastic Modulus for four tested materials as a function of cumulated dissipated energy.
