Efthymiadis, P., Dashwood, R., Shollock, B. et al. (2016) Multiscale characterisation of the mechanical properties of austenitic stainless steel joints. *Materials Science and Engineering: A*, 676. pp. 324-335. ISSN: 0921-5093

Multiscale characterisation of the mechanical properties of austenitic stainless steel joints

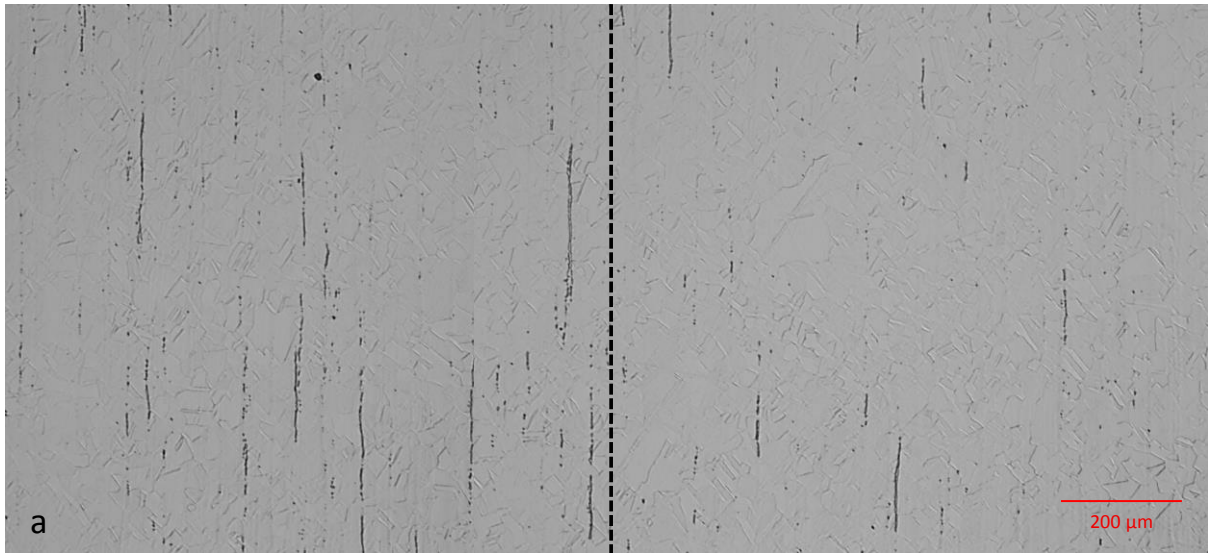
Fig. 1. a) Optical microscopy image of the microstructure of the two sheets within the region of the diffusion bond, b) EBSD map at the area of the joint.

Two commercial grade 316L stainless steel plates - which initially had three distinct surface roughness (1, 3 and 9 μm) - have been diffusion bonded at 1050⁰ C and 120MPa, for 2 hours. The two sheets had the same thickness of 7mm. An optically microscopy image was taken at the joint area and is shown in Fig. 1a. The diffusion bond can be distinguished as one of the sheets has the δ -ferrite precipitated along the Rolling Direction. The band contrast EBSD map is shown in Fig. 1b at the region of the diffusion bond, acquired via EBSD for 20kV and 240 mA aperture size. The phase shown with green colour is the δ -ferrite phase. The EBSD map was also used to obtain a better understanding of the microstructural features, such as grain size and shape, grain growth if occurred along the bond line and at the base steel sheets and grain orientation.

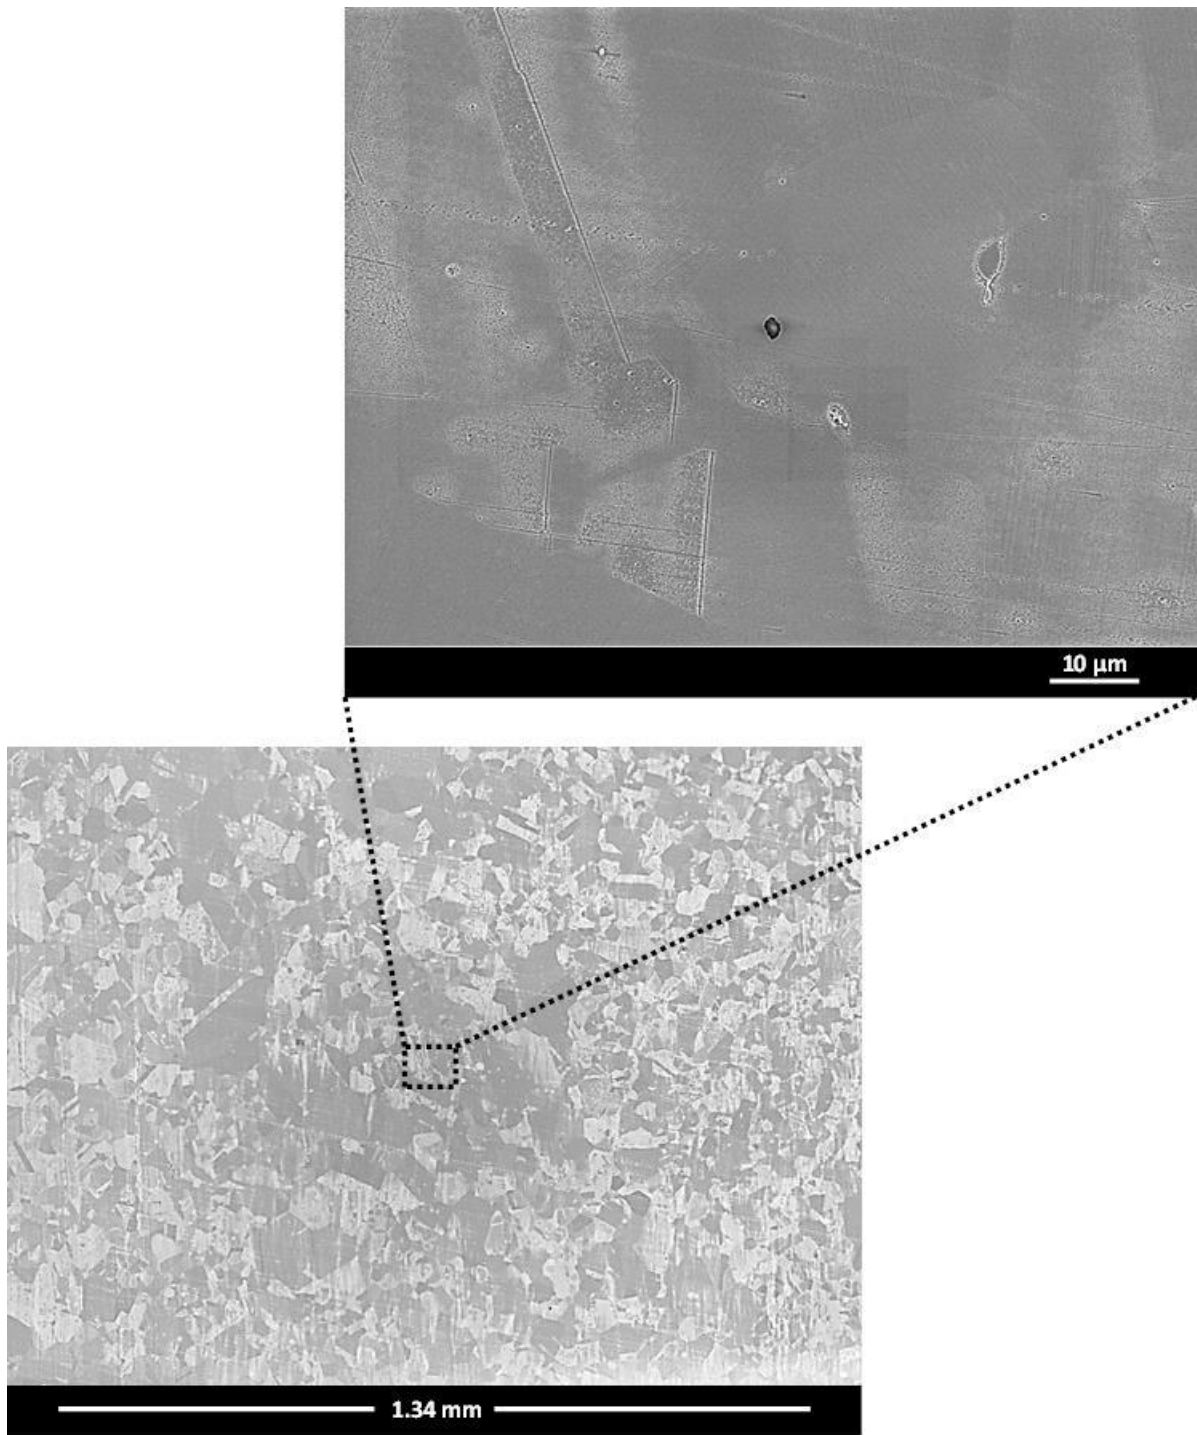
Fig. 7. Low and high magnification SEM images selected for this study. The low magnification image was selected to obtain the ‘macroscopic’ strain fields at the joint region and the high magnification image provides evidence of the ductility of the corresponding material at the joint.

Therefore in situ micro-mechanical testing was performed at two distinct magnifications (Figs. 6 and 7) in order to capture the global strains over a large area of 1mm x 1mm and the local strains within the joint. Furthermore the high magnification images revealed the microstructural deformation characteristics of this alloy, the formation of slip bands and twins. At the first stages of plastic deformation in Fig. 8 distinct slip bands formed within the grains, at the corresponding critical slip systems which were close to a 45° angle between the loading axis and the orientation of the slip bands. The spacing between these bands within the grain was large enough that any interaction can be ignored initially. Also the formation of twins was captured within some grains depending on the crystal orientations. Yet in situ EBSD measurements during tensile testing was not employed to accurately measure the evolution of twinning as the purpose of this study was to reveal the mechanisms of plastic deformation and the mechanical performance of the joint. So evaluating the local strain fields by means of DIC was set to be of great importance.
