# When is a terrace not a terrace? The importance of understanding landscape evolution in studies of terraced agriculture

\*C. Ferro-Vázquez<sup>1</sup>; C. Lang<sup>1</sup>; J. Kaal<sup>2,3</sup> and D. Stump<sup>1</sup>

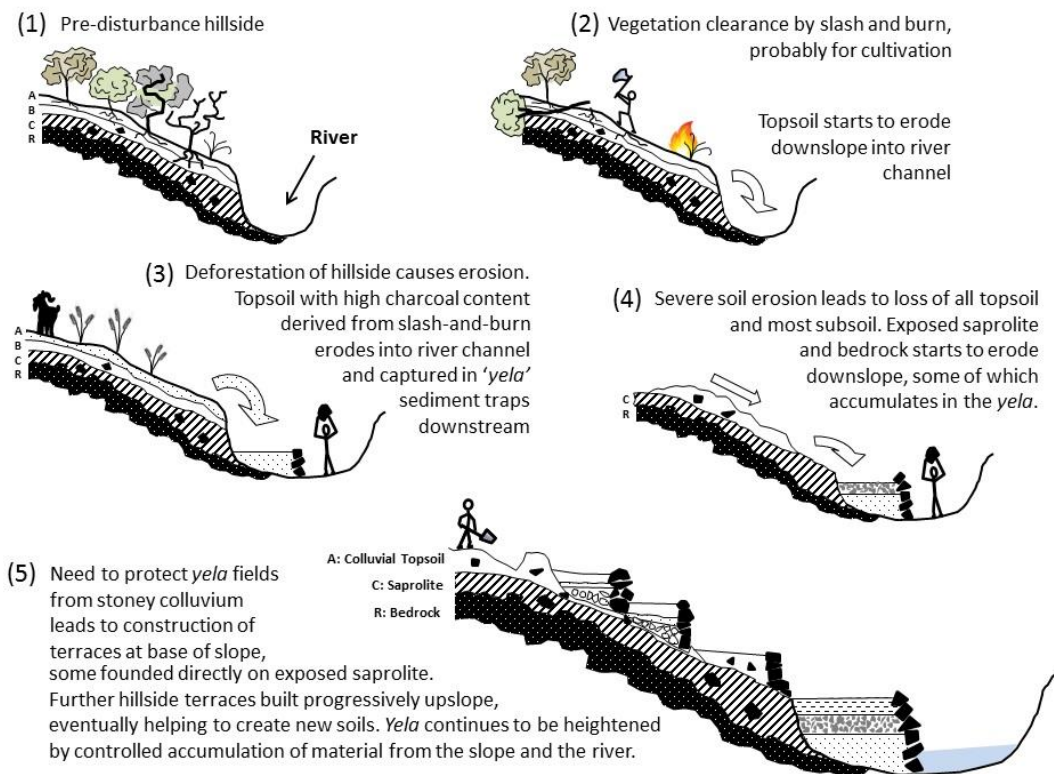
**Figure 6: Schematic representation of the landscape development sequence in the Sahayto area, northeast Konso.**
