When is a terrace not a terrace? The importance of understanding landscape evolution in studies of terraced agriculture

*C. Ferro-Vázquez¹; C. Lang¹; J. Kaal^{2,3} and D. Stump¹

Key words: terraces, archaeology, landscape evolution, agriculture, land management

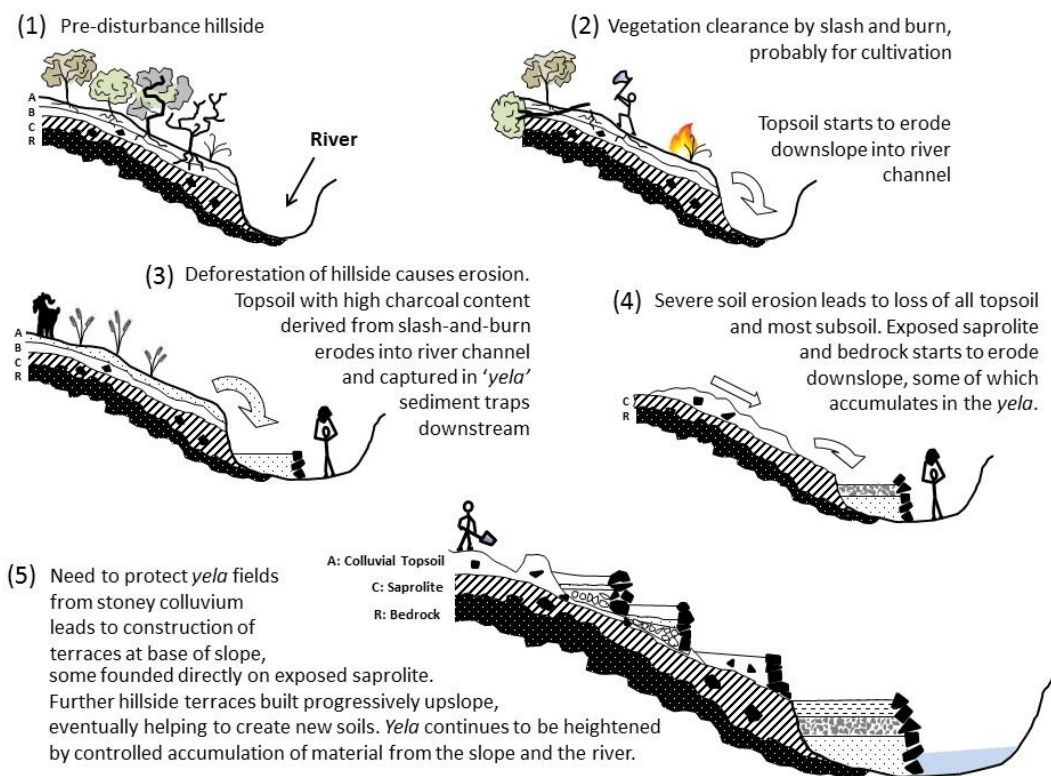
Figure 6: Schematic representation of the landscape development sequence in the Sahayto area, northeast Konso.

Since the stratigraphic sequence of the investigated hillside terraces shows that the agricultural landscape expanded up the slopes from the valley bottom (Figures 3, 4 and 6), this suggests the earliest terraces would have been conceived specifically as a means of protecting the agriculturally important and irrigable *yela* fields. Furthermore, the stratigraphy of the excavated locations, illustrated by the sequence of Section 118, shows that most of the terraces surveyed in the catchment have been constructed directly on the saprolite, indicating that the original slope material was already eroded when the terraces were built. This supports the idea that *yelas* were the key agricultural resource in an early stage of the system, as they were constructed and heightened by capturing topsoil that was being eroded from the non-terraced slopes upstream.
