# When is a terrace not a terrace? The importance of understanding landscape evolution in studies of terraced agriculture

\*C. Ferro-Vázquez<sup>1</sup>; C. Lang<sup>1</sup>; J. Kaal<sup>2,3</sup> and D. Stump<sup>1</sup>

## Abstract

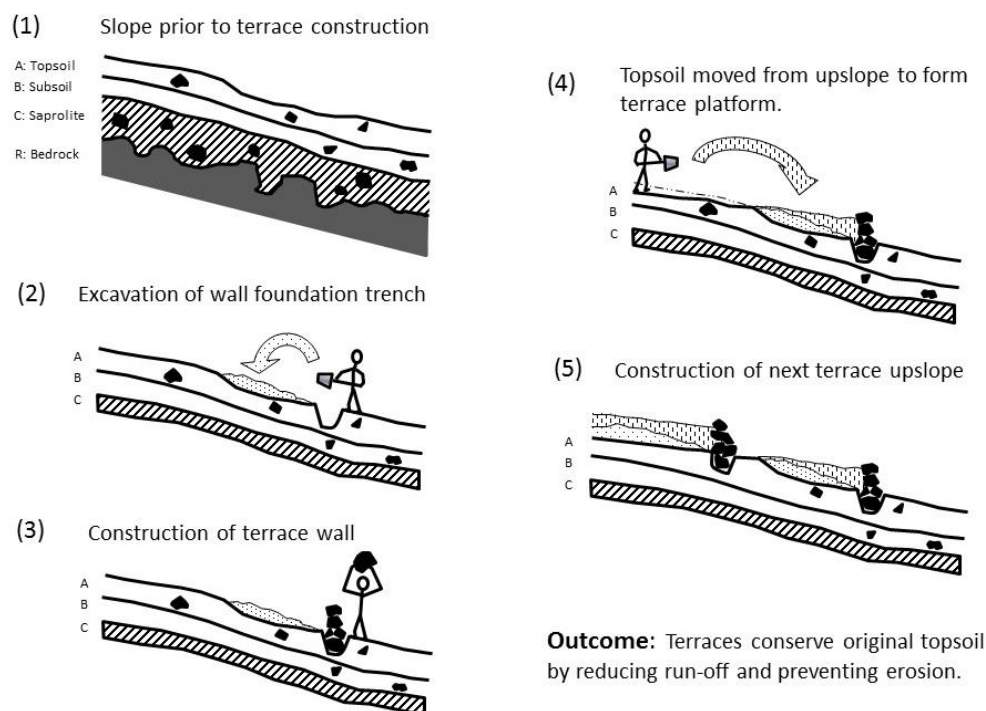
**Figure 2: Schematic representation of the process of hillside terrace construction as described to Beshah (2003). Compare this schematic to that based on excavation, Figure 4.**

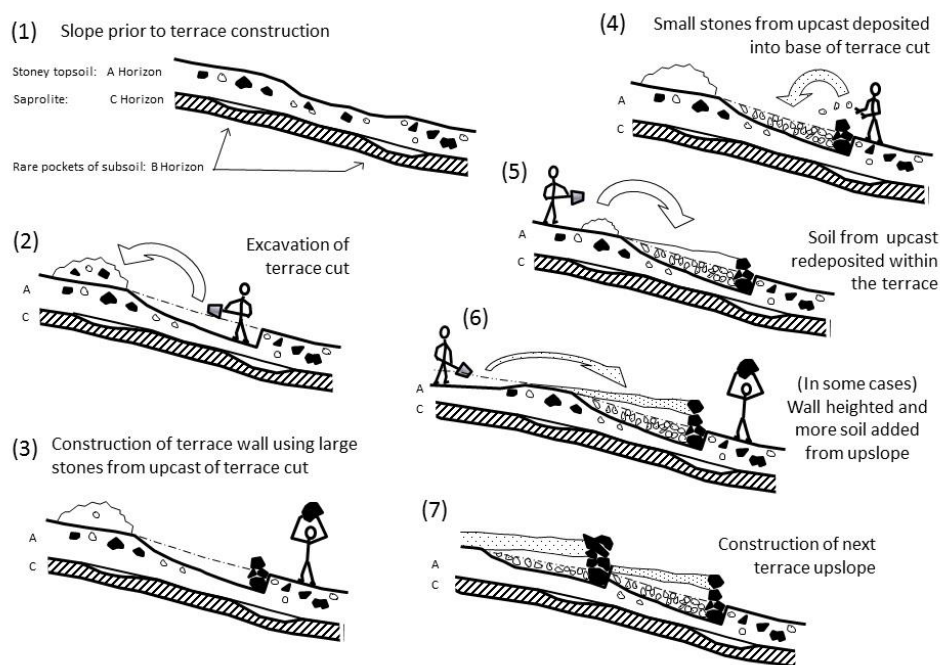
**Figure 4. Sequence of hillside terrace construction as revealed by stratigraphy and soil descriptions, demonstrating loss of original topsoil and most subsoil prior to terrace construction, and suggesting that terracing was undertaken partially to reduce the number of stones in the upper rooting zone. Compare this sequence to that described during interviews shown in Figure 2.**

Section 118 thus shows the construction of three and probably four terraces: first the terrace associated with wall (266), then that represented by stoney layer (268) and the subsequent palaeosol (269), followed by the terrace bounded on its downslope side by riser wall (271), and finally by the construction of wall (270). In terms of pedegenic classification the deposits thus form a 1Ap, 1BC, 2Ap, 2C, 3Ap, 3C, R sequence. This is perhaps clearest if illustrated, and a simplified schematic of this sequence is presented in Figure 4.

Since the stratigraphic sequence of the investigated hillside terraces shows that the agricultural landscape expanded up the slopes from the valley bottom (Figures 3, 4 and 6), this suggests the earliest terraces would have been conceived specifically as a means of protecting the agriculturally important and irrigable *yela* fields. Furthermore, the stratigraphy of the excavated locations, illustrated by the sequence of Section 118, shows that most of the terraces surveyed in the catchment have been constructed directly on the saprolite, indicating that the original slope material was already eroded when the terraces were built. This supports the idea that *yelas* were the key agricultural resource in an early stage of the system, as they were constructed and heightened by capturing topsoil that was being eroded from the non-terraced slopes upstream.
