Suspended timber ground floors: Heat loss reduction potential of insulation interventions

S. Pelsmakers^{a,*}, C.A. Elwell^b

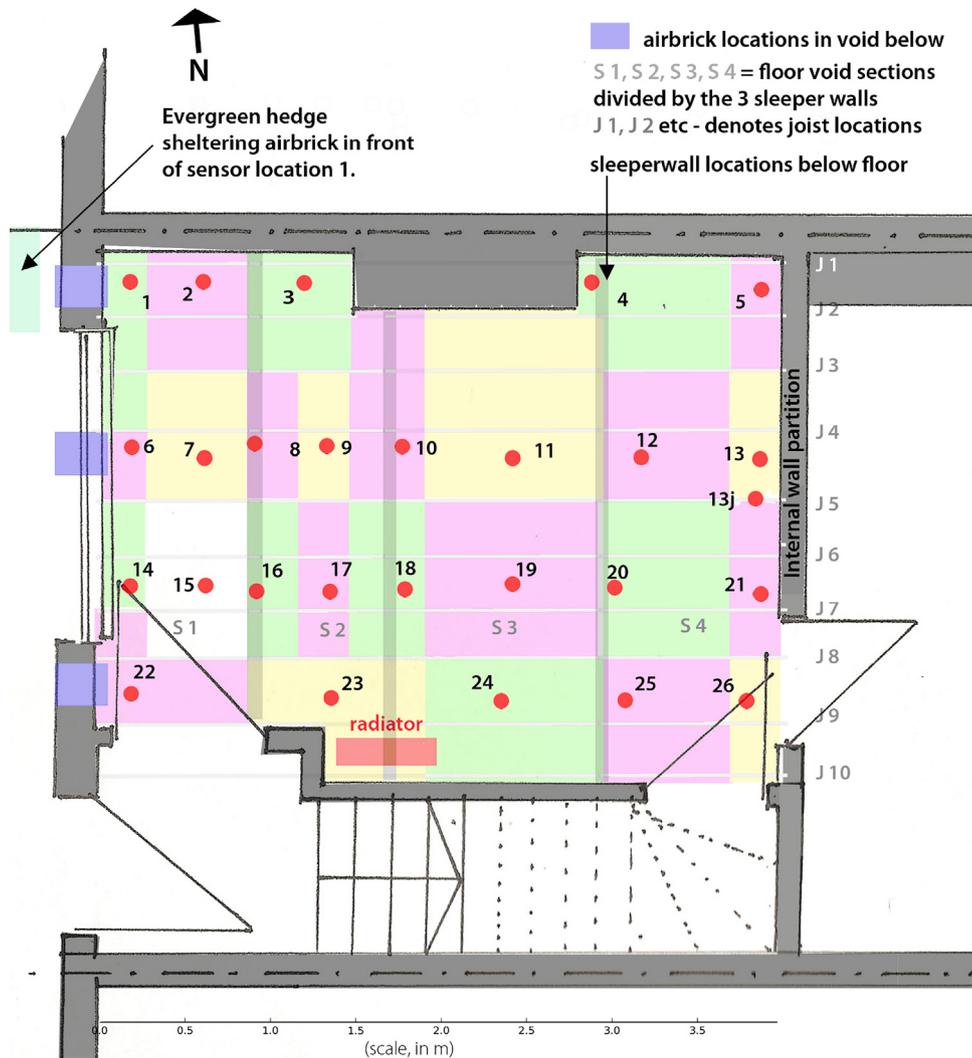
Fig. 1. Floor plan with heat flux sensor locations (red circles and numbered); airbrick locations (blue), and sleeper walls (grey). Approximate joist locations are marked with a faint grey line and annotated with J1, J2 etc. Location 13j is the only location measured on a joist. Portable radiant oil-filled electrical plug-in heaters are marked on the plan. Note that the colours have no meaning other than each colour distinguishes one representative area around a HF sensor from another. Representative areas were derived from infrared images. (For interpretation of the references to colour in this figure legend, the reader is referred to the web version of this article.)

An area weighted U -value (U_{wf}) was obtained by defining areas (as shown in Fig. 1) around each heat flux sensor for the uninsulated floor, for which its measured per unit area heat flux was considered the most representative available. This was achieved by detailed thermography, whereby surface temperatures were inspected and areas of similar surface temperature around heat flux plates identified. This informed method of area selection around each sensor ensures that construction-specific heat flow characteristics can be identified (such as near the perimeter and airbricks) and area-weighted to reflect the extent of these effects. This method reduces spatial uncertainty associated with sensor placement, which would not be accounted for in simple averaging. Instead the U_{wf} -value reflects the whole floor heat loss more accurately, and any differences were within the error margin when compared to simple averaging (U_{avg}) – see Table 3. Slightly different configurations of the areas made no significant difference on the final estimated U_{wf} -value. Generally lower U_{wf} -values were obtained compared to U_{avg} -values, but still within the margins of error, due to a slight bias towards a proportionally larger number of perimeter sensor locations given their limited effect. Each sensor's individual estimated error is combined in a similar manner to obtain the whole floor estimated error margin. The estimated whole floor U -value for the woodfibre insulated floor is $0.36 \pm 0.07 \text{ Wm}^{-2} \text{ K}^{-1}$, which is a mean U_{wf} -value reduction of 65% compared to the uninsulated floor. As expected, the bead insulated floor had a low estimated whole floor U -value ($0.09 \pm 0.03 \text{ Wm}^{-2} \text{ K}^{-1}$), due to both the $\sim 3.6 \text{ m}^3$ of

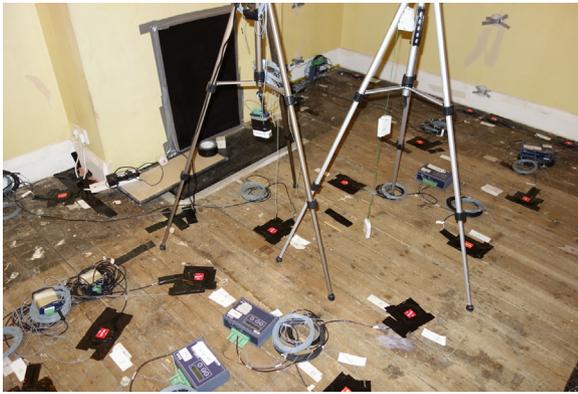
Fig. 3. Post-bead insulation with monitoring instruments in place.

Loose graphite coated EPS beads ($\lambda = 0.033 \text{ Wm}^{-1} \text{ K}^{-1}$ [50]) were blown into the full depth of the four floor void sections, allowing the insulation of floors without the disruption of lifting and re-fitting all of the floorboards. As the entire floor void depth is filled with EPS beads, and to avoid beads spilling out, airbricks were sealed with airtightness tape and covered with waterproof plastic boxes on the outside and bubble wrap on the inside. However this is yet to be proven appropriate, as airbricks are in place to regulate moisture in the void [51–53]; the long-term impact of sealing airbricks remains uncharacterised at present. Four floorboards – one in each section – were lifted to fill the entire 250 mm floor void under the joists and in between and up to the top of the 100 mm joist height, using the same equipment as cavity blown EPS beaded insulation, without the binding agent to allow for later removal of the beads by vacuuming them out. After mechanical filing, beads were manually filled and smoothed to the top of the joists – see Figs. 2 and 3.

After bead removal,² all instruments and floorboards (as illustrated in Fig. 3) were removed and 100 mm woodfibre insulation ($\lambda=0.038 \text{ Wm}^{-1} \text{ K}^{-1}$ [54]) was installed between the joists (see Fig. 4), held by a tightly stretched and stapled breather membrane suspended over and under the joists with taping of overlapping joints. This is a typical insulation solution, but generally the insulation is a more flexible product such as mineral wool, which can be more easily inserted between unevenly spaced floor joists and often installed DIY [55,56] and held in place by netting. Reduced insulation had to be fitted where radiator pipes and services encroached in the space between joists, as was the case near sensor locations 23–26. Near the airbricks, the insulation was also reduced by chamfering the edge to allow airflow underneath (see Fig. 5). Insulation was fitted tightly between the joists to minimise any air gaps which could lead to increased convective heat loss [57]. The airflow between sleeper wall sections was likely significantly reduced due to the insulation being installed between joists, which were the largest openings between floor void sections prior to insulation (see Fig. 6).

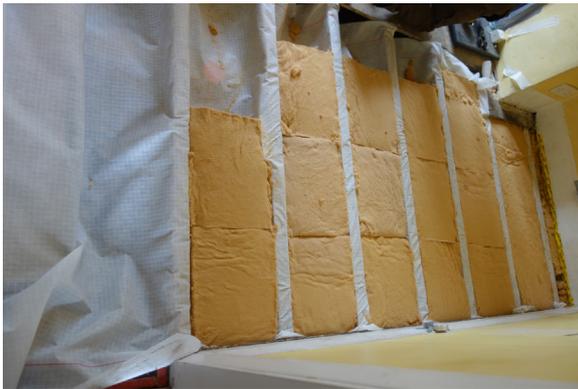
Fig. 4. Installation of woodfibre insulation in between the joists, held in a breather membrane over and under joists.

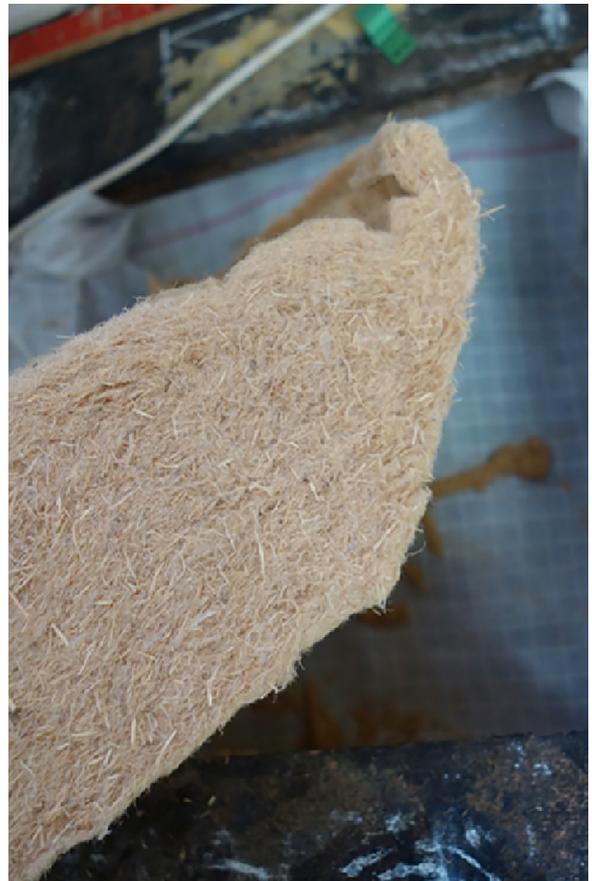
Fig. 5. Close-up of the chamfered woodfibre insulation to enable airbrick airflow.

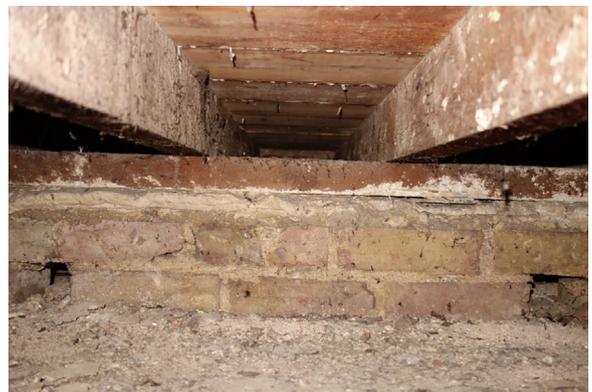
Fig. 6. A typical sleeper wall, showing also the openings between the joists, which were filled with insulation and hence leading to significantly reduced airflow between different floor sections.
