Deposited via The University of Sheffield.

White Rose Research Online URL for this paper:

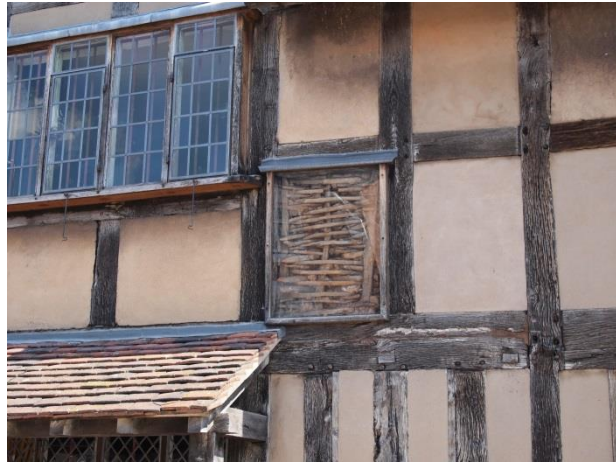
12 *Figure 2* Half-timber frame with wattle and  
daub infill

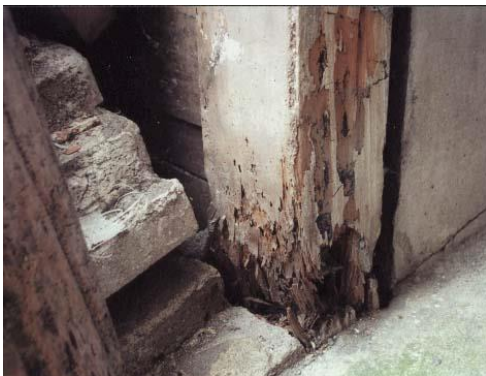
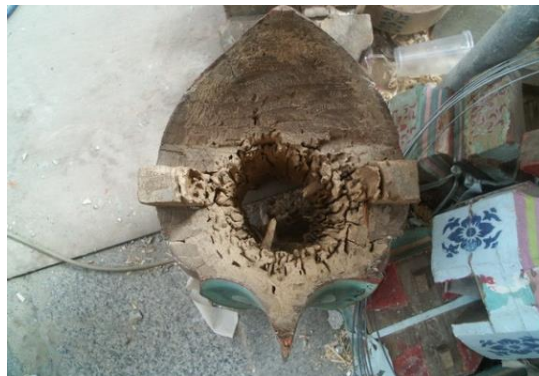
*Figure 3* Bio-deterioration in a column that has contact with the ground      *Figure 4* Timber strut attacked by termites

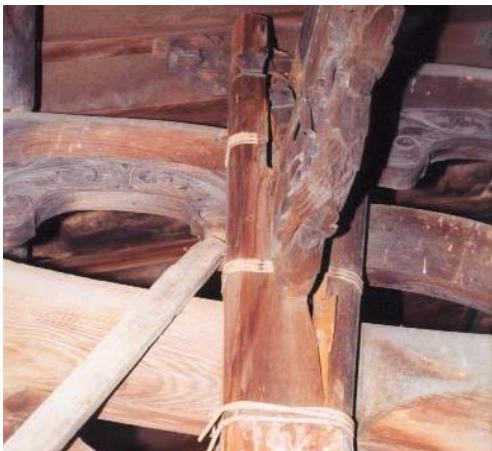
*Figure 5* A column damaged due to an earthquake

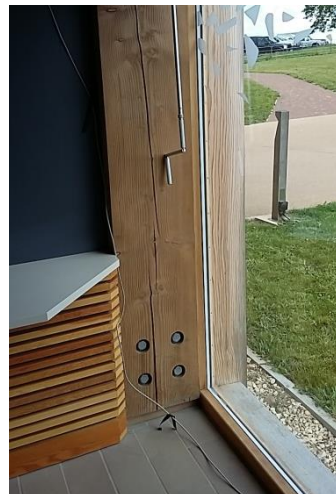
*Figure 6* Vertical cracks occur in a column

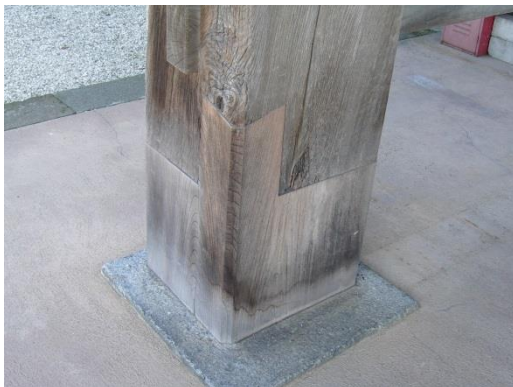
*Figure 7* A new timber component was used to partially replace a rotten column with traditional carpentry

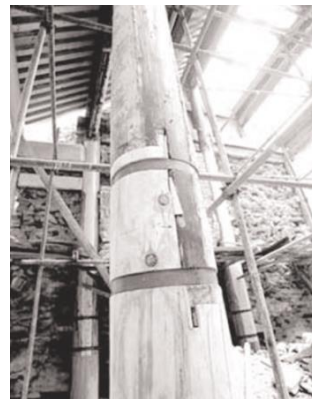
*Figure 8* Partial replacement repair in Daibei Temple (1550), China [4]

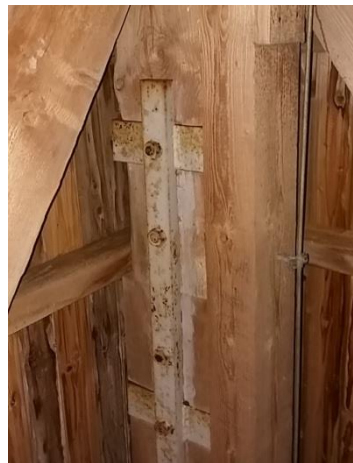
7  
 8 *Figure 11 Steel members are used to connect two columns to transfer load*  
 9

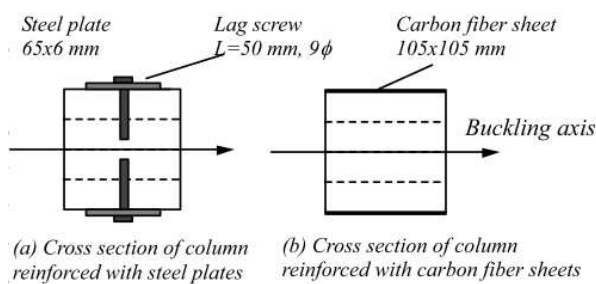
*Figure 12 Section of the columns reinforced by steel plates and carbon fibre sheets [6]*

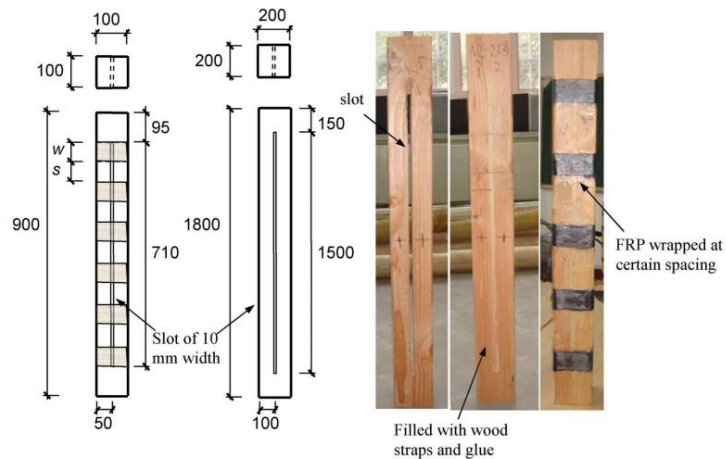
1  
2 *Figure 14* The specimens and different factors considered in the series of tests carried out by  
3 Zhang et al. [12]

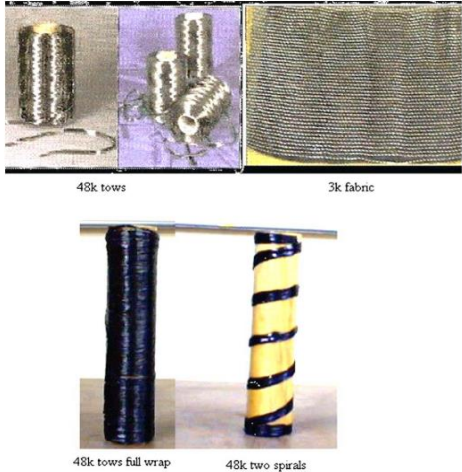
Figure 15 Column specimens and carbon reinforcement used by Najm et al. [16]

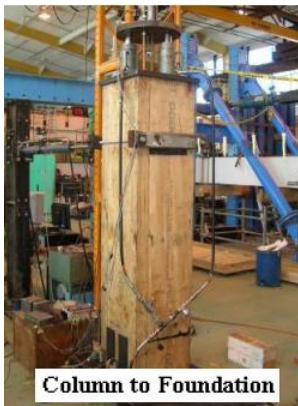
Figure 17 Column to foundation specimen with post-tensioned reinforcement and external energy dissipater [18]

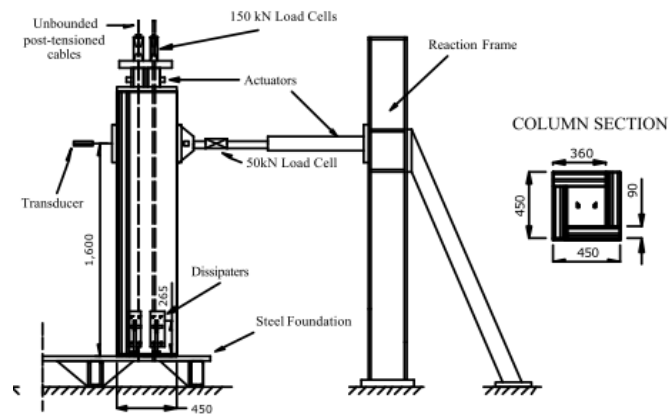
Figure 18 Experimental setup for post-tensioned strengthening of LVL column [17]

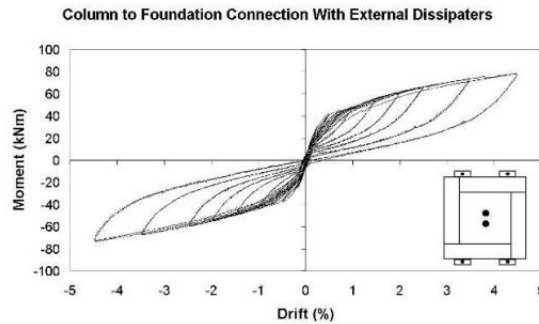
Figure 19 Hysteretic loop of a post-tensioned strengthening LVL column [17]

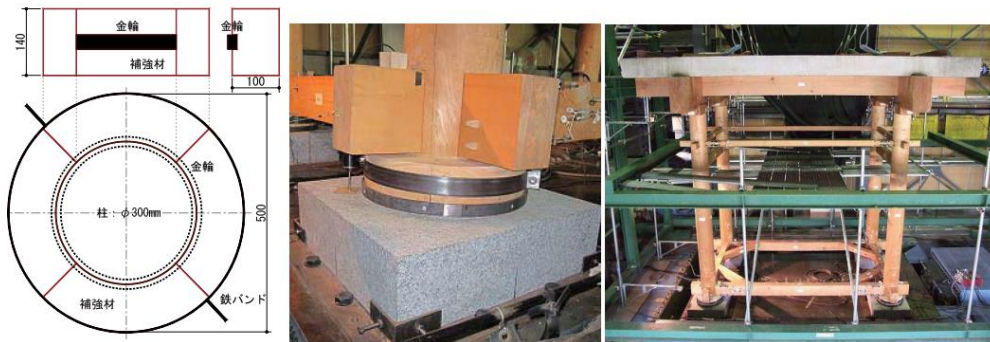
Figure 20 Enlargement of column base proposed by Suda, Tasiro and Suzuki [20]

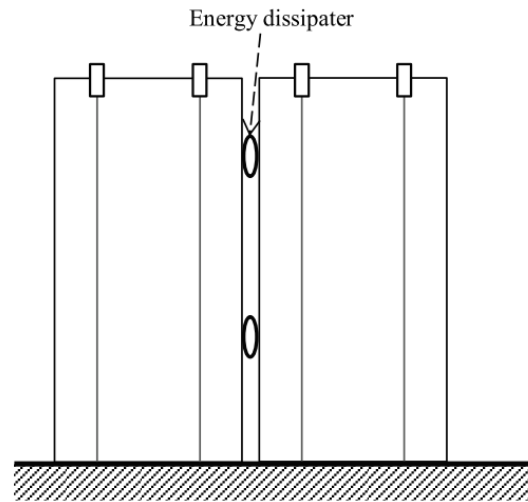
Figure 24 Schematic illustration of coupled post-tensioned timber shear walls

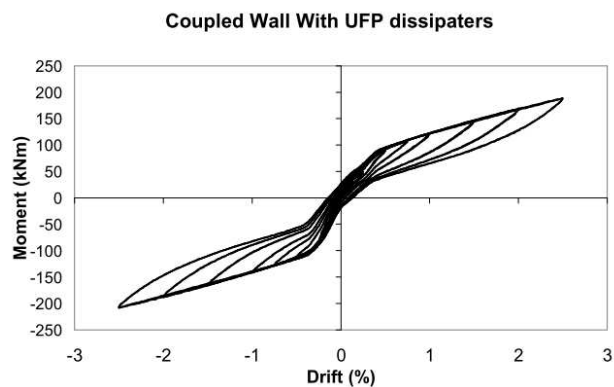
Figure 25 Hysteretic loop of coupled walls [17]
