Zhang, B. and Marshall, M.B. (2018) Investigating the Application of a Honeycomb Abradable Lining in the Turbine Stage of an Aero-Engine. *Tribology International*, 125. pp. 66-74. ISSN: 0301-679X

Abstract

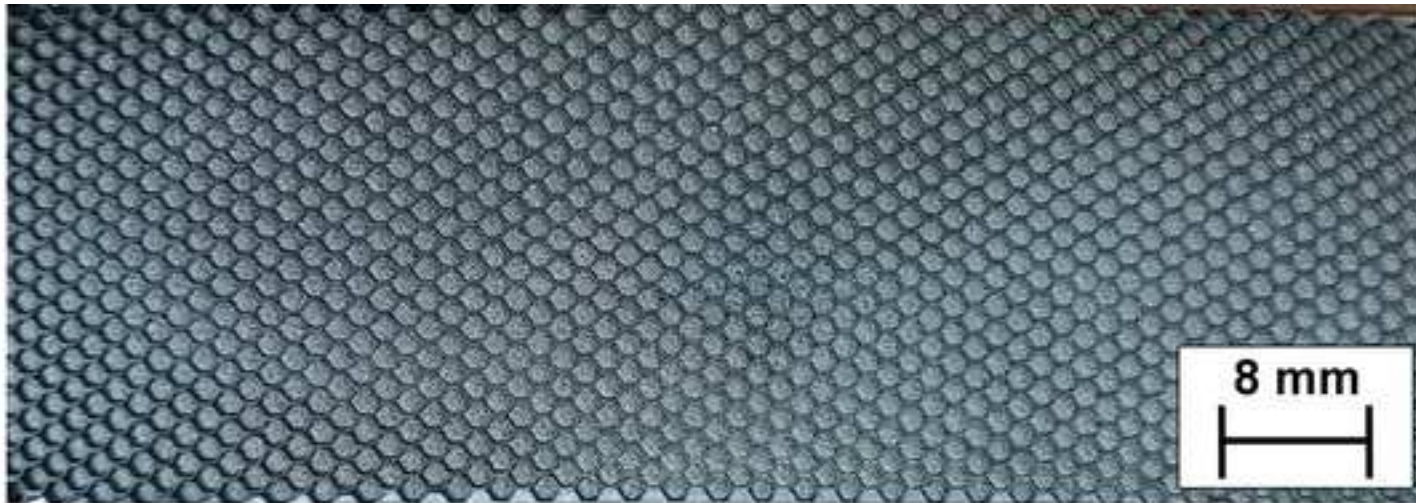
a) Honeycomb Abradable Sample

The abrasible samples used in this study consisted of a nickel superalloy honeycomb structure with nickel aluminide filler (Figure 2a). The first three samples were in the un-aged condition and had a standard, nickel rich and aluminium rich filler respectively. The nickel-aluminium powder, which is also called nickel aluminide, has two phases, NiAl and Ni₃Al; and these phases shift with different nickel contents [15]. Generally, Ni₃Al is harder and has lower thermal conductivity than NiAl [16-18], and it is also important to note that NiAl transforms to Ni₃Al under high temperature [19]. The standard filler has a Ni-Al weight ratio of 86%-14% [5], which is typically used in aero-engines. The second set of samples have the same honeycomb structure and filler combinations, but this time are in the aged condition, to compare the effect of the ageing process. The ageing process is conducted by heating as-manufactured samples continually for 100 hours under 1000°C to simulate the real-life engine working environment. Following exposure to high temperature, the nickel aluminide is oxidised and produces NiAl₂O₄ [20]. NiAl₂O₄ has a spinel structure that leads to a very high level of hardness and very low thermal conductivities [21, 22].

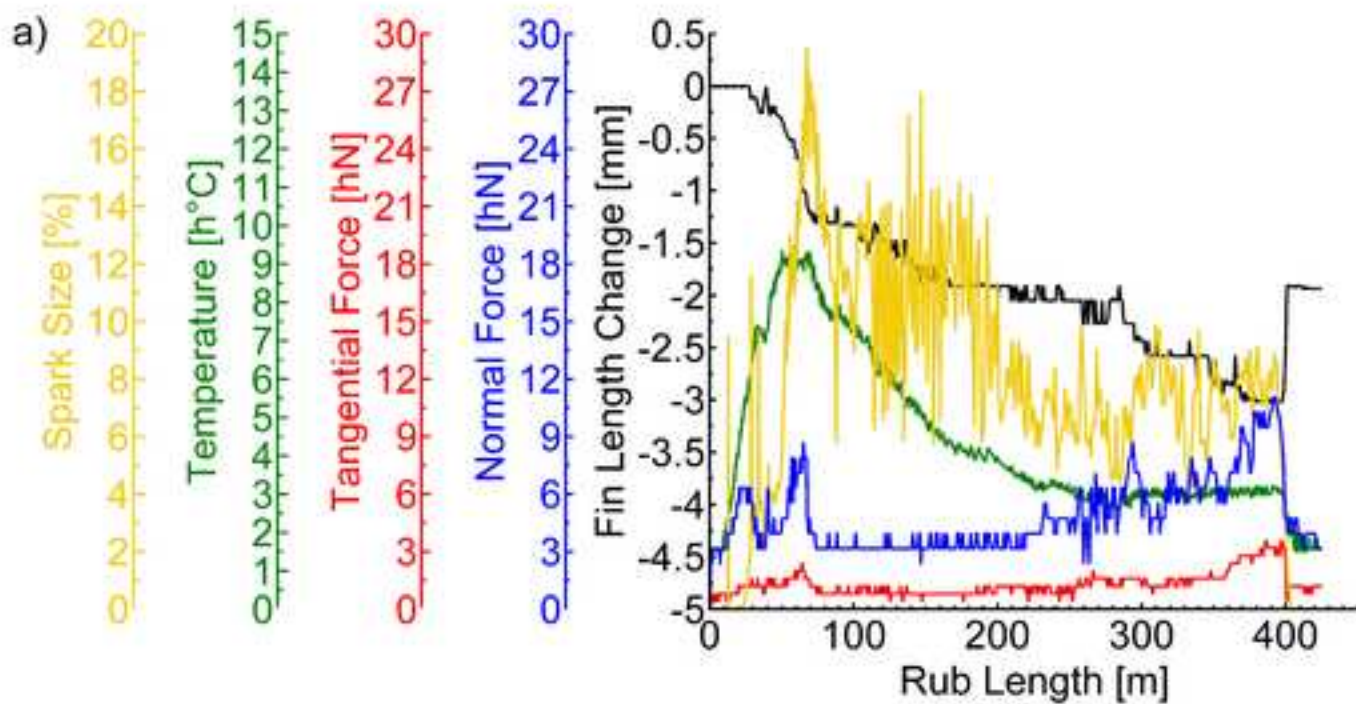
Figure 6 Test results for standard abrasives, a) Test - S b) Test – A,S

Figure 6 shows the fin length change, force (normal and tangential), temperature and spark results from the standard and the aged-standard tests. These results have been selected as they contain features typical of the different incursion tests. As shown, after the start of the test the force and temperature at the contact point increase and reach a peak value around a rub length of 50 to 60 meters. During this event the fin length begins to shorten, and just prior to the force and temperature reducing, a spark (represented by the spark size) is released. As shown in Figure 6b, in some cases cyclic behaviour is also observed with this process repeated periodically during the test. In other cases, as shown Figure 6a, the test is more stable with less peaks in the force and temperature data. However, in the latter case it should be noted that sparks continue to be emitted.

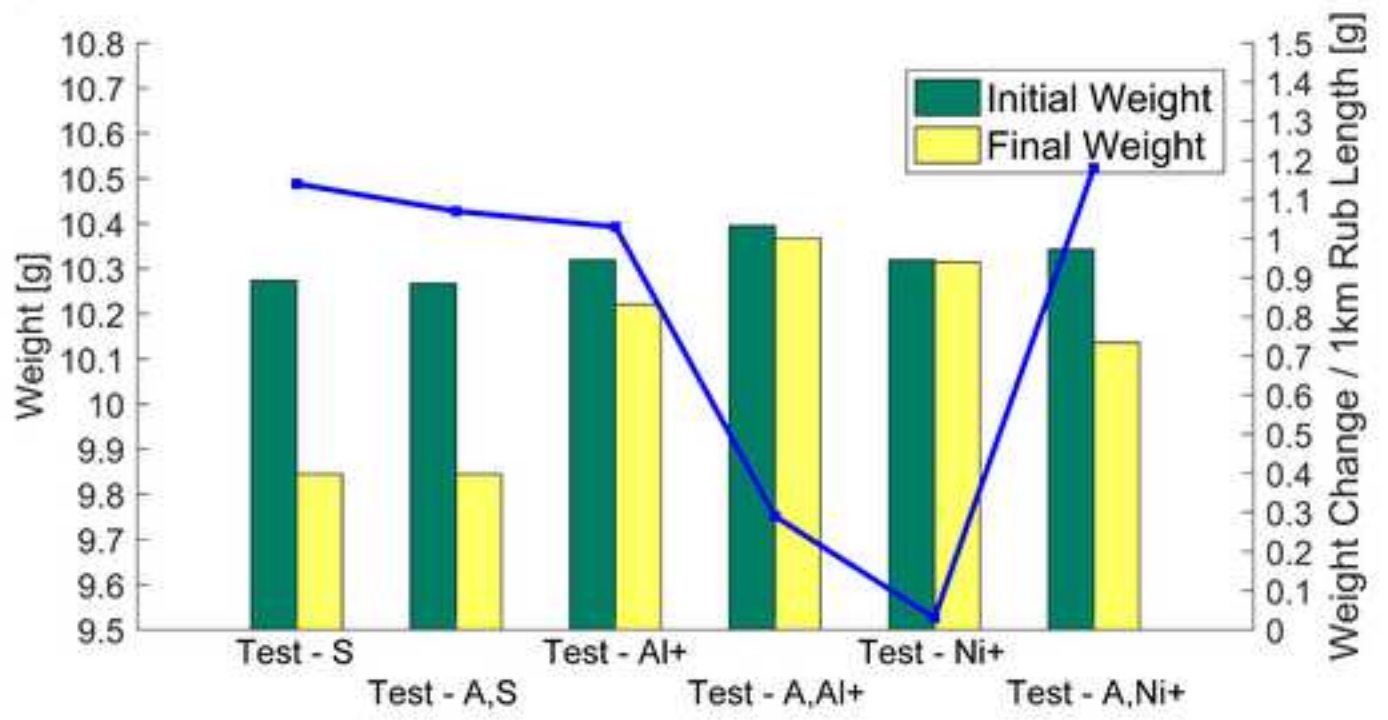
Figure 7 Fin weight change before and after incursion test

Further numerical analysis was applied to all the incursion test results in order to compare the different tests more directly. The fin wear condition was quantitatively analysed by measuring the fin length and weight before and after the test (shown in Figure 7). However, as noted, the total rub lengths were different between tests, meaning that further processing of results was required to make a valid comparison. Previous research has shown that material loss is proportional to rub length for abrasible material [10]. Therefore in order to compare between the six tests, the fin length and weight change was normalised with respect to total rub length, and is similarly shown on Figure 7. As shown in Figure 7, both standard and aged standard abrasibles suffer significant wear damage as does the aged nickel rich one. It should also be noted that even though there is no fin length change observed after the test with nickel rich abrasible, the fin weight is slightly reduced. As shown in Figure 5, in this case the loss of material can be seen on the leading edge of the fin tip, where the tip coating is slightly removed due to wear. As a general point, the fins tested with aluminium rich abrasibles tend to experience less wear, with this especially true for the aged case.

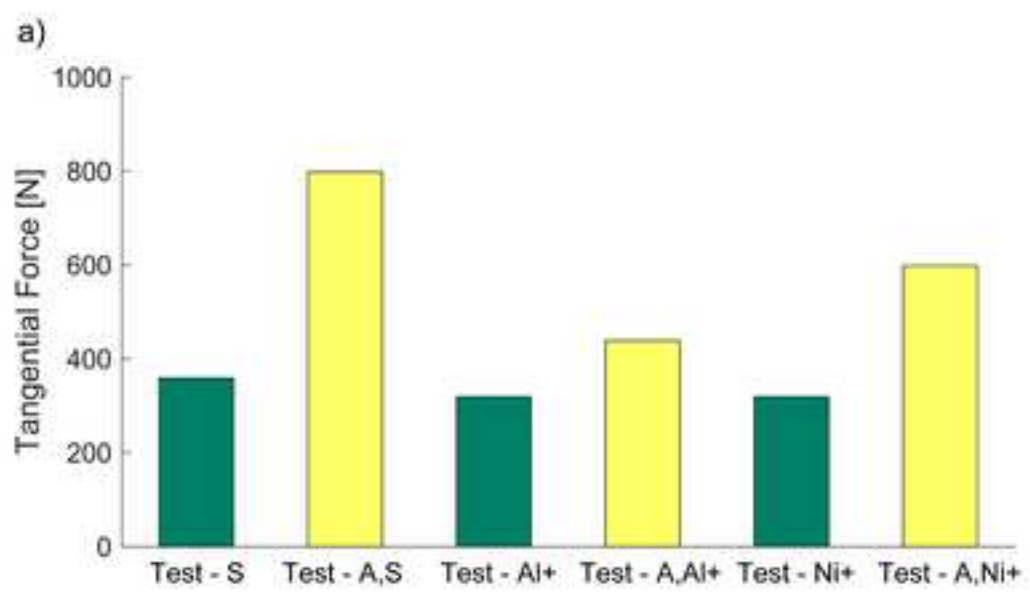
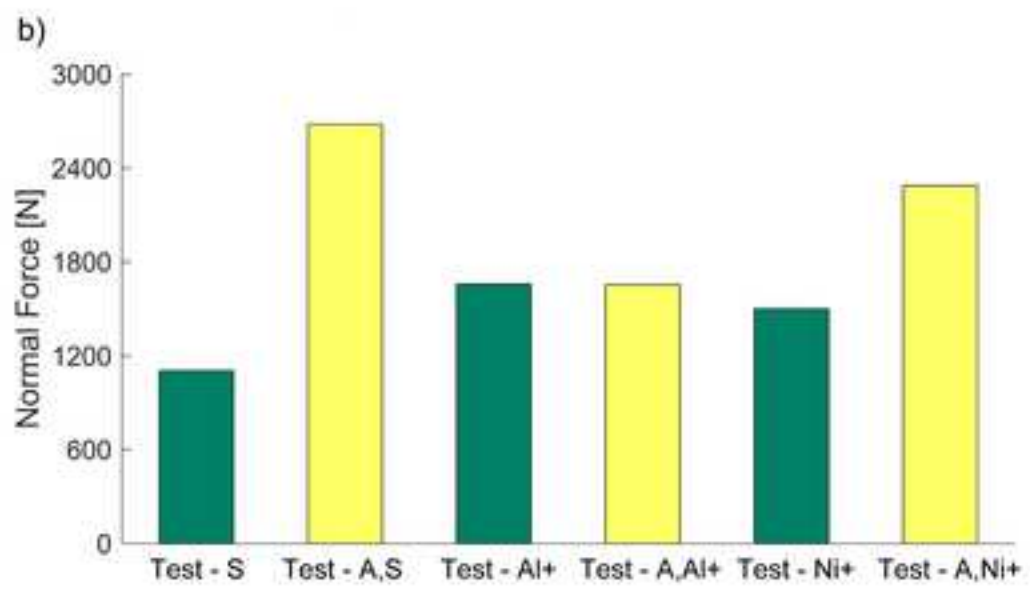
Figure 8 Comparison of maximum force and temperature

The maximum force and temperature data were extracted from the steady state test results to evaluate the difference between each test (Figure 8). With regards to force, it can be observed that the maximum tangential forces of the tests with aged abrasives are higher than the un-aged ones. The temperature results also suggest that more frictional heating is generated during the tests with aged abrasives. It is also interesting to note that there is more variation in the force results for the aged abrasives than compared to the un-aged case; where with the exception of the normal force for the standard un-aged abrasive, normal forces are similar for all the filler types, as are the tangential forces.

As will be discussed later, the link between force and temperature is complicated, as changing the aluminium-nickel ratio in the filler changes the thermal diffusivity and mechanical properties. For example, the nickel rich abrasive has relatively high forces, but lower temperatures when compared to the other tests. However, what is clear is that upon ageing a given abrasive, both the force and temperature rise, suggesting that additional frictional heating occurs.

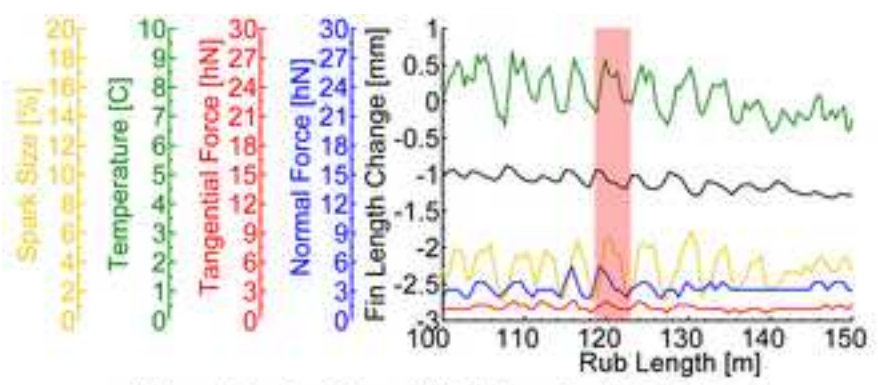
Figure 11 General results of incursion test with aged standard abrasible

a) Incursion Test Result (Rub Length: 100 - 150 m)

b) Wear Groove Surface View

c) Wear Groove Sectioning View

As highlighted in the results section, cyclic behaviour in terms of force and temperature has been observed, coupled with sparking. This behaviour occurred in the tests with standard, aged standard and aged nickel rich abrasibles, and was similar in nature to that observed in previous studies [13]. As shown by the microscope images in section 4.1, the groove surfaces on these abrasibles is coarse, with the microscopic images presented in section 4.3 suggesting that this type of surface is made up of two layers. The upper layer is shiny, with XRF results suggesting that the shiny layer is consolidated material from both the abrasible and fin tip. The lower layer is rough, and has a relatively dark colour, and has been identified as the filler in a compressed powder form. Further, the fractured nature of the upper layer also indicates it cracks and periodically peels off, resulting in the observed coarsely worn surface.

Combining these observations with the cyclic force and temperature behaviour recorded during tests, the sparking mechanism can be divided into four steps, and is summarised in Figure 11. Taking the aged standard abrasible as an example, initially the fin tip touches the abrasible surface and the abrasible is compacted. This results in high forces and frictional heating as the material is compressed, leading to a hard dense metal layer containing a mixture of fin and abrasible material. As the incursion progresses, force and temperature continue to rise, until at a certain point ductility in the compacted layer is exceeded and fracture occurs. The solid surface then splits into small hot chips and is peeled away due to the high forces, resulting in sparks. The ejection of material then leads to a gap,
