This is a repository copy of *Durability and degradation mechanisms of GFRP reinforcement subjected to severe environments and sustained stress*.

Fergani, H., Di Benedetti, M. orcid.org/0000-0001-7870-1323, Mias Oller, C. et al. (2 more authors) (2018) Durability and degradation mechanisms of GFRP reinforcement subjected to severe environments and sustained stress. *Construction and Building Materials*, 170. pp. 637-648. ISSN 0950-0618

Durability and degradation mechanisms of GFRP reinforcement subjected to severe environments and sustained stress

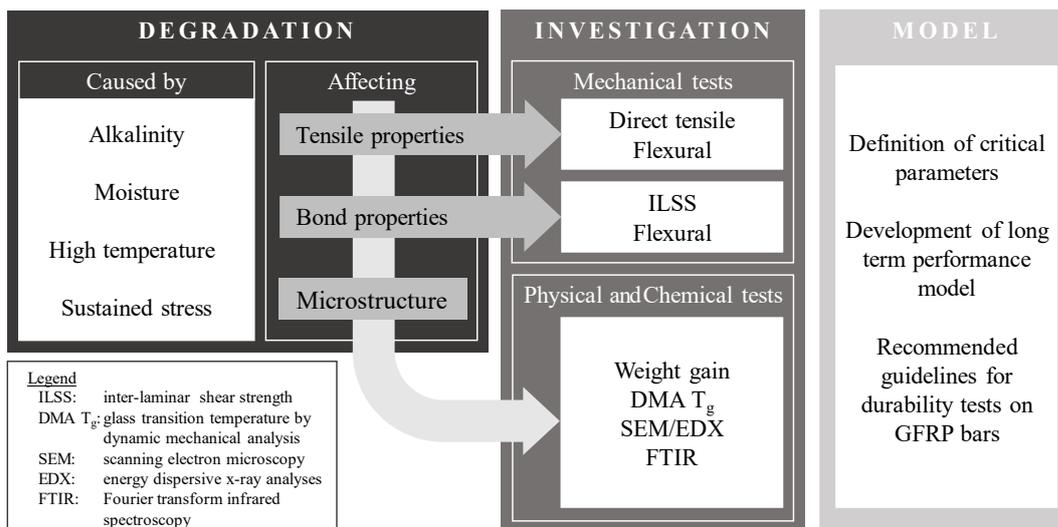
100 **Fig. 1.** Overview of experimental program.

88 **Fig. 1** presents a flow chart summarizing the complementary experimental program carried out in this
 89 research. The flow chart is divided in three sections: Section 1 – Degradation; Section 2 – Investigation; and
 90 Section 3 – Model. Section 1 shows the conditioning parameters (i.e. moist and alkali environments, high
 91 temperature and sustained stress) considered in this research and the GFRP bar properties that are affected (at
 92 both the macro level - tensile and bond properties - as well as at the micro level). Section 2 summarizes the
 93 tests used to assess the investigated material properties. The use of this complementary set of tests was
 94 implemented to enable a more comprehensive assessment of the degradation processes based not only on the
 95 outcomes of the mechanical tests but also on the results of the physical and chemical tests. Section 3 is
 96 presented in the chart as the logical convergence of this study, however a durability model still being

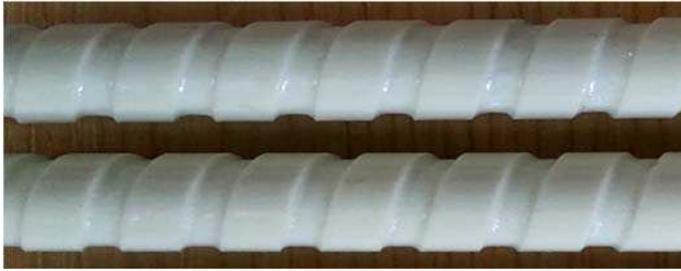
108
109 **Fig. 2.** Appearance and surface geometry of the bar specimens

102 The test matrix (Table 1) consisted of 334 GFRP samples obtained from bars with a nominal diameter of
 103 8mm. The GFRP bars used in this research work are commercially available and made of continuous E-
 104 CR Glass fibres impregnated with a vinyl ester resin and a glass fibre content of approximately 88% by
 105 weight. After the bars have gone through the pultrusion process, ribs are cut in the hardened bars and their
 106 surface is subsequently coated (**Fig. 2**).

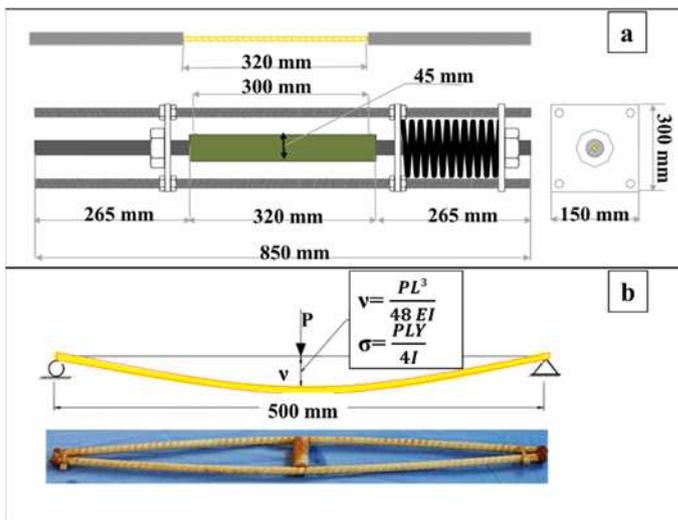
137
138 **Fig. 3.** Sketch illustrating the methods of application of sustained stress for (a) tensile and (b) moisture absorption test
139 specimens.
140

121 A sustained stress inducing a tensile strain of 3000 µε was applied to the FRP bars as recommended in ACI
122 440.3R and CAN/CSA-S806 [22,21], while a higher stress inducing a strain of 5000 µε was examined to
123 assess the effect of less stringent serviceability limits (corresponding to larger allowable crack widths and
124 deflections) [29]. The sustained stress inducing the desired level of tensile strain was applied using two
125 different configurations: via a spring of adequate stiffness mounted in a stiff pre-tensioning rig (**Fig. 2-a**); or
126 by tying pairs of specimens at the two ends with a wedge interposed at mid-length to impose the required
127 curvature (**Fig. 3-b**). During the conditioning period, the strain level of the bars was measured periodically
128 using a caliper and demec gauge system. The length of the steel springs used in the loading system were also
129 checked regularly using a digital caliper with an accuracy of 0.02 mm to assure that the load was maintained

305 tend to propagate circumferentially around the outermost layer of fibres, while the cracks are concentrated on
306 the tension side of the stressed samples and propagate both radially and circumferentially as a result of the
307 three-point bending setup used to stress the specimens (**Fig. 3-b**).
308

417 The results from the ILSS tests show that the higher the conditioning temperature, the higher the strength
418 degradation, but also that stressed specimens experienced lower reduction in ILSS than unstressed ones.
419 Such findings are in good agreement with previous tests carried out in this study, suggesting that the
420 increased temperature favoured the ingress of moisture leading to a premature inter-laminar de-bonding and
421 that the state of stress induced using the test setup described in Fig 3b limited moisture ingress mitigating the
422 reduction in ILSS.

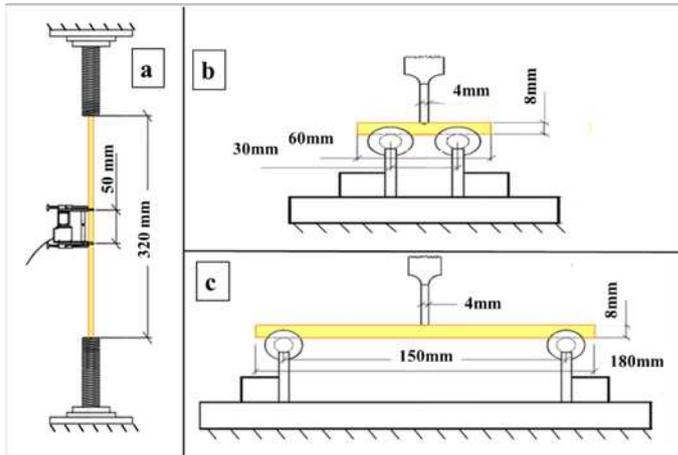
145 FLX), respectively. Data were recorded at 1 Hz using an NI LabVIEW data acquisition system. Details of the
146 setup of each test are shown in. **Fig. 4.**

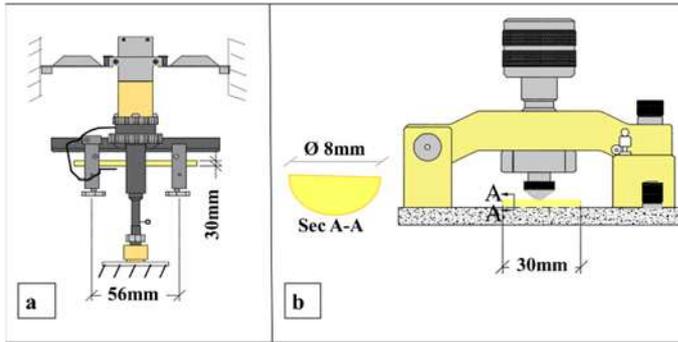
Fig. 5. Set up for (a) Tg and (b) FTIR tests.

160 conditioning environments at the same time, their surface was wiped dry with a cloth, and weighed
161 immediately. In addition, scanning electron microscopy (SEM), energy dispersive x-ray analyses (EDX) and
162 Fourier transforms infrared spectroscopy analysis (FTIR) were carried out following procedures available in
163 the literature [12, 34] (**Fig. 5-b**).

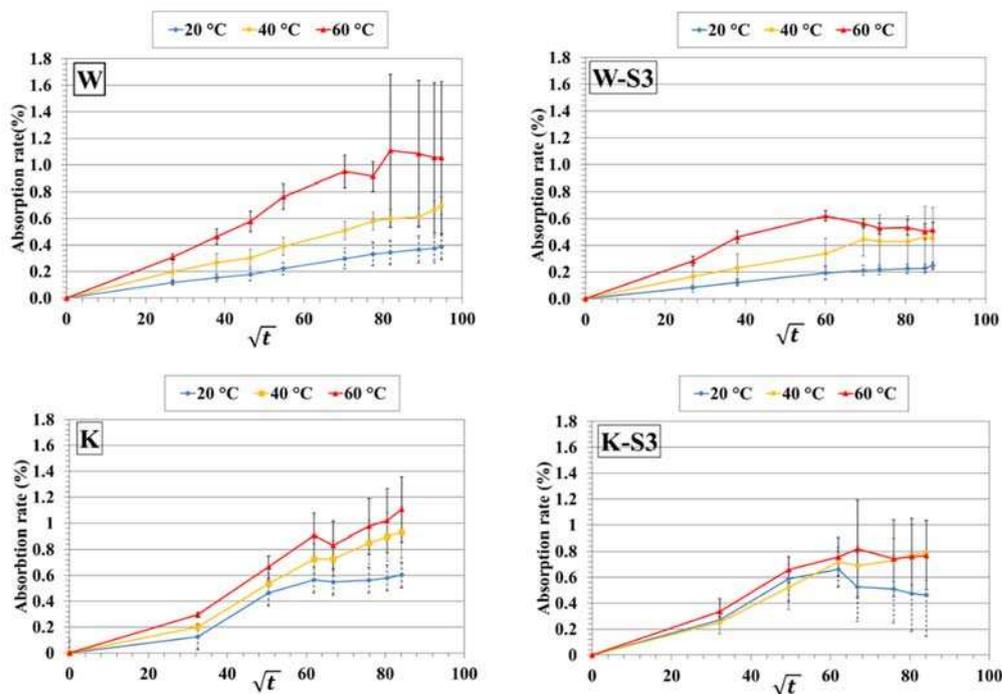
196 **Fig. 6** shows the absorption rate of stressed (S3) and unstressed GFRP bars in water (W) and alkaline (K)
197 environment against the square root of the exposure time. The absorption rate was calculated as the ratio
198 between the average moisture uptake and the initial weight.

200 **Fig. 6.** Moisture absorption rate of unstressed and stressed (S3) GFRP bars immersed in water (W) and alkaline solution
201 (K) at different temperature.

203 In all samples, weight increased gradually with respect to the exposure time, following the Fick's law up to
204 about 4500 hr ($\sim 67 \sqrt{\text{hr}}$). At this stage, the diffusion mechanism started to become unstable (non-Fickian
205 behaviour) resulting in absorption rate curves characterized by portions of weight loss, due to the degradation
206 of the outer layer leading to material loss, and by portions of weight gain, possibly due to the filling of new

207 or pre-existing voids and micro cracks. While no saturation was reached at the end of the considered ageing
208 period (8760 hr - $\sim 93 \sqrt{\text{hr}}$), stressed samples consistently showed a lower moisture uptake than unstressed
209 ones. This phenomenon could be attributed to the method used to stress the samples (i.e. bending, **Fig. 3b**)
210 which reduces the number of open pores in the portion of the bar in compression. This is discussed further in
211 section 4.2.2. In addition, the exposure temperature played a critical role on the absorption process. The
212 measured data showed that the higher the temperature the higher the absorption rate. This can be attributed to
213 an increase in the chemical reactions rate as well as to a higher void pressure resulting from an increase in
214 the volume of gases as temperature rises. This pressure build-up favoured the propagation of micro cracks

215 and consequently increased the free volumes within the bars that could be filled by the surrounding solution.
216 It can be finally observed that, for all temperatures, specimens exposed to alkali solution showed slightly
217 higher moisture uptake than those exposed to tap water as the former contains more free hydroxide ions (OH^-

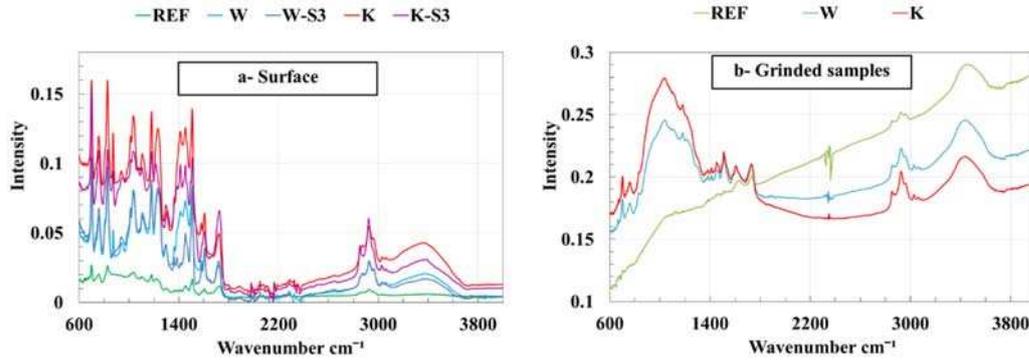
237
 238 **Fig. 7.** FTIR spectra for the resin matrix on (a) the surface of GFRP bars and on (b) grinded samples. Results for
 239 unstressed and stressed (S3) specimens conditioned in water (W) and alkali solution (K) at 60°C for 8760 hr are
 240 compared to benchmark samples (REF).
 241

230 substances. Thus, changes in the OH/CH (I3400/I3026) and $\text{C}=\text{O}/\text{CH}$ (I1722/I3026) ratios as well as in the
231 $\text{C}-\text{O}/\text{CH}$ (I1295/I3026) ratio can be used to gage hydrolysis and oxidation reactions, respectively. Similarly,
232 changes in the $\text{C}=\text{C}$ peak, also referred to as curing index [35], were monitored to gain information on the
233 curing process.
234 The FTIR spectra were calculated on the surface of control (REF), unstressed (W and K) and stressed (W-S3
235 and K-S3) samples (**Fig. 7-a**) as well as on a deeper portion of control (REF) and unstressed (W and K)
236 samples (**Fig. 7-b**, grinded samples). All samples were conditioned for 8760 hr at 60°C.

242 The results of the FTIR analysis on the surface of the samples (Table 3) showed that all the OH/CH ratios
 243 increased with respect to REF and that such increase was more marked in unstressed samples than in stressed
 244 ones. This directly confirms that moisture entered the polymer matrix promoting the hydrolysis reaction and
 245 it also implies that stressed samples had lower chemical interaction (i.e., lower hydrolysis). As the intensity
 246 of OH was similar for unstressed samples (only slightly lower for K), the C=O/CH (I1722/I3026) ratio was
 247 used as an additional indicator of the hydrolysis reaction taking place and to assess the effect of the
 248 conditioning environment. The reduction in C=O/CH (I1722/I3026) was due to the breakage of the end of
 249 the vinyl ester chain and, as suggested by the lower value, the alkaline solution seemed to cause more
 250 breakage of the ester chain than water (i.e. more hydrolysis). Conversely, while oxidation occurred in all

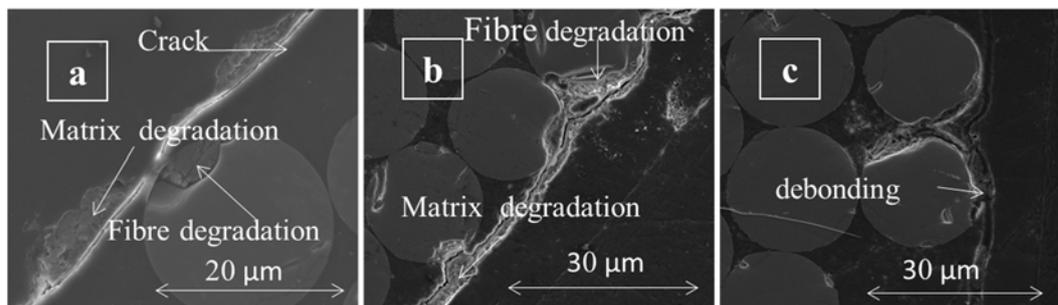
274
 275 **Fig. 8.** SEM images of the cross-sections of specimen conditioned in (a) water and (b and c) alkaline solution at 60°C for
 276 8760 hr.

263
 264 For both surface and grinded specimens, an increase in the C=C/CH (I920/I3026) ratio with respect to REF
 265 was observed (column 4 in Tables 3 and 4). This may be attributed to additional repeating units connecting to
 266 the backbone chain and increasing the number of benzene rings, and consequently the stiffness of the resin.
 267 The ratio of C=C/CH at different locations of the polymer chain (i.e. 1608/I3026) (column 5 in Table 3, 4)
 268 showed a reduction in the outer layer and an increase in the inner part of the bars, thus providing evidence of
 269 degradation on the surface and post curing of the core portion of the bars.
 270 Additional evidence of matrix deterioration (i.e. cracks, voids and de-bonding from the fibres) was provided
 271 by the SEM images of the outer layers of GFRP bars conditioned in water (W) and alkaline solution (K) at
 272 60°C for 8760 hr (Fig. 8).

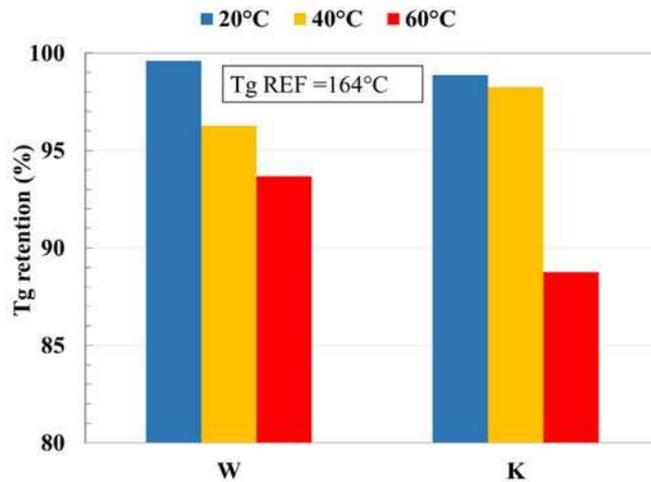
287
 288 **Fig. 9.** Change in glass transition temperature (T_g) for the core of specimens conditioned in water (W) and alkaline
 289 solution (K) at different temperatures for 8760 hr.

282 to the storage modulus (E') method. Fig 9 shows that the change in T_g was negligible for low temperatures,
 283 while a reduction of more than 5% was observed at 60°C for both environments. Since a reduction in T_g
 284 indicates a reduction of transfer properties of resin matrix, it can be concluded that, at least at elevated
 285 temperatures, the matrix properties in the core of the specimens were also affected.
 286

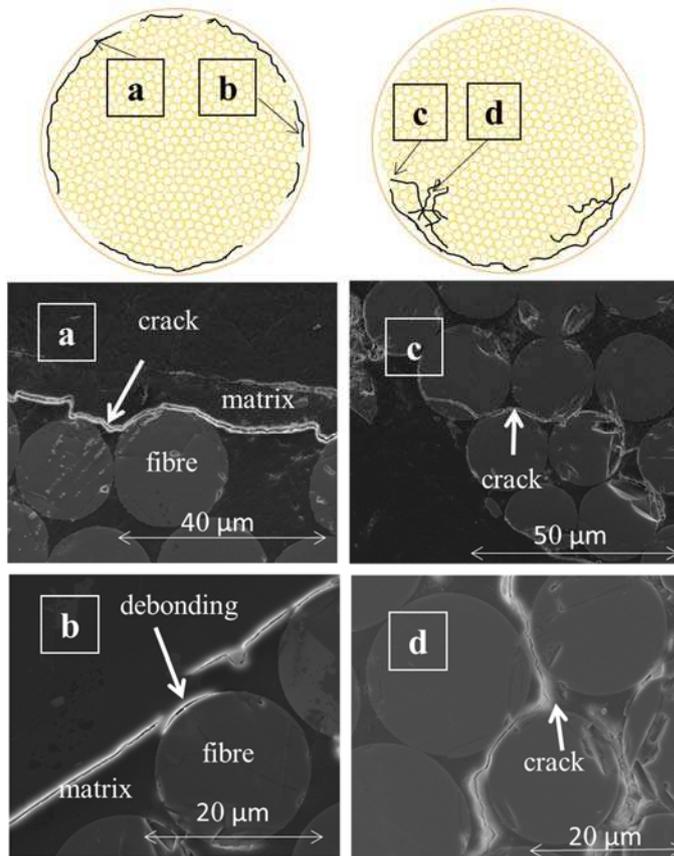
309 **Fig. 10.** SEM images of the cross sections of unstressed specimen (left) and stressed specimens (right) conditioned in
310 water at 60°C for 8760 hr.
311
312

299 **Fig. 10** shows, at the top, the typical crack pattern observed in the cross-section of unstressed (left) and
 300 stressed (right) samples, as well as the approximate locations where the SEM images (a, b, c and d) were
 301 taken. As no significant deterioration was seen in samples conditioned at low temperatures, only images of
 302 samples conditioned in water and alkaline solution at 60°C for 8760 hr are presented. These results confirm
 303 that moisture dissolved the saline substances at the interface causing local loss of bond between fibres and
 304 matrix (i.e., cracks and debonding). In addition, it can be noticed that for the unstressed sample the cracks

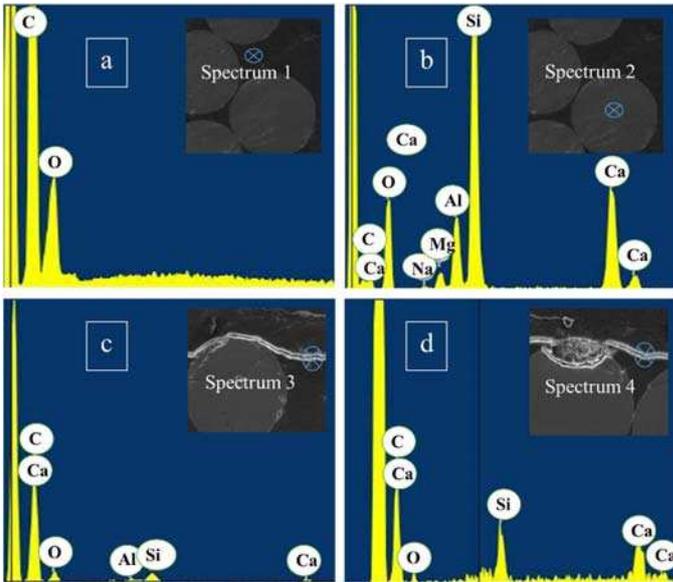
323
 324 **Fig. 11.** Results of EDX scans for specimens conditioned (c) in water and (d) alkaline solution at 60°C for 8760 hr are
 325 compared to benchmark samples for (a) matrix and (b) fibres.
 326

318 The results of the EDX analysis carried out on the matrix and the fibres of a reference sample (**Fig 11-a** and
319 **Fig 11-b**, respectively) and on the matrix of samples conditioned in water and alkaline solution at 60°C for
320 8760 hr (**Fig 11-c** and **Fig 11-d**, respectively) are presented in the form of the spectra displaying the
321 concentration (peaks) of each chemical element identified in the analysis.

327 In all figures, the location where the analysis was performed is indicated by a target. The EDX analysis
 328 detected the aforementioned chemical elements in the resin matrix near to the fibre/matrix interface both for
 329 specimens conditioned in water (W, **Fig 11-c**) and alkaline solution (K, **Fig 11-d**). This confirmed that water
 330 molecules and hydroxide ions, through micro-cracks in the matrix, reached the glass fibres deteriorating
 331 them. Additional evidence of the fibre deterioration within the outer layer was provided by SEM images as
 332 shown in **Fig. 12**.

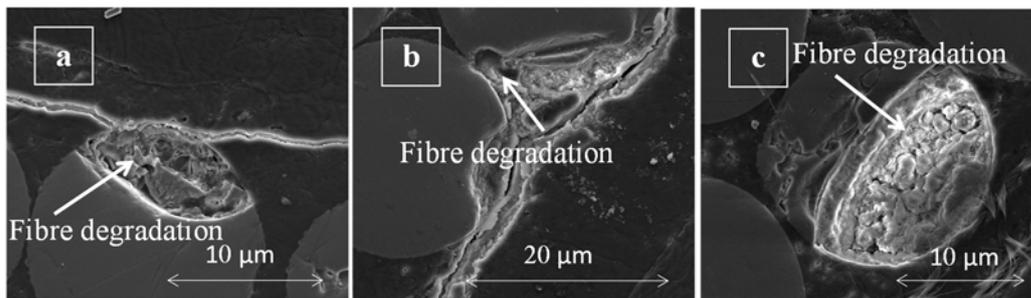
334
 335 **Fig. 12.** SEM images showing the degradation in glass fibres after conditioning in alkaline solution at 60°C for 8760 hr
 336

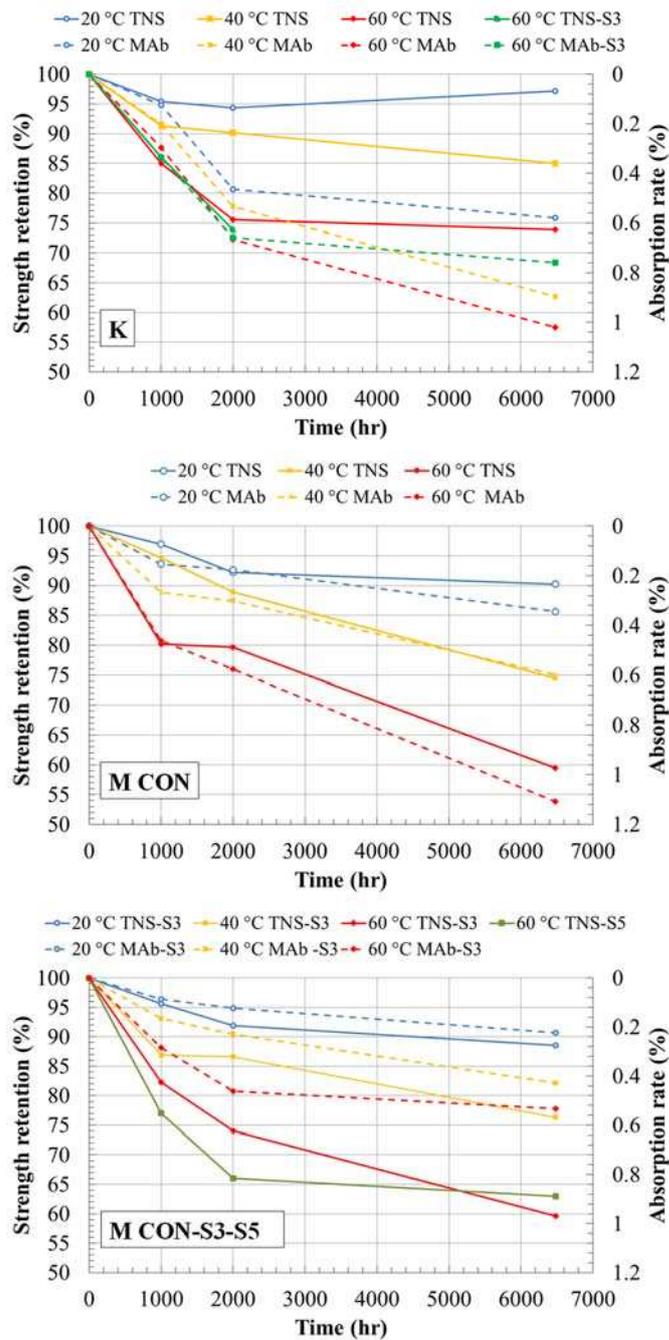
354 **Fig. 13.** Tensile strength (TNS) retention and moisture absorption (MAb) over time for unstressed and stressed (S3 and
 355 S5) bars conditioned in alkaline solution (K) and concrete (M-CON).
 356
 357

346 **Fig. 13** shows the tensile strength and moisture absorption rate over the conditioning time for unstressed and
 347 stressed specimens exposed to moist concrete (M-CON, M-CON-S3, and M-CON-S5) and alkaline solution

348 (K and K-S3) at 20, 40 and 60°C. The results indicate that tensile strength decreased as moisture uptake
 349 increased and these effects were accelerated by increasing the temperature. It should be mentioned that
 350 moisture absorption and strength retention were measured on different specimens configurations (see Fig. 3)
 351 and the different stress distribution within the direct tension specimens might have affected moisture
 352 absorption, which was possibly underestimated as a result of the different induced cracking pattern.
 353

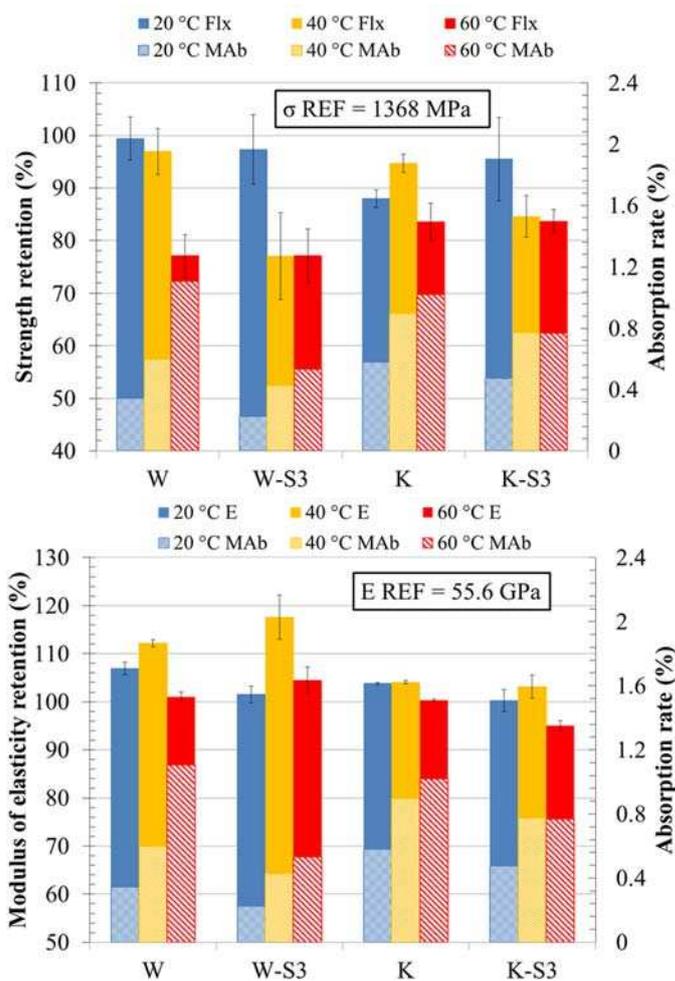
Fig. 14. Flexural strength (Flx) and modulus of elasticity (E) are compared to moisture absorption results (MAb) for different conditioning environments after 6480 hr.

386 The retention of mechanical properties is also shown in **Fig. 14** and **Fig. 15** along with the moisture

It can be noticed that the average flexural strength of all conditioned specimens decreased compared to the reference specimens. In particular, for exposures at 20 and 60°C, the higher the temperature, the lower the flexural strength, which is in line with the findings previously discussed for TNS and MAb tests. Conversely, at 40°C, the application of sustained stress appears to affect strength retention significantly, as the strength of stressed samples was much lower than that of unstressed ones. However, this behaviour was only recorded for flexural tests and the same trend was not observed in TNS and ILSS tests results. This can be attributed to the different state of stress and failure mode generated within specimens subjected to different test configurations. Although flexural tests are relatively simple to perform, the different behaviour of composite materials in tension and compression (with unidirectional FRP being typically characterised by a lower compressive strength) can result in underestimating tensile strength and in an increased variability of results. The variability in the results obtained from flexural tests can also increase for conditioned specimens, especially when deterioration occurs at the fibre/matrix interface and can affect compression behaviour. As stiffness is always determined within the perfectly elastic load-deformation range, the values determine for flexural stiffness generally agree well with those obtained from direct tension tests. The average values of the flexural modulus of elasticity increased marginally for most of the specimens, with the exception of samples conditioned in water at 40°C for which the flexural stiffness increased more than 10%. The overall higher stiffness could have been caused by post-curing of the matrix during conditioning. This is in line with the results obtained from the direct tension tests as well as the FTIR findings, albeit at lower temperature.

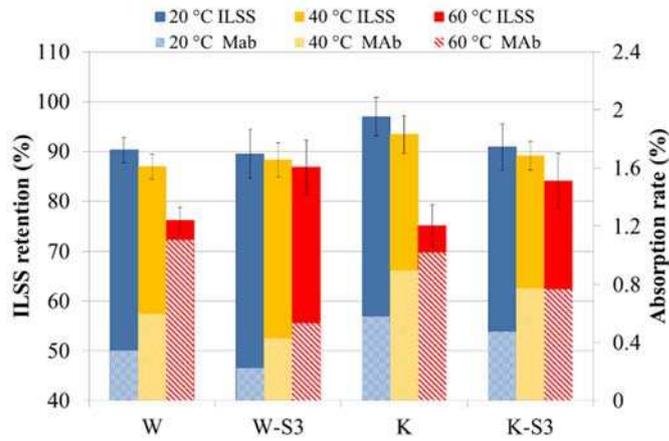
Fig. 15. Inter laminar shear strength retention (ILSS) is compared to moisture absorption results (MAB) for different conditioning environments after 6480 hr
