Brown, M., Wright, D., M'Saoubi, R. et al. (5 more authors) (2018) Destructive and non-destructive testing methods for characterization and detection of machining induced white layer: A review paper. CIRP Journal of Manufacturing Science and Technology. ISSN 1755-5817

Destructive and non-destructive testing methods for characterization and detection of machining-induced white layer: A review paper

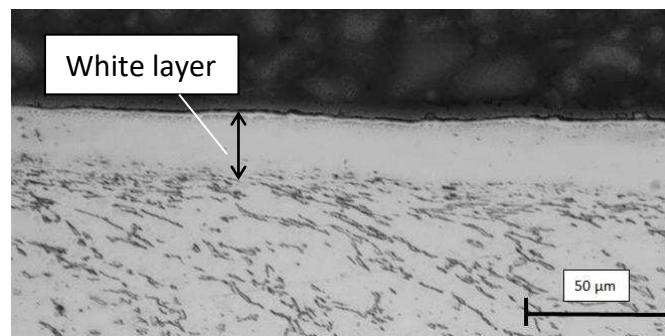
Figure 1. A 25 μm white layer in milled Ti-6Al-4V (Cutting speed = 40 m/min, axial depth of cut = 2 mm, radial engagement = 16 mm, artificially worn insert VB = 0.5 mm). The image is the Author's own obtained through optical microscopy of an etched titanium sample.

In industry, white layer is typically defined as a region at the machined surface, in the cross-section, in which the microstructure cannot be distinguished at a magnification which allows the bulk microstructure to be easily resolved, as demonstrated in Figure 1. The white appearance of this region has traditionally been attributed to an increased resistance to etching relative to the bulk material (Griffiths, 1987, Chou and Evans, 1999), which means the grain structure is not revealed in the white layer. More recently, it has been proposed that the scattering of the incident light used to illuminate the sample during subsequent optical microscopy inspection in the cross-section, results in the appearance of the white layer (Akcan et al., 2002). Due to its comparatively larger wavelength, white light is thought to be scattered from the small diameter grains in the white layer, resulting in a featureless layer. Although white layers are typically 1-10 μm in thickness, layers in excess of 20 μm have been observed in extreme cases (Wusatowska-Sarnek et al., 2011).

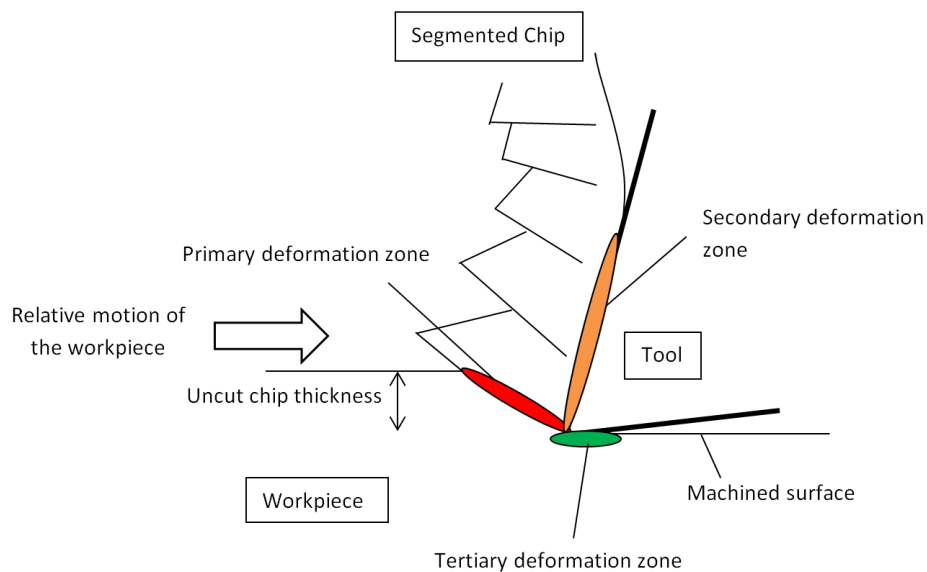
Figure 2. Schematic highlighting the primary, secondary and tertiary shear zones during cutting, after (Groover, 2007).

High temperatures and rapid cooling rates can result in a phase transformation of the near-surface region of metallics during machining. Heat is generated during mechanical cutting operations such as turning and milling due to severe plastic deformation (SPD) of the workpiece and considerable frictional contact conditions caused by the cutting tool-workpiece interaction. SPD occurs in the primary, secondary and tertiary shear zones, as outlined in Figure 2, with the direct effect of the tertiary shear zone on the machined surface immediately apparent. Guo et al. (2011) showed, using particle image velocimetry, that the deformation effect of the primary shear zone extends into the workpiece such that material that does not form part of the chip is still deformed in a fan-shaped deformation zone in front of the tool. It is, therefore, appropriate to consider that the primary shear zone, in addition to the tertiary shear zone situated at the tool and workpiece surface interface, may affect the workpiece surface integrity.

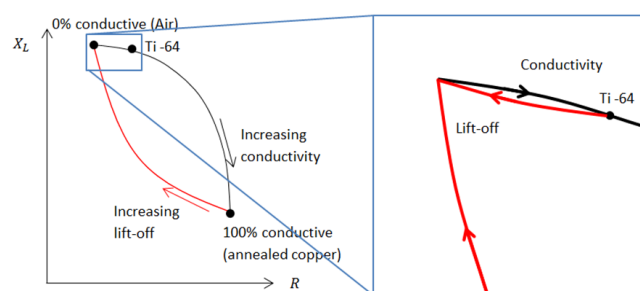
Figure 3. Conductivity and lift of curves on the impedance plane, after (Cox, 2000).

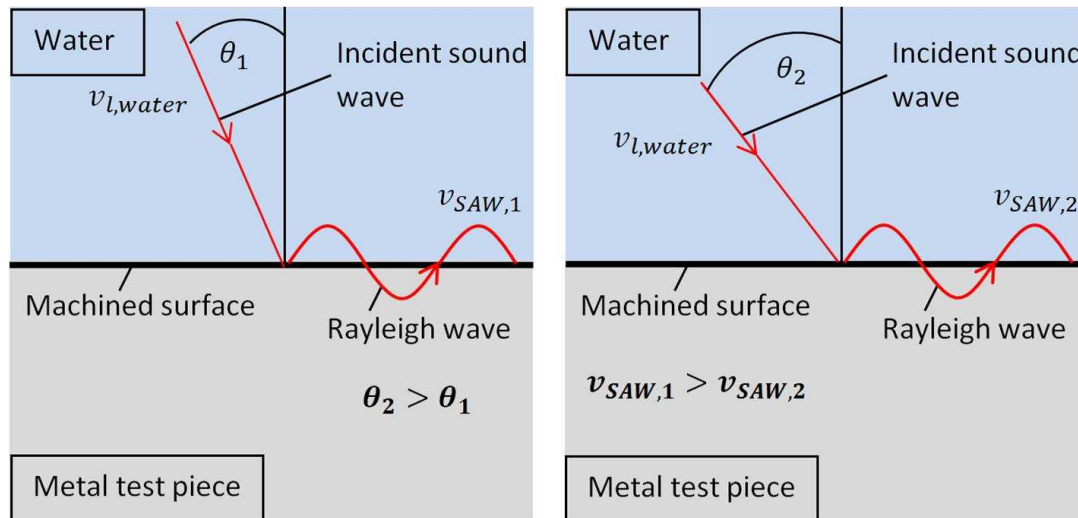
Figure 4. A schematic showing the dependence of the incident beam angle on SAW speed.

SAW velocity as highlighted by Equation 3.1 (Patton et al., 2011) and shown schematically in Figure 4.

In Equation 3.1, θ_{SAW} is the incident ultrasound wave angle required to generate a SAW and v_{water} and v_{SAW} are the velocity of ultrasound in water and the velocity of a Rayleigh wave in the test piece respectively. Patton et al. (2011) proposed that this technique could detect damage due to changes in the elastic modulus of the surface region. Further investigation at higher frequencies, where penetration depth is smaller, could improve the capability to specifically detect white layer rather than simply identifying broader machining damage. Due to the findings of Patton et al. (2011), an investigation into the elastic modulus changes in the white layer and swept grain regions of titanium could reveal key differences between these features and aid the development of an NDT method to specifically target white layer.
