Investigating material removal mechanism of Al-Si base abrasible coating in labyrinth seal system

Boxiu Zhang, PhD Student, Mechanical Engineering, University of Sheffield

Abstract

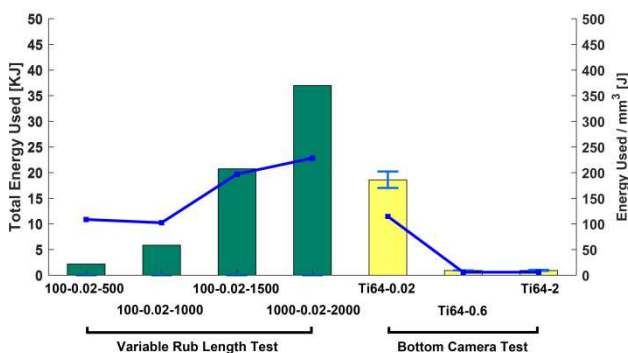
As shown in Figure 14, whilst the energy does rise with test duration for the test at 0.02 microns per pass, this increase is less significant when compared to the changes seen overall with incursion rate, and also when normalized with respect to volumetric material removal. In this latter case, it is interesting to note that as the sample is flat the arc length increases during the test as the fin penetrates the abrasible sample and the volume of removed material grows. Given that the test at low incursion rate appears to have a rubbing mechanism, compared to an extrusion dominated mechanism for the tests at intermediate and high incursion rate, this suggests that the increasing normal force observed, may be as a consequence of the rubbing mechanism present in this particular case.

Figure 14 Estimated total energy for the incursion event and energy used to remove a unit volume of material
