Lai, F., Qu, S., Lewis, R. et al. (3 more authors) (2019) The influence of ultrasonic surface rolling on the fatigue and wear properties of 23-8N engine valve steel. *International Journal of Fatigue*. ISSN 0142-1123

The influence of ultrasonic surface rolling on the fatigue and wear properties of 23-8N engine valve steel

Key words: ultrasonic surface rolling; surface enhancement; engine valve steel; fatigue properties; wear properties

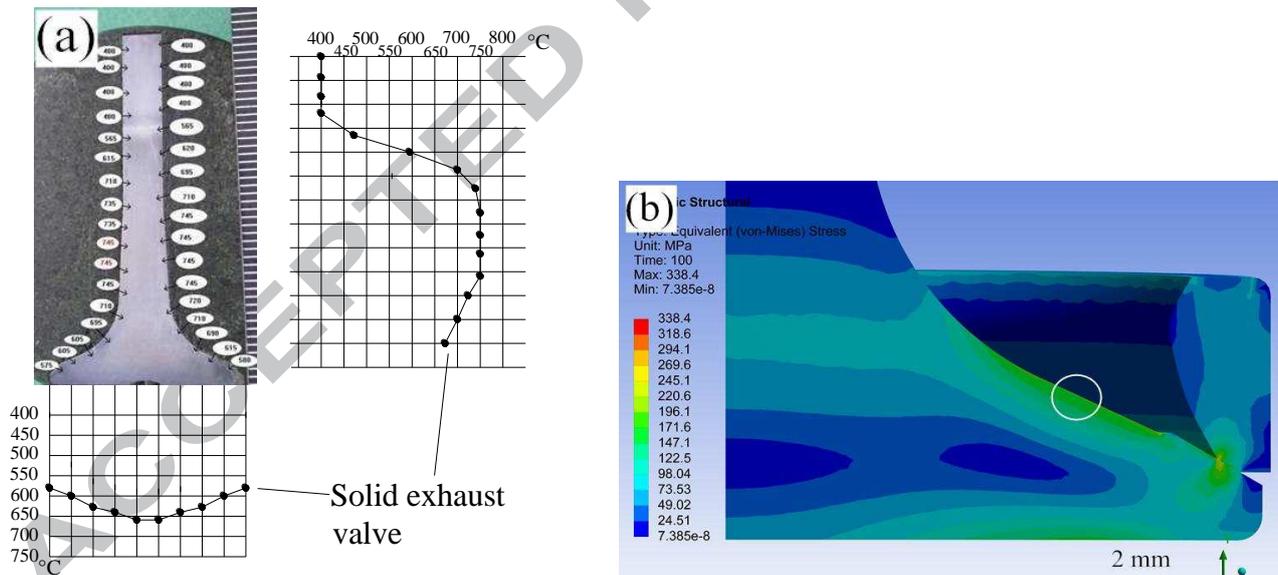
Fig. 1. (a) Exhaust valve operating temperature [3]; (b) finite element method results of valve head stress contours with combustion pressure.

The operating conditions and environment of internal combustion engine exhaust valves are extremely severe. The exhaust valves must resist high frequency cyclic stress generated from the valve motion and combustion pressure, high temperature and corrosive environments, and the possible presence of particulates and third bodies [1, 2]. The recent increases in specific performance of internal combustion engines has resulted in an increase of combustion chamber temperature and particularly pressure. In addition, due to the washout of the exhaust gas, the concave area of exhaust valve suffers notably high temperatures. For instance, the temperature distributions of a traditional solid exhaust valve were measured in previous research [3], as presented in Fig 1(a) where the results were obtained via a thermometric valve installed in a dynamometer gasoline engine. It was found that the temperature of the concave area of an exhaust

Similarly, the concave area of the valve withstands much higher stress, as indicated by the white circle in Fig 1(b). The stress contours were obtained from simulation results of exhaust valves using a finite element method. It is also reported by Worthen and Rauhen that the concave area of an engine valve is at a high stress level [4]. Furthermore, the improper assembly of the valve and seat insert and heat deformation of the cylinder head might cause a distortion of the seat insert in a firing engine. Subsequently, the distortion would lead to bending loads acting on the concave area of valves [5]. Failure is most likely to occur near the concave area of the valve and would be catastrophic to the engine once the valve head is fractured. Consequently, surface enhancement treatments are increasingly required to be applied to internal combustion engine exhaust valve designs, improving fatigue resistance at high temperatures.

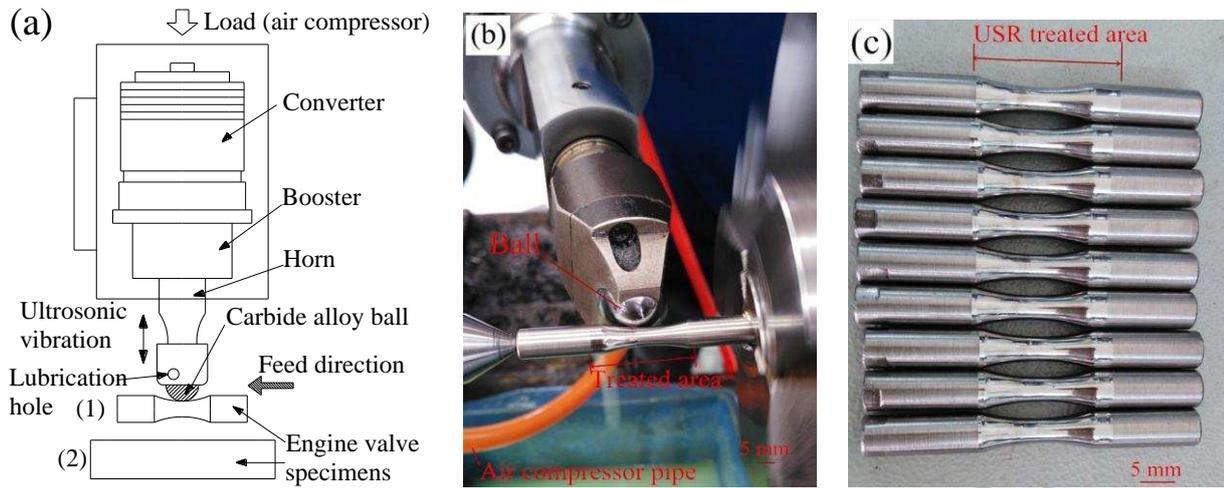
Fig. 2. (a) Schematic of USR treatment; (b) USR treatment; (c) specimens after USR treatment.

After the heat treatment, the steel bars were machined into smaller bars and hourglass shape specimens. They were then processed by USR on a lathe using a tungsten carbide rolling ball. Based on the methodology presented in the previous investigations of Qu et al. on titanium alloy with hardness of 325 HV [15-17], the residual stress and hardened depth of modified layer was increased when the static force was increased from 600 N to 900 N. Hence, optimized processing parameters of USR were chosen and they are listed in Table 3. The applied static force was chosen at 900 N and the amplitude of vibration was set at 10 μm . The frequency of ultrasonic vibration was respectively chosen at 20 kHz and 30 kHz, and an air compressor was used to support the static force at a certain air pressure. A schematic and photographic images of the USR treatment are presented in Fig. 2(a) and (b), and of the hourglass shape specimens used for the fatigue test after treatment are presented in Fig. 2(c). The rolling ball vibrated and rolled against the surface of materials during the processing, and was lubricated and cooled by environmental Inner HM 111 rapeseed oil base cutting compound, in order to avoid high temperatures on the specimen surface.

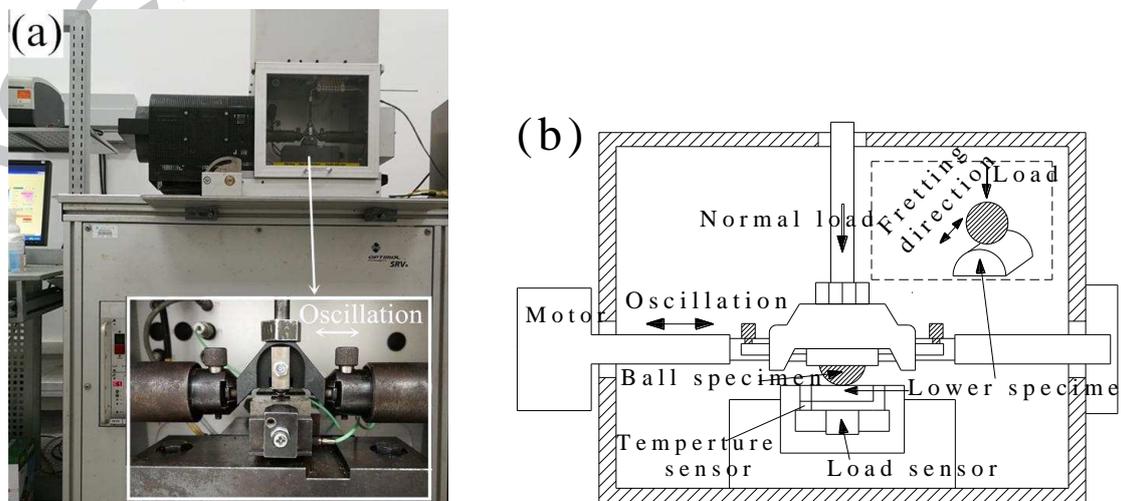
Fig. 3 Ball-on-disk fretting tribometer: (a) photograph with cutaway detail; (b) schematic diagram.

The specimens for fretting wear tests were taken from bars with and without USR treatment applied. The wear tests were performed using a ball-on-disk fretting tribometer (SRV IV, Optimol, Germany). A photograph and schematic diagram of the tribometer are presented in Fig. 3(a) and (b), respectively. Based on the experience of previous friction and wear research on a titanium alloy with and without USR treatment [15], similar test parameters were chosen and they are listed in Table 4. The load was set at 5 N in the run-in period with the first 5 minutes for every specimen, then the load was set at different levels in the later 30 minute test period for the corresponding specimen. The oscillation frequency was set at 10 Hz, which equals 18,000 reciprocating sliding cycles in each test period. The other parameters such as oscillation frequency and stroke were kept the same with all specimens. The same test parameters were used for the untreated and treated materials to obtain data for the wear resistance comparison and evaluation. All the tests were carried out without lubrication at room temperature in the ambient atmosphere (25 °C, humidity of 70 %). The counterface was a Si_3N_4 ceramics ball with a diameter of 10 mm for each test.

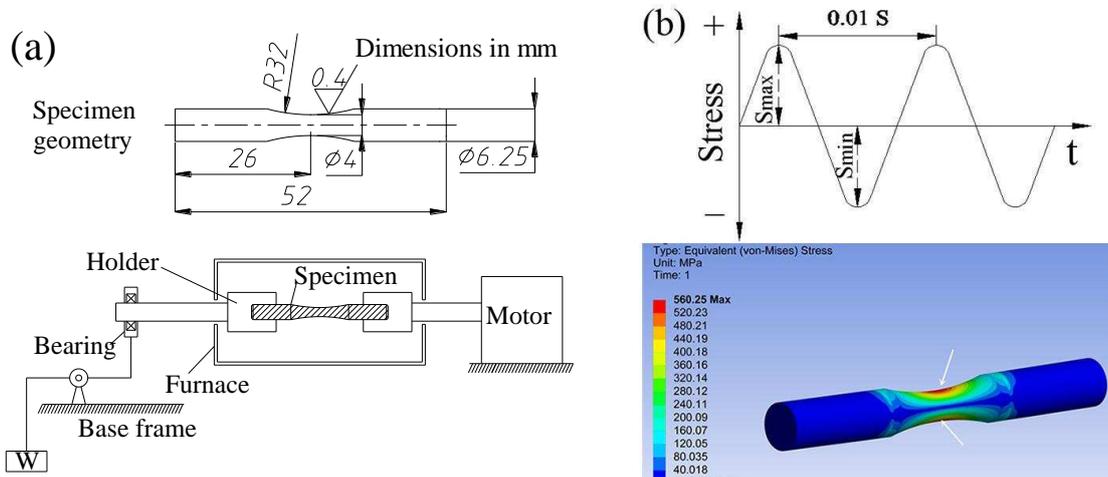
Fig. 4 (a) Schematic diagram of rotating bending fatigue tester and specimen geometry;

(b) the waveform of stress at a position on the central surface of hourglass shape specimen.

In order to improve the performance and durability life of engine valves, USR treatment can be applied in the concave area of the engine valve components during the manufacturing process. However, such comparative fatigue tests of engine valve components should ideally be conducted in a firing dynamometer engine or a specially designed apparatus, and this can be very resource intensive. Thus, the pilot study fatigue test was carried out through a rotating bending fatigue tester (QBWP, Changchun, China) utilizing material specimens, and the schematic diagram of the tester is presented in Fig. 4(a). The rotating bending fatigue test was performed with a stress ratio of $R = S_{\max} / S_{\min} = -1$, and a frequency of 100 Hz. For instance, the waveform of stress at a position on the central surface of hourglass shape specimen is presented in Fig. 4(b). The fatigue specimens were tested at two temperatures (25°C and 650 °C) in the ambient atmosphere and after ten million cycles had occurred the fatigue testing was automatically suspended. It should be noted that the small material fatigue specimens with hourglass shape were used in the rotating bending fatigue tester. Bending stress amplitude σ in the net section of the specimen was estimated by accounting for the balance of the inertia forces arisen at bending load, as presented in Equation (1) [18].

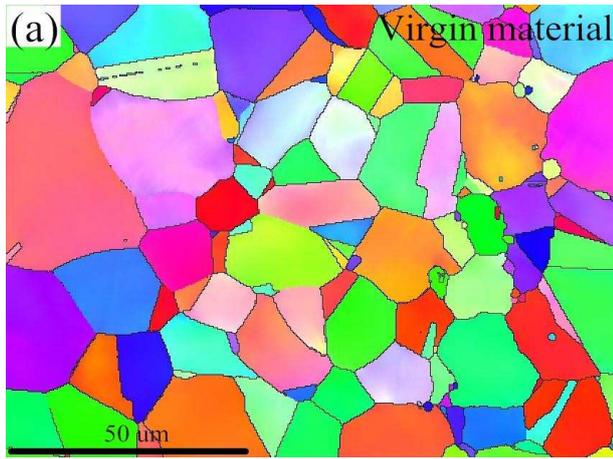
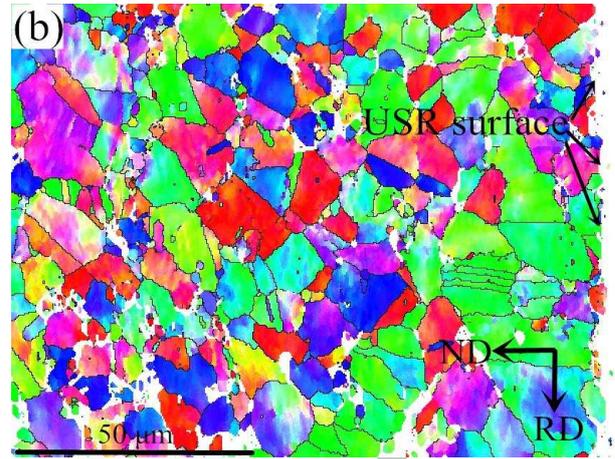
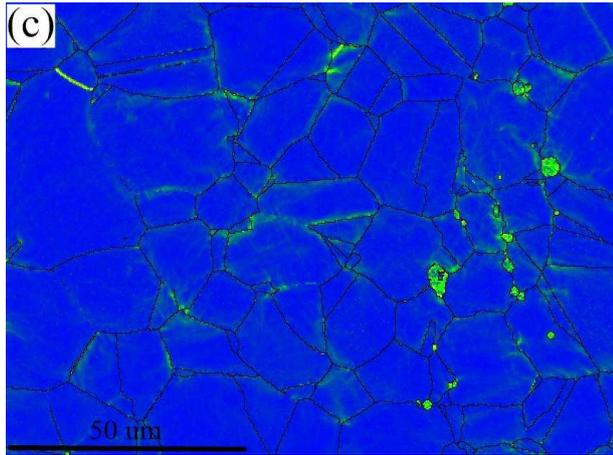
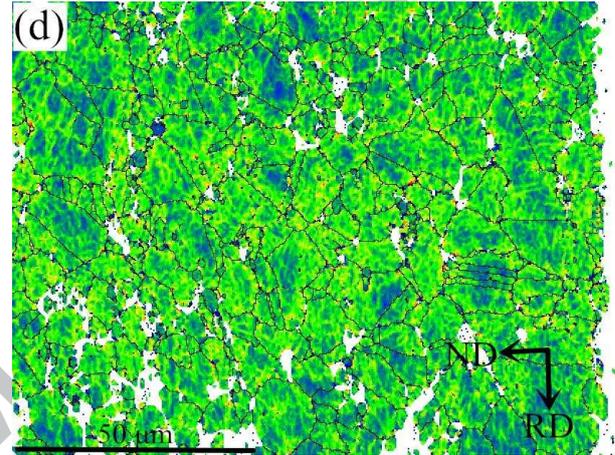
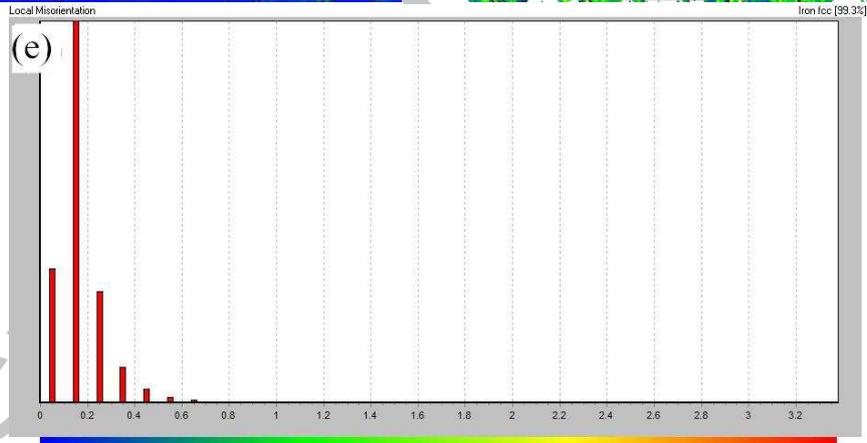
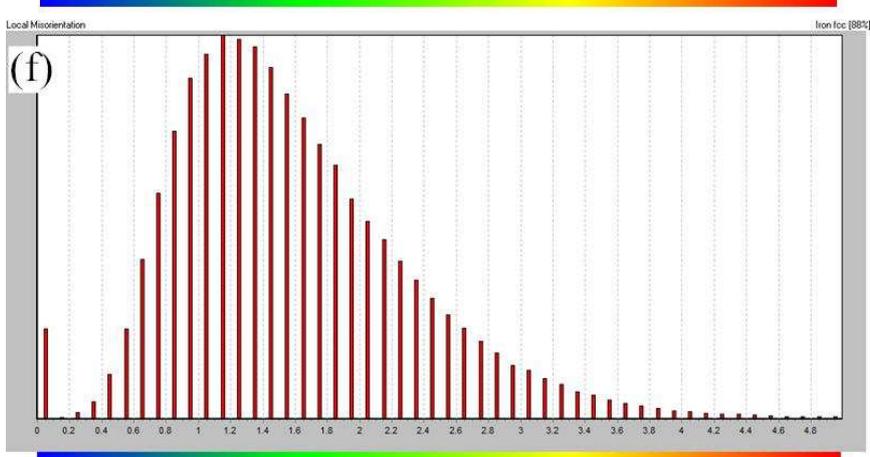
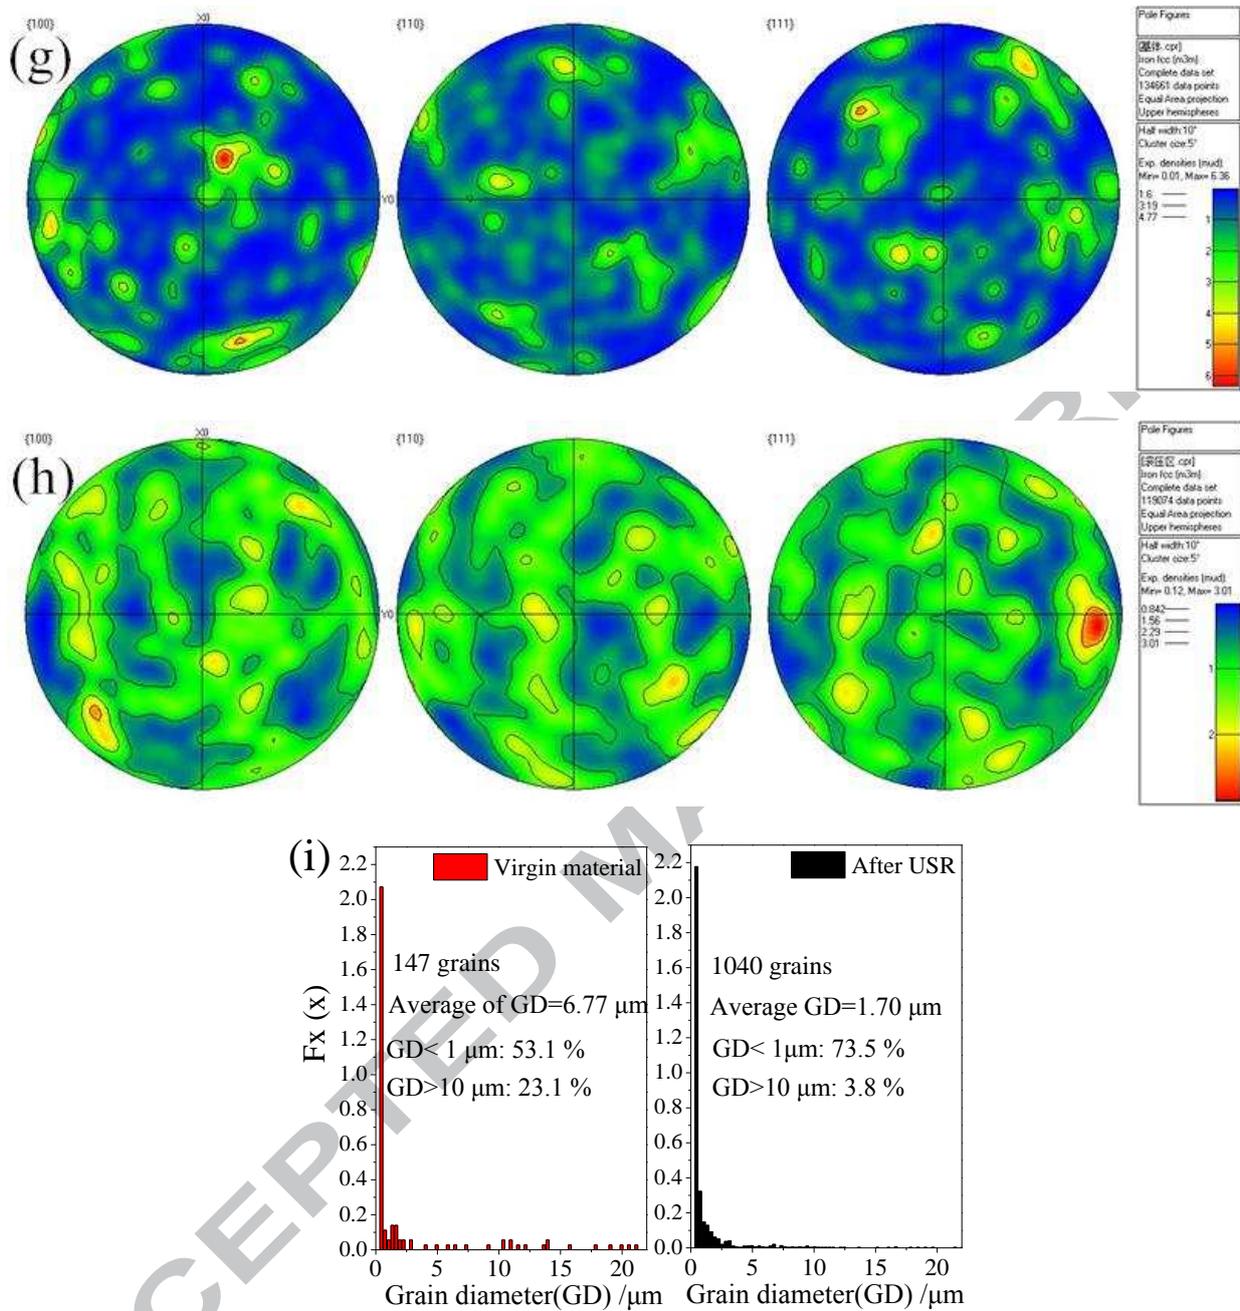
Fig. 5 (a) Crystal orientation map of the virgin material; (b) crystal orientation map of the USR treated material; (c) KAM distribution of the virgin material; (d) KAM distribution of the USR treated material; (e) KAM curve of the virgin material; (f) KAM curve of the USR treated material; (g) pole figure of the virgin material; (h) pole figure of the USR treated material. (i) statistical result of grains of two materials.

The results of cross-sectional EBSD observations of the as-received virgin (i.e. not treated with USR) material and USR treated (30 kHz, 900 N) material are presented in Fig. 5-7. The crystal orientation map of the two materials is presented in Fig. 5(a) and (b), where RD represents the rolling direction (feed direction of the rolling ball) and ND represents the normal direction. Kernel average misorientation (KAM) during EBSD analysis can be used as a measure of local grain misorientation and the average misorientation around a measurement point with respect to a defined set of nearest neighbour points is quantified in KAM [19]. The KAM distribution of the untreated and treated material is presented in Fig. 5(c) and (d). The blue colour indicates the smaller

misorientations of grains, the larger misorientations are shown in yellow and red colour. The KAM curves of the two materials are presented in Fig. 5(e) and (f), respectively. Based on the results presented in Fig. 5(e) to (f), it is observed that the treated material had a higher value of KAM than the untreated material. As reported by Li et al. [20], generally KAM is high in deformed grains due to higher dislocation density. It can be inferred that the deformation and strain of the grains in the treated material was significantly increased.

The statistical results of grains are shown in Fig. 5(i). It is found that the average of grain diameter (GD) of the virgin material was 6.77 μm , the average area of grain was 149.48 μm^2 , and the GD of 53.1 % of the grains was lower than 1 μm and 23.1 % higher than 10 μm . The treated specimen was observed in a region close to the top surface, which is indicated in the right edge in Fig. 5(b). The average of GD of the USR treated material was 1.70 μm , the average area of grain was 13.51 μm^2 , and the GD of 73.5 % of grains was lower than 1 μm . However, only 3.8 % of the grains's GD was higher than 10 μm . It is determined that the grain refinement was evident after USR treatment at 30 kHz at 900 N.

The direction of any three-dimensional vector in a crystal, i.e. a crystallographic direction or the normal to a crystal plane, could be described as a point on the reference sphere. Pole is the point of intersection of normal to this figure [21]. Pole figure represents the orientation of the crystal coordinate system in the specimen coordinate. The pole figures of two materials are presented Fig. 5(g) and (h). It is found that the virgin material possessed weak textures, and the density of pole was comparatively high. However, the orientation of grains of the USR treated material were distributed more randomly, suggesting that the steel did not hold the texture after USR treatment and the density of pole was significantly decreased.

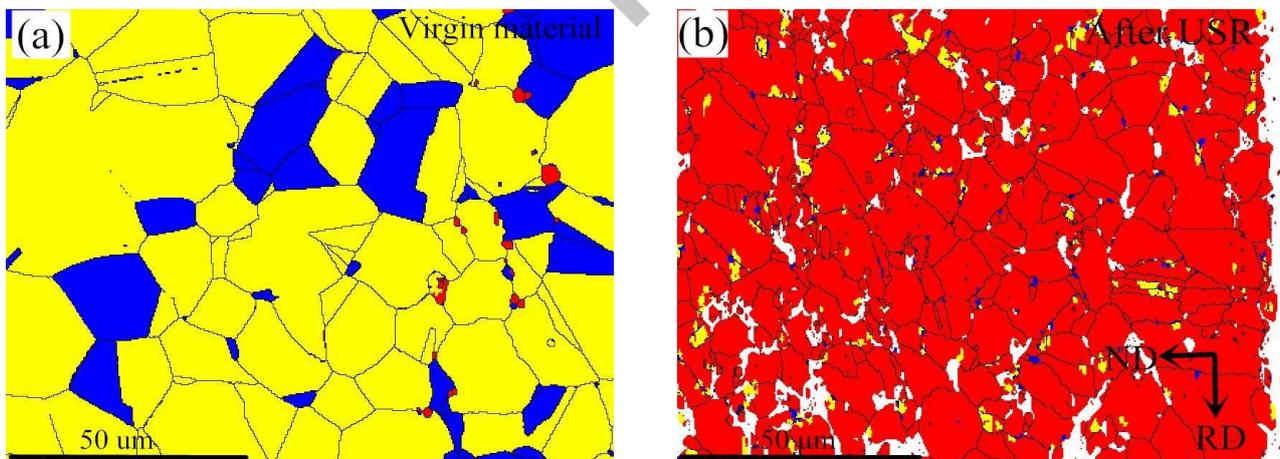
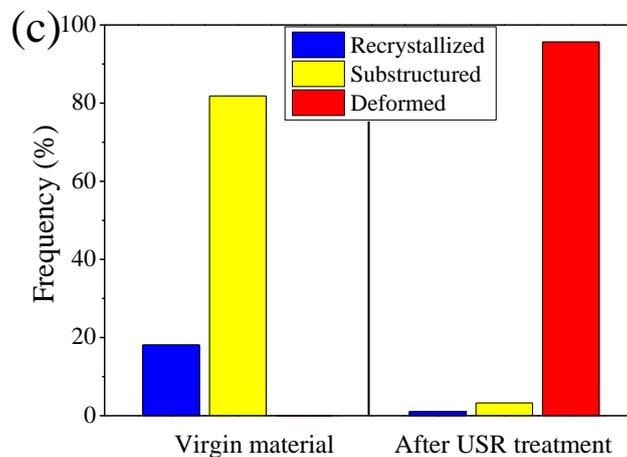
Fig. 6 (a) Recrystallization map of virgin material, (b) recrystallization map of USR treated material; (c) statistical result of recrystallization of two materials.

Fig. 6(a) and (b) presents the recrystallization map of two materials, and the statistical result of grain

recrystallization status is presented in Fig. 6(c). Compared to the virgin material, the proportion of recrystallized grains and substructured grains were decreased, however, the proportion of deformed grains was significantly increased. As reported by Wang et al., grain refinement in 40Cr steel during the ultrasonic surface rolling processing is mainly produced by deformation, and plastic deformation takes place primarily by dislocation movements [12]. Dislocations tangle with each other and then to form cellular structures which then develop to subgrains (with independent slip systems). With the increase of strain, subgrains turn to new grains with small or big angle grain boundaries [12]. It can be indicated that the deformed grains resulted from severe plastic deformation from the high frequency vibration and surface rolling. This also agrees well with the fact that the difference of recrystallization maps of virgin and USR treated material (Fig. 6(a) and (b)).

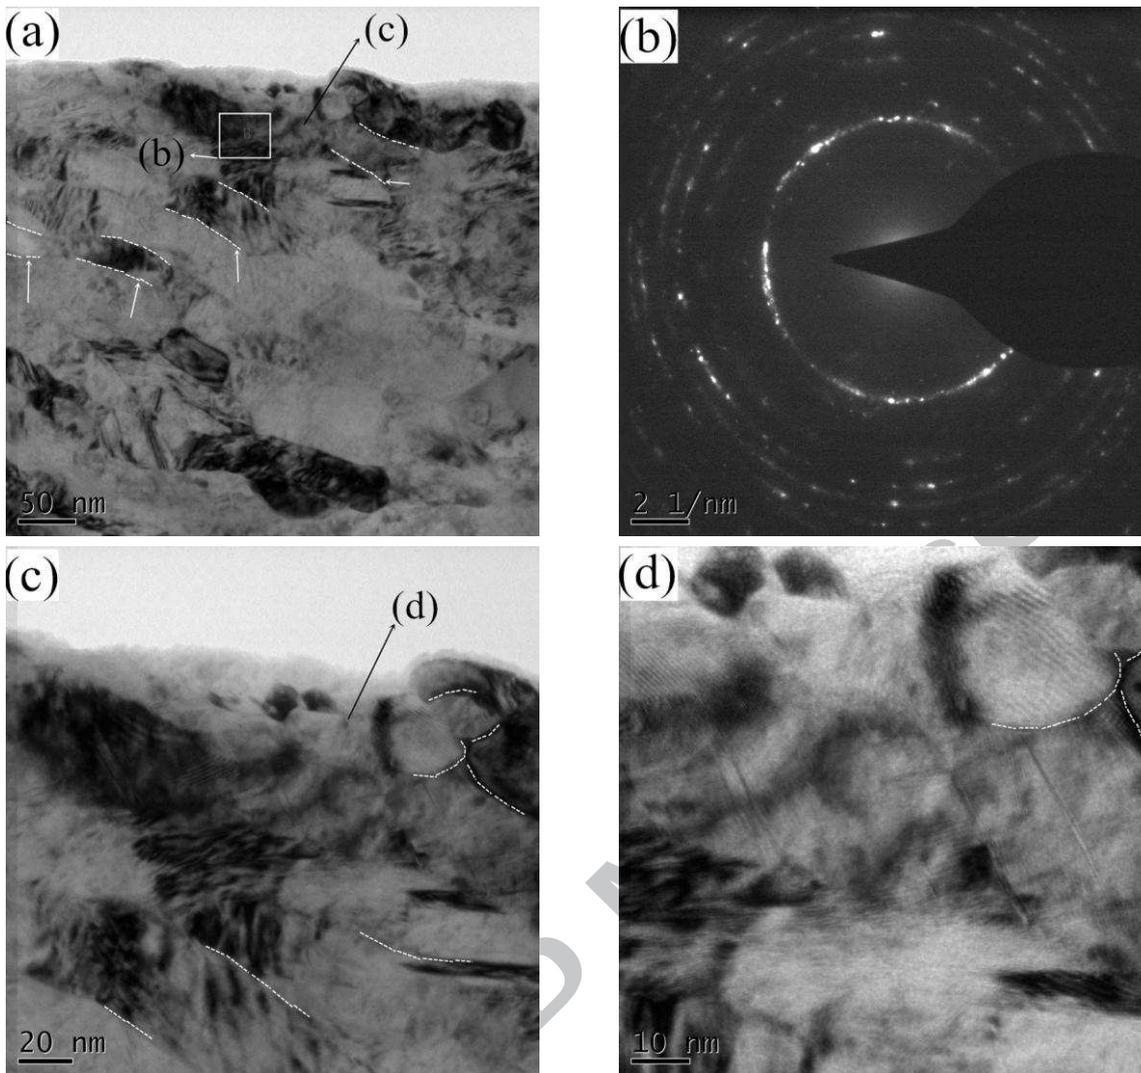
Fig. 7 TEM images from the top surface of USR treated specimen: (a) bright field image; (b) selected area electron diffraction pattern; (c),(d) enlarged bright field image.

In order to obtain a better characterization of microstructure of the region near the top surface of the treated specimen, the severe plastic deformation layer was detected by focused ion beam and TEM analysis, and the corresponding selected area electron diffraction were obtained by TEM. A TEM image from the top surface of the USR treated (30 kHz 900 N) specimen is presented in Fig. 7(a). It is found that the microstructure consisted of nanoscale lamellar grains, some grain boundaries were marked with dotted lines and arrows in the figure. The width of the grains was about 50–150 nm. In addition, there are many rings in the corresponding selected area electron diffraction pattern (Fig. 7(b)), indicating the presence of nano-grains [13, 22]. Furthermore, the lamellar grains consisted of nanostructured subgrains, as presented in the enlarged image of grains (Fig. 7(c) and (d)). The subgrains had a non-uniform morphology, and the subgrains displayed blurred boundaries (Fig. 7(d)). As reported by Kheradmandfard et al. [22], similar results was found in β -type titanium alloy processed by ultrasonic nanocrystal surface modification. The USR treatment can be considered as micro-cold-forging effect on the grains [14], leading to severe dislocation of the original grains interior and boundary. It was reported that some dense dislocations can be found in the grain interior and boundaries in the ultrasonic surface rolling processing treated 40Cr steel and titanium alloy [12, 15]. Dense dislocation can provide the strain energy with high density. The new boundaries of grains can be formed by the mode of annihilating, accumulating and rearranging of dislocation [16]. With the dislocation accumulating at the grain boundaries, the dislocation density was increased.

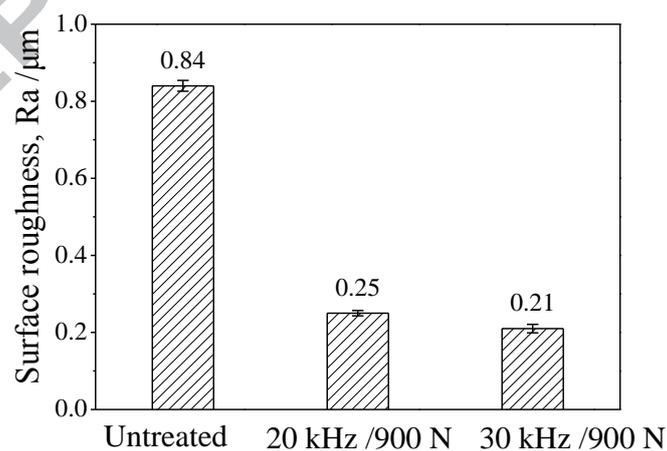
Fig. 8 Surface roughness Ra of different specimens.

The surface roughness (R_a , arithmetical mean deviation of the profile) values after the USR treatment in the surface zone are presented in Fig. 8, and the compressive residual stress distribution of different specimens is presented in Fig. 9. The average surface roughness of the untreated material was $0.84 \mu\text{m}$, and the average surface roughness of the treated material was decreased to $0.25 \mu\text{m}$ and $0.21 \mu\text{m}$. It is observed that the untreated specimen had a -210 MPa residual stress, which resulted from the machining process of the specimens.

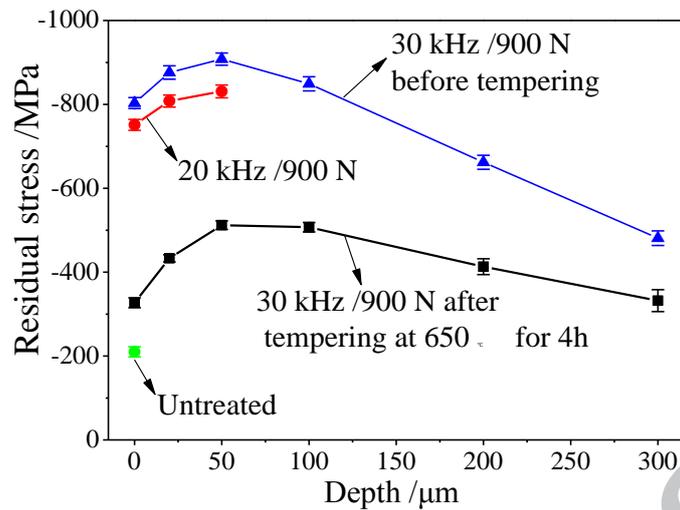
Fig. 9 Comparison of residual stress variation with depth.

After the USR treatment at 20 kHz and 900 N, the treated specimen had an average residual stress of -751 MPa on the surface and -808 MPa at a depth of $20\ \mu\text{m}$ and -831 MPa at $50\ \mu\text{m}$. For the treated specimens at 30 kHz and 900 N, the residual stress reached -803 MPa on the surface and -876 MPa at a depth of $20\ \mu\text{m}$ and -908 MPa at $50\ \mu\text{m}$. Compared to the USR treatment at 20 kHz, it was found that a higher residual stress and lower surface roughness could be produced through the treatment at a frequency of 30 kHz. It can be attributed to a higher grain dislocation being produced by a vibration with higher frequency, which means a higher energy. However, as reported by Qu et al. [15], the USR treatment at 40 kHz lead to slight oxidation and adhesion behaviour on the surface of Ti-6Al-4V titanium material due to the excessive transient impact energy. Based on the comparative results and former researches [15-17], the USR treatment at 30 kHz at 900 N was considered to be a suitable processing parameter for 23-8N engine valve steel. The different depth and residual stress were obtained from different severe plastic deformation processes. It was reported in many studies that different severe plastic deformation surface treatments would lead to different distributions and depth of compressive residual stress [12, 23-25].

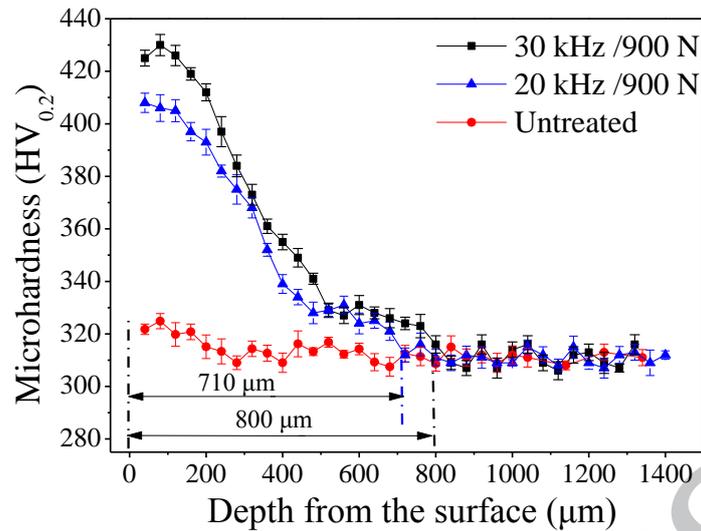
Fig. 10 Microhardness profile of cross-sectional surface.

Fig. 10 presents the microhardness profile of the cross-sectional surfaces. The hardened depth after USR treatment at 20 kHz and 30 kHz was 710 μm and 800 μm, respectively. As reported by Wu et al., the hardened depth value of plasma-nitrided S45C steel after ultrasonic nanocrystal surface modification treatment was about 800 to 1000 μm [10]. However, the hardened depth of Ti-6Al-4V titanium material was only about 20 μm to 60 μm [15-17]. According to the Hall-Petch relationship [26], the microhardness of the material surface and severe plastic deformation layer could be increased by good grain refinement, and the work hardening effect will be produced by plastic compressive deformation, which resulted from the high frequency ultrasonic surface impacts. Based on the compressive residual stress distribution (Fig. 9) and microhardness profile of the cross-sectional surfaces (Fig. 10) of USR treated specimen, it can be derived that a higher value of residual stress accompanied by a higher microhardness.

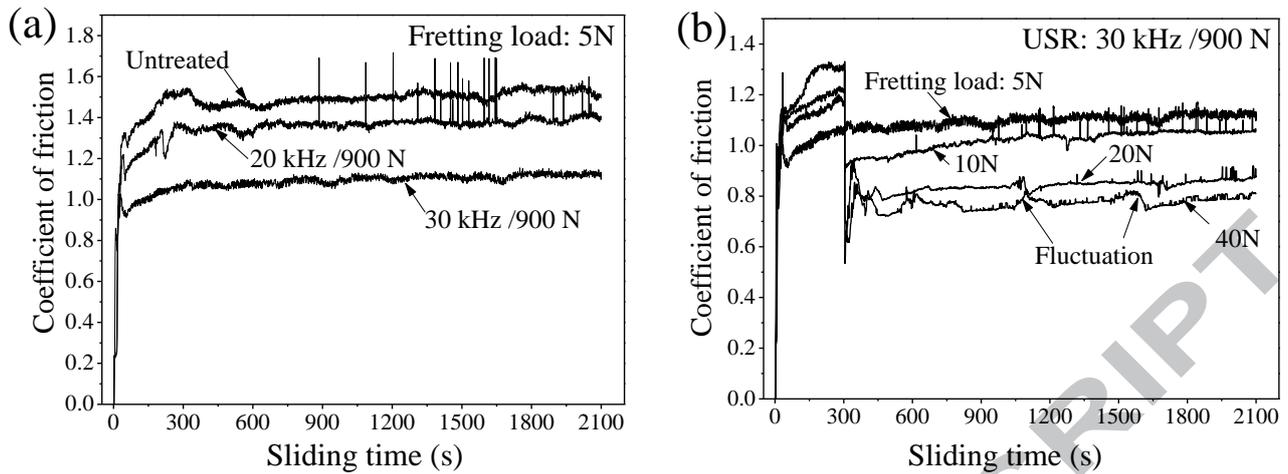
Fig. 11. (a) The CoF of the different materials; (b) the CoF of USR treated (30 kHz, 900 N)

materials with different fretting loads.

The coefficient of friction (CoF) for the different material conditions are presented in Fig. 11(a). Compared to the untreated materials, the CoF of the USR treated material is significantly decreased. It has also been reported by other researchers that surface modified layers generated by severe plastic deformation processes could lead to a reduction in CoF [15, 23, 27]. Furthermore, the frequency of ultrasonic vibration has an evident effect on the value of the CoF curve. The CoF of material treated at 30 kHz was lower than that treated at 20 kHz. Fig. 11(b) presents the CoF of the treated (30 kHz, 900 N) material under different fretting loads. With an increase of fretting load from 5 N to 40 N, the CoF further decreased. It can also be seen that more serious fluctuation of CoF occurred in the steady-state period of the tests with high fretting load (40 N).

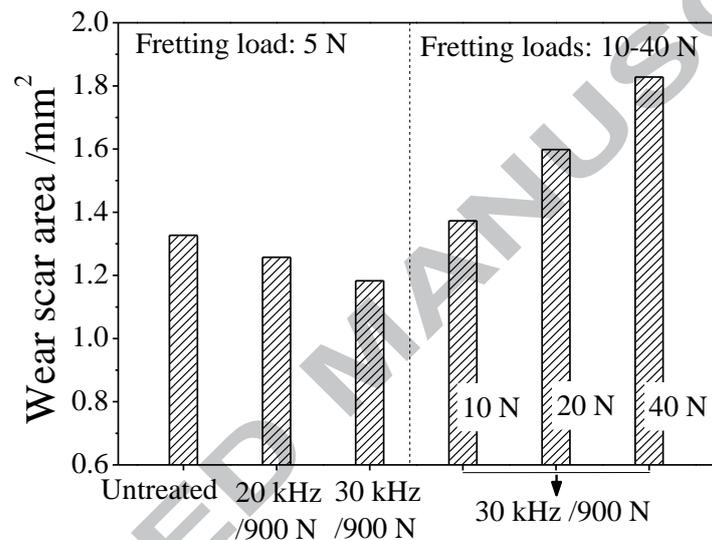
Fig. 12. Wear scar area of untreated and treated specimens.

After the fretting wear tests, the worn surfaces of the specimens were evaluated by SEM. The results of wear scar area are presented in Fig. 12, and the SEM images of fretting wear tracks and the corresponding EDS results are presented in Fig. 13. Compared to the virgin material, the wear resistance of the treated materials was significantly increased (Fig. 12). The wear scar area was decreased 11.3 % (from 1.33 mm² to 1.18 mm²). This result can be attributed to the higher hardness and increased level of compressive residual stress of the modified surface layers, which resulted from the refinement of the grain size and the internal strain of the crystal lattice introduced by the USR treatment. Furthermore, the wear resistance of the material treated at 30 kHz was better than that treated at 20 kHz, indicating that a higher frequency of ultrasonic vibration can produce a higher hardness and compressive residual stress (Fig. 9), and likely a better wear resistance. With the increase of fretting loads, the wear scar area was increased.

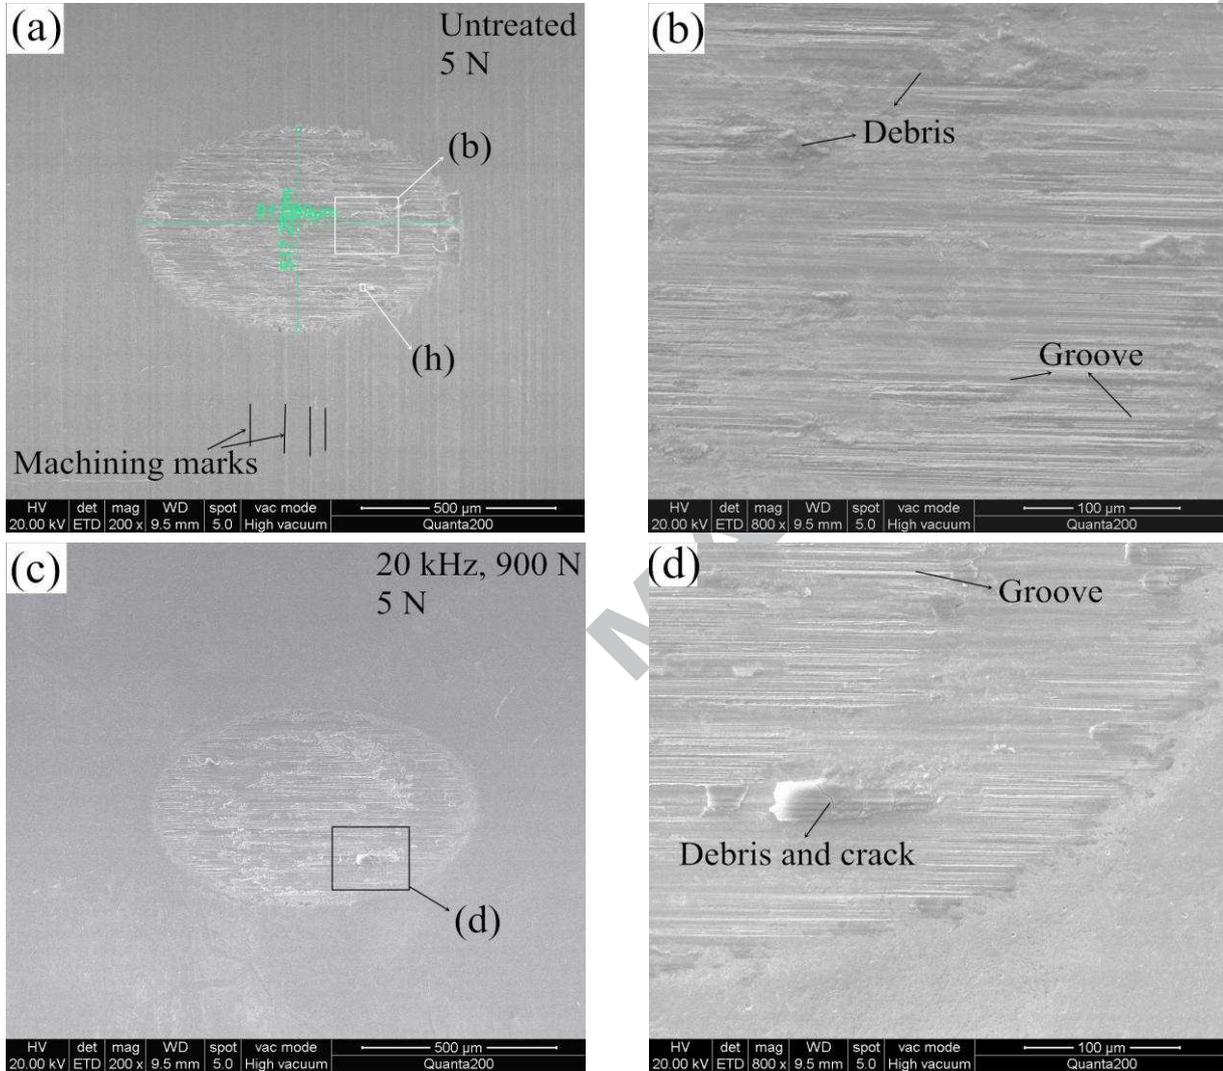
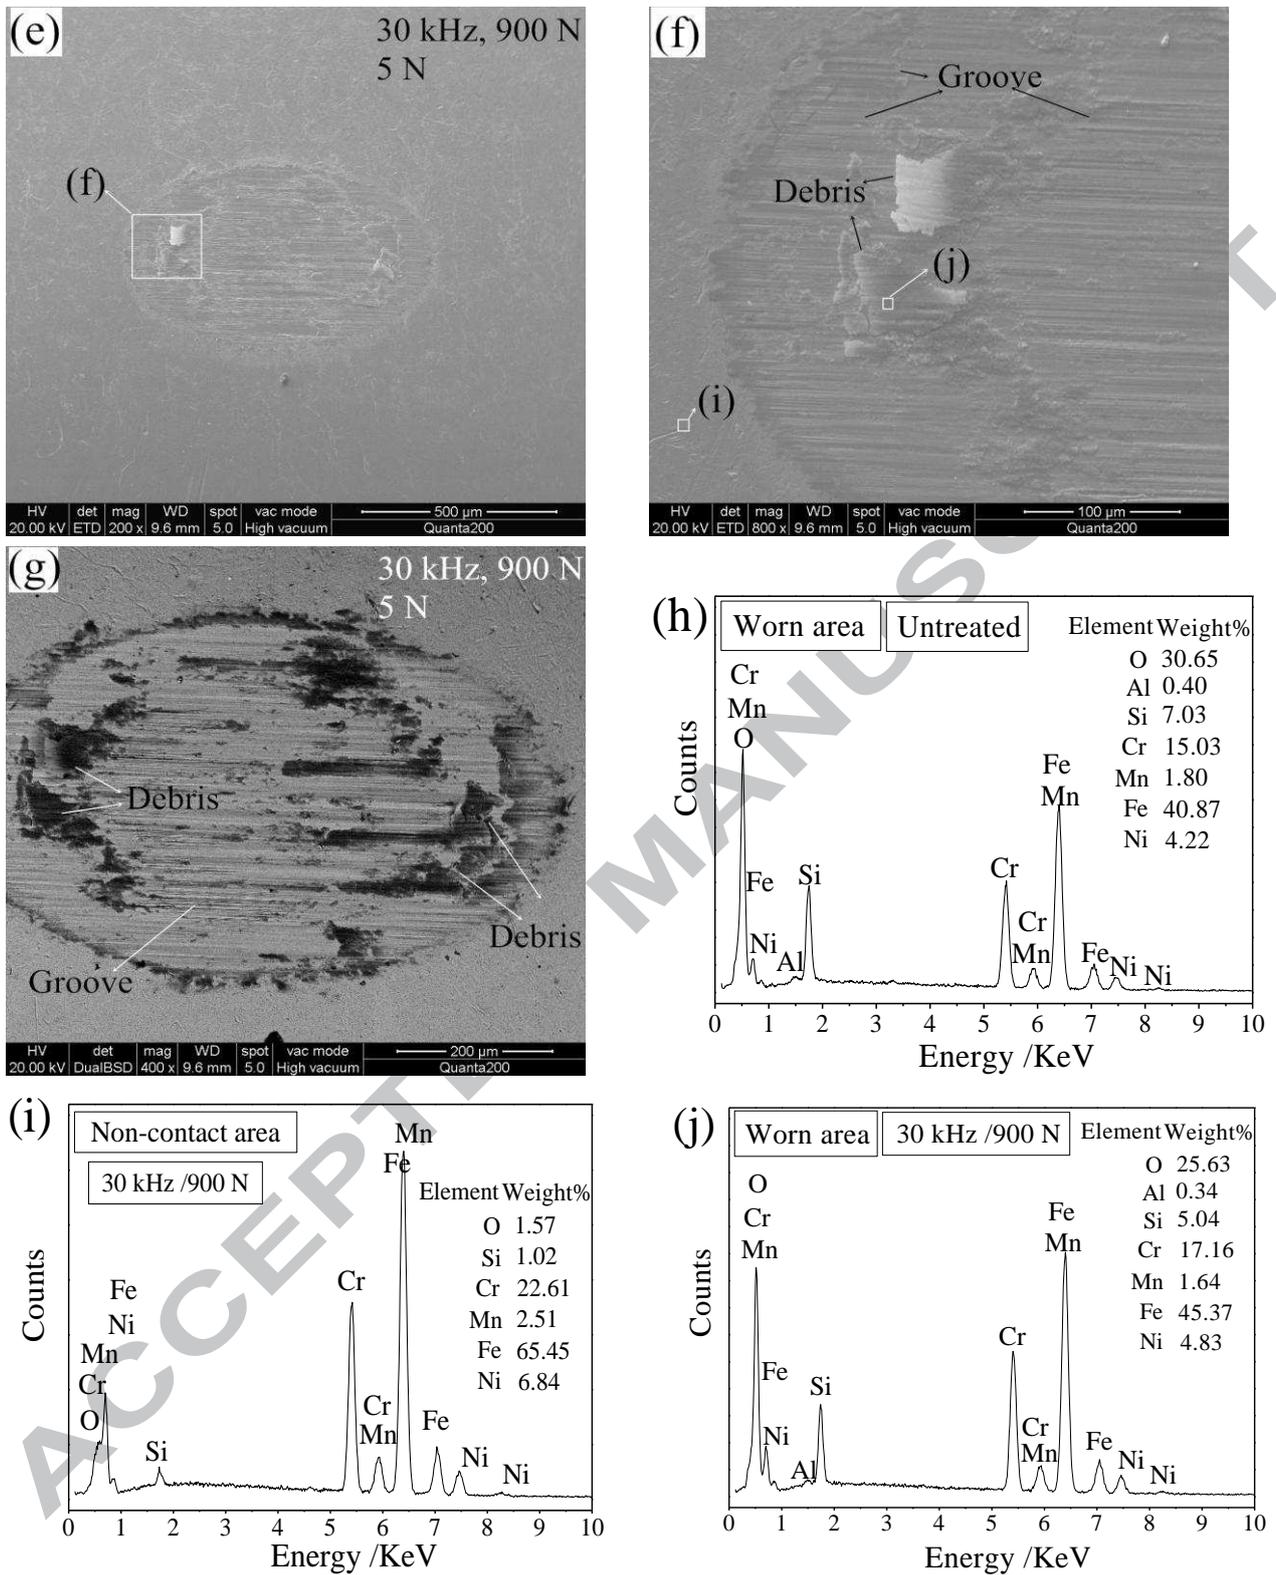
Fig. 13 (a-g) Worn surfaces of the specimens after fretting wear test; (h-j) the EDS results of worn surfaces.

The machining marks (labeled in black lines in Fig. 13(a).) could be observed in the non-contact area on the untreated material surface. However, the non-contact areas on the surface of the treated materials are seen to be much smoother with a lower surface roughness (Fig. 13(c) and (e)), which has been also verified in Section 3.2 (Fig. 8). It is believed that wear debris particles would be generated from the relative movement of contact surfaces under pressure. Many of the debris particles would be removed from the rubbing interface due to the reciprocating sliding with fretting loads, leading to the wear loss of materials, but other debris particles are retained between the rubbing surfaces. These debris persist and agglomerate in the contact zones as moving particles

ploughed the surfaces to generate grooves. Consequently, slight grooves are characterized in the worn areas of all materials, as presented in Fig. 13(b), (d), (f) and (g). The generation of these grooves and slip regions can be identified as abrasive wear during sliding [17].

As sliding continues, some of the debris particles (already agglomerated or individually) retained in the contact were highly compacted together to form localized tribolayers covering a part of the worn surfaces. The agglomeration behaviour of debris from the three specimen types were different. As presented in Fig. 13(b), the tribological layers on the untreated material were seen to be more consolidated than those on the treated materials, which could be attributed to the debris with lower hardness spalled from the untreated materials being easier to compact in the contact. These exhibit a better relative wear resistance, because of a higher hardness and compressive residual stress of surface and subsurface of the treated materials, as indicated in Fig.12. It is believed that micro-scale debris from the treated materials still maintains finer grains and higher hardness. Thus, such debris is more difficult to compact to form the localized tribolayers. Under the pressing and sliding of the counterface (the ceramic ball), the layers were delaminated. Those broken layers and debris agglomerated together near the edge of the worn area, as illustrated in Fig. 13(d), (f) and (g). Thus, the wear mechanisms of USR treated material are also identified as adhesion and delamination.

The remaining debris and formed layers were further ground, rolled and compacted. Compared to the EDS results of the non-contact area of material (Fig. 13(i)), oxygen and silicon element percentage was increased in the worn areas of the untreated and treated materials (Fig. 13(h) and (j)), as well the aluminium element was detected in these worn areas. Aluminium and silicon were transferred from the (ceramic ball) counterface to the steel worn surfaces. It is indicated that a certain wear existed on the surface of ball, even though the Si_3N_4 ceramic material has a much

higher hardness of 1500 HV_{0.5} [17, 29]. Additionally, the increase of oxygen present on the worn surfaces of the untreated and treated materials can be considered evidence of the existence of oxidative wear.

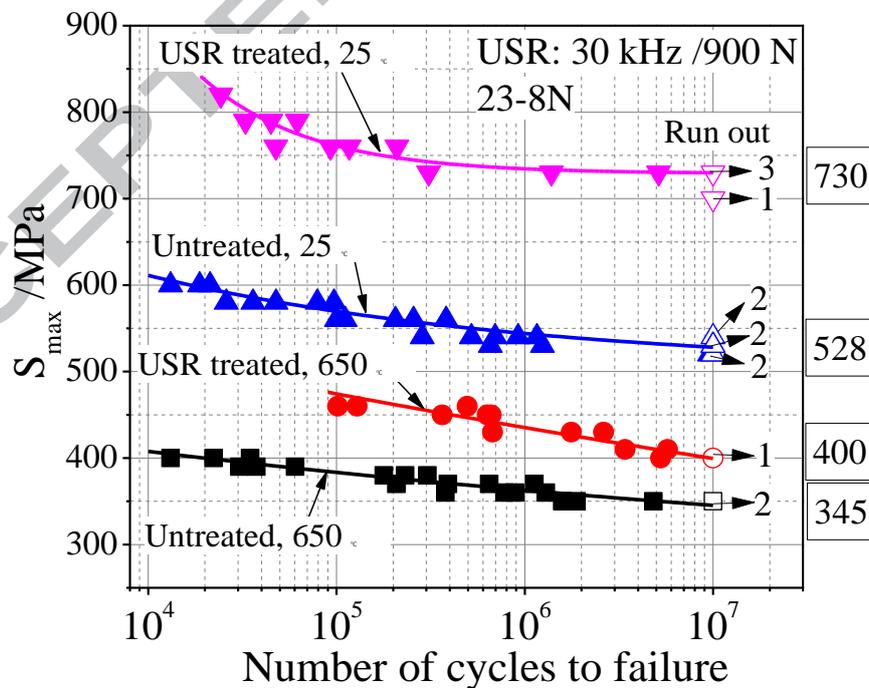
Fig. 14. S-N curves of rotating bending fatigue tests at 25 °C and 650 °C.

Based on the results of microhardness, compressive residual stress and fretting wear test (Sections 3.2 and 3.3), the USR treatment at 30 kHz at 900 N is considered to obtain the best performing modified layer. Hence, the specimens for the rotating bending fatigue test were processed through treatment at 30 kHz at 900 N. The fatigue results of specimens with and without treatment at the two temperatures were statistically analysed and the S–N curves are illustrated in Fig. 14. Then, according to the S–N equation and curve, the fatigue strength on the base of 10 million cycles can be determined. Compared to the untreated specimens, the fatigue strength of the specimens at 25 °C after treatment increased 38.3 % (from 528 MPa to 730 MPa). At 650 °C, the fatigue strength increased 15.9 % (from 345 MPa to 400 MPa). The results show that USR treatment would produce a significant extension in fatigue resistance.

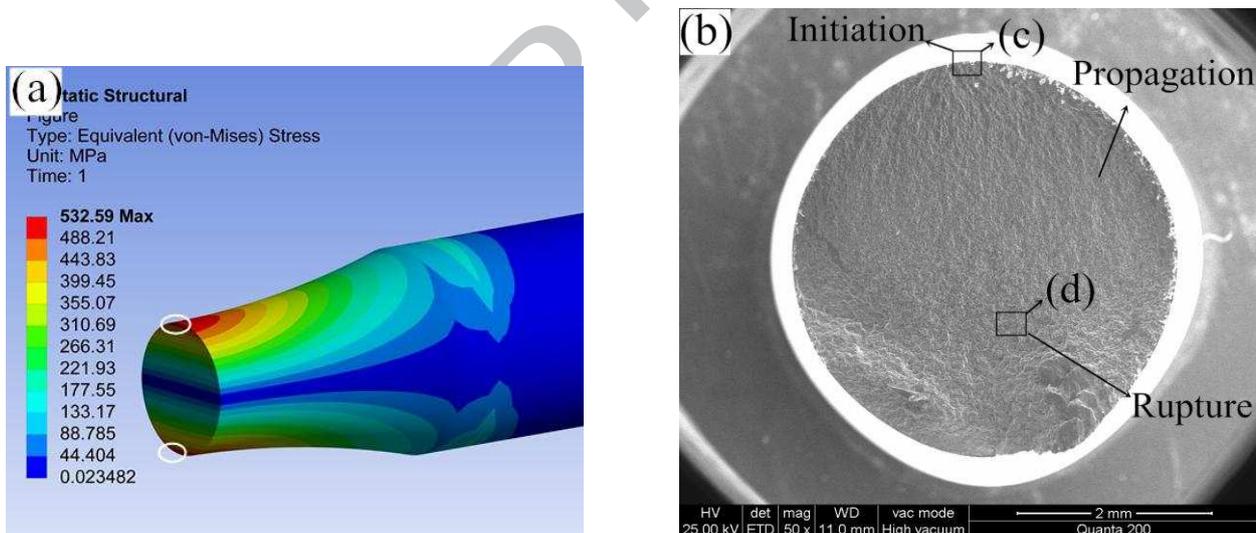
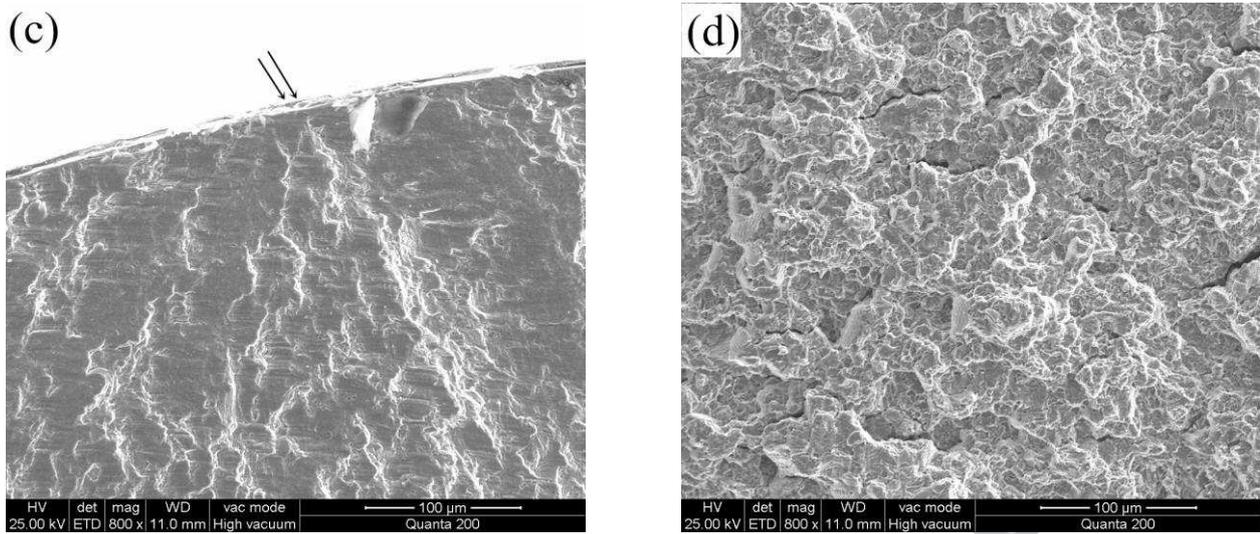
Fig. 15 (a) The von Mises stress of untreated specimen at the bending stress of 530 MPa at 25 °C;

(b-d) typical fracture surfaces of the untreated specimen tested at 25 °C ($S_{\max} = 540$ MPa, $N = 285,503$ cycles).

The fractured surfaces of the hourglass shape fatigue specimens were cleaned and then observed by SEM. Fig. 15(a) shows the von Mises stress of the specimen at a nominal bending stress (produced by weight and lever in the tester) of 530 MPa, it is found that the maximum von Mises stress occurs on the surface of the round notch of the specimen, as indicated by the white circles. As presented in Fig. 15(b), three clear regions existed in the typical fracture surfaces of the untreated specimens, including the crack initiation region, the crack propagation region and the final rupture region. During the fatigue test, the cracks initiated on the surface of specimen (Fig. 15(c)). After the initiation of cracks, cracks displayed as fluvial stripes in the crack propagation region. Finally, the specimen would fracture. Fig. 15(d) presents the fatigue final rupture region, which is significantly more precipitous than the other two regions.
