Lai, F., Qu, S., Lewis, R. et al. (3 more authors) (2019) The influence of ultrasonic surface rolling on the fatigue and wear properties of 23-8N engine valve steel. *International Journal of Fatigue*. ISSN 0142-1123

The influence of ultrasonic surface rolling on the fatigue and wear properties of 23-8N engine valve steel

Key words: ultrasonic surface rolling; surface enhancement; engine valve steel; fatigue properties; wear properties

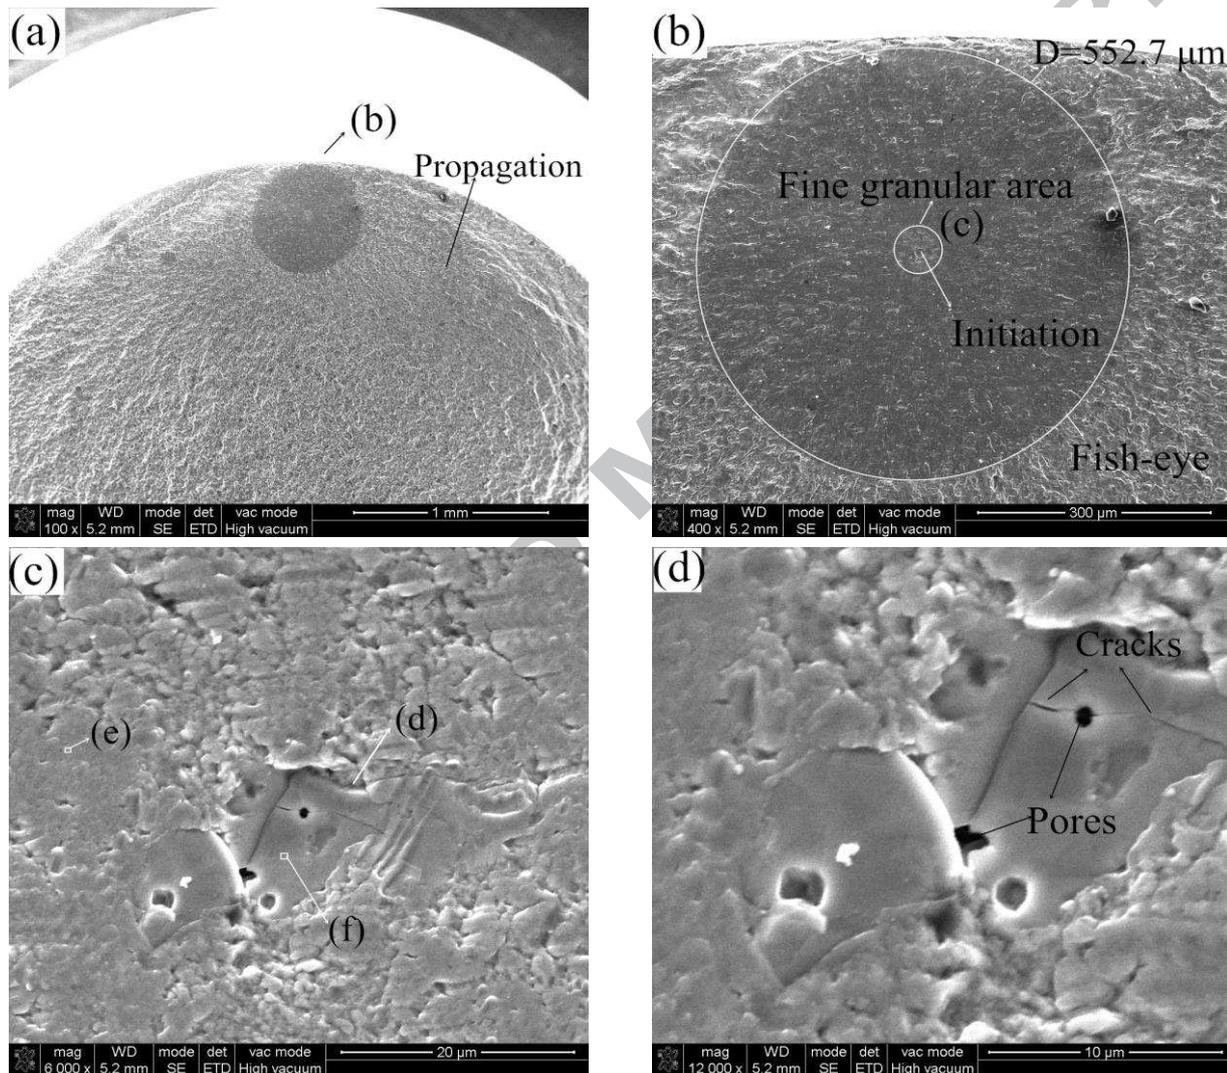
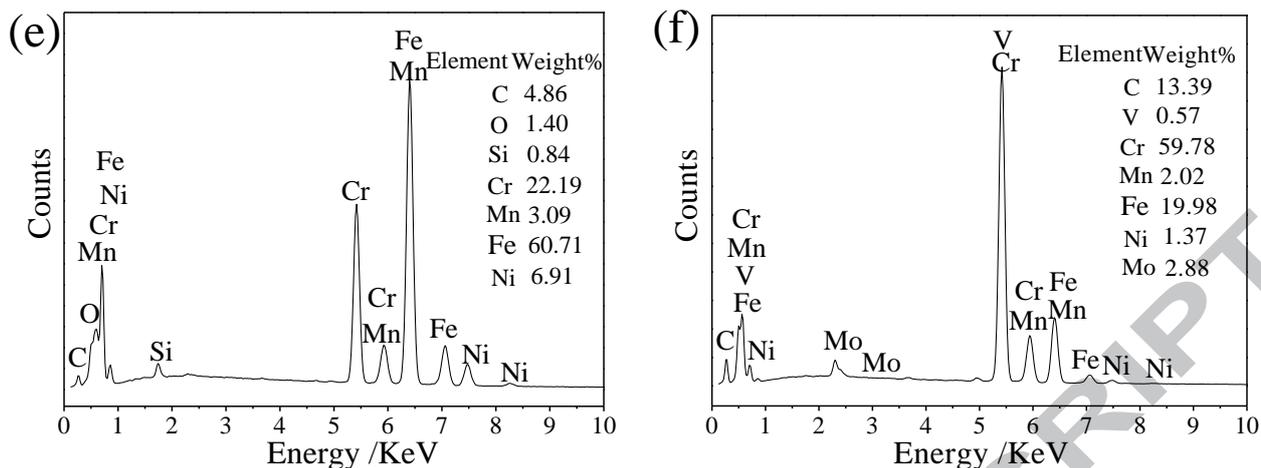
Fig. 16 (a-d) Fracture surfaces of the USR treated specimen tested at 25 °C; (e-f) EDS results of the inclusion area on specimen surfaces ($S_{\max} = 730$ MPa, $N = 5,145,187$ cycles).

For the fracture surfaces of treated specimens tested at lower loads at 25 °C, the crack initiation sites are shifted to the subsurface region (Fig. 16(a) and (b)), leading to the forming of a fish-eye pattern. It can be seen from the Fig. 16(c) and (d) that the fatigue cracks initiated from an internal inclusion in the specimen, and the internal inclusion was always located at the centres of the fish-eye. In the vicinity of the inclusion, one area often described as a fine granular area was observed [30], as indicated by the smaller white circle in Fig. 16(b). It is also reported by Qu et al. and Suh et al. that the crack initiation position was shifted to the subsurface region after the surface enhancement with ultrasonic vibration technology [16, 23]. As presented in Fig. 9, compared to the untreated specimen, the USR treatment produces much higher compressive residual stress on the specimen surface and subsurface, the maximum residual stress reached -908 MPa at a depth of 50 μm. Zhu et al. reported that the crack initiation process is affected by the gradient distribution of residual stress from specimen surface to matrix material [31]. For the USR treated specimen, it is inferred that the produced residual stress could change the actual applied mean stress leading to a

location dependent strength along the specimen cross section [31]. The cracks initiated in the subsurface region of specimens which were tested at lower loads. However, the residual stress were relaxed during cyclic loading in the fatigue test [32]. Additionally, the residual stress would relax in the initial cycles in the fatigue test, and a higher fatigue load would lead to a faster residual relaxation at room temperature [31]. This agrees well with the fact that the cracks also initiated on the surface of treated specimen tested at higher loads.

Fig. 16(e) and (f) present the EDS results of the matrix material and the inclusion in the fine granular area, respectively. Compared to the matrix material, much higher carbon and chromium weight percentage were detected in the inclusion, indicating likely brittleness of the inclusion. Sakai et al. investigated the fatigue properties of a bearing steel in the long-life region. They concluded that the fatigue fracture of the bearing steel in the long-life region contained three processes: the formation of a fine granular area, crack propagation to form the fish-eye and rapid crack propagation to cause fracture [30]. In the research on the inclusion-induced interior cracking mechanisms, Zhu et al. conducted a study of a precipitation-hardened stainless steel in high cycle and very high cycle fatigue regimes [33]. They found that the physics of inclusion-induced interior cracking is a microstructure-dependent crack initiation and stage I growth process. Similarly, small cracks and pores were observed in the inclusion (Fig. 16(c) and (d)). Furthermore, after the martensitic laths's breakdown, dislocation cell structures were formed in the stainless steel, and the fine granular area on the fracture surface was characteristic of several nano-scale grains [33]. In addition, in the investigation of failure mechanisms and fatigue assessment of a low strength steel welded joint, Zhu and Xuan proposed a physical criterion for formation of a fine granular area: the ratio of accumulation to release rates of cyclic plastic energy was higher than one [34]. In the

current research, the fish-eye pattern and fine granular area were only observed in two USR treated specimens whose fatigue life was more than one million cycles at 25 °C. They were tested at relative lower applied load with a longer fatigue life. It could be concluded that the USR treatment influenced the fracture mechanism and the formation of a fine granular area, leading to shift of the crack initiation sites from the surface to the subsurface region.

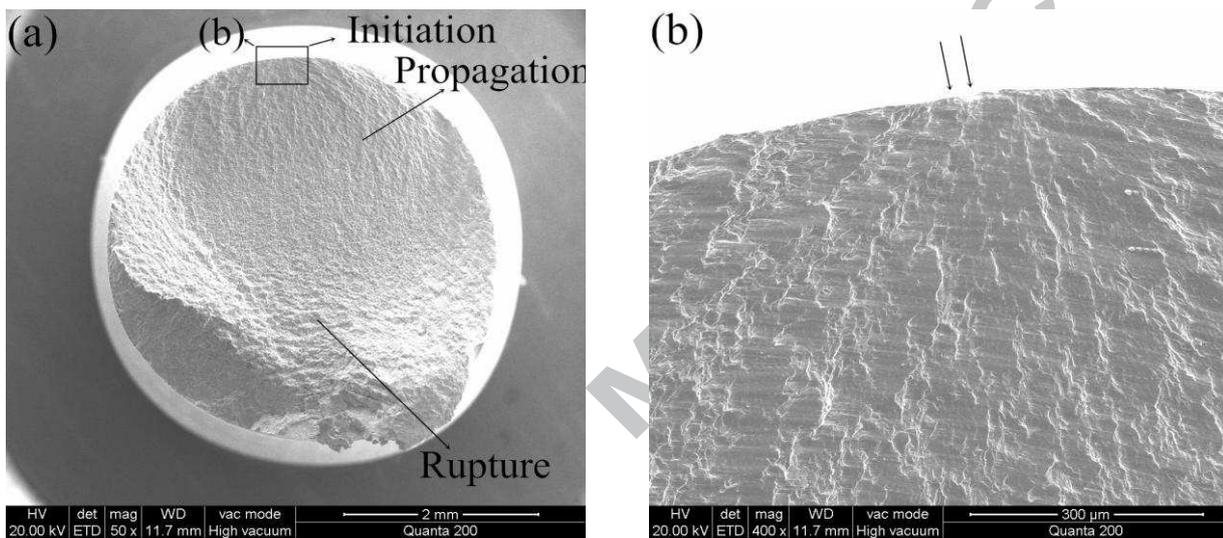
Fig. 17 (a), (b) Fracture surfaces of the untreated specimen tested at 650 °C ($S_{\max} = 370$ MPa, $N = 647,502$ cycles).

Fracture surfaces of the untreated specimen tested at 650 °C are presented in Fig. 17, and the fracture surfaces of the USR treated specimen are presented in Fig. 18. Generally, it is found that the typical fracture surfaces can be classified as three regions, as presented in Fig. 17(a), which is similar to Fig. 15(b). The cracks initiated on the surface of the specimen (Fig. 17(b)), which is similar to Fig. 15(c). For a USR treated specimen tested at 410 MPa, the cracks were observed in the region very close to the surface (Fig. 18(b)), indicating the crack initiation sites was shifted to the subsurface region. However, compared to the USR treated specimen tested at 25 °C, the shift distance was much smaller and no fish-eye pattern and a fine granular area were formed on the fracture surface. Fig. 9 presents the residual stress distribution of the USR treated (30 kHz, 900 N) specimens before and after tempering at 650 °C for 4 h. It could be noted that residual stress relaxation occurred at high temperature. After heating at 650 °C, the compressive residual stress on specimen surface was relaxed from -803 MPa to -329 MPa. The maximum residual stress still existed at a depth of 50 μm , and it was relaxed from -908 MPa to -512 MPa. It is also reported by Zhu et al. that more serious degradation of residual stress (even under lower applied loads) occurred at

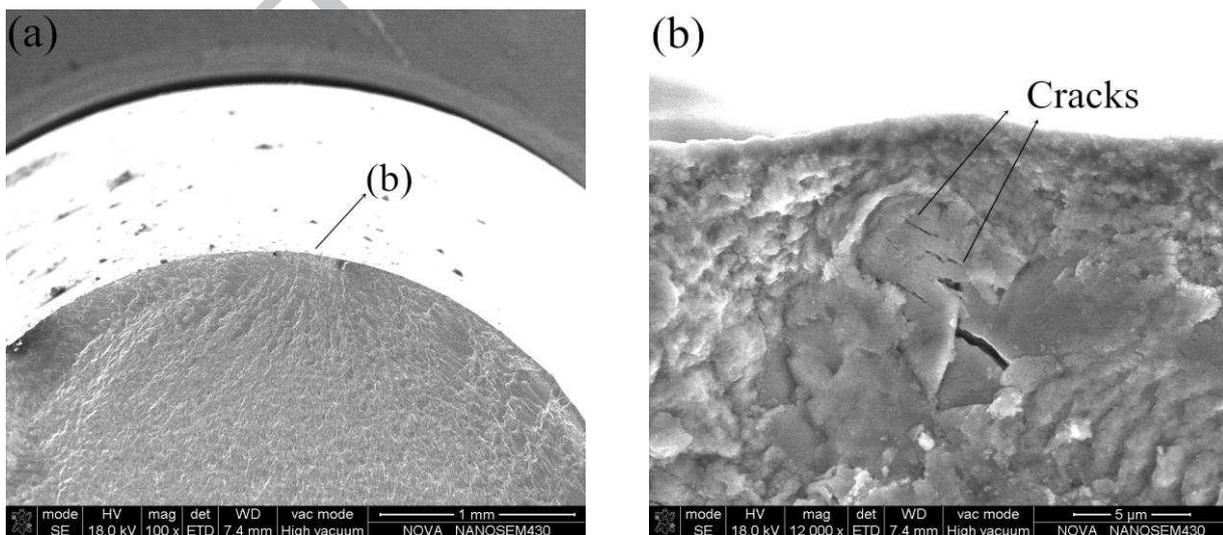
Fig. 18 (a), (b) Fracture surfaces of the USR treated specimen tested at 650 °C ($S_{\max} = 410$ MPa,

N=5,732,637 cycles).

higher temperatures [31]. Furthermore, the applied fatigue load and the number of fatigue cycles resulted in the relaxation of residual stress. It could be ascribed to the combination of thermally activated processes and cyclic deformation during the test [31]. Hence, the decrease of the shift distance of crack initiation sites from the surface to subsurface at high temperatures can be attributed to the material performance degradation of severe plastic deformation layer, including the softening and oxidation of the material and relaxation of the compressive residual stress.
