TWIN DISC ASSESSMENT OF WEAR REGIME TRANSITIONS AND ROLLING CONTACT FATIGUE IN R400HT – E8 PAIRS

J.F. Santa^{1,3}, P. Cuervo^{1*}, P. Christoforou², M. Harmon², A. Beagles², A. Toro¹, R. Lewis²

Abstract: Twin disc tests were carried out to evaluate the wear resistance and Rolling Contact Fatigue (RCF) of premium R400HT rail samples in contact with E8 wheel samples. The wear rate and friction coefficient were correlated with the frictional work expended at the contact interface (the Tgamma approach). Accelerated RCF tests were also carried out on the premium R400HT rail and the results were compared to those obtained for standard R260 rail. The wear rates of rail samples were consistently lower than those reported in the literature for other contacting pairs in which the rail material studied is softer than R400HT. Also, the energy needed for the transition from the moderate to severe wear regime significantly increased for the hardened rail. Fatigue cracks were shallower for R400HT when compared with standard rail material. Hardened rails also showed lower mean spacing between fatigue cracks. This new information can be used to improve wear simulations of wheels and rails by usin

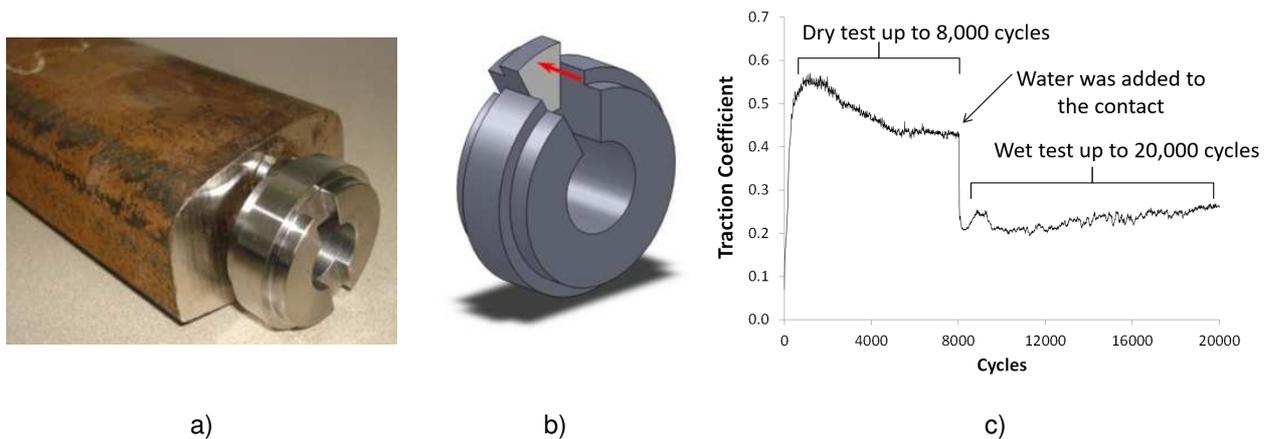
Figure 1. Details of samples and twin disc testing conditions. a) Extraction of a sample from the rail head, b) Sectioning of a sample to examine the deformed layer and the cracks formed during the tests, c) Typical variation of friction in dry and wet conditions.

The rolling contact fatigue tests were performed on a SUROS machine [21] using 1% creepage and a maximum contact pressure of 1300 MPa. An initial experiment consisted in running a fixed number of dry cycles (8000), a methodology that has been used before [23, 24]. After the tests, the samples were cut as shown in **Fig. 1b**, polished and chemically etched to measure the thickness and microhardness ($HV_{100g, 10s}$) of the strain-hardened layer formed as a result of the contact conditions.

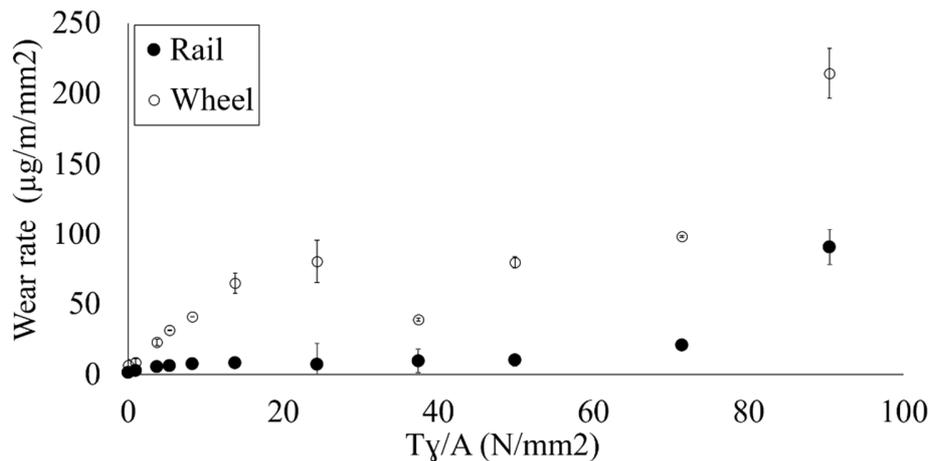
Figure 2. Average wear rates for R400HT rails rolling-sliding against E8 wheels for different slip ratios from 0 to 20%

Fig. 2 shows the wear rate of wheel and rail samples plotted against the wear index $T\gamma/A$, where T refers to the tangential force at the contact interface in newton, γ is the dimensionless slip ratio, and A is the contact area in mm^2 . The wear rate for the wheel sample was about one order of magnitude higher than that for the rail sample for a wide range of slip values. A linear relationship between wear rate and wear index was observed for wear indices below 25 N/mm^2 while no clear dependence of the wear rate on the wear index was seen for wear indices between 25 and 80 N/mm^2 . When the slip ratio was increased to 20%, $T\gamma/A$ reached about 90 N/mm^2 and the wear rate of the rail sample tripled, which indicates that a transition from a severe to a catastrophic wear regime had occurred.

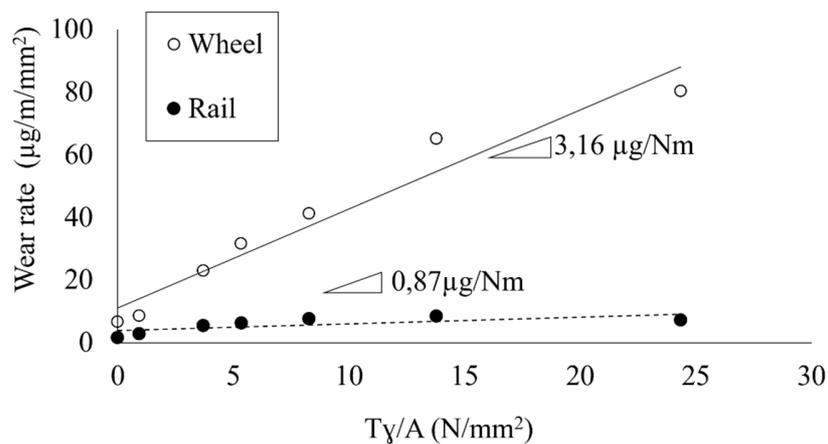
Figure 3. Wear rate for R400HT rail samples rolling-sliding against E8 wheel samples for wear indexes lower than 25 N/mm².

A close-up of the Tgamma curve for wear indices between 0 and 25 N/mm² is shown in **Fig. 3**, where two features become evident: a) for low slip values, a linear relationship between the wear rate and the wear index T γ /A can be established for both wheel and rail samples, and b) different T γ /A thresholds can be defined for the wheel and rail samples to mark the end of the linearly dependent region; this agrees with previous reports by Lewis & Olofsson [2]. The wear rate of the rail samples did not exceed 100 $\mu\text{g}/(\text{m}\cdot\text{mm}^2)$ even under the very harsh conditions imposed using a slip ratio of 20%. On the other hand, under such aggressive conditions, the wear rate of the wheel samples significantly increased, as did the magnitude of the surface damage observed at the end of the tests.

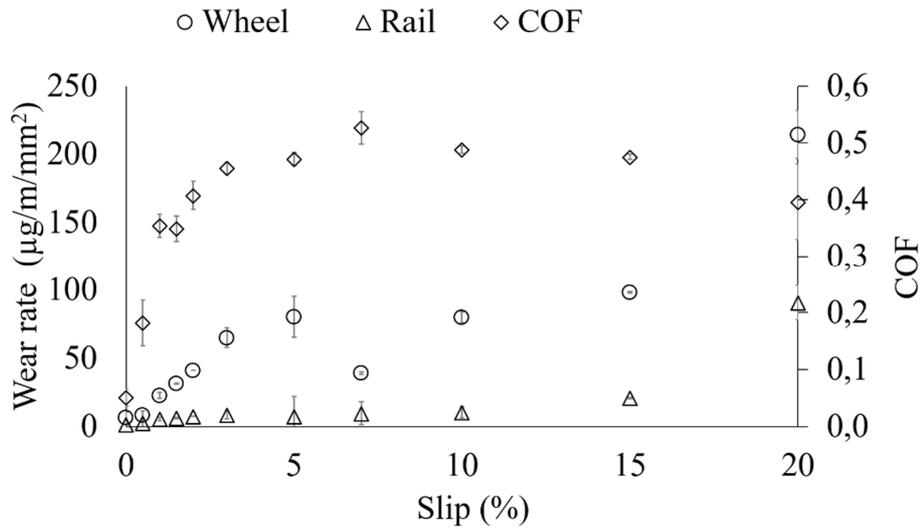
Figure 4. COF and wear rates versus slip ratio for R400HT rail samples in contact with E8 wheel samples for different slip ratios.

Fig. 4 shows the COF and the wear rates of wheel and rail samples versus the percentage of slip. The COF initially increases with slip ratio, and then stabilizes around a value of 0.5 for slip ratios higher than about 7%. For very high slip percentages there is a slight decrease in COF; a value of 0.4 was measured in the tests performed with a slip of 20%.

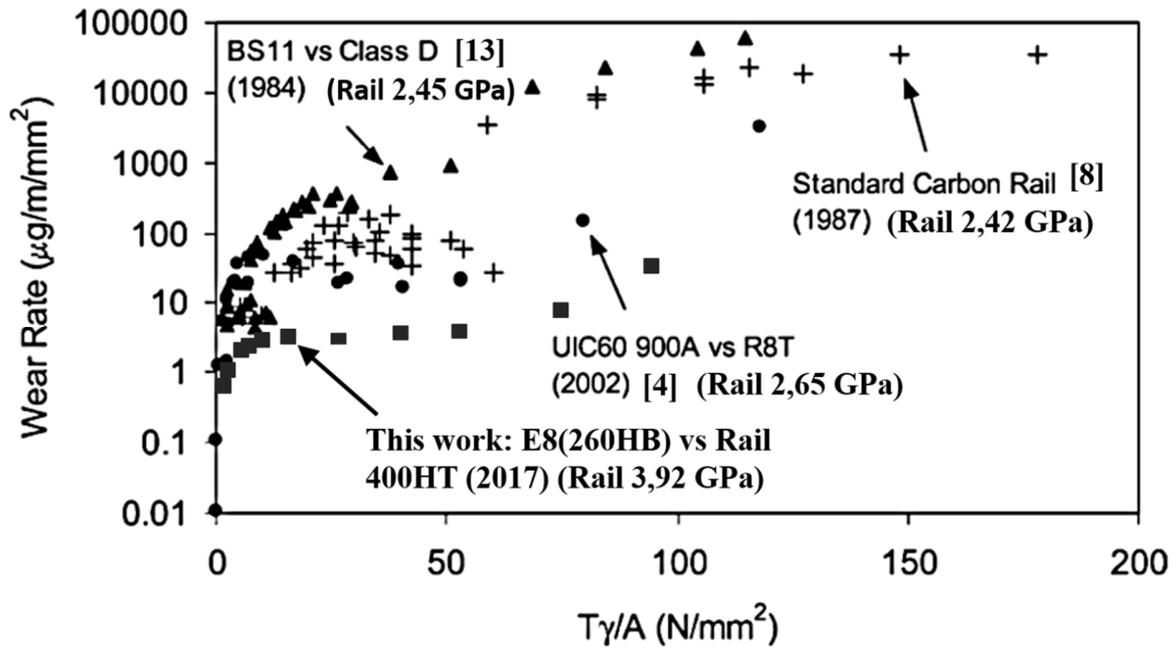
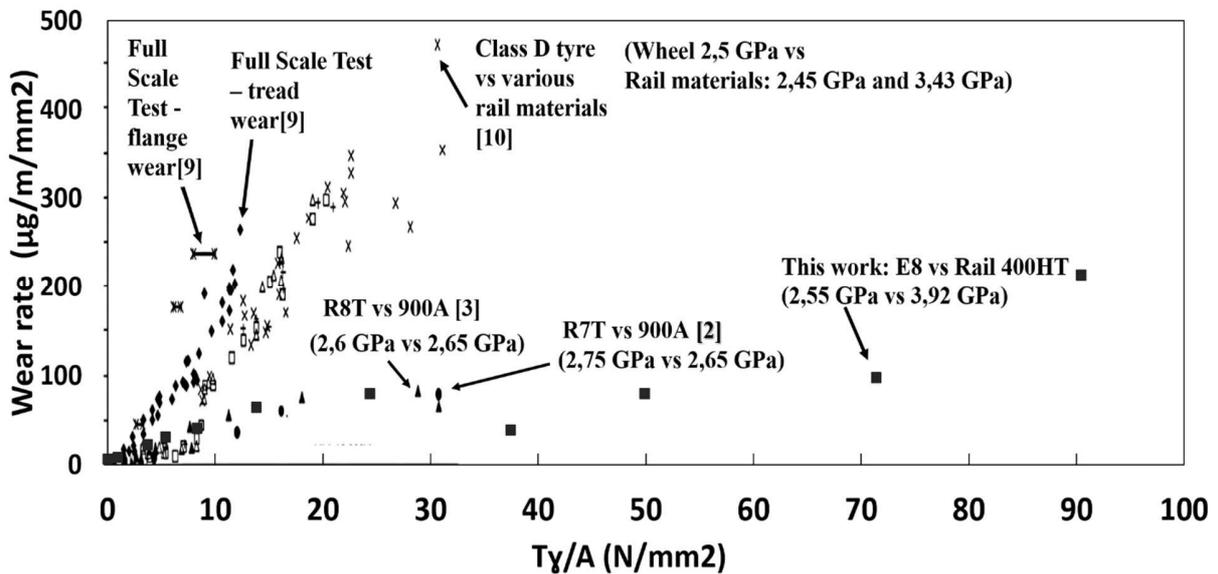
Figure 5 . Comparison of wear rates of R400HT rail steel (a) and E8 wheel steel (b) with reports from the

literature for several wheel-rail material pairs. Figures adapted from [4] and [2] respectively with new data added.

Fig. 5 compares the wear rates of R400HT rail (a) and wheel E8 (b) tested in this work with those reported in the literature for other rail and wheel materials [2,3,7-9,10,13]. The wear rates for the R400HT-E8 pair are significantly lower than those found in other pairs for virtually all the $T\gamma/A$ values studied. Comparison with the results reported in the literature after tests with Class D wheel material are of special interest since this steel has hardness and microstructure similar to the E8 steel studied in this investigation, so the differences in the behaviour of the pairs can be associated mostly with the characteristics of the rail materials. It is worth noticing that the measured wear rates for R400HT rail samples were always below $50 \mu\text{g}/(\text{m}\cdot\text{mm}^2)$ regardless of the value of $T\gamma/A$, with the sole exception of the case when $T\gamma/A$ was extremely high, about $90 \text{ N}/\text{mm}^2$, while the BS11 rail material, for instance, shows wear rates higher than $50 \mu\text{g}/(\text{m}\cdot\text{mm}^2)$ even for $T\gamma/A$ values as low as $10 \text{ N}/\text{mm}^2$.

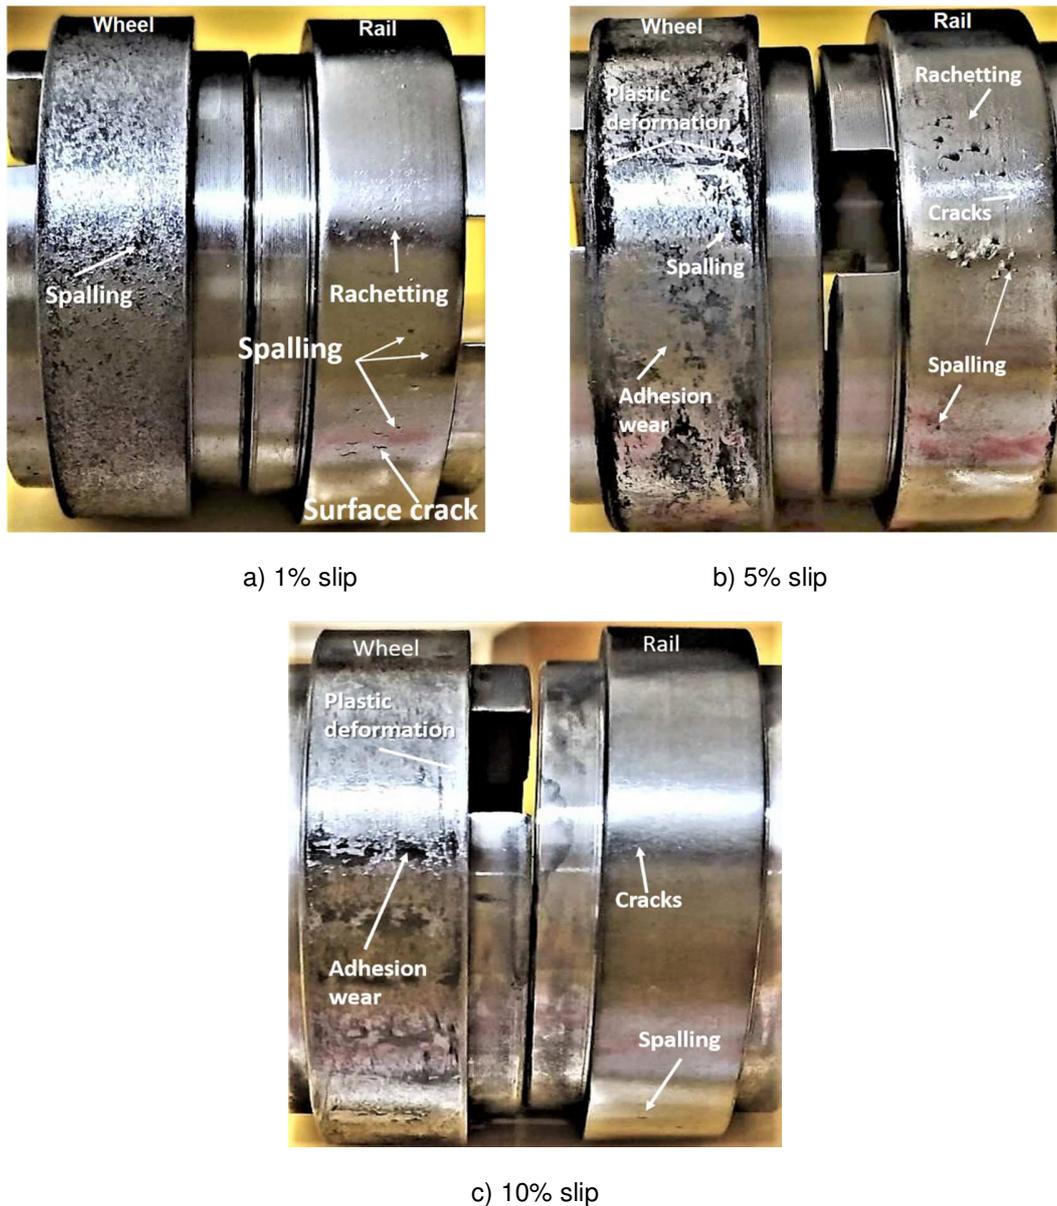
Figure 6. Aspect of the worn surface of wheel and rail samples after twin disc tests with different slip ratios.

Fig. 6 shows the typical aspect of the worn surface of rail and wheel samples after the twin disc tests with 1%, 5% and 10% slip ratio. Damage in rail samples proceeds mainly by ratchetting and surface cracking, while in wheel samples spalling and adhesive wear are the predominant mechanisms.

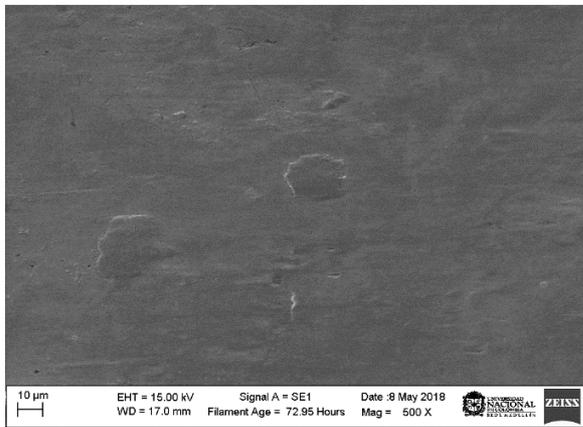
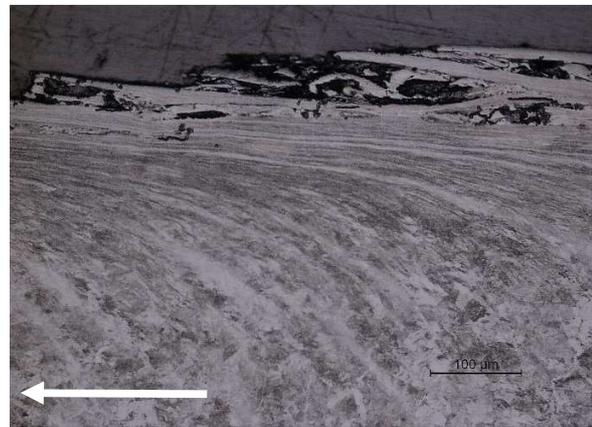
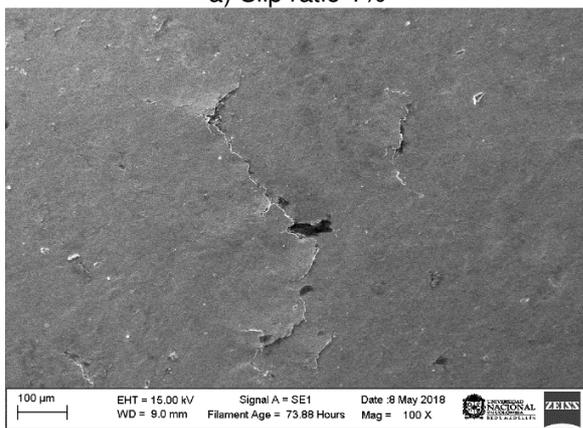
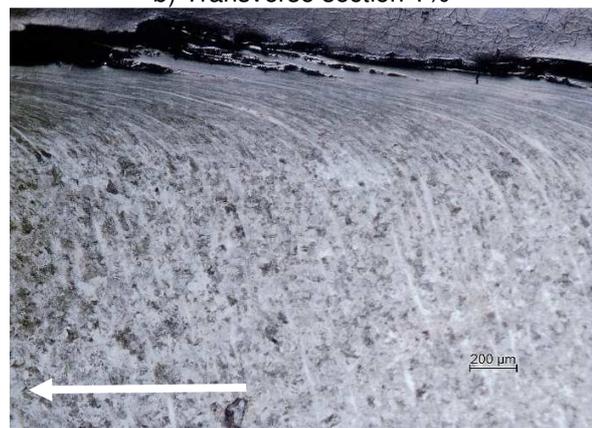
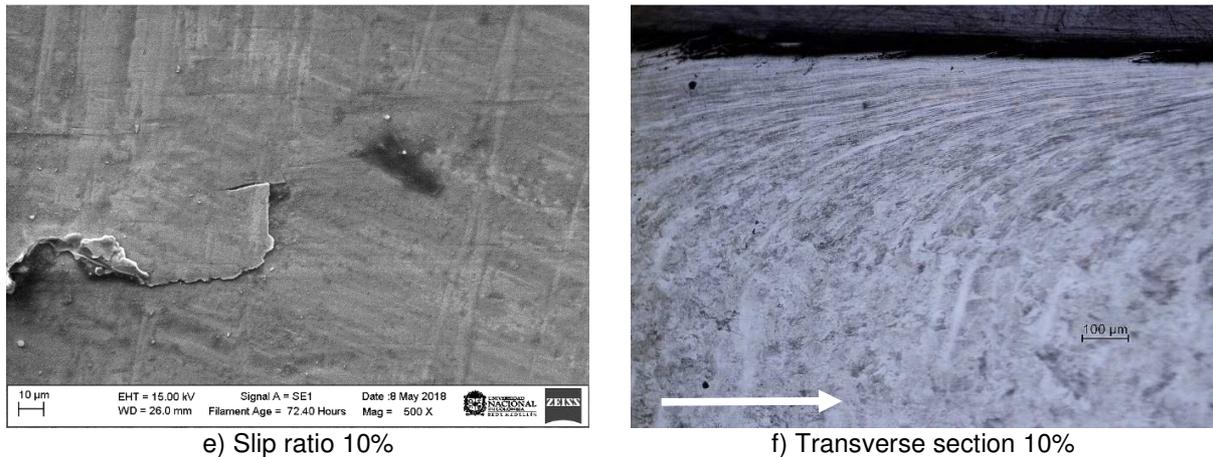
a) Slip ratio 1%

b) Transverse section 1%

c) Slip ratio 5%

d) Transverse section 5%

Figure 7. Aspect of the worn surface (SEM: a, c, e) and cross-section (LOM: b, d, f) of premium R400HT rail after twin-disc tests with different slip ratios. The arrows on cross-sections (b, d, f) show the rolling directions.

Fig. 7 presents SEM images of the worn surface and light optical microscope (LOM) images of the cross section of rail samples after tests with slip ratios of 1%, 5%, and 10%. Ratchetting marks and small surface cracks are evident in samples tested with 1% slip ratio, in which the mean angle of propagation of the cracks with respect to the surface is circa 5°. After the tests with 5% slip ratio the ratchetting marks become larger and the overall damage of the surface is more intense, while for 10% slip ratio the amount and size of the wear marks reduce again, and the surface is somehow similar to that observed after the tests with 1% slip ratio.

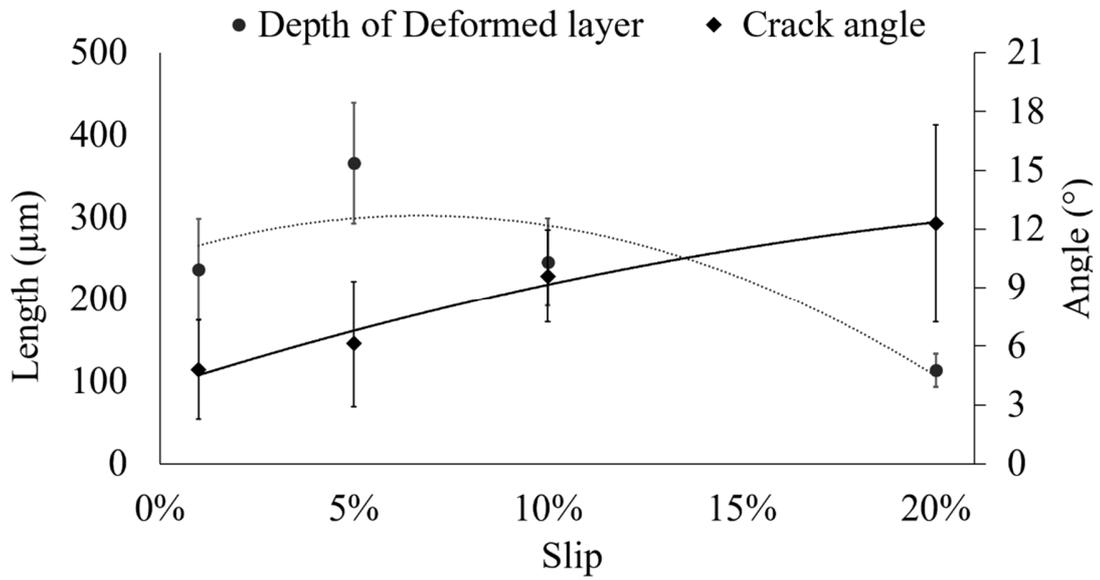
Figure 8. Variation of mean crack angle with respect to the surface and depth of deformed layer as a function of the slip ratio for premium R400HT rail.

The crack angle increases with the slip ratio to a value around 12° for slip ratio 10% as shown in **Fig. 8**, in which it can also be seen that the depth of the deformed layer reaches a maximum of $365\ \mu\text{m}$ at 5% slip ratio and then decreases to circa one third of that value at 20% slip ratio. These results are consistent with the observed variation of microhardness with the distance from the surface as illustrated in **Fig. 9**. Changing the slip ratio from 1% to 5% causes a significant increase in the hardness near the contact surface as well as in the depth of the hardened layer. On the other hand, when the slip ratio increases to 10% the depth of the hardened layer is just slightly larger than that observed for a slip ratio of 1%. Further increases in slip ratio lead to a softer surface despite the strain hardening process being more intense for larger slip ratios. This is caused by the removal of external, harder layers, of material due to sliding friction, leaving sub-surface, softer layers, as “new” surfaces.

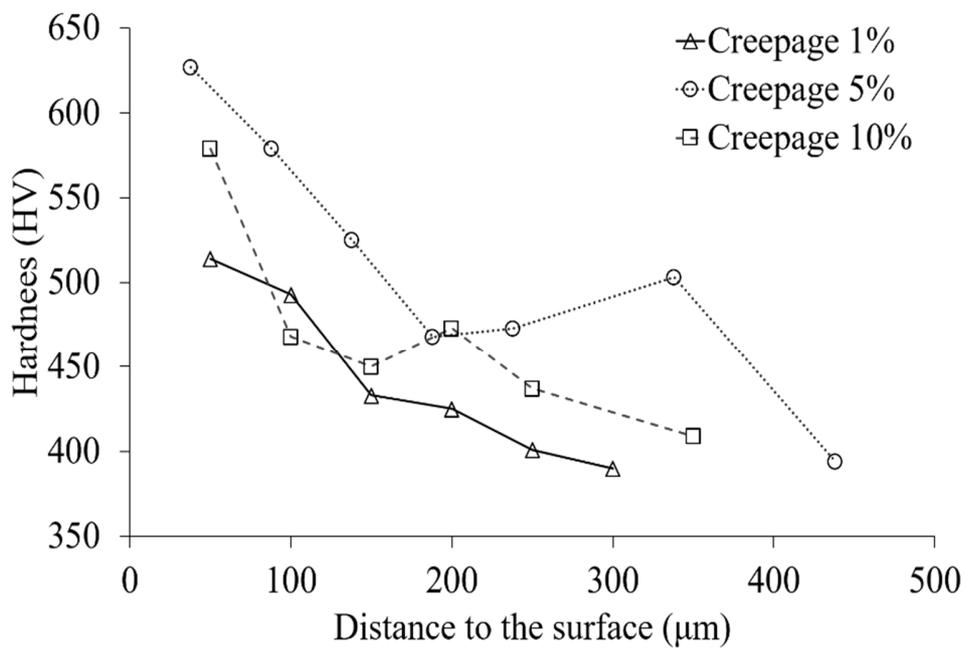
Figure 9. Variation of microhardness of premium R400HT rail as a function of the distance from the worn surface for three different slip ratios.

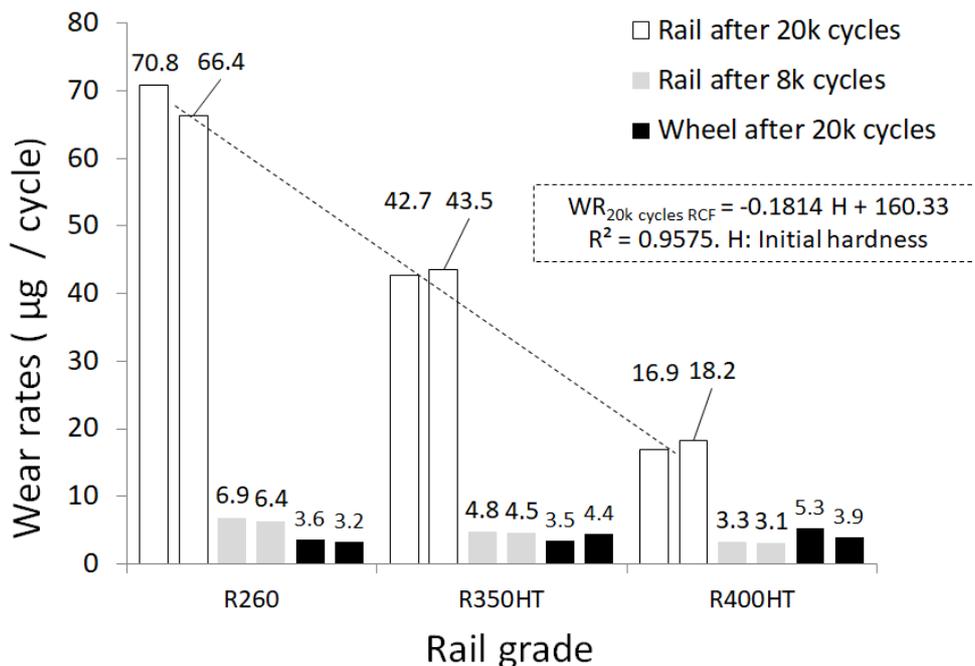
Figure 10. Wear rates after dry and wet tests with different rail materials

The results of mass losses of the three rail steels with two replicas after wear tests performed up to 20 thousand (20k) cycles (8k dry cycles and 12k wet cycles) are shown in **Fig. 10**. Generally speaking, when the hardness (H) of the rail is higher the wear rates (WR) are lower.

When rolling contact fatigue is induced by pressurization using water, the lowest mass loss was found for the hardened R400HT rail. The highest mass losses were found for the standard R260 rail for which the wear rate was around 4 times higher than in R400HT rail. The coefficient of friction for the test rails (not shown) was very similar for all the tested pairs although slightly lower values were found for the softer rails. **Fig. 10** also shows the wear rates under dry conditions (after 8k cycles). From the data the same trend (lower wear of the rail material for higher hardness) was observed, with the wear rate under dry conditions for the standard rail (R260) being around 2 times higher than that for the hardest rail (R400HT).

An issue that has been discussed by maintenance engineers is if the use of hardened rails will affect the behaviour and/or cause high wear rates in the wheels. **Fig. 10** also shows that the wear rates of wheels after 8k dry then 12k wet cycles were higher when the hardened R400HT was used. Results obtained by the manufacturer of premium rails in Full-Scale Rig (FSR) tests [26] showed that the wear rates of the wheels rolling against different rails were very similar. However, these results were obtained under dry rolling-sliding after 100k wheel passes (cycles). The damage caused by shelling in the twin-disc test can affect the results since the debris from the rail (detached shells) can cause abrasion on the surface of the wheel samples. This clearly has to be considered since it does not represent the conditions in the field.

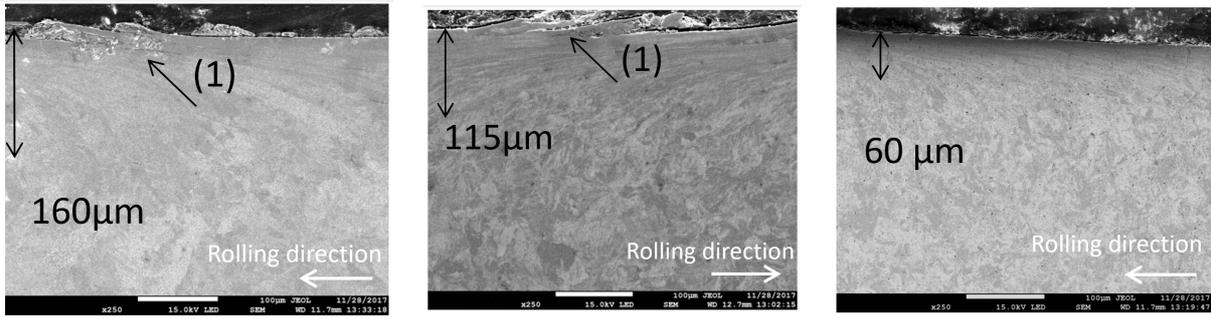
d) Transverse section R260

e) Transverse section R350HT

f) Transverse section R400HT

Figure 11. Worn surfaces of the samples after the tests

Fig. 11 shows the worn surfaces of the samples after the 20k cycles of testing. The damage was different for every rail and the largest flakes were found for the R260 rail. The same figure also shows the deformed layers after rolling-sliding for 8k dry cycles. The white arrows at the bottom-right show the rolling-sliding directions. The thickness of the deformed layer varied from 60 to 160 μm for the different rail materials. The deepest deformed layer was found for the R260 rail, while the shallowest one was found for the R400HT rail. Similar to what was found for the hardness, there is a linear relation between the thickness of the deformed layer (t) in μm and the wear rate (WR) during the test.

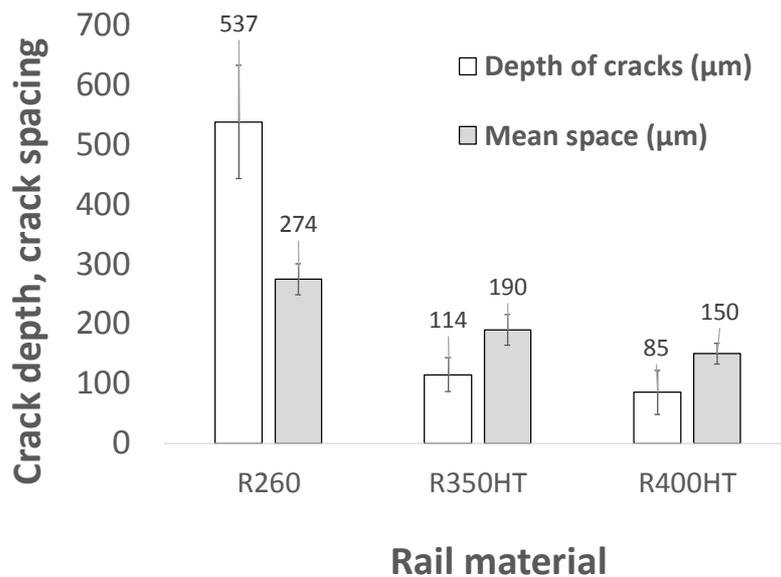
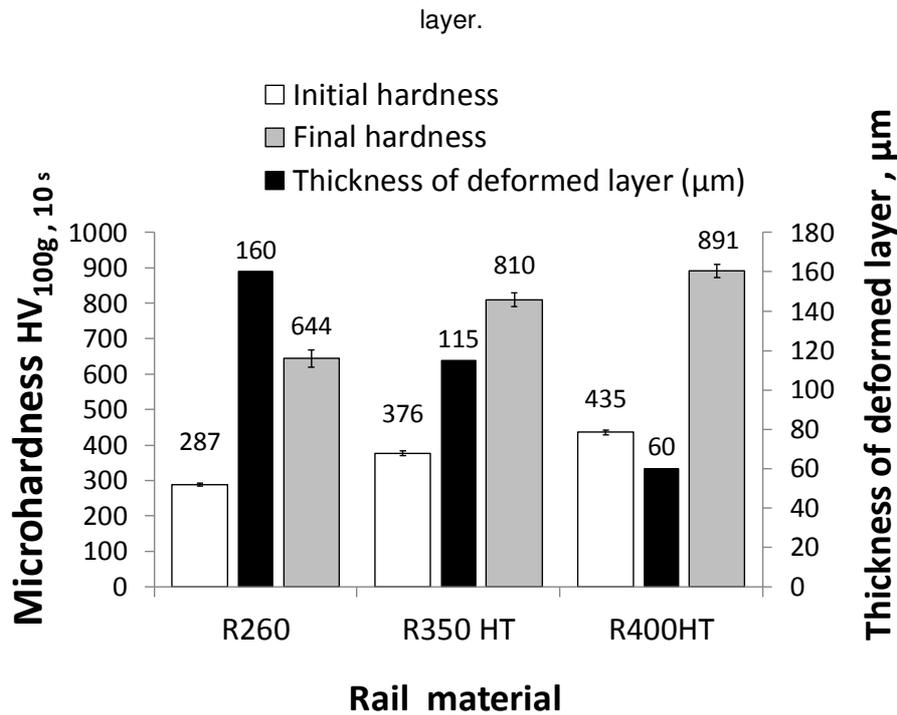
a) Initial and final hardness after 8k dry cycles and thickness of the deformed

b) Maximum cracks depth and mean space between cracks in the discs after 20k cycles

Figure 12. Results from rolling contact fatigue tests

Fig. 12 shows the initial and final hardness after 8k dry cycles, as well as the thickness of the deformed layer for the three rail materials studied. The difference between the final and initial hardness shows that even harden rails can be strain-hardened during rolling-sliding tests. **Fig 12** also shows the depth of the cracks for the different rail materials and the spacing between them. The cracks were shallower for the hardened rail (R400HT) while the deepest cracks were found for the standard rail material (R260). A closer inspection of the samples after the full 20k cycles showed cracks with lengths ranging from 153 μm to 730 μm with mean angles from 8° to 23°. The density of cracks was higher for the softer rail.
