Alsaadi, A., Meredith, J., Swait, T. et al. (3 more authors) (2019) Structural health monitoring for woven fabric CFRP laminates. *Composites Part B: Engineering*, 174. 107048. ISSN 1359-8368

# Structural Health Monitoring for Woven Fabric CFRP Laminates

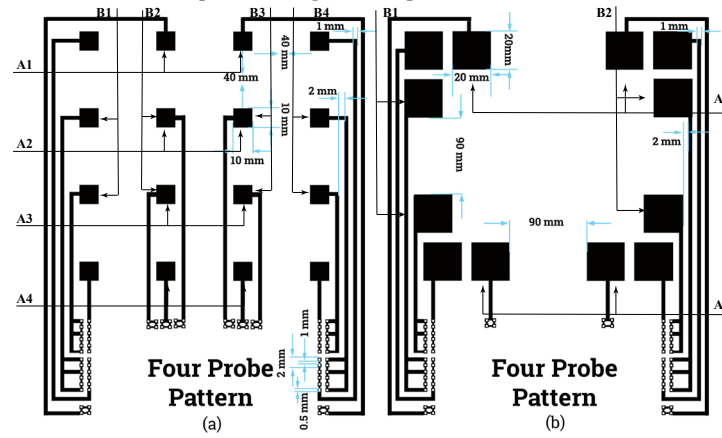
Figure 3: Sensing pattern designs are shown in (a) pattern used to manufacture sensing mat 1, and (b) pattern used to manufacture sensing mat 2. Steps to fabricate sensing mats are shown in (c) a flexible circuit board after exposing to UV light, (d) sensing mat passing the developing stage, and (e) ready to use sensing mat 1.

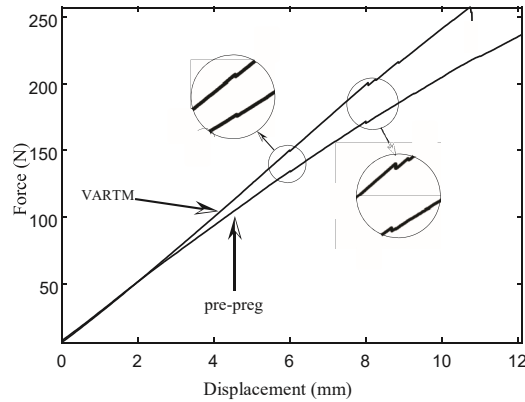
Figure 8: Force - displacement curve of CFRP laminates, the deviation in the curves at 6mm and 8mm were likely attributed to matrix cracking, the test was stopped when a fibre splitting occurred. Flexural Young's modulus of VARTM laminates  $E_f = 55\text{GPa}$  and  $E_f = 57\text{GPa}$  for autoclave processing laminates.

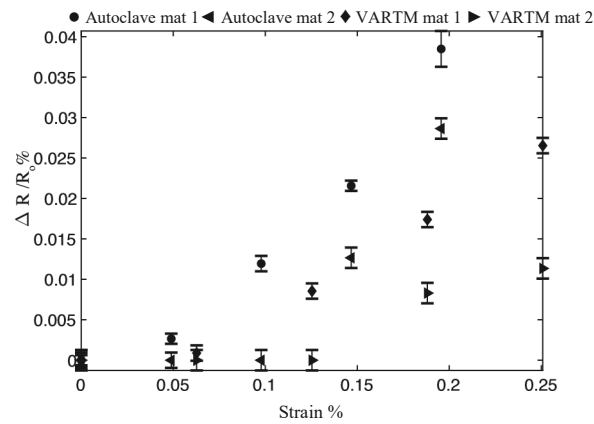
Figure 9: Electrical resistance variations due to applied strain, the electrical resistance was measured when the CFRP laminates strained. Reversible electrical resistance variations were observed up to 0.18% of strain and then irreversible electrical resistance variations were noticed after a threshold of 0.19% of strain where a damage in form of matrix cracks evolved.

The positive electrical resistance, i.e. positive piezoresistivity, shown in Figure 9 was attributed to the location of the sensing mat, where the *mats* placed on to the bottom surface of the laminate, i.e. surface under tension loading. The

electrical resistance increased with the loading due to the increase of the alignment of the fibres and therefore decrease fibre-fibre contacts between adjacent plies.
