Lu, P., Lewis, S.R., Fretwell-Smith, S. et al. (3 more authors) (2019) Laser cladding of rail; the effects of depositing material on lower rail grades. *Wear*, 438-439. ISSN 0043-1648

LASER CLADDING OF RAIL; THE EFFECTS OF DEPOSITING MATERIAL ON LOWER RAIL GRADES

Abstract: This paper presents a study comparing the wear performance of laser clad rails. A grade of martensitic stainless steel (MSS) was deposited on two substrate materials: The European standard grade rail steel R260, and a lower grade rail steel R200. A twin-disc method has been used to simulate the contact of wheel and rail under closely controlled conditions. Although cladding on a lesser grade of rail has an effect on the hardness and wear performance of the clad layer (due to dilution), the resulting wear performance of the clad layer assessed using this approach is still vastly improved over R260 material alone.

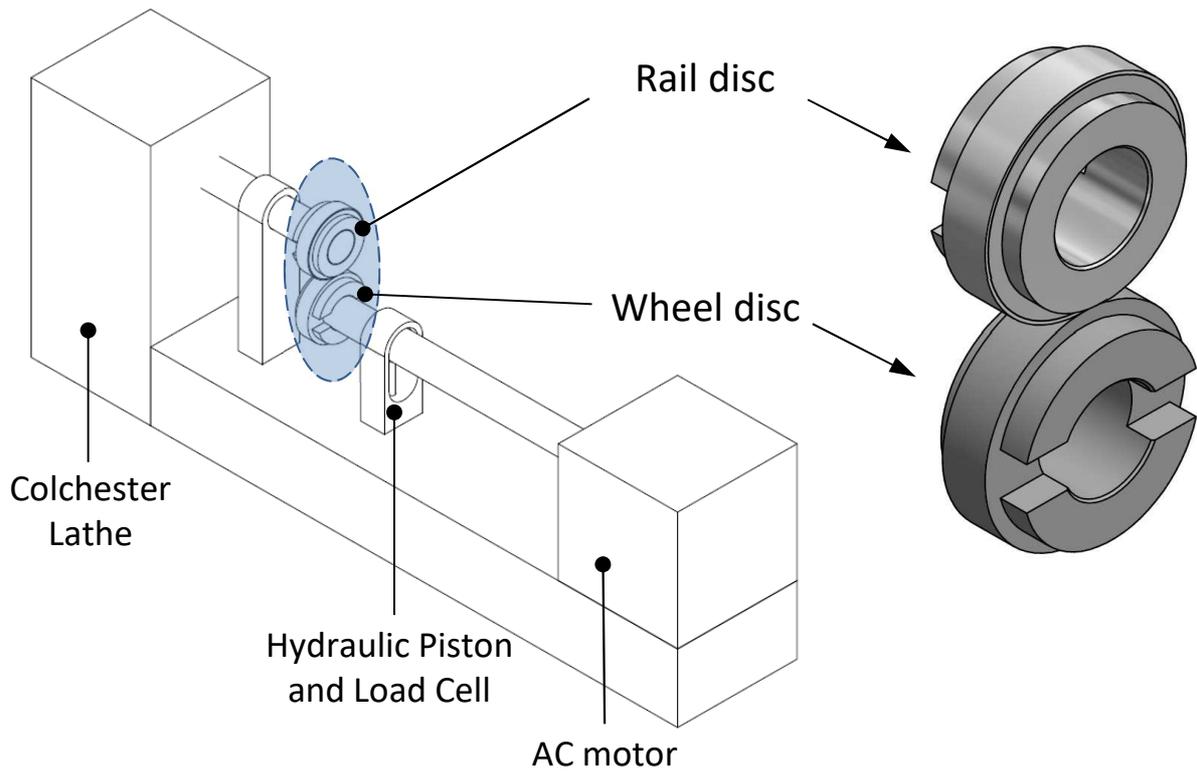
The wear experiments were carried out using the Sheffield University Rolling Sliding (SUROS) twin-disc test machine [19]. Figure 1 shows a schematic of the SUROS rig and typical discs used. This machine uses a line contact between twin-disc specimens to simulate the normal load and rolling-sliding behaviour at the wheel/rail interface. Two discs with diameters of 47 ± 0.2 mm serve as a rail disc (upper specimen) and a wheel disc (lower specimen). These discs are powered and controlled by an AC motor and a Colchester lathe. The difference of speed of wheel and rail discs is used to control the creep. The slip ratio is defined in Equation 1, where ω and r are the rotational speed and rolling radius of the discs, respectively. The load is applied to the wheel disc by a hydraulic piston and load cell.

Figure 1. Schematic of the SUROS machine and SUROS wheel & rail disc samples.

Testing was conducted using the SUROS twin-disc testing machine shown in Figure 1, taking the 47mm diameter wheel and rail discs and loading them to produce a small-scale contact capturing the key elements of combined rolling-sliding behaviour characteristic of a rail-wheel contact. With a line contact length in the lateral dimension of wheel/rail rollers of 10 mm, contact load of 7.14 kN which gives a maximum Hertzian contact pressure of 1500 MPa. A rail disc rotational speed of 400 rpm and creep of 1% was also used representing a driving wheel condition. Wear tests were conducted under dry conditions. During the wear testing the tests were stopped every 5,000 cycles so that the evolution of the wear rate could be measured. These are standard wear settings for SUROS testing [19].

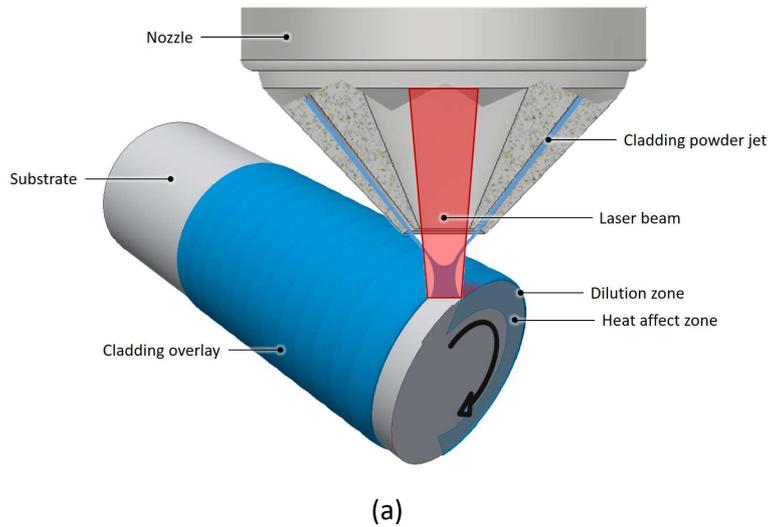
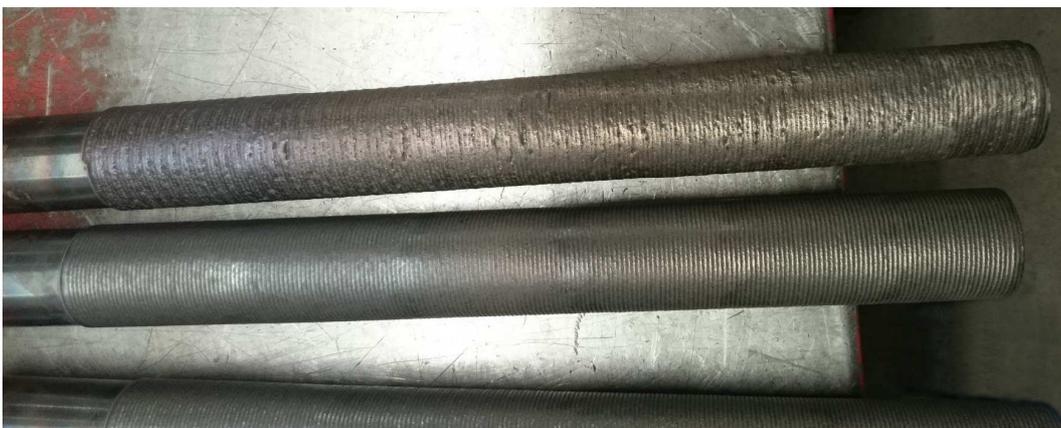
In this study, one-step laser cladding by powder injection was employed to clad the rail cylinder specimens. A grade of martensitic stainless steel (MSS) CHROME CORE DN-S (Welding Alloys Group) was used as the cladding material. The composition was attempted to be replicated by powder mixes, yielding the following results: C 0.06; Mn 1.22; Si 0.46; Cr 14.64; Ni 3.31; Mo 0.42; Co 2.01; V 0.51; W 0.62; N 0.04; Al 0.01; S 0.005; P 0.009. This has been found to be less susceptible to ratchetting due to its high hardness and shear yield strength in previous tribological tests [16], was deposited onto the two different grades of rail material. Figure 2(a) shows a schematic of this cladding process, where the high energy laser beam is focused on and scanned across the curved surface of the rail substrate. As the MSS powder passes through the laser it is melted and fuses with the melt pool on the surface of the substrate material. The shaft rotates under the laser to allow a single track of clad to be deposited on the surface. Individual tracks are then overlapped side-by-side to cover the shaft surface. As the laser passes the substrate will start to cool at a rapid rate. This high rate of cooling is due to the greater volume of substrate which is at a lower temperature than the freshly laid deposit. This heating and rapid cooling of the substrate causes changes in its microstructure throughout a certain depth of the bulk, which is called the heat affected zone (HAZ).

Figure 2 (b) gives an example of the cylinders coated by cladding tracks. It should be noted that all the cladding parameters including the MSS powder feeding rate, the laser power and the rotating speed of the shaft were all optimized to achieve a poreless clad layer with outstanding mechanical properties, as well as a satisfactory bond between the substrate and deposit.

Figure 2. Laser cladding (a) laser cladding scheme (b) laser clad cylinders prior to finish grinding.

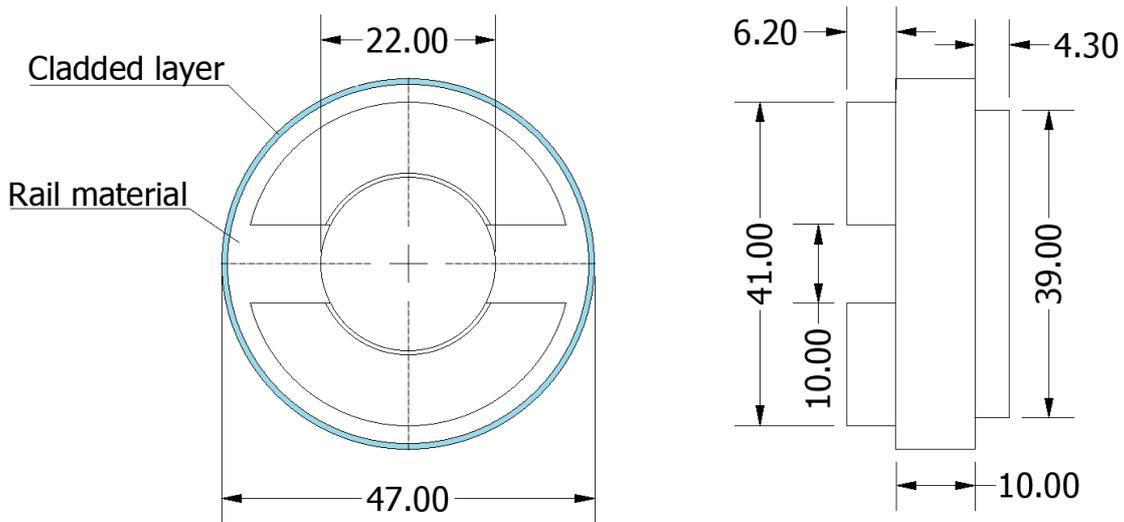
The single layer of MSS material had a mean post-grinding thickness of 1.10 mm. The ground cylinders were then sectioned and machined into SUROS rail specimens with dimensions as shown in Figure 3. The wheel discs were not clad as the focus of this work was the cladding of rails only.

Figure 3. Cladded rail disc parameters.

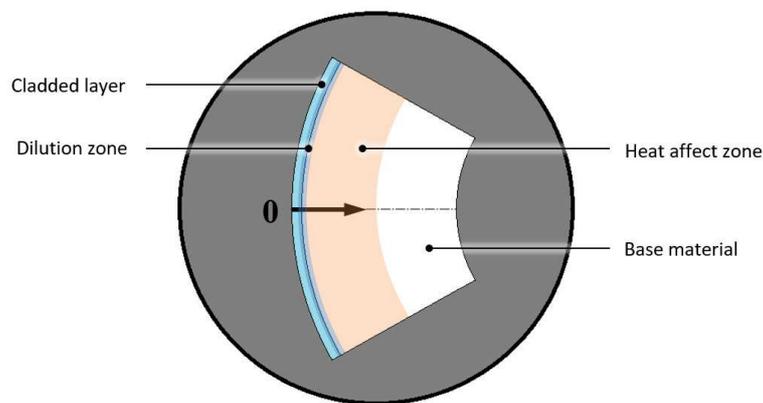
For microhardness mapping, the discs were sectioned, mounted in Bakelite base and polished for the micro-hardness and microstructural analysis. Pre-test micro-hardness measurements were taken with un-tested discs. These results were generated after cladding, but prior to any load application, so did not capture any strain hardening under load. Vickers micro-hardness measurements were taken using a load of 1.00 kg and dwell time of 10 seconds. The indentation process started from the cladding edge towards the centre of the specimen, and the edge was defined as the zero position, see Fig.4.

Figure 4. Hardness mapping direction and location.

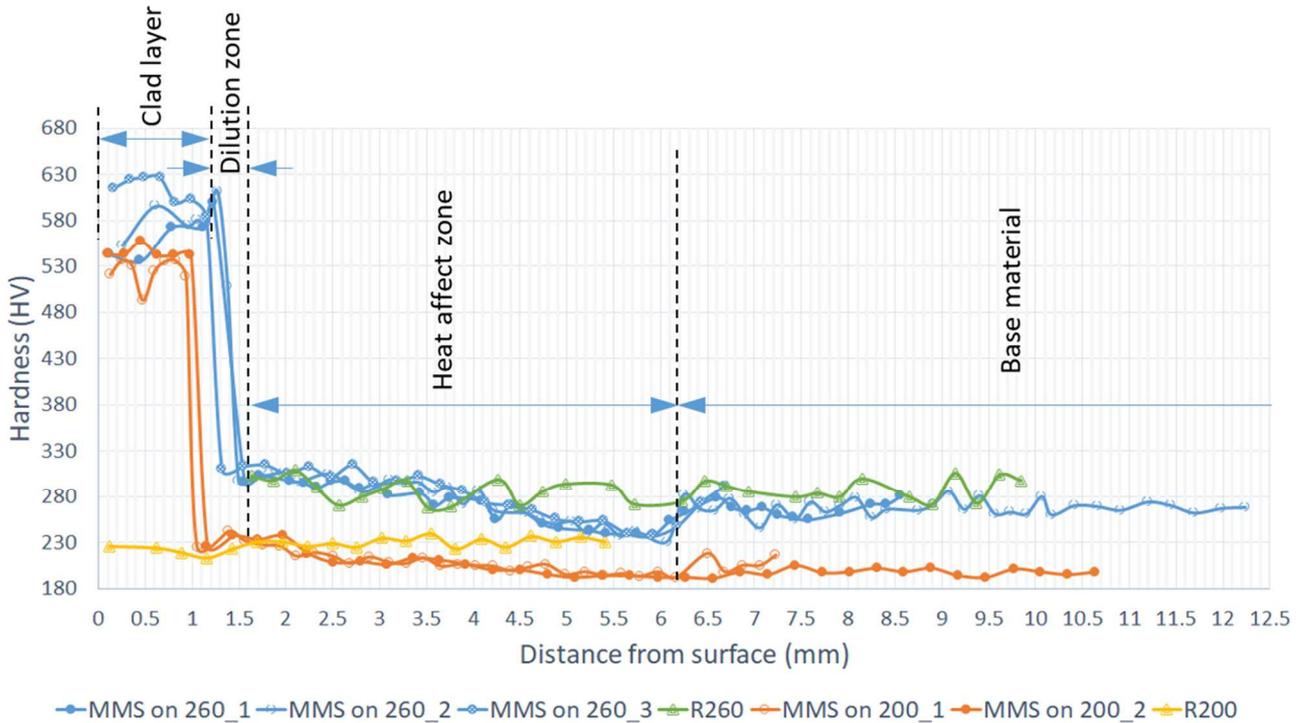
Figure 5 shows results of microhardness measurements for the R200 and R260 rail material clad with a single layer of MSS material. As shown in Figure 5, the hardness of the MSS clad layer ranges from 530HV for MSS on the R200 steel substrate to 630HV for MSS on the R260 substrate. It can also be seen that the increase of the hardness of the substrate material leads to a corresponding increase in the hardness of the MSS deposit, possibly caused by mixing of the deposit material with the lower (R200) or higher (R260) carbon content substrate during the fusion stage of the cladding process.

The material in the “dilution” zone, where the clad material mixed with the base material, has a hardness value between that of the clad layer and the base material. While in the HAZ, where the base material’s

microstructure is changed during the heating and cooling process, the hardness reduced gradually towards the boundary with the base material. This could be in part due to the fact the grain size changes through the HAZ. Other factors could be related to microstructural changes including partial spheroidisation of cementite lamellae or differences in pearlite spacing.

Figure 5. Hardness mapping for all samples before SUROS testing.

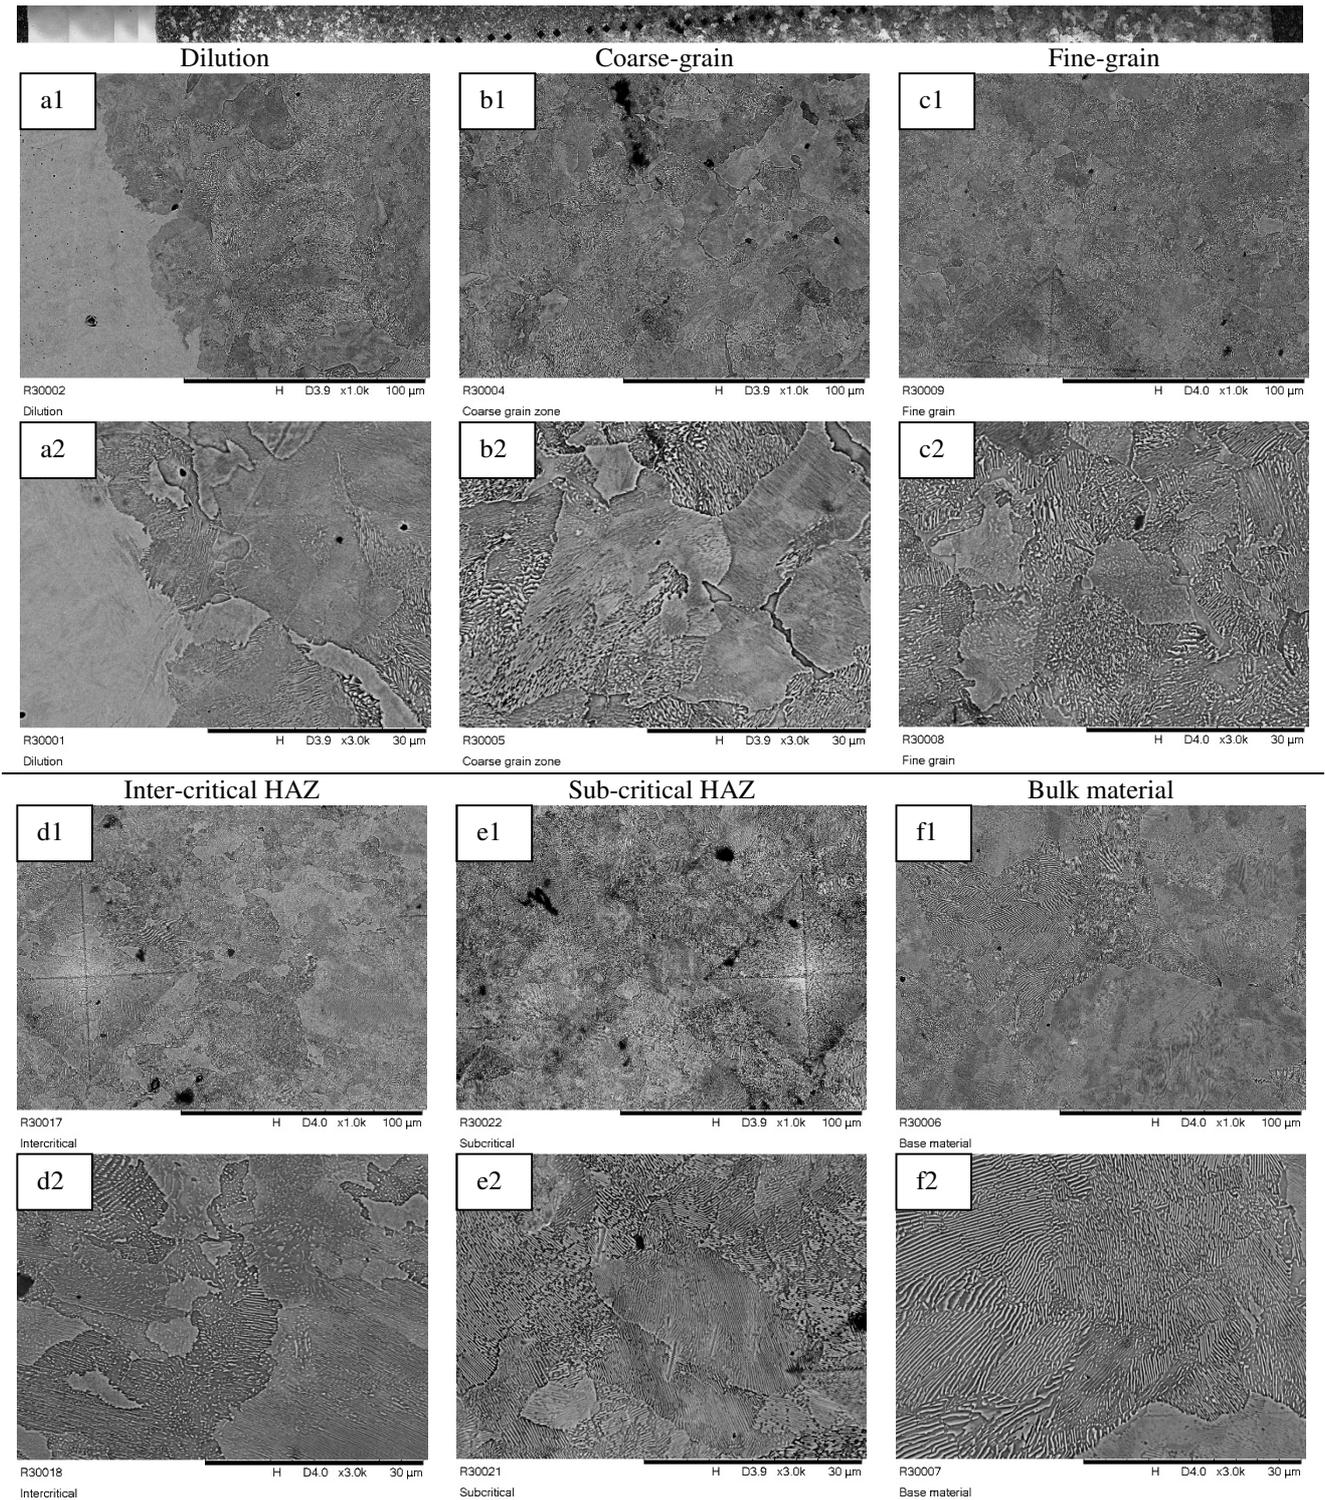
Images of all microstructure are shown in Figures 6 and 7. The heat affected zones (HAZ) were classified according to the term system of Farichild [21]. All polished specimens for microscope and SEM analysis were etched with 2% Nital to expose the microstructural features. For each material, low magnification overview images were taken using an optical microscope CARL ZEISS axio imager a2m (Zeiss Göttingen, Germany). Higher magnification assessment was then carried out via backscattered electron (BSE) SEM analysis by using a Hitachi TM-3030 Tabletop Scanning Electron Microscope (SEM). Images are provided in two magnifications to highlight the difference in microstructure (coarse vs. fine grained) as a function of distance throughout the clad layer. The overview in Figures 6 and 7 show a HAZ dilution zone, coarse grained, and fine grained microstructure zone, followed by an inter-critical and sub-critical HAZ adjacent to the base material of the untested cladding on R260 and R200, respectively.

Figure 6. Microstructure of HAZ in untested MMS on R260 (2% Nital etched): (a1), (a2) are for the Dilution zone. (b1), (b2) are for the Coarse-grain. (c1), (c2) are for the Fine-grain zone. (d1), (d2) are for the Inter-critical zone. (e1), (e2) are for the Sub-critical zone. (f1), (f2) are for the Base material.

Figure 6 (a, b, c) shows the HAZ in the region where full reversion to austenite and subsequent

transformation to lamellar pearlite has occurred during the laser cladding thermal cycle. The coarser grain size adjacent to the cladding/parent material interface is due to the higher temperature experienced at this position. Figure 6 (a1, a2) show the unetched MSS cladding (white), with the dilution zone then showing the first appearance of very fine-structured pearlite colonies. The dilution zone in Figure 6 then changes into a coarse grained (b1, 2) and fine grained (c1, 2), slightly hypo-eutectoid pearlite microstructure, with small ferritic regions embedded amid large pearlitic colonies and grains.

Figure 6 (d, e, f) shows the R260 pearlitic steel microstructure with individual pearlite colonies and grains. Figure 6 (d1, d2) shows the microstructure in the intercritical region. At this location only partial reversion to austenite occurs and the regions which have reaustenitised have transformed to fine lamellar pearlite on cooling. The regions where austenite reversion has not occurred can be seen in Figure 6 (d1, d2) as globular, broken up regions of pearlite; this occurs when the temperature is not sufficiently high for reversion to austenite and the lamellar pearlite begins to break down into the equilibrium constituents for this temperature, i.e., spheroidised cementite particles within a ferrite matrix. The sub-critical HAZ shown in Figure 6 (e1, e2) are comprised mainly of spheroidised pearlite due to the temperature remaining just below the eutectoid temperature of 723°C. However, there are still one or two regions where transformation has occurred as evidenced by the lamellar pearlite in the micrographs. Figure 6 (f1, f2) show the lamellar pearlite structure typical of R260 grade rail; the lamellar being most clearly evident in the higher magnification micrograph of Figure 6 (f2). Figure 6 (d1, e1) also show hardness indents.

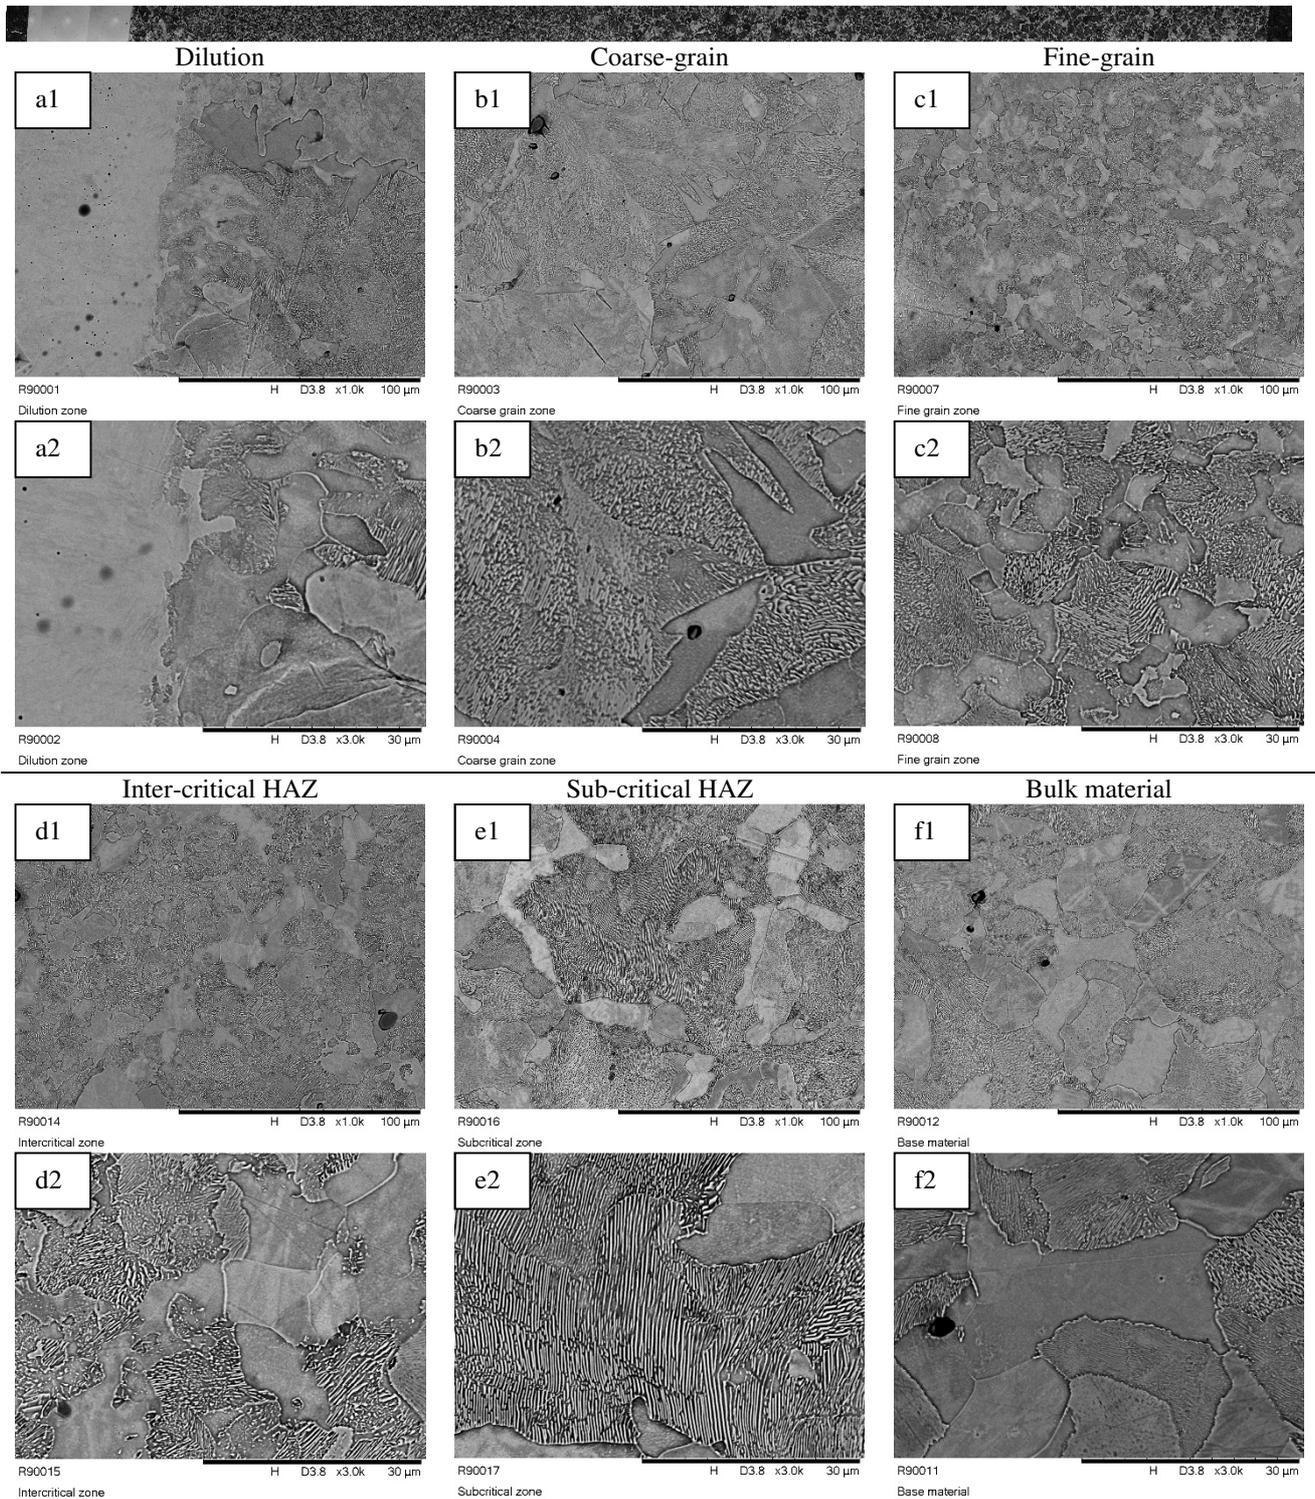
Figure 7. Microstructure of HAZ in untested MMS on R200 (2% Nital etched): (a1), (a2) are for the Dilution zone. (b1), (b2) are for the Coarse-grain. (c1), (c2) are for the Fine-grain zone. (d1), (d2) are for the Inter-critical zone. (e1), (e2) are for the Sub-critical zone. (f1), (f2) are for the Base material.

A similar microstructure appearance can be seen in Figure 7, with however a more pronounced hypo-eutectoid pearlitic steel substrate of the R200 steel with individual pearlite colonies, separated by larger ferrite grains. This is apparent in all regions in Figure 7 (a-f). R200 has a much lower carbon content than R260 grade rail and as a result the microstructure of the parent rail contains a continuous network of pro-eutectoid ferrite around the prior austenite grain boundaries.

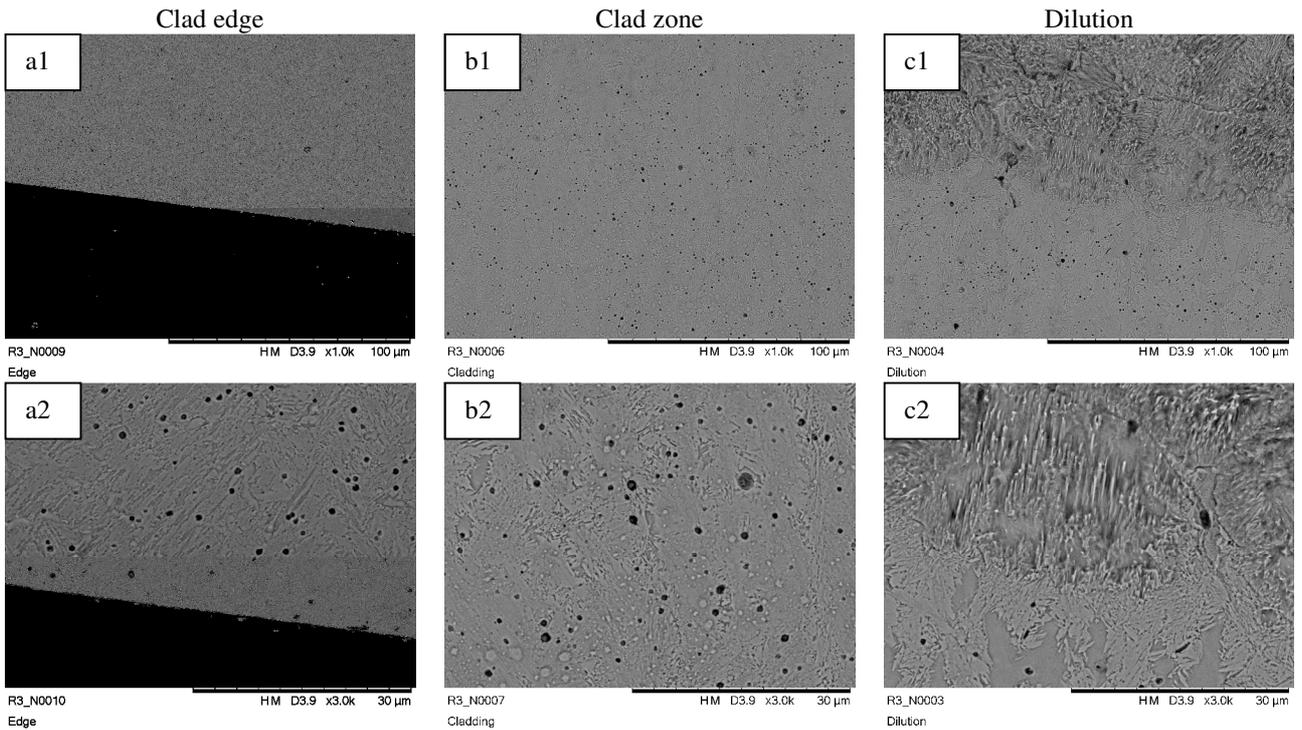
For the clad layers, the 2% Nital acid solution could not expose microstructural features, therefore a more corrosive solution of 4.76% nitric acid, 47.62% hydrochloric acid in 47.62% water, was used to reveal their microstructure, and the results are shown in Figures 8 and 9 for MSS on R260 and MSS on R200, respectively. It should be noted that the strong etchant caused some local dissolution/attack of additional microstructure constituents, as none of them can be observed from the 2% Nital etched samples shown in Figures 6 and 7. The clad layer is characterised as the clad edge (close to the top side of the cladding), the clad zone, and dilution zone close the substrate HAZ.

Figure 8. Microstructure of clad zone in untested MMS on R260 (4.76% Nitric, 47.62% hydrochloric and 47.62% water etched): (a1), (a2) are for the clad edge. (b1), (b2) are for the clad zone. (c1), (c2) are for the dilution zone.

The microstructure of the MMS within the clad zone consisted of a mixture of martensite, retained austenite and delta ferrite for both the deposit on the R200 grade rail and that on the R260 grade rail (Figures 8 and 9). Adjacent to the interface the microstructure of the MMS deposit appeared to contain a higher proportion of blocky austenite, particularly for the deposit on R260 grade rail grade (Figure 8 (c2)). The higher carbon of this rail grade will reduce the amount of delta ferrite and increase the amount of austenite within the microstructure. This was less evident in the deposit adjacent to the interface on the lower carbon R200 grade deposit, although some blocky austenite can be seen (Figure 9 c2).

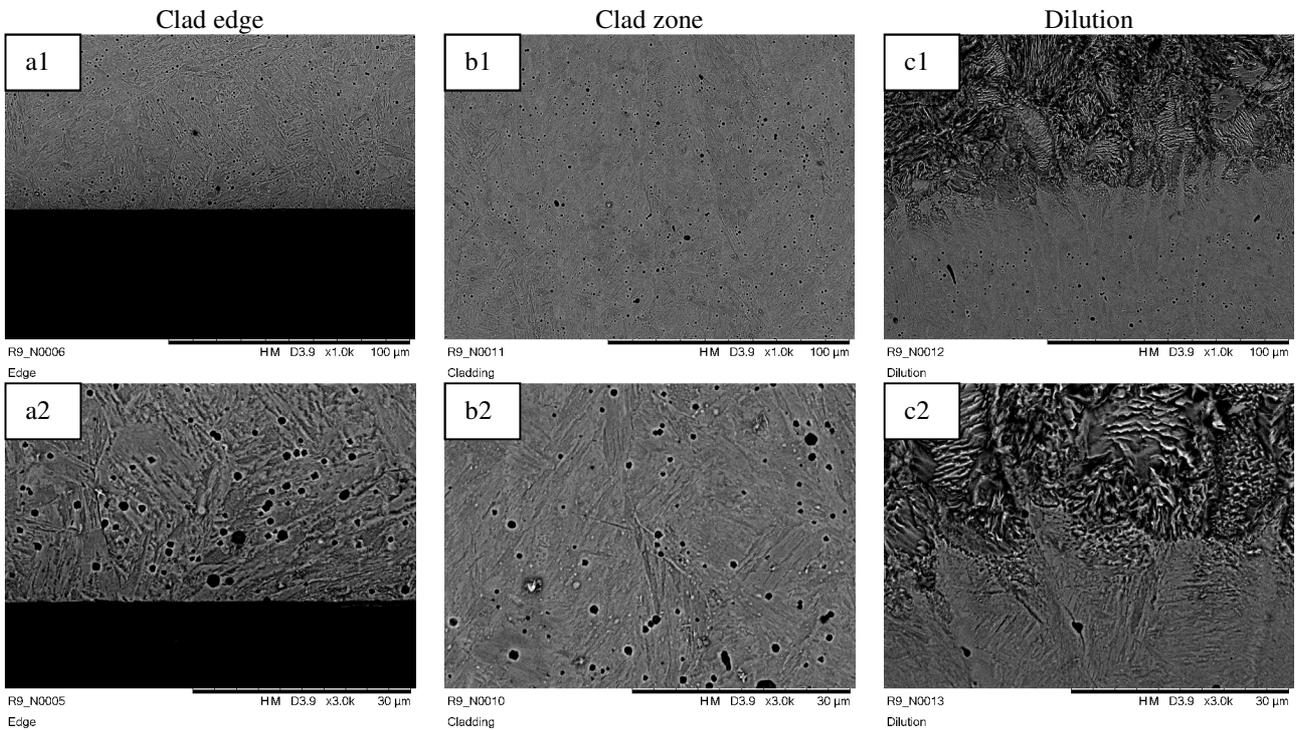
Figure 9. Microstructure of clad zone in untested MMS on R200 (4.76% Nitric, 47.62% hydrochloric and 47.62% water etched): (a1), (a2) are for the clad edge. (b1), (b2) are for the clad zone. (c1), (c2) are for the dilution zone.

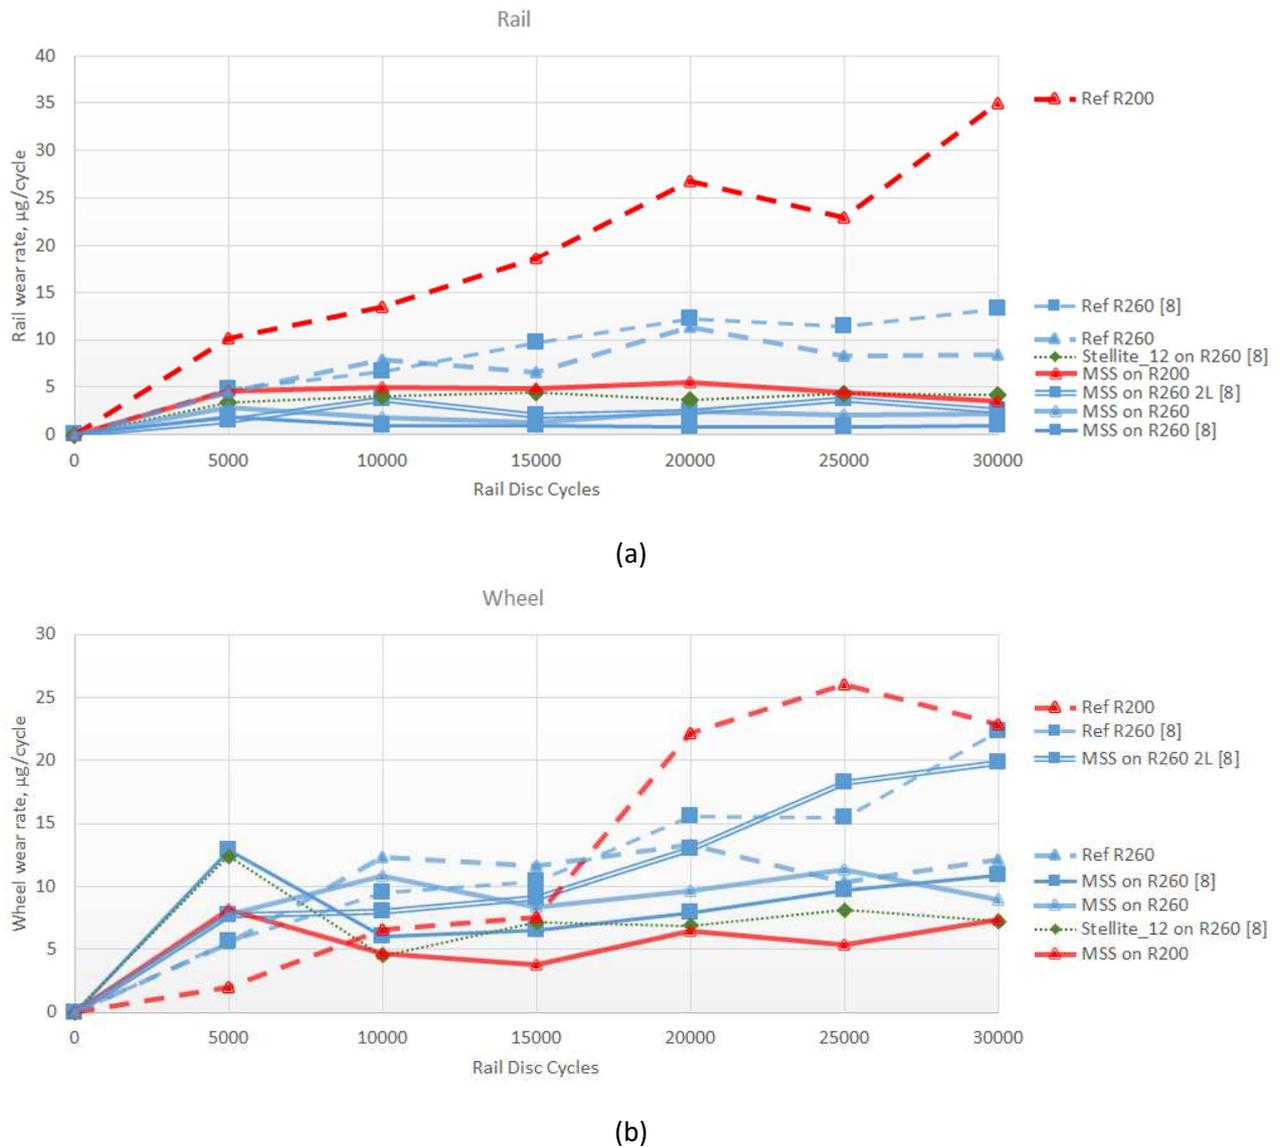
Figure 10 shows the evolution of the wear rates of the rail and wheel discs. All tests depicted in this section were conducted under dry contact condition with a maximum Hertzian contact pressure of 1500 MPa and 1

Figure 10. Wear rate evolution of (a) the rail discs and (b) the wheel discs with the number of test cycles for the R200 clad with MSS and R260 clad with MSS. The chart includes data from [8] with various material deposited onto R260 material. All tests were performed under identical conditions. 1L indicates 1 layer and 2L indicates a 2-layer sample. All samples tested in the work reported in this paper were made with 1 layer.

From Figure 10 (a), it can be seen that the MSS on R200 and MSS on R260 rail discs wore at similar rates and had similar performance to an R260 disc clad with Stellite 12 and MSS tested in previous work [8]. It is encouraging that an MSS clad layer on a lower grade of rail steel is still giving a good improvement in wear resistance over the R260 baseline. Even though, as Figure 5 demonstrates, its hardness directly after cladding, was affected. Interestingly the post-test surface hardness of the MSS 1L tested in [8] was 766HV compared to 630 HV for the MSS clad on R260 sample tested here (see Figure 5). It must also be noted though that the 1 layer samples tested in this work wore more than the 1 layer MSS sample tested in [8]. There are a few potential explanations for this: a) that the powder and hence the eventual deposited MSS

was from a different batch for the tests reported in this paper as compared to the samples in [8]. Also, in this work, whole cylinders of R200 and R260 material were clad and then manufactured into SUROS samples. In [8] the SUROS samples were first machined and then individually clad. This latter approach caused issues with heat dissipation during the cladding process and very high cooling rates of the clad were observed. The tests without cooling air applied did not differ from those without so are not shown.

Table 2 summarises the wear rate of all the rail specimens shown in Figure 10 averaged over the whole 30,000 cycle test period. In Table 2 any wear rate which was in excess of either the Reference (R260 Grade) wheel or rail, i.e. 100% or greater, has been highlighted in red. Any wear rate which is less than the reference is highlighted green indicating good wear performance. Wear rates which are less than 50% of the reference case are highlighted light green indicating superior wear performance.

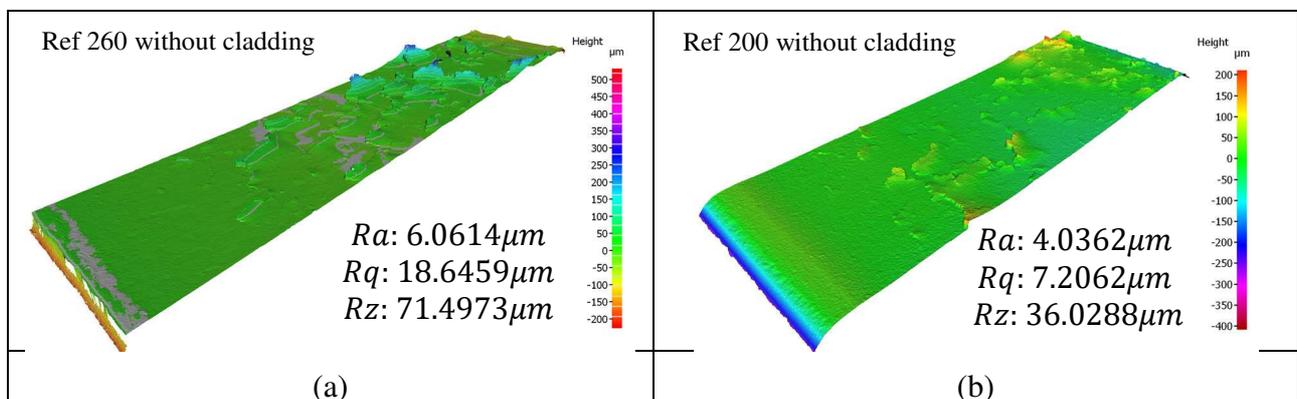
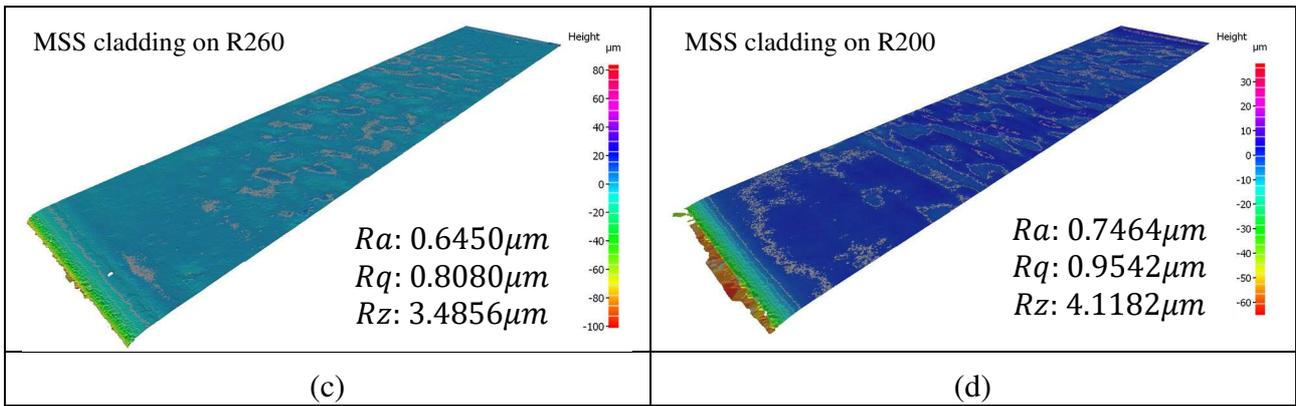
Figure 11. Topography measurements of tested samples.

As can be seen from Figure 11, both MSS on R260 and MSS on R200 specimens have shown a smooth surface finish after tests, with a surface roughness $R_a < 0.75\mu m$. This indicates that only mild wear occurred during tests, and these smooth surfaces show no sign of flake formation characteristic of a significant depth of material reaching the ductility exhaustion strain at which large flakes would form. In contrast, on the reference R260 rail disc it can be observed that the top layer of material was peeling up from the surfaces, and the surface roughness was 10 times higher than that of the cladded specimens. This suggests that strain in the surface has accumulated (i.e. by a ratchetting mechanism) to the point of ductility exhaustion at which it loses integrity and breaks away from the main body of the steel.

All surfaces were examined using the optical (non-contact) Alicona Infinite-Focus SL profilometer (Alicona Imagine GmbH, Raaba, Austria) after 30000 cycles, producing high-resolution images and 3D surface profiles measurements with a vertical resolution of up to 10 nm.

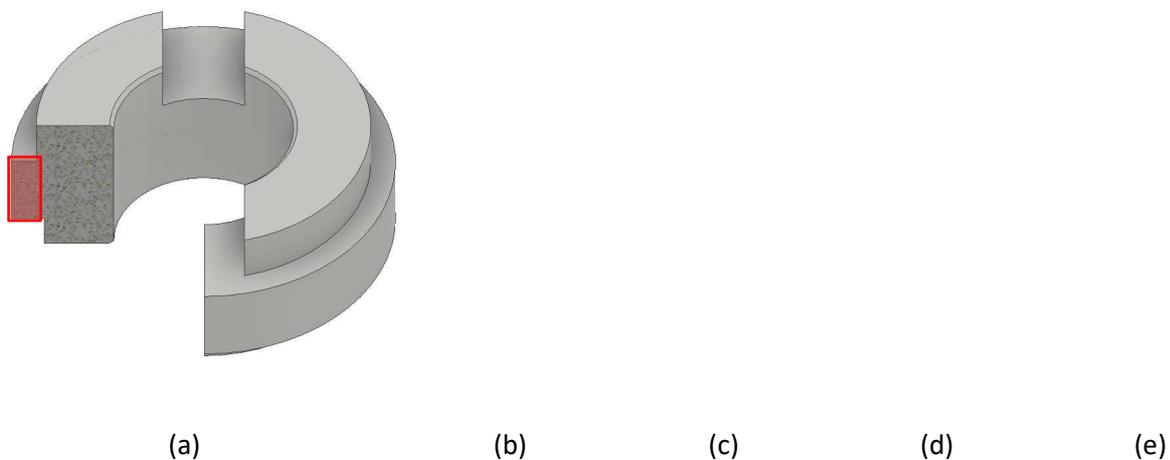
After the surface topography measurements, tested rail specimens were then sectioned and examined for: micro hardness and micro- structural changes. The specimens were sectioned in the radial direction, as indicated in Figure 12 (a). The 2% Nital etched cross-sections from the tested samples are shown in Figure 12 (b), (c), (d) and (e). Clearly deformation can be observed with the non-clad specimens, Figure 12 (b) and (d), where the edge was squeezed out of the contact. The subsurface microstructure in the middle zone was heavily compressed, while the microstructure at the edge remained the same with the original substrate, which indicates the deformation happened in the early stage of wear tests. For the clad specimens, Figure 12 (c) and (e), only minimum deformation occurred. It should be noted that for the MSS on R260 specimen, the edges were chamfered rather than worn out.

Figure 12. Cross-section deformation of SUROS discs (a) Section view, (b) R260, (c) MSS on R260, (d) R200 and (e) MSS on R200.

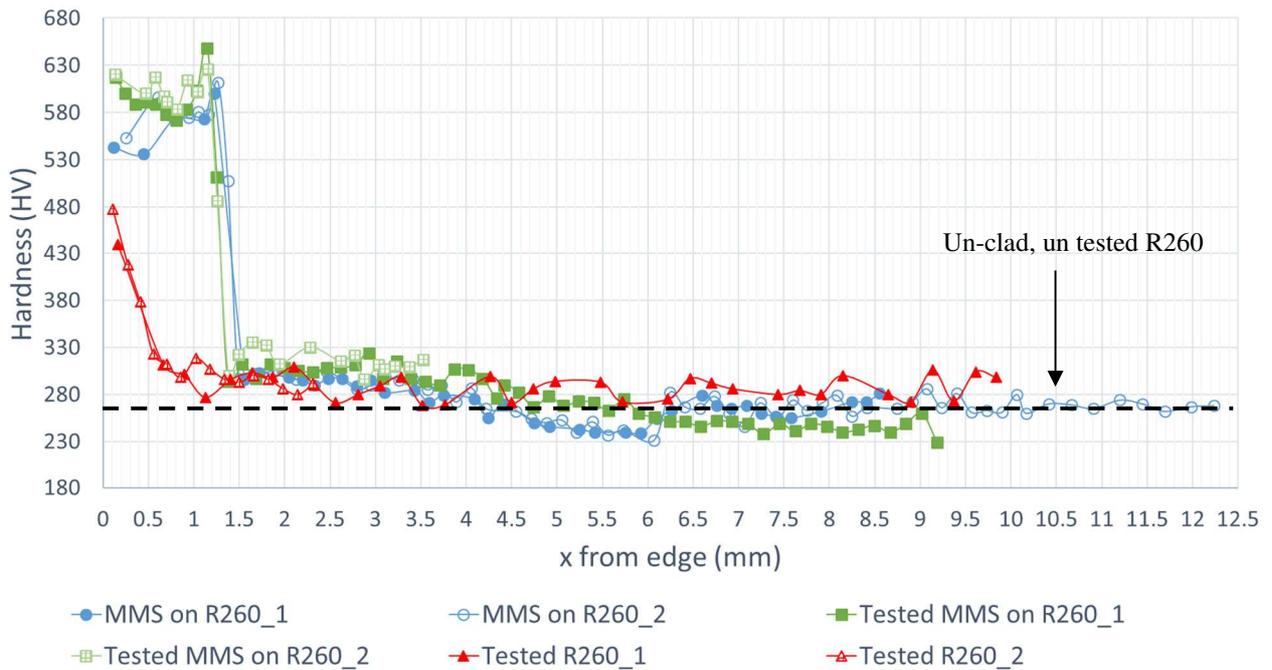
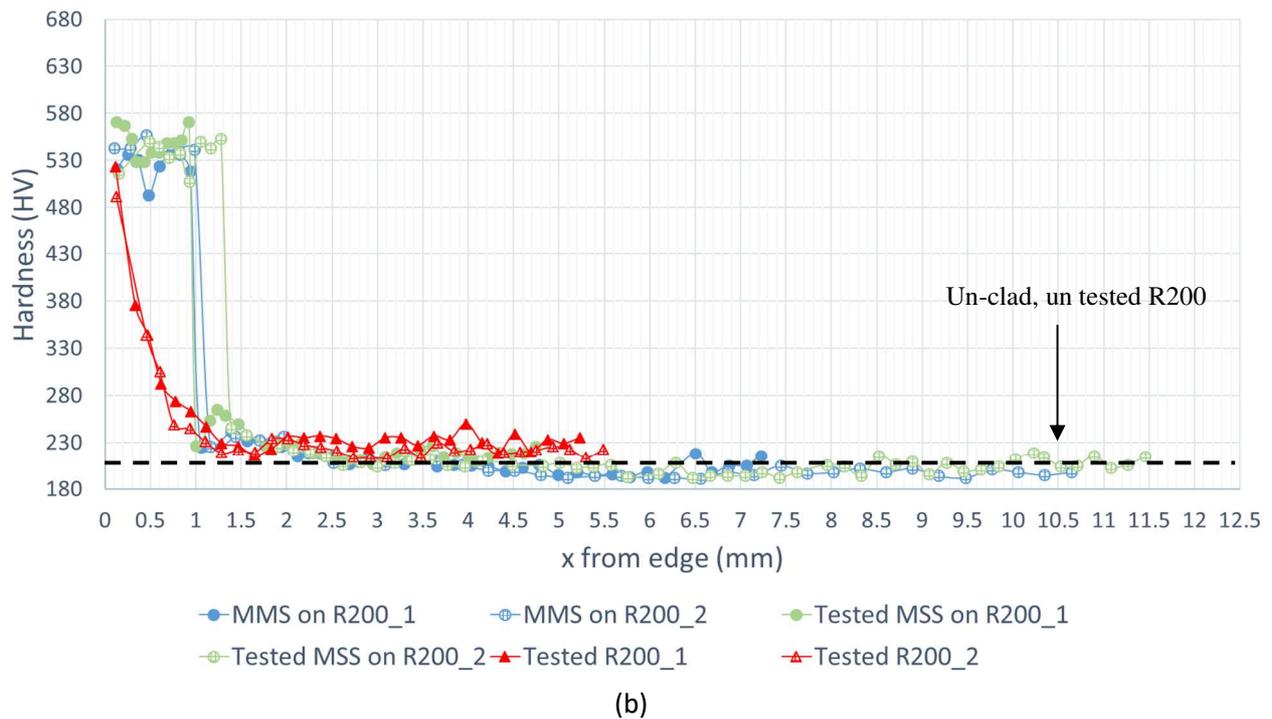
Figure 13 gives a comparison of the hardness pre and post testing. The average hardness profile of the

tested-specimens' cross-section in Figure 13 demonstrates the effective depth of plastic deformation. It should be noted that these hardness values were gathered from different specimens, but all were taken from the same parent material. As can be seen from the hardness measurements shown in Figure 13, the outside layer of both non-clad materials were worked hardened during tests. For the non-clad R260 sample, the bulk hardness was reached at about 0.7 mm from the surface. The maximum hardness, roughly 480 HV, was measured from the sub-surface region. For the non-clad R200 sample, a maximum hardness of around 530 HV was achieved near the top surface, and the maximum work hardened depth was around 1.1 mm. For the cladded rail specimens, the work-hardened effects were not as marked as for the reference non-clad samples.

Figure 13. Microhardness measurements for the (a) MSS clad on R200 and tested reference R200 sample
 (b) MSS clad on R260 and tested reference R260 sample
 with the straight line representing the mean microhardness of standard un-clad, un-tested rail material.
 All measurements were performed with a load of 1kg.
