Shahin, Y. orcid.org/0000-0001-7425-7798, Choudhary, R., Al-Naser, S. et al. (1 more author) (2009) Early loosening and secondary dislocation due to a broken trochanteric osteotomy wire following a Charnley total hip arthroplasty : a case report. *Cases Journal*, 2. 7117.

Case report

Early loosening and secondary dislocation due to a broken trochanteric osteotomy wire following a Charnley total hip arthroplasty: a case report

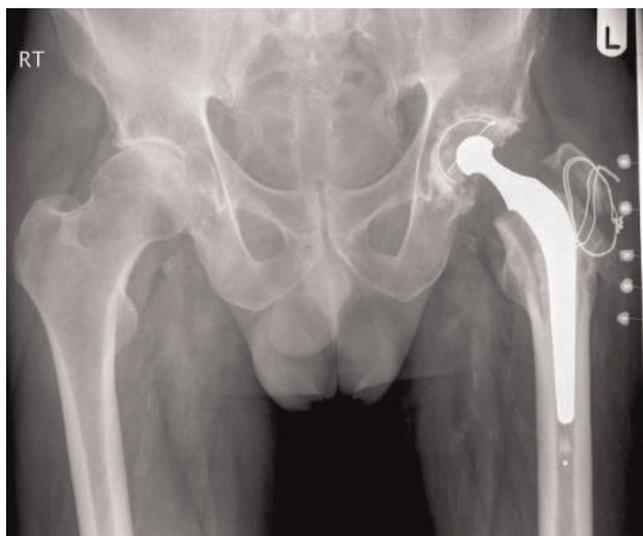
Figure 1. Post Charnley left total hip replacement plain X-ray of the pelvis.

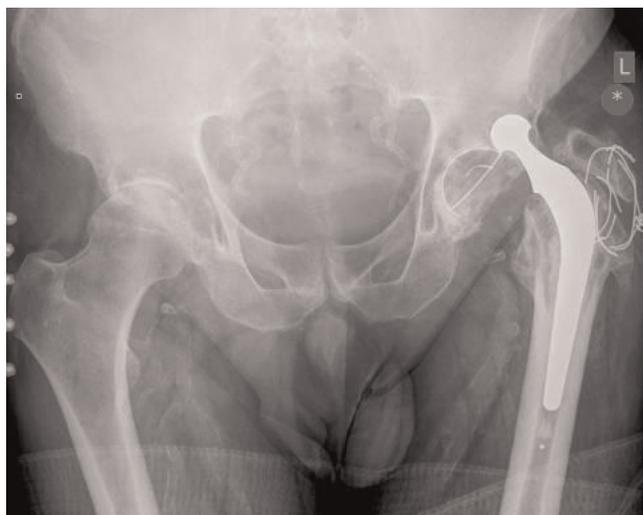
Plain X-ray of the pelvis showed a dislocated left Charnley total hip arthroplasty and it also showed a foreign body in the hip joint (broken wire) (Figure 2). The hip was reduced under general anaesthesia. The hip joint was stable up to 90 degrees flexion and 10 degrees of internal rotation.

Figure 2. Plain X-ray of the pelvis showing a dislocated left hip with a broken wire in the left hip.

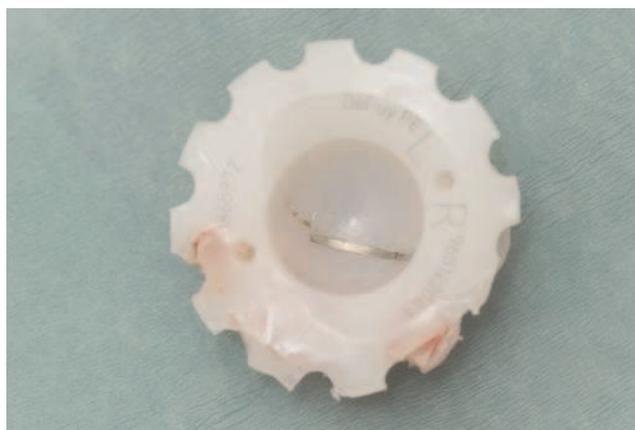
In April 2008, the patient had a revision of left Charnley total hip arthroplasty with a good result. Intraoperatively, a broken wire was found embedded in the polyethylene acetabular component and the polyethylene bearing surface was found to be worn (Figure 3).

Figure 3. The acetabular component with a worn bearing surface and the broken wire embedded in it.

The interposition of broken trochanteric wires in the hip joint post Charnley total hip arthroplasty can cause a third body effect leading to early loosening and early wear of the prosthetic components leading to dislocation of the hip. It is a complication that should be considered when performing a Charnley total hip arthroplasty which might necessitate an early revision surgery.
