Essah, EA, Russell, SJ, Waring, SD et al. (2020) Method for evaluating the snagging propensity of roofing membranes in buildings by roosting bats. *Building Research & Information*, 48 (8). pp. 886-898. ISSN: 0961-3218

Method for evaluating the snagging propensity of roofing membranes in buildings by roosting bats

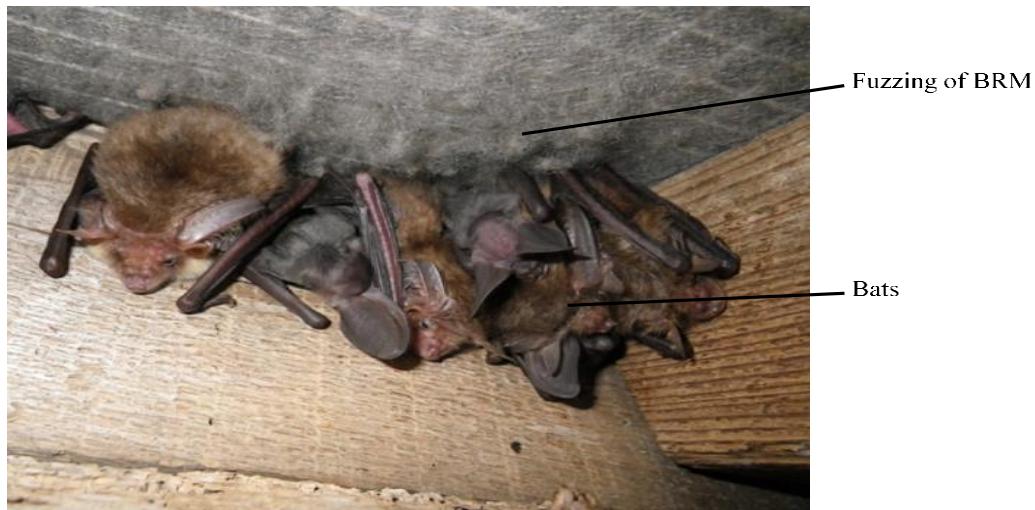
Figure 4. Example of fuzzing on a nonwoven membrane within a bat colony (Courtesy of John Martin, Cumbria, UK)

During roosting, bats physically interact with the surface of roofing membranes through the gaps between battens and in the roof space (Figure 4). Their claws snag the surface of the NBCRM, which can cause loops of continuous filaments to be teased free from the fabric structure to produce surface 'fluffiness'. Concerns have been raised since 2004 about the level of bat mortality (Waring et al, 2013; Waring, 2014) as they are often caught in these loose, strong filaments, becoming fatally entangled. In Scotland this situation would not normally arise in the roof void as the membrane would be located behind the wooden sarking boards, against which the bats would roost. However, there is still potential for crevice dwelling bats such as *Pipistrelle* species to interact with the NBCRMs when roosting underneath roof tiles.

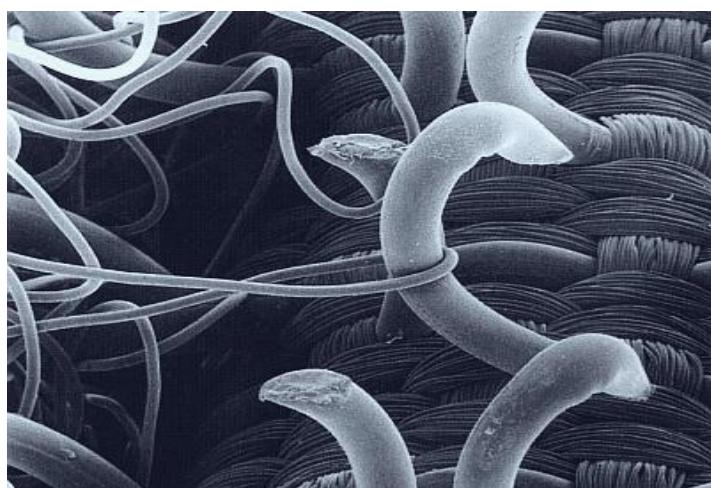
Figure 6. SEM image (x35 magnification) of standard Velcro® showing the projecting hooks attaching to adjacent filament loops (Images taken by the Boston Museum of Science, 2012)

Therefore, for practical reasons, a reproducible synthetic material that has the advantage of being robust, reproducibly manufactured and readily applied by multiple laboratories was used. One side of Velcro® consists of a woven base fabric from which small filamentous hooks project. It was observed that the projecting hooks of the Velcro® structure (Figure 6) crudely mimic a bat claw in terms of curvature and stiffness. Initial evaluations with fine pins and needles were also made, but none mimicked the claw action as well as the Velcro®. Although this might be a potential limitation regarding how accurately the bat claw was mimicked, use of the natural material was impossible as it would have required the killing of a number of bats which are a protected species. The use of Velcro however, provided significant accuracy within limits to the nature and movement of the bat claw.

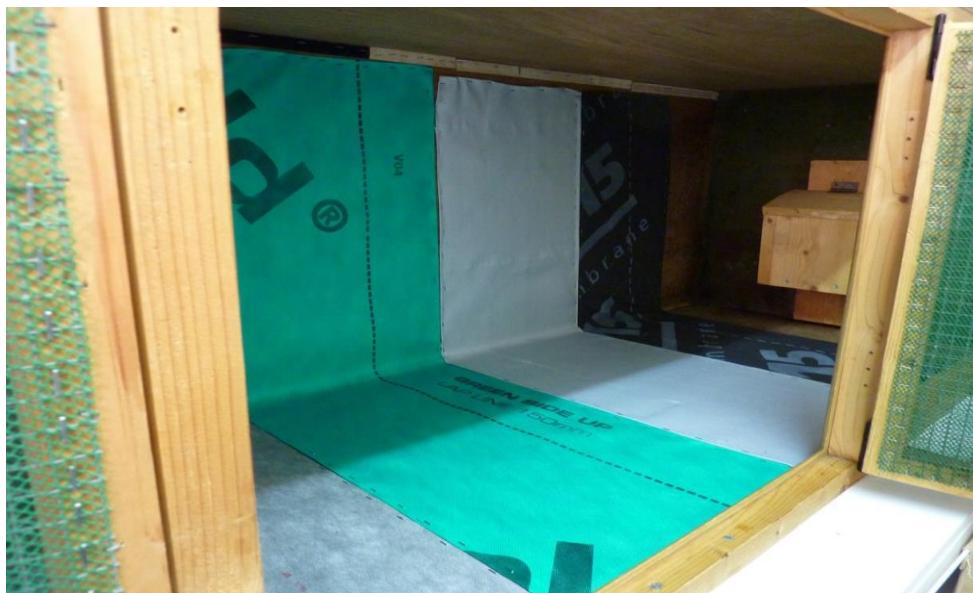
Figure 10. Photograph showing the four test specimens fitted inside the pipistrelle aviary

A small field study was conducted to verify susceptibility to disintegration and loop formation of three different BRM samples (sample A-C) and one nPRM (sample D) when bats crawl across their surface within a roost. These observations were then compared with the corresponding laboratory pilling box, test data. A sample of each NBCRM specimen (300mm x 900mm) was fitted into an aviary at the Isle of Wight bat hospital (Figure 10). Two aviaries were chosen because they contained bat species; pipistrelles and serotines, which have been previously reported to have been found entangled in BRMs installed in real buildings. The four specimens A, B, C, and D (see Table 1) were fitted into the aviaries (Figure 10). An aviary (flight cage) at a bat hospital was chosen as this enabled ground truthing of the interaction of bats with the membrane but within a controlled environment in which the bats were under observation to prevent any risk of injury or death as a result of entanglement. This approach would have not been possible in a roof-void roost and was therefore discounted as unethical. This is acknowledged as a limitation of this approach although the bat hospital proved a valid proxy. In addition, the fact that only the front surface (i.e. where bats mostly roost) of the NBCRM was considered maybe a limitation since bats can be found to also roost between the tiles and the battens (i.e. the back surface of the material).

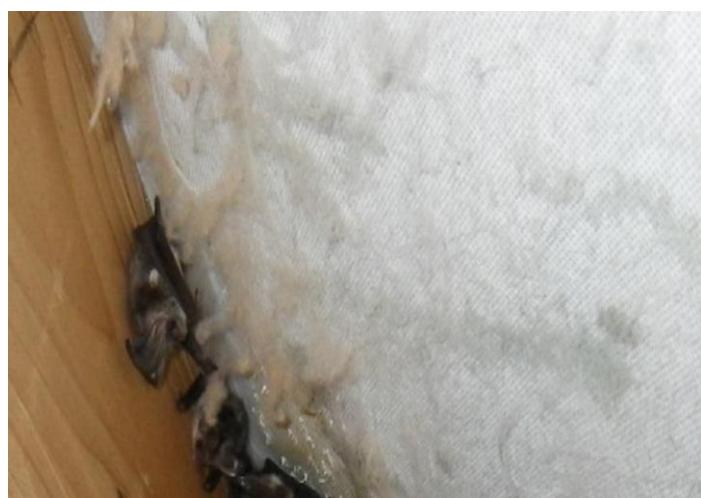
Figure 14. ‘Fluffing’ of a BRM surface four months after being fitted in a bat roost (Sample B)

It is informative to consider these results in the light of the field study data obtained for the samples exposed to live bats at the Isle of Wight bat hospital. Firstly, it is evident from Figure 14 that the mode of damage, i.e. dislodgement of continuous filaments and ‘fluffing’ of the fabric surface evident in the bat aviary-retrieved samples is replicated in the pilling-box test method reported herein.
