Chakraborty, S. orcid.org/0000-0002-1387-0385, Mandal, R., Chakraborty, S. et al. (2 more authors) (2021) Chemical attack and corrosion resistance of concrete prepared with electrolyzed water. *Journal of Materials Research and Technology*, 11. pp. 1193-1205. ISSN 2238-7854

Chemical attack and corrosion resistance of concrete prepared with electrolyzed water

This work investigates the sulfate and chloride resistance of cement composites (mortar and concrete) manufactured using electrolyzed water. Control and electrolyzed water-based cement composites were prepared using distilled water and 30 min electrolyzed water, respectively. These were exposed to 5% Na₂SO₄, 3.5% NaCl, and a combined mixture of 5% Na₂SO₄ and 3.5% NaCl solution for 200 days. Additionally, rebar reinforced control and electrolyzed water-based samples were exposed to ambient air and 5% NaCl solution for 180 days, and their corrosion potential was monitored. For control specimens, the results show compressive strength losses of 5, 12.4, and 6.1% when exposed to the above solutions, respectively, whilst for electrolyzed water-based specimens, the losses were reduced to 1, 10.1, and 3.4%, respectively. Statistical

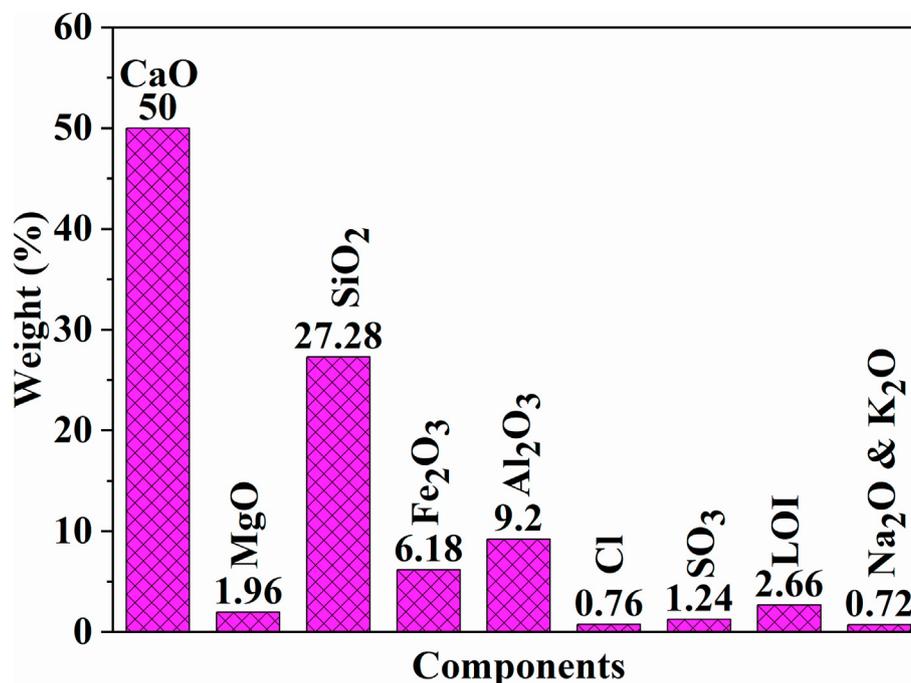
Fig. 1 – Oxide composition (in percentage) of Portland pozzolanic cement used in this study.

the oxides are calcium and silicate. The specific gravity of cement was measured to be 2.79 [37,38] using a Le Chatelier's flask and moisture-free Kerosine of specific gravity 0.79.

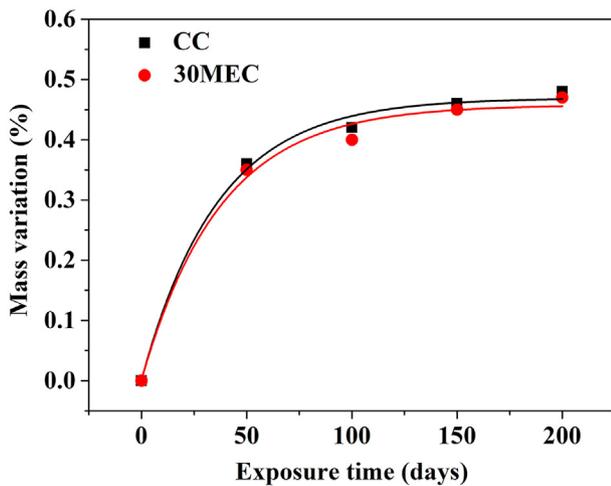
Fig. 2 – Mass variation of CC and 30MEC (concrete) specimens exposed to the combined (5% Na₂SO₄ and 3.5% NaCl) solution with increasing exposure time.

Fig. 2 shows the mass variation of CC and 30MEC exposed to the combined sulfate and chloride solution versus exposure time. There is a small (less than 0.5%) increase in mass possibly due to the formation of further cement hydration products with time and or the precipitation of salts inside of the samples due to the ingress of sulfate and chloride ions from the exposure solution [32]. The mass increase of 30MEC is slightly smaller than that of CC, possibly due to lower ion permeation into its less porous and more compact microstructure. This concurs with the hypothesis that electrolyzed water speeds up cement hydration reactions and achieves more compact and mature microstructure with less porosity than that of the normal water based cement composites [36,38]. This hypothesis be further examined by the FTIR and SEM analysis.

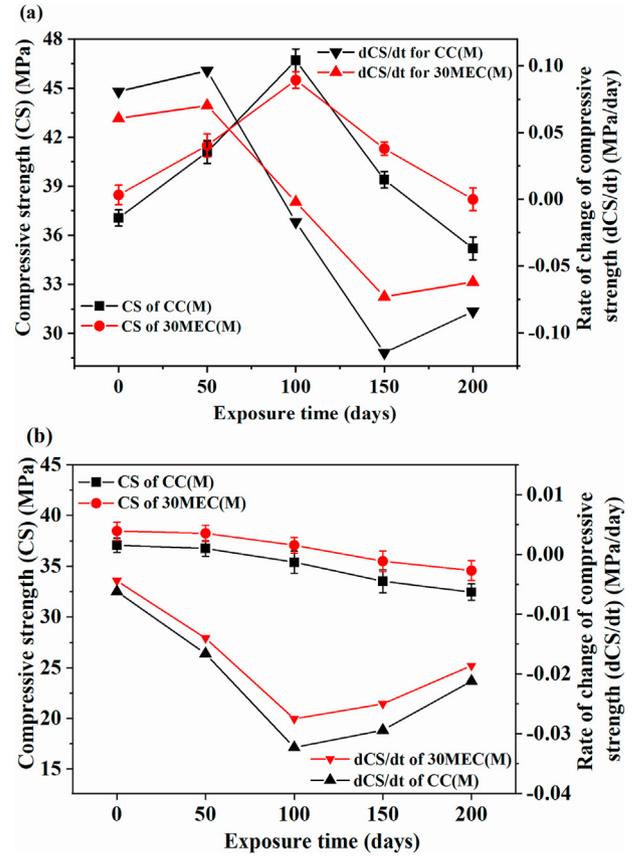
Fig. 3 – Compressive strength and rate of compressive strength versus time for mortar samples exposed to (a) 5% Na₂SO₄ solution and (b) 3.5% NaCl solution.

Fig. 3 shows the variation in compressive strength (MPa) and the rate of compressive strength change (MPa/day) of mortar samples CC(M) and 30MEC(M) exposed to (a) Na₂SO₄ and (b) NaCl solutions with exposure time. For sulfate exposure up to 100 days, Fig. 3a shows that the compressive strength of both CC(M) and 30MEC(M) increases by 26 and 18%, respectively. This strength enhancement is likely to be due to the permeation of sulfate ions and formation of gypsum and secondary ettringite in the matrix pores. The higher strength enhancement in CC(M) is likely to be due to the formation of larger amounts of secondary products by the percolation of a greater amount of deleterious ions through its higher porosity than that of 30MEC(M) [38]. Beyond 100 days of exposure, the compressive strength of both the mortar samples decreases,

indicating internal degradation. This is likely to be the result of expansive pressures caused by the formation of secondary ettringite and gypsum formation [1,2]. The loss of strength is relatively lower in the 30MEC(M) samples (1% after 200 days exposure) than that of CC(M) (5%) due to its denser structure, which restricts ion penetration and secondary product formation.

For exposure to the chloride solution, it can be seen from Fig. 3b that the compressive strength of both the mortar samples decreases with exposure time. Strength losses of 12.4% and 10.1% are observed for CC(M) and 30MEC(M), respectively, after 200 days exposure. Though less severe overall degradation takes place than for sulfate exposure, the degradation starts from the beginning, with faster degradation at the early ages and slower after 100 days of exposure (see Fig. 3).

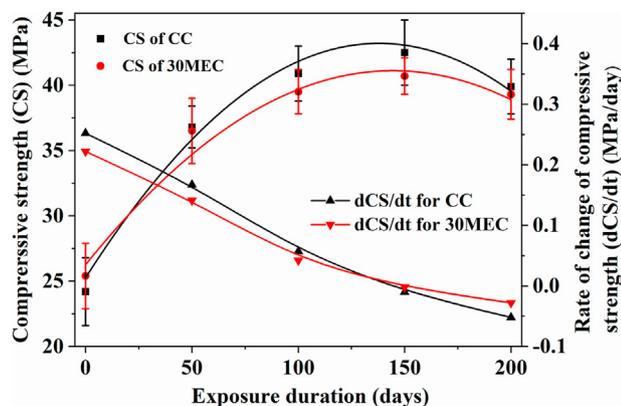
Fig. 4 – Compressive strength and rate of compressive strength versus time for CC and 30MEC (concrete) samples exposed to the combined (5% Na₂SO₄ and 3.5% NaCl) solution.

For exposure to combined sulfate and chloride solution the results are shown in Fig. 4. The compressive strength of both the concrete samples (CC and 30MEC) increases up to 150 days, followed by a slight loss at 200 days exposure. The rapid initial strength increase seen in this case may be attributed to the hydration of cement, as these samples appear to have hydrated much less than the other samples by the time they were exposed to the chemical environment. The formation of secondary products due to the permeation of sulfate and chloride ions into the concrete matrix may also have helped.

The loss of strength at 200 days may be due to: (i) leaching out of Ca²⁺ ions through the formation of the soluble salts as a result of the drop in pH due to the presence of chloride ions and (ii) volume expansion due to the formation of secondary ettringite and gypsum as a result of the sulfate attack [17,25]. It appears that the sulfate attack is inhibited in the presence of the chlorides. These phenomena will be further examined by microstructural analysis.

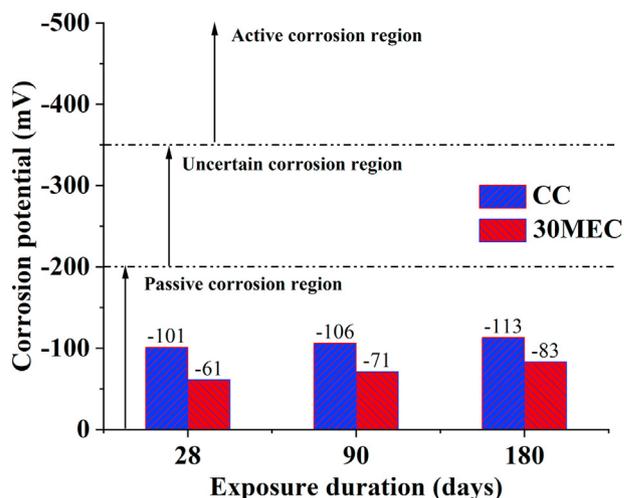
Fig. 5 – Corrosion potential value of rebar embedded in CC and 30MEC (concrete) exposed to the ambient environment (25 ± 2 °C, 65% RH, and atmospheric CO₂ content: 408.5 ppm).

Fig. 5 shows the corrosion potential of rebar embedded CC and 30MEC samples exposed to the ambient environment up to 180 days, whilst Fig. 6 shows images of two specimens that were split open after the test. Each data point presented in Fig. 5 is the average of three data points obtained from three different positions on the circular cross-section of the specimen surface, keeping the distance between the edge of the specimen and electrode/circular line constant. The corrosion potential of both samples is less than -200 mV, indicating that no corrosion has taken place on the rebar. The analysis also reveals that the value of corrosion potential is always lower for the 30MEC samples, possibly due to the anticipated formation of a thicker passive layer on the rebar than on that embedded in CC.

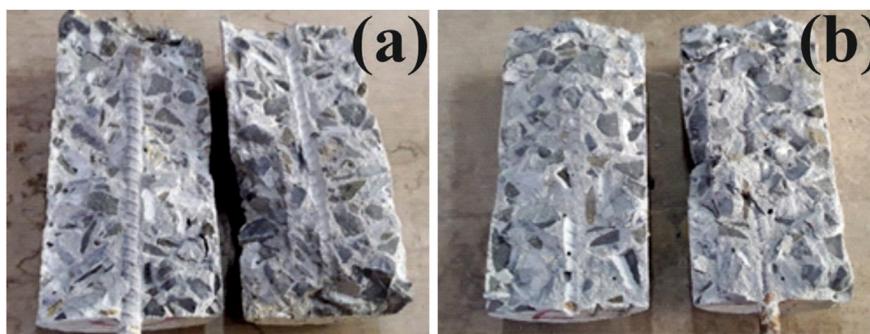
Fig. 6 – Visual inspection image of the split surface and rebar embedded in concrete exposed to ambient condition for 180 days; (a) CC and (b) 30MEC.

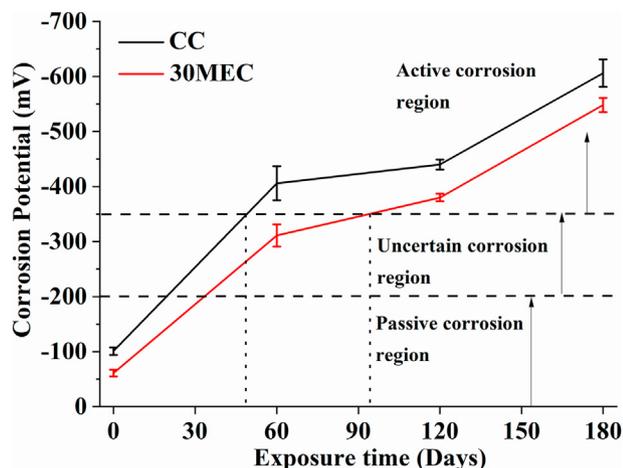
Fig. 7 – Corrosion potential value of rebar embedded in CC and 30MEC (concrete) exposed to the accelerated (5% NaCl solution) environment for 180 days (Atmospheric condition: $25 \pm 2\text{ }^\circ\text{C}$, 65% RH, and atmospheric CO_2 content: 408.5 ppm).

Fig. 7 shows the corrosion potential of rebar embedded samples exposed to 5% NaCl solution versus exposure time. The corrosion potential was measured from ten different positions and the curves show the average and range. Corrosion potential values of 30MEC are consistently lower than those of CC and they enter the active corrosion stage at about 100 days of exposure, twice the time it takes for the CC specimens. This clearly shows that the use of electrolyzed water enhances the corrosion resistance of concrete. This is further verified by visual inspection, see Fig. 8a and b, of the split specimens after testing. The lower corrosion rate is likely to be due to the high pH of the electrolyzed water (9.3 ± 0.1) that facilitates the

formation of a thicker passive layer around the rebar [23,25,49]. This slows down the corrosion process, but eventually the rapid chloride ion penetration into the concrete depletes the passive layer of the rebar.

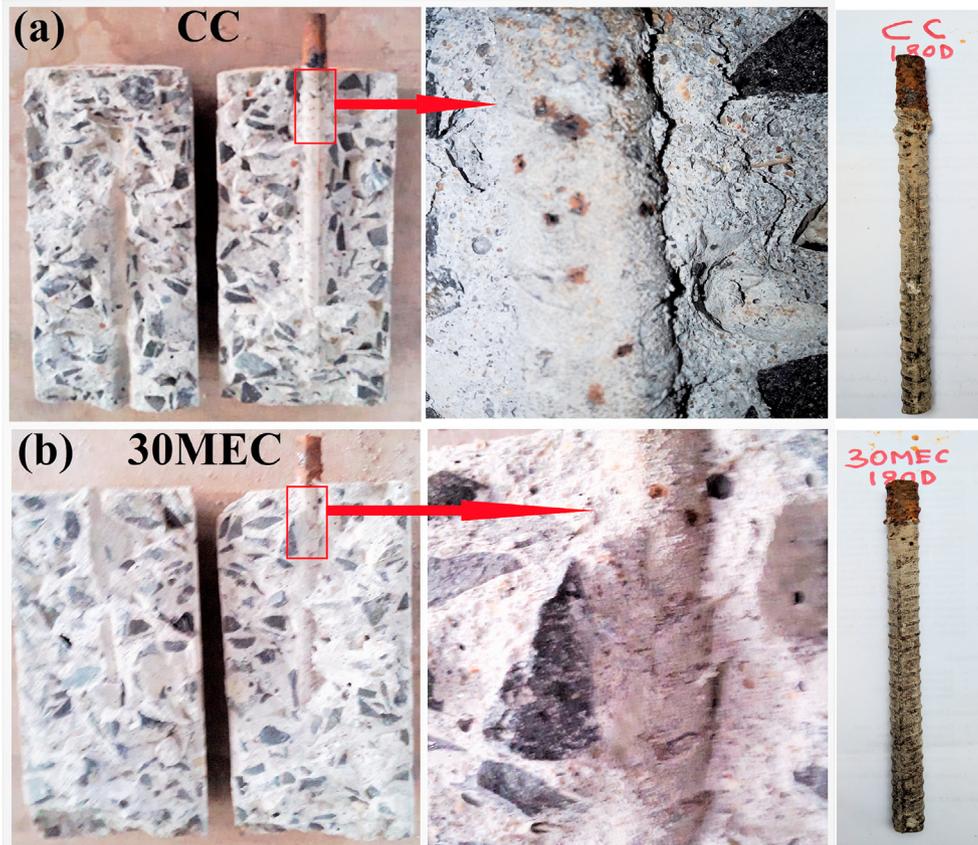
Fig. 8 – Visual inspection image of the split surface and rebar embedded in (a) CC and (b) 30MEC exposed to 5% NaCl solution for 180 days.

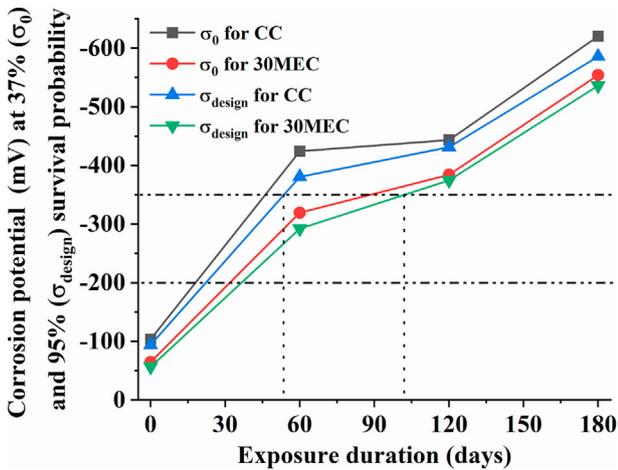
Fig. 9 – σ_0 (corrosion potential at 37% survival probability) and σ_{design} (corrosion potential at 95% survival probability) values of CC and 30MEC as the function of exposure time.

3.3.2.1. Statistical analysis of corrosion level using Weibull distribution. The corrosion potentials measured from the 10 locations of a particular sample vary to some extent as shown in Table 2. Hence, there is a need to assess the level of corrosion for a particular sample at a particular confidence level. This was done using the Weibull distribution model considering 95% survival probability, as shown in Table 3 and Fig. 9. For each set of data, the plot of $\ln(\sigma)$ vs $-\ln(1/S_j)$ shown in Fig. S3 (supplementary information) follows the linear fitting with $R^2 \geq 0.90$, demonstrating the suitability of the Weibull model to precisely predict the level of corrosion. Based on the Weibull analysis at the 95% survival probability, it is assessed that the corrosion potential of both the samples (CC and 30MEC) will not be higher (means less negative) than -585.8 and -536.2 mV, respectively, when exposed to 5% NaCl for 180 days. Additionally, it can be seen that to reach a threshold value (-350 mV) of the active corrosion potential, 30MEC takes twice the time (102 days) needed for CC (53 days). Hence, it can be anticipated that the corrosion of 30MEC is likely (95% survival probability) to be delayed by ~49 days (or ~92%) than that of CC when exposed to a 5% NaCl solution.

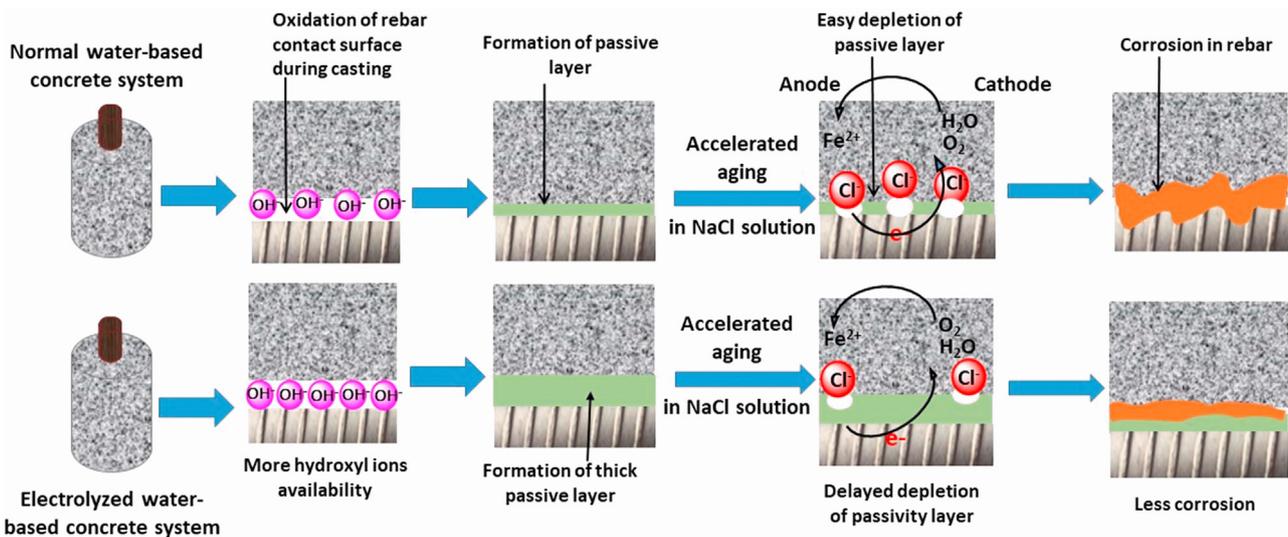
Fig. 10 – A plausible model to explain the corrosion mechanism of rebar embedded in the normal and electrolyzed water based concrete exposed to NaCl solution.

Corrosion in reinforced concrete is an electrochemical process that occurs due to the differences in electrochemical potential on the steel surface in the presence of water and oxygen [9]. Hence, corrosion of reinforced steel occurs due to the formation of anodic and cathodic regions at tiny parts of the rebar connected by the electrolyte, i.e., pore water of hardened cement. At the anode, Fe^{2+} ions pass into the solution, whereas, electrons pass along the rebar toward cathode and combine with oxygen and water to produce hydroxyl ions [9]. These hydroxyl ions then travel through the electrolyte and combine with Fe^{2+} to form ferrous hydroxide that is subsequently converted into ferric hydroxide and then oxidized to form rust [9,20,23]. Additionally, chloride-induced corrosion occurs as chloride ions penetrate the protective oxide film (passive layer) [9] forming hydrochloric acid at the anodic side that destroys the passive layer, leaving the steel vulnerable to corrosion through the formation of rust by reacting with oxygen and moisture [9,20].

The lower corrosion of rebar embedded in electrolyzed water based concrete is likely to be due to the combination of a denser microstructure that retards the chloride penetration and the presence of a higher amount of hydroxyl ions [50] that

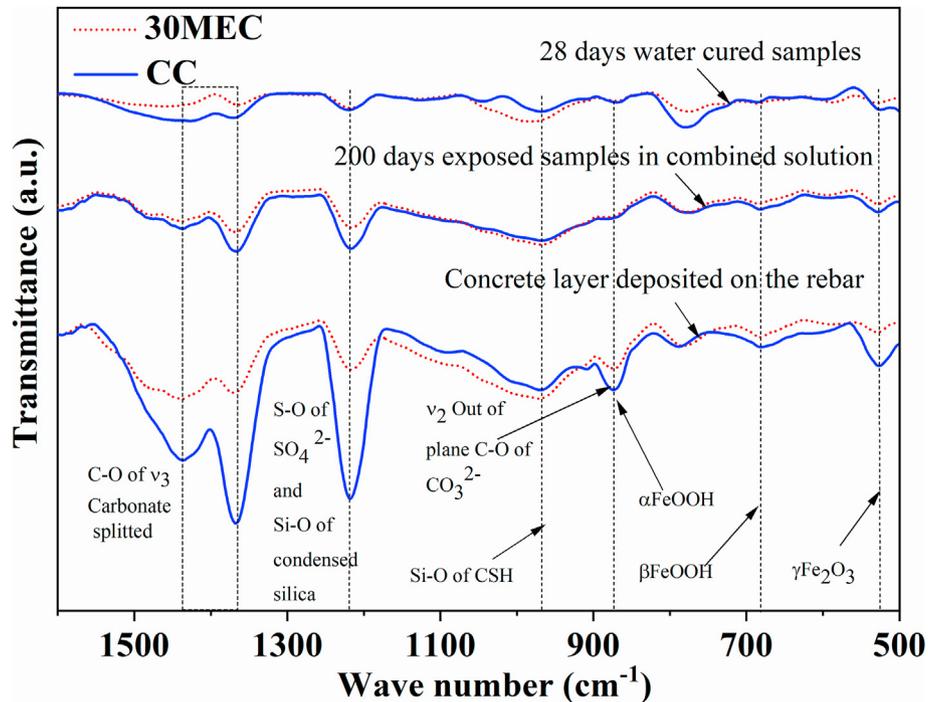
Fig. 11 – FTIR spectra of CC and 30MEC (concrete) cured in water for 28 days, exposed to the combined (5% Na_2SO_4 and 3.5% NaCl) solution for 200 days, and the layer deposited on the rebar embedded in CC and 30MEC exposed to 5% NaCl solution for 180 days. IR band description: 1440 cm^{-1} and 1365 cm^{-1} : $\nu_3\text{C-O}$ (splitting) stretching of carbonate, 975 cm^{-1} : Si-O stretching of polymeric silicate of CSH, around 1200 cm^{-1} : Si-O of condensed silica, 1217 cm^{-1} : S-O of SO_4^{2-} , 877 cm^{-1} : Fe-O of αFeOOH , 680 cm^{-1} : Fe-O of βFeOOH , and 525 cm^{-1} : Fe-O of and $\gamma\text{Fe}_2\text{O}_3$.

3.4.1. *Fourier transform infrared spectroscopy (FTIR) analysis* Fig.11 shows the FTIR spectra in transmittance mode of CC and 30MEC samples cured for 28 days in water and exposed to combined sulfate and chloride rich solution for 200 days. Additionally, the figure also represents the FTIR spectra of the cementitious layer deposited on the rebar embedded in CC and 30MEC specimen exposed to 5% NaCl solution for 180 days. The most informative bands in the IR spectrum of CC and 30MEC cured in water and exposed to combined sulfate and chloride solution appear around 1440 and 1365 cm^{-1} due to the $\nu_3\text{C-O}$ (splitting) stretching of carbonate and the band around 975 cm^{-1} that appears due to the Si-O stretching of polymeric silicate of CSH [36,51,52]. A broader IR band around 1217 cm^{-1} appears for 28 days water cured CC and 30MEC samples due to the S-O stretching of sulfate ions present in the hydrated cement [53]. However, this band is observed to be more prominent for CC and 30MEC samples exposed to the combined sulfate and chloride solution for 200 days. Moreover, it is noted that a more intense SO_4^{2-} band appears for CC than for 30MEC. This implies that a greater extent of sulfate attack takes place in CC than in 30MEC. IR band at 975 cm^{-1} of 28 days water cured 30MEC is also observed to be slightly more intense than that of CC. This clearly indicates a greater degree of hydrated product, i.e., a larger amount of Calcium-Silicate-Hydrate gel formed in 30MEC than in CC [36,38]. The formation of more hydrated products in 30MEC reduces the porosity in 30MEC as compared to that of CC [36,38], which, in turn, resists the permeation of aggressive ions. Eventually, the deterioration of 30MEC is less than that of CC when exposed to the combined solution.

IR spectra of the cementitious layer collected from the surface of the rebar of CC and 30MEC exposed to NaCl solution for 180 days show IR bands including: C-O of carbonate and Si-O of polymeric silicate, and some other bands at 877 , 680 , and 525 cm^{-1} . These are possibly due to the Fe-O of αFeOOH , βFeOOH , and $\gamma\text{Fe}_2\text{O}_3$, respectively [15,24]. These may only appear when the surface of the steel rebar oxidises by reacting with the hydrated cement products, air, and moisture [15]. IR band at 877 cm^{-1} appears to be due to the combination of ν_2 stretching of carbonate and Fe-O. Additionally, the sharp intense band around 1200 cm^{-1} is assumed to be due to the

Si–O stretching of condensed silica [53]. In fact, the appearance of these bands in IR spectrum could be due to the combination of the passive oxide layer formed on to the steel rebar surface and the development of corrosion products. As the sample contains Fe–O bond, it can be considered to be the de-passivated (oxidised) component which was loosely bonded to the rebar surface. The collection of the strong passive layer/protective oxide film formed on to the rebar surface is more difficult because of its stability and binding ability with the rebar surface. Therefore, considering the IR bands and their intensities, it can be said that more de-passivated components (corrosion products) were formed on the rebar embedded in CC than in 30MEC as the IR band intensities of Fe–O bonds are more for the CC sample.

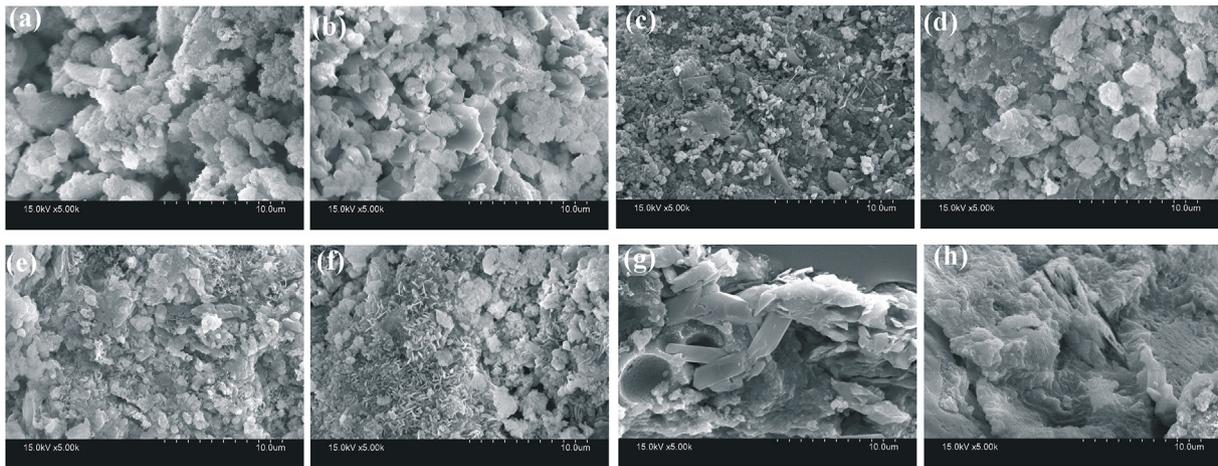
Fig. 12 – SEM image of 28 days water cured (a) CC and (b) 30MEC, 200 days exposed to Na_2SO_4 solution (c) CC(M) and (d) 30MEC(M), 200 days exposed to NaCl solution (e) CC(M) and (f) 30MEC(M), and 200 days exposed to the combined sulfate and chloride rich (5% Na_2SO_4 and 3.5% NaCl) solution (g) CC and (h) 30MEC.

Fig. 12a and b shows the SEM images of 28 days water cured CC and 30MEC, respectively. The microstructures of both the samples seem to be similarly matured. However, comparatively less flaky and compact microstructure is observed for 30MEC (Fig. 12b) than for CC (Fig. 12a), because of the formation of a greater amount of hydrated products as evidenced by the spectral analysis. A denser structure is also expected to resist more deleterious ion permeation and show less deterioration. This is investigated in Fig. 12c and d for 5% Na₂SO₄,

It is observed from Fig. 12c and d that both the samples CC(M) and 30MEC(M) exposed to 5% sodium sulfate solution

contain rod like secondary product crystals, with CC (Fig. 12c) containing more secondary gypsum crystals and flaky microstructure than 30MEC (Fig. 12d). This is likely due to the ingress of larger amounts of sulfate ions through the capillary

pores of CC [38]. More gypsum crystals will lead to more volume expansion and result in faster deterioration of CC than 30MEC.

Fig. 12e and f shows the SEM images of CC(M) and 30MEC(M) samples exposed to 3.5% NaCl solution for 200 days. The microstructure of CC(M) (Fig. 12e) seems to be flaky and scattered, whilst the 30MEC(M) sample still contains some calcium hydroxide and calcium carbonate with a less scattered microstructure (Fig. 12f). The chloride ion permeation degrades the concrete matrix by destroying the stable network of hydrated products.

Gypsum seems to be formed in both CC and 30MEC samples, see Fig. 12g and h, due to the permeation of SO_4^{2-} ions [54] when they are exposed to the combined solution. As expected, more gypsum crystals are seen in CC than of 30MEC per unit area. This generation of secondary products can fill pores in CC faster and result in a better improvement in strength at the early ages of exposure. However, with prolonged exposure, further production of secondary products leads to expansive internal pressure resulting in the greater deterioration of CC than 30MEC.

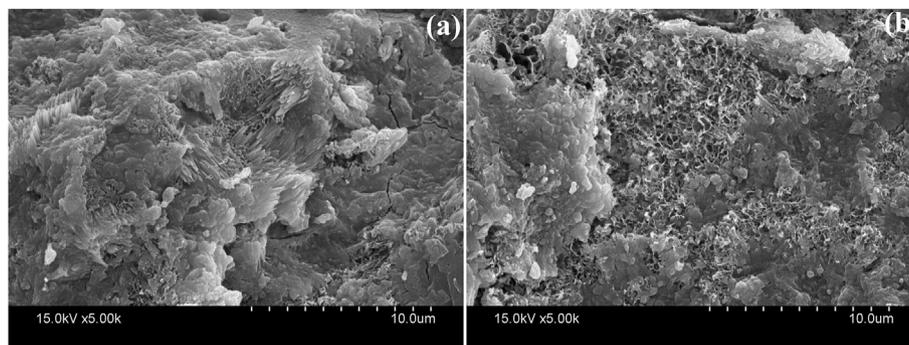
Fig. 13 – SEM image of the cementitious layer deposited on the rebar embedded in (a) CC and (b) 30MEC exposed to 5% NaCl solution for 180 days.

Figs. 13a and b shows the SEM images of the cementitious layer deposited on the rebar embedded in CC and 30MEC exposed to 5% NaCl solution for 180 days. It appears that CC contains iron oxides (needle like structures),

i.e., possibly goethite (αFeOOH) and akaganeite (βFeOOH) like structures [24], which may grow at the interface region of rebar surface and cementitious layer. However, no such type of crystal is observed in the microstructure of the cementitious layer collected from the rebar surface of 30MEC. The appearance of iron oxide in the cementitious layer of CC is presumed to be due to the depletion of the

passive film on the rebar surface by the ingress of Cl^- ions and corrosion due to presence of moisture and oxygen. As there is no trace of iron oxide in the microstructure of the cementitious layer of 30MEC, it can be seen as evidence of the higher resilience of its passive film, which protects the rebar from the corrosion.
