Seismic intervention options for multi-tiered Nepalese Pagodas: The case study of Jaisedewal temple

Dimitris Dais^{a,b,*}, Vasilis Sarhosis^{b,c}, Eleni Smyrou^a, İhsan Engin Bal^a

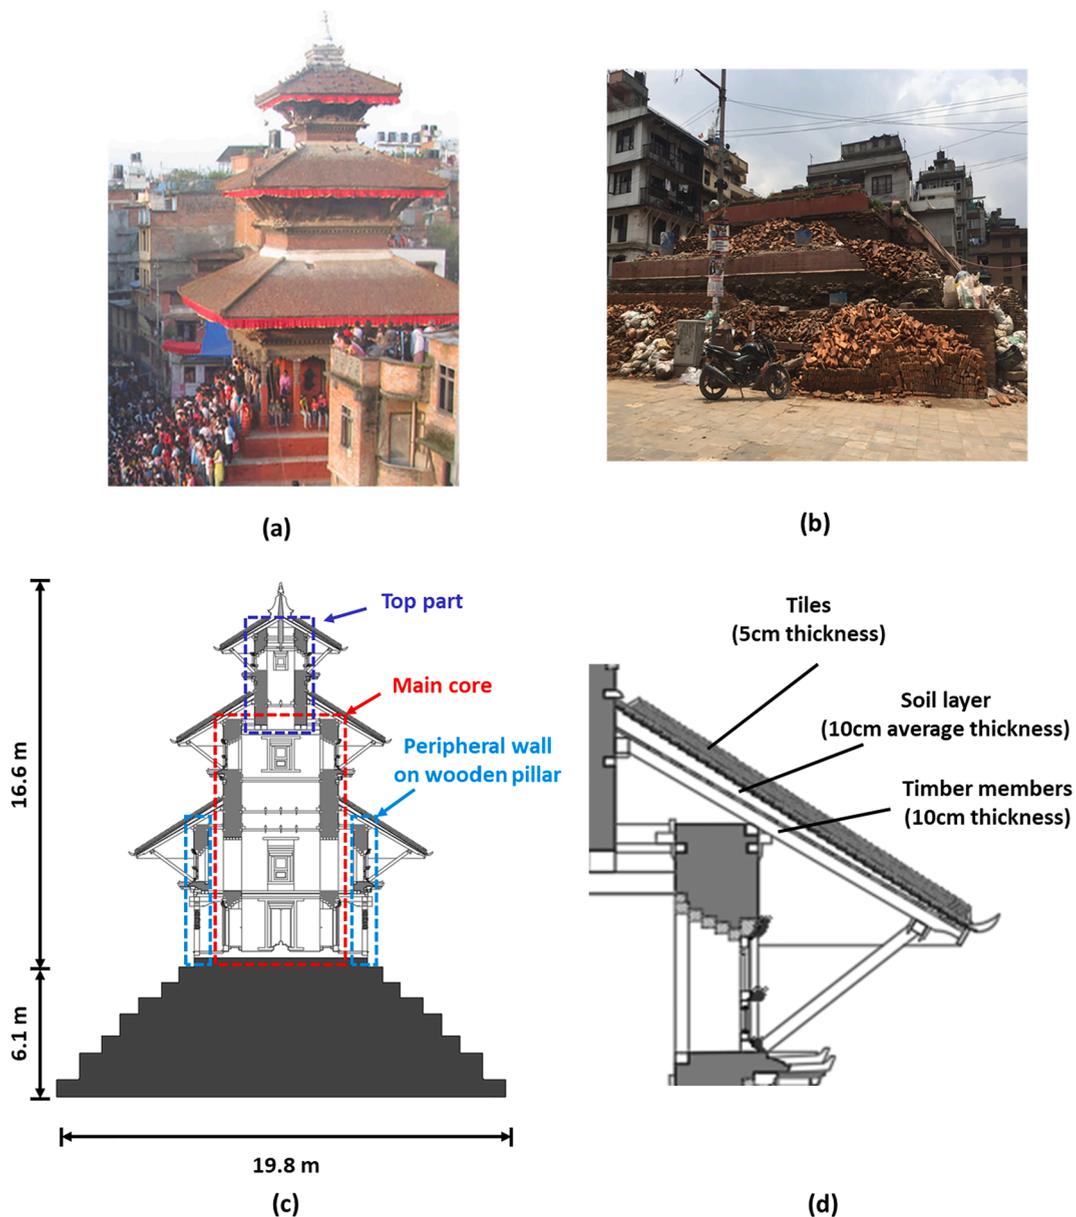
Fig. 1. Jaisedewal temple: (a) before and (b) after the Gorkha earthquake, (c) cross section (illustration of foundation is indicative) and (d) detail of the roof system.

The Jaisedewal temple (Fig. 1a) was chosen as case study and its seismic response was assessed. It is noted that the temple collapsed during the Gorkha earthquake and only the plinth base survived (Fig. 1b). The structure is a typical example of the Nepalese architecture in the Kathmandu Valley. The Jaisedewal temple is a three-tiered temple sitting on a massive exposed foundation plinth, the dimensions of which are $19.8\text{ m} \times 19.8\text{ m}$ at the bottom and $7.6\text{ m} \times 7.6\text{ m}$ at the top. The height of the plinth is 6.1 m while the height of the upper structure is 16.6 m (Fig. 1a). The exposed foundation has been constructed using red clay bricks bonded together by mud. The temple is characterized by a box-type configuration. Fig. 1c and d show a cross-section of the Jaisedewal temple as well as

structural details of the roof system together with its different components (i.e. tiles, soil layer and timber elements). The walls of the temple were made of masonry clay units bonded together by brick mortar [8]. The structural system of the temple consists of a thick main core of walls in addition to a peripheral external wall sitting on wooden pillars (Fig. 1c). At the top of the temple there is an internal core with thinner cross-section, which does not sit on the main core of the structure but is simply connected with some crossing timber beams (Fig. 1c). For further details regarding the Jaisedewal temple, the reader is referred to the work of Kumar et al. [45] where a reconnaissance survey was undertaken and a geotechnical study on the site of the temple was presented.

Similar to the Jaisedewal temple, the Nepalese Pagodas are generally found on a massive plinth base (Fig. 1). The plinth is usually of low-quality workmanship and limited cohesion, thus of inferior performance than the supported temple [46]. According to [47], the Nepalese temples were placed on plinths in order to improve their seismic response against the wave amplification and to avoid the resonance with the soil layer. Although the structure could have been considered as an integral system consisting of the upper structure and the massive plinth base, the contribution of the latter has been neglected in previous numerical studies (see Section 2.2). In this study, the base plinth was incorporated in the numerical model and its influence on the overall response of the temple under seismic loads was investigated.

Another intervention to reduce the seismic demand is the reduction of the mass of the structure. More specifically, the mass reduction can be achieved from the roofs and the masonry walls. Regarding the roofs, the soil layer (Fig. 1d) can be removed and the existing timber planks can be replaced with lighter ones. It is highlighted that the soil layer existing in the tiers could attract vegetation which diminishes the structural integrity of the timber roofs [10,46] (Fig. 4a) while rotten timber elements are typical observation during inspection of the Nepalese temples [51] (Fig. 4b). The restoration of the roofs is undertaken by local engineers and practitioners, while traditional techniques are followed and locally available hardwood, i.e. Shorea robusta, that is typically preferred for its strength and durability is installed adhering to the preservation of the architectural style of the Nepalese temples [51] (Fig. 4c and d). As far as the mass reduction from the masonry walls is considered, binding mortar is used and additionally hollow bricks could replace the existing solid ones which are heavier.

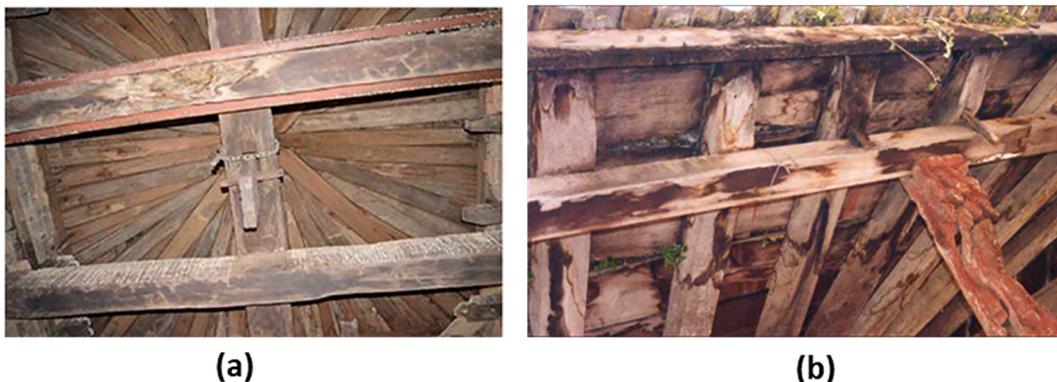
Fig. 2. (a) Timber floors poorly connected with limited bracing elements [48]. (b) Rotting roof beams and planks [46].

Different interventions have been suggested for upgrading the seismic behaviour of the Nepalese Pagodas [10,24,43,46,51]. Some of the common practises are the stiffening of floors and strengthening of the traditional connections. In particular, timber floors with poorly connected elements and limited bracings, a common observation in the Nepalese temples, fail to provide diaphragmatic action and can be considered as rather flexible [48] (Fig. 2a). The replacement of the timber floors with stiffer elements can be part of the

maintenance of the Nepalese Pagodas given the fact that degradation has been observed in many cases [46] (Fig. 2b). Other typical examples of poor connection details are the timber beams that the top tier of the Pagodas usually sits on [49] (Fig. 3a) and the timber peg connections between the main masonry wall and the peripheral wall (Fig. 3b and c). The latter interventions are considered of low interference, since they are not visible and can be easily removed in order to bring the structure in its previous state.

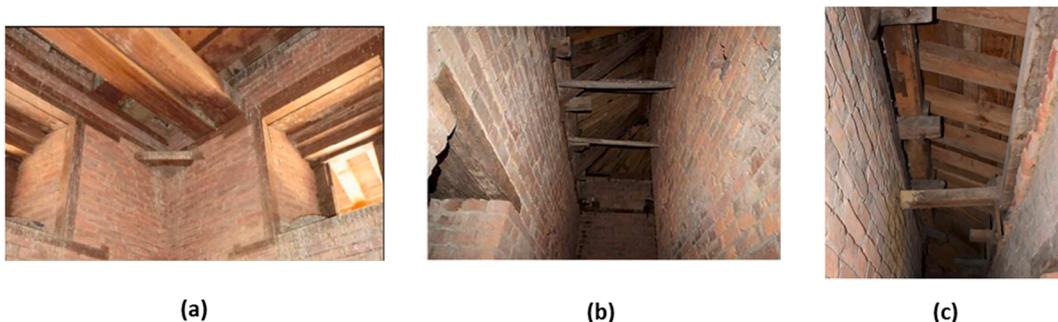
Fig. 3. (a) The top tier of the Nepalese Pagodas usually sits on timber beams [49]. The traditional timber peg connections between the main masonry wall and the peripheral wall: (b) [48] and (c) [49].

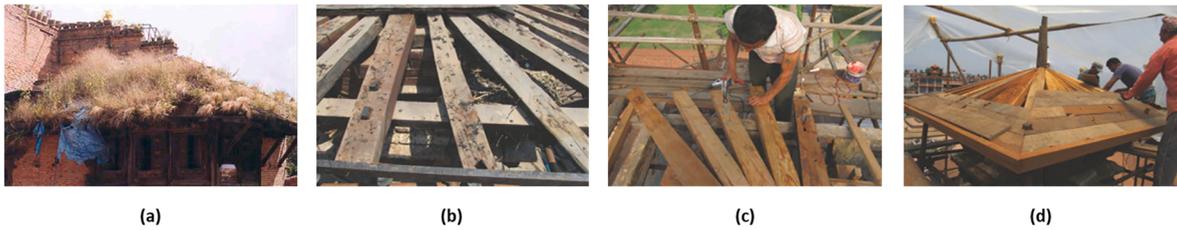
Fig. 4. (a) Vegetation attracted by the soil the soil layer existing in the tiers of the Nepalese temples [46]. (b) Rotten timber elements observed during inspections of the roofs of the Pagodas [51]. (c) and (d) Local material and techniques are used for the restoration of the roofs [51].

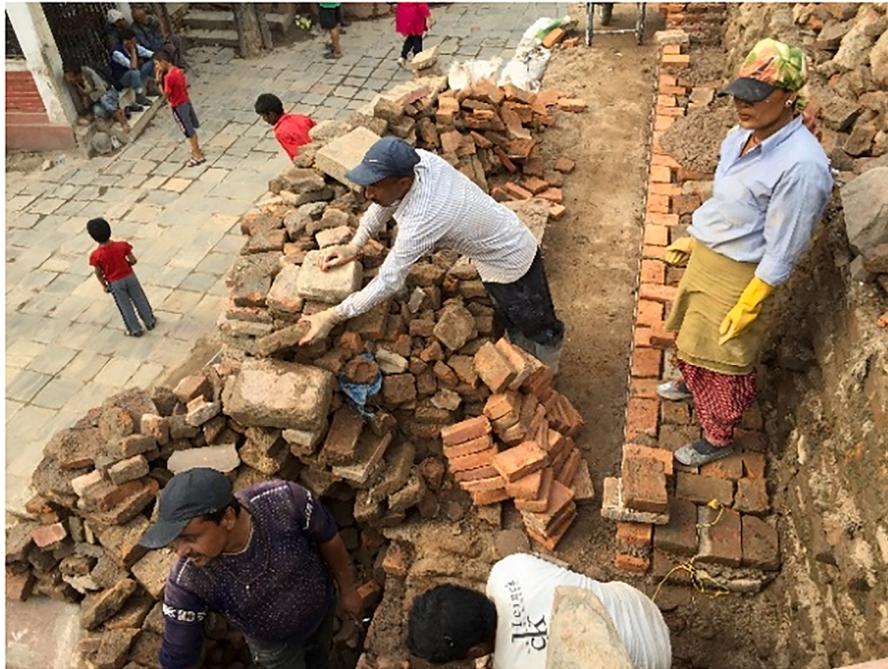
Fig. 5. A common intervention on the Nepalese temples is to remove the existing bricks in the perimeter of the plinth base and replace them with new material.

A common intervention applied on the Nepalese temples involves the removal of the existing bricks in the perimetry of the plinth base and replacing them with new masonry with higher strength characteristics (Fig. 5). Further information for the application of the intervention at the Silu Mahadev temple, which collapsed up to the plinth level during the Gorkha earthquake, are provided by GoN [52]. In detail, the outer shell of mud mortar plinth, two feet width is carefully removed and replaced by Lime Surkhi brick-wall without disturbing the inner core. This type of intervention has been practiced widely. Nevertheless, it affects the authentic style of the temples given that it is rather visible, while its efficacy has not been investigated yet.

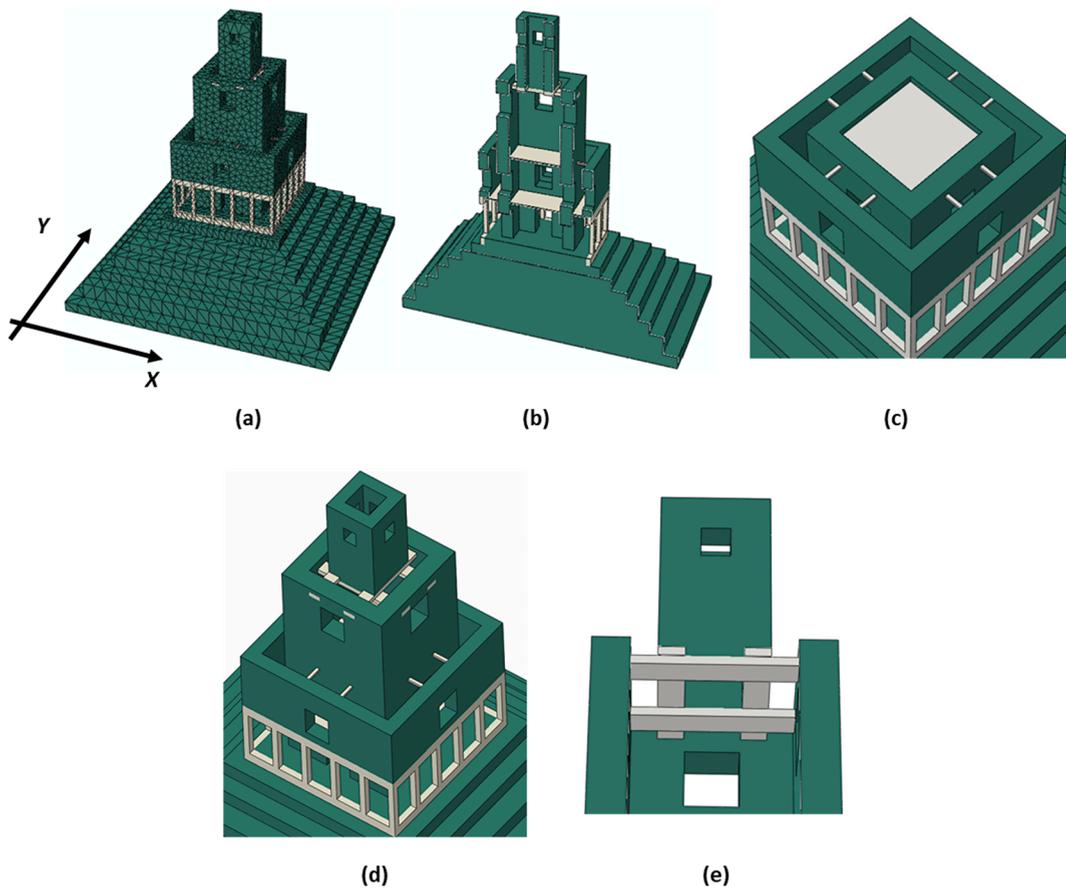
Fig. 6. The developed initial model: (a) meshing, (b) vertical cross-section. (c) Horizontal cross section right above the top level of the peripheral wall. (d) and (e) display close-up details of the upper structure. Brickwork with mud mortar is shown with green colour and timber elements with grey colour. (For interpretation of the references to colour in this figure legend, the reader is referred to the web version of this article.)

A three-dimensional finite element model (Fig. 6) based on the macro-modelling approach has been developed in the commercial

software ABAQUS [53] to analyse the seismic response of the Jaisedewal temple. The complex geometry of the temple was retrieved from drawings received by the Department of Archaeology in Nepal before collapse (Fig. 1) and was precisely incorporated in the numerical model. Due to the symmetry of the structure, loading was applied only along the horizontal ($X-X'$) direction (Fig. 6). The structural members of the temple, i.e. timber parts and masonry walls, were simulated with 3D solid continuum elements (Fig. 6). A sensitivity study was considered in order to determine the size of the elements that yields the best compromise between accuracy and computational cost. In particular, it was found that with element size in the range of 450 mm the computational cost remained manageable in terms of analysis time while no reduction in the accuracy of the results was observed. The top masonry walls of the temples do not directly sit on the underlying masonry core and this could affect the performance of the temple to earthquake loads. An example of this connection detail is displayed in Fig. 3a, while the representation of the connection in the developed model is shown in Fig. 6e. This type of construction creates a discontinuous loading path. In fact, there were numerous examples of temples which survived the earthquake, but the top part collapsed (Fig. 7) [54,55]. Thus, special care was given to accurately reproduce this type of connection in the numerical model (Fig. 6). The timber elements were modelled as linear elastic while the masonry walls were modelled with nonlinear elements based on the Concrete Damage Plasticity (CDP) constitutive law [53]. This nonlinear constitutive law is suitable for the analysis of quasi-brittle materials, such as unreinforced masonry (URM), and to reproduce the main failure mechanisms of masonry i.e., cracking in tension and crushing in compression. This numerical approach has been used extensively to simulate historical URM structures [50,56–59]. The CDP constitutive law assumes different yield strength in tension and compression and stiffness degradation is incorporated in the post-yield phase. The degradation of the elastic stiffness is characterized by two damage variables, d_c and d_t for compression and tension respectively, and their evolution is a function of the plastic strains. If E_0 is the initial (undamaged) elastic stiffness of the material, the stress–strain ($\sigma - \epsilon$) relations under uniaxial tension and compression are:

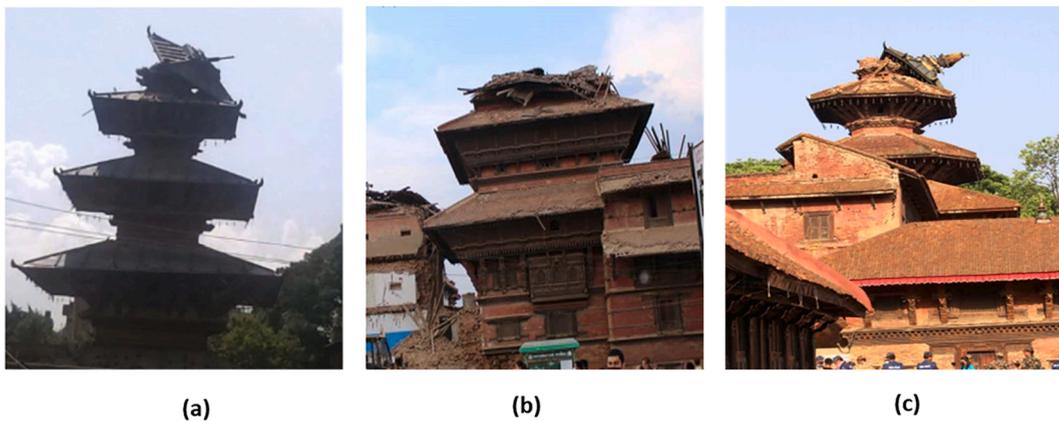
Fig. 7. (a) Different cases of collapse of the top part of the Nepalese temples during the Gorkha earthquake that hit Nepal in 2015, (a) [54], (b) and (c) [55].

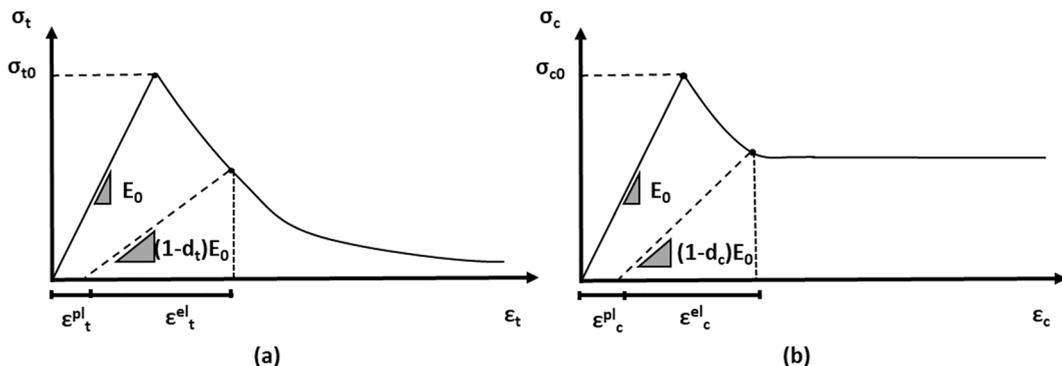
Fig. 8. The response of Concrete Damage Plasticity constitutive law to uniaxial loading in (a) tension, and (b) compression.

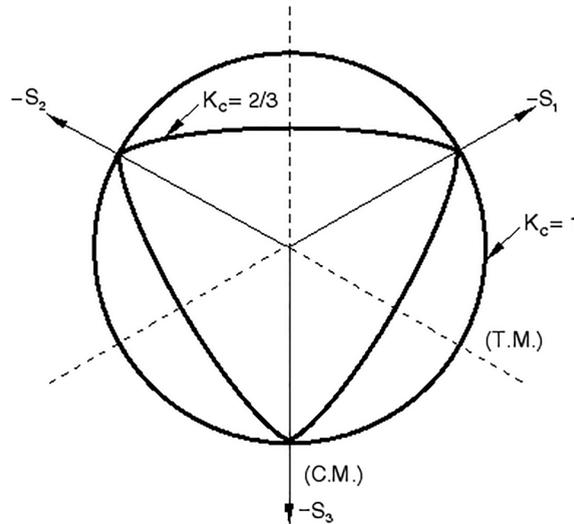
Fig. 9. Yield surfaces in the deviatoric plane, corresponding to different values of K_c [53]. C.M.: compressive meridian and T.M.: tensile meridian.

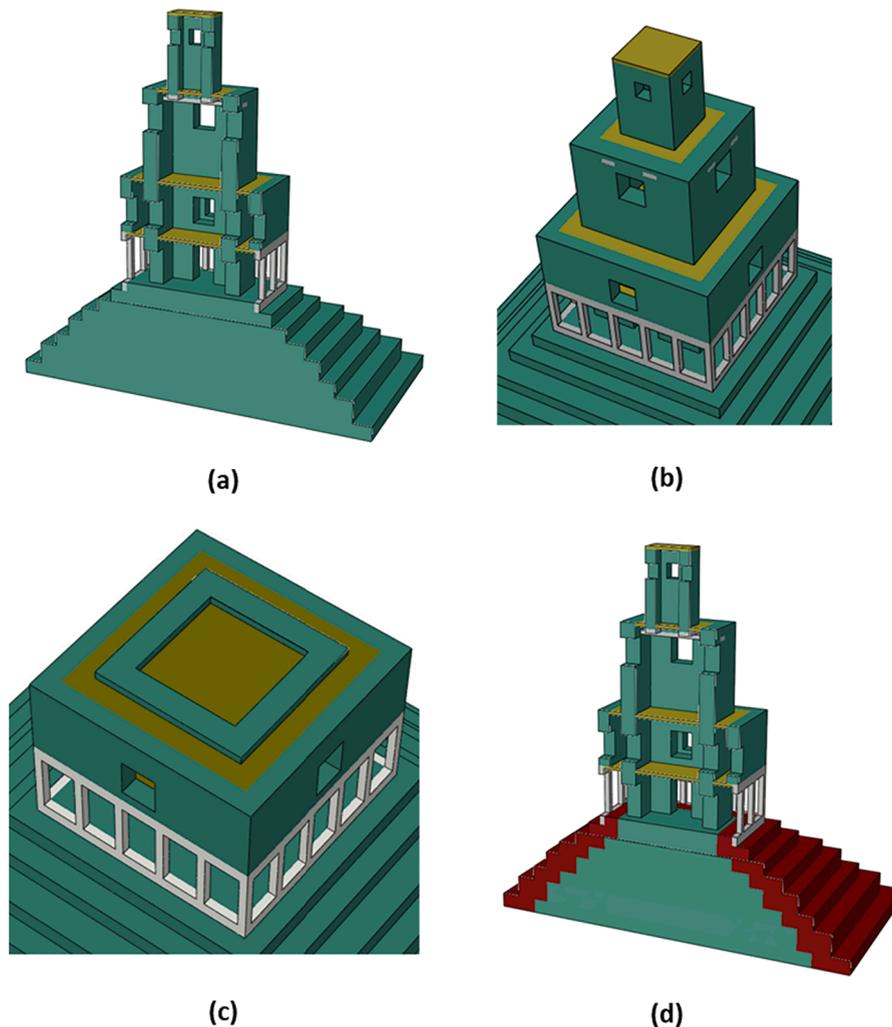
Fig. 10. The developed retrofitted model with stiffened-floors: (a) cross-section and (b) detail of the upper structure. (c) Horizontal cross section right above the top level of the peripheral wall (d) The retrofitted model with the interventions stiffened-floors and new-stairs implemented. Brickwork with mud mortar is shown with green colour. Timber elements existing at the Jaisedewal temple before any intervention are shown with grey colour while timber elements added in the retrofitted model are displayed with yellow colour. Red colour denotes the new-stairs at the perimetry of the plinth base replaced with new material. (For interpretation of the references to colour in this figure legend, the reader is referred to the web version of this article.)

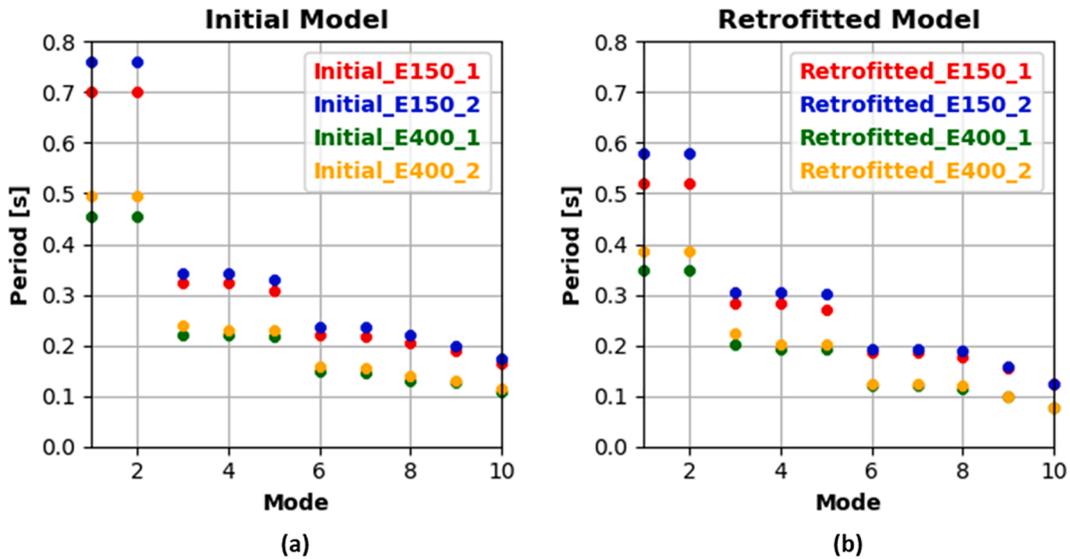
Fig. 11. The first ten modes as calculated for different configurations of: (a) the initial and (b) the retrofitted models.

The periods of vibration of the first ten modes as calculated for different configurations of the initial and the retrofitted models are presented in Fig. 11. For all the different configurations examined, it was found that the first four modes were translational in the two horizontal directions of the temple, that is x and y (see Fig. 6a for a definition of the axes), while the fifth was torsional. The rest modes were local. It is noted that for the retrofitted models, the mode shapes did not alter significantly, but the obtained periods decreased up to 30%. Similarly, when the plinth base was ignored in the model, the first period of the temple reduced by approximately 10% but the type of the first ten modes did not change in comparison to the models containing the plinth base. Furthermore, the obtained periods, when higher material properties were considered, were profoundly reduced in comparison to the analyses with low material properties (see Fig. 11).

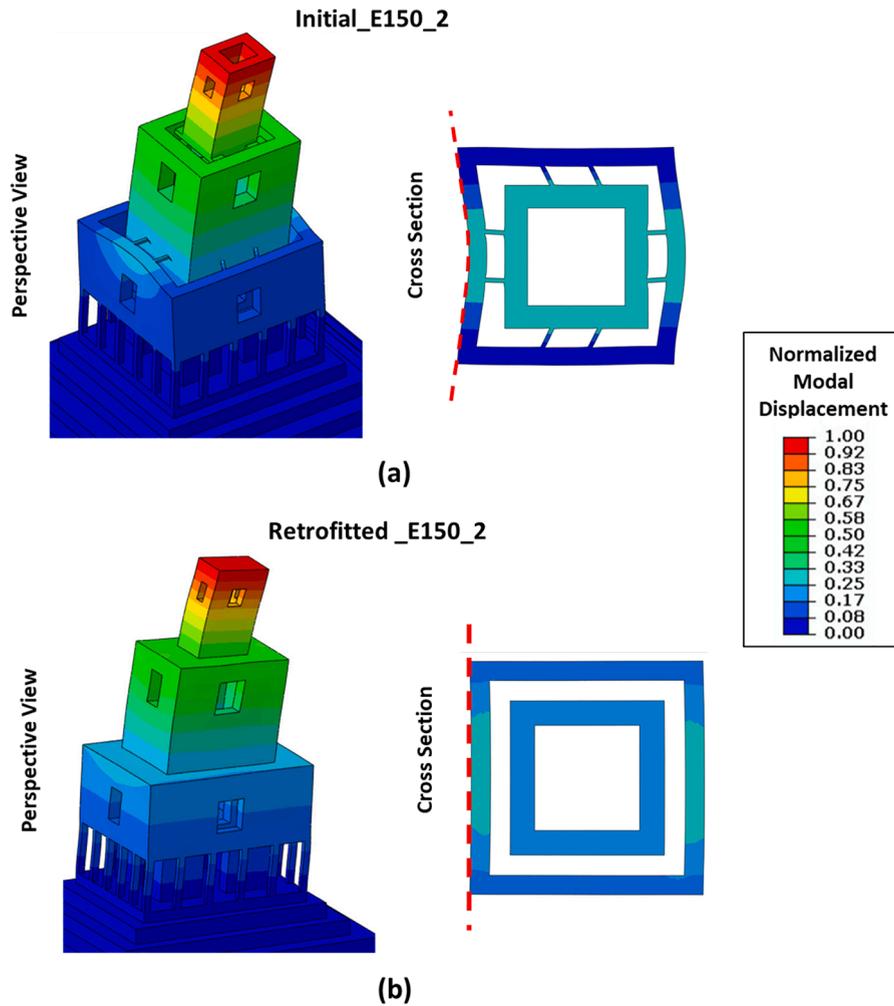
Fig. 12. The first mode shape of the (a) initial (Initial_E150_2) and (b) retrofitted (Retrofitted_E150_2) models with mass participation ratios in the x direction (see Fig. 6a for the definition of x axis) 51% and 57% respectively. For each model a perspective view and a cross section at the top level of the peripheral wall are demonstrated in left and right respectively. The OOP motion of the peripheral wall is denoted with a red dashed line. The contours demonstrate the normalized modal displacement.

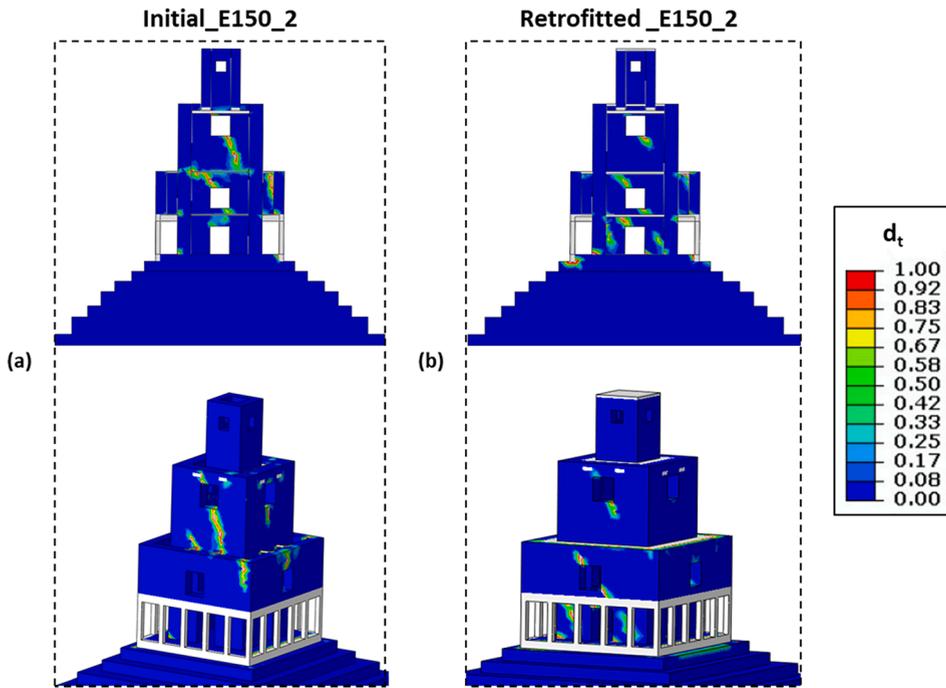
Fig. 13. The distribution of tensile damage d_t for cross-section (top) and perspective view (bottom) of the deformed structure when drift ratio 0.5% is attained during the pushover analysis for (a) the initial (Initial_E150_2), and (b) the retrofitted (Retrofitted_E150_2) models.

Fig. 13 shows the failure patterns for the initial (Initial_E150_2) and retrofitted (Retrofitted_E150_2) models, when low material properties are considered and the plinth base is modelled, as obtained from the pushover analysis. The results are presented for 0.5% drift ratio at the top of the main core, which is the value of drift ratio that corresponds to the yield limit for URM structures as defined in [64].

At the Initial_E150_2 model, concentration of damages occurs around the timber pegs which connect the main core to the peripheral wall (Fig. 13a). Due to the lack of diaphragmatic action at the level of the timber floors, the structure experiences extensive damage at the corners of the peripheral walls. Furthermore, the failure of the timber joist connections leads to OOP deformations in the middle of the peripheral wall, responsible for the development of cracks at these areas. Consequently, it can be inferred that the

Fig. 13b shows the failure patterns for the retrofitted model Retrofitted_E150_2 as obtained from the pushover analysis for 0.5% drift ratio at the top of the main core. The main damages manifest as diagonal cracks on the main core. The tendency of the peripheral wall for OOP deformations has been eliminated and the cracks at the corners of the peripheral walls are limited. A limitation of the retrofitted structure is that the wooden pillars participate more in carrying horizontal loads, thus higher stresses are transmitted to their foundation causing the formation of cracks. Consequently, the foundation of the wooden pillars needs to be checked if it can safely carry these extra horizontal loads. After the retrofit has taken place, the whole temple follows the deformed shape of the main masonry core and the impact of local failure modes is limited.

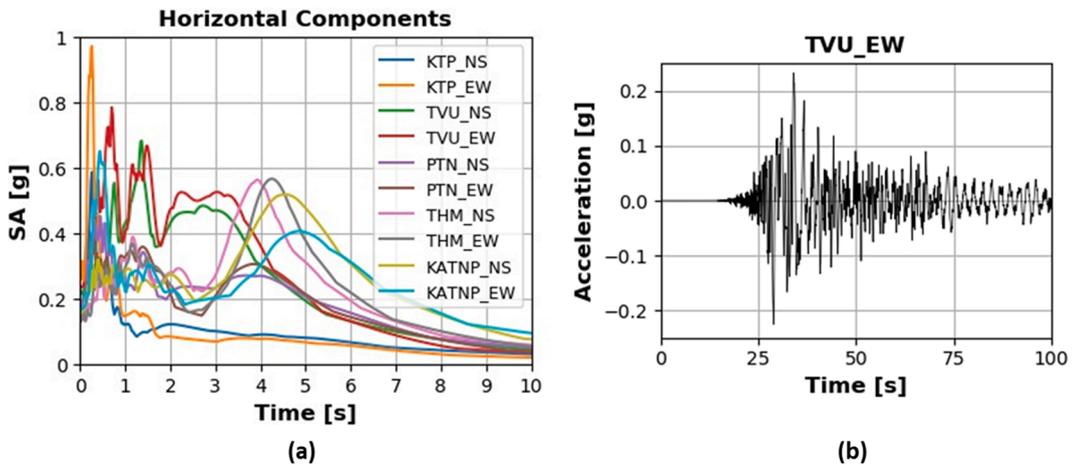
Fig. 14. (a) The response spectra corresponding to the horizontal components of the main records of the Gorkha earthquake Nepal (April 25, 2015), and (b) the record used for the time-history analysis.

station. The response spectra of the main records of the Gorkha earthquake are presented in Fig. 14a. The record coming from the EW component of the TVU station [65] was chosen for the time-history analyses performed in this work (Fig. 14b). The distance between the TVU station and the Jaisedewal temple is 3 km. The chosen record has PGA of 0.23 g and more importantly, it produces spectral accelerations of up to approximately 0.8 g at the period of 0.7 s, which coincides with the fundamental period of the Jaisedewal temple. It is highlighted that the long duration of the Gorkha earthquake containing multiple pulses (Fig. 14b) was extremely destructive for the Nepalese monuments. As will be shown below, the Jaisedewal temple reached its capacity in the very first pulses of the excitation, while the next pulses pushed the structure even further making the total collapse inevitable.

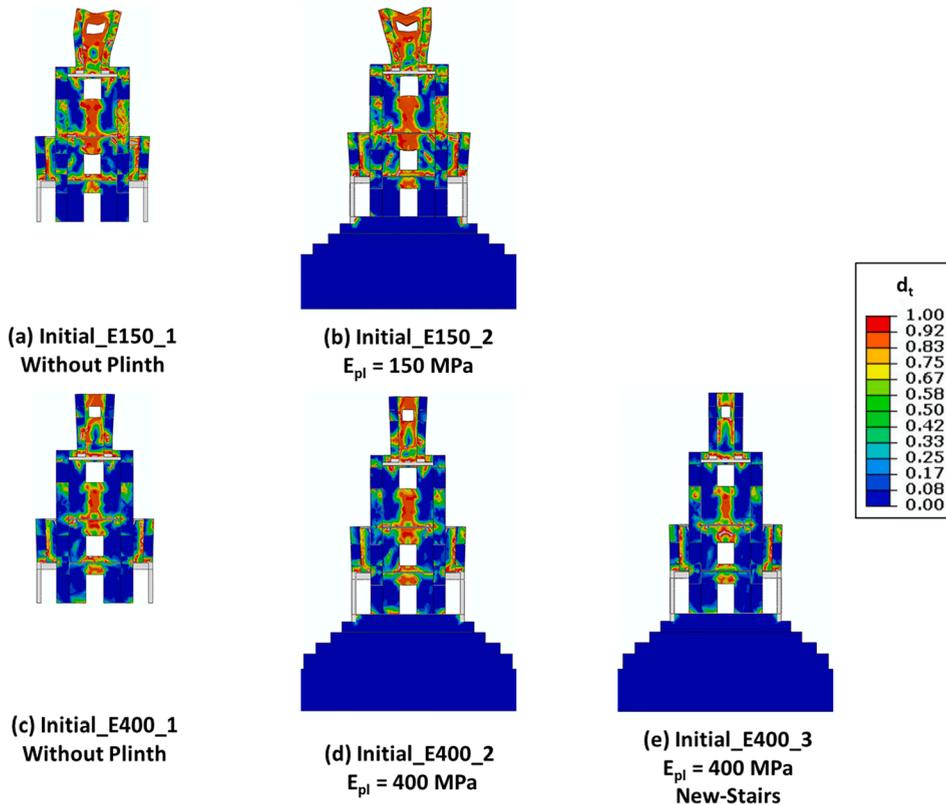
Fig. 15. The distribution of tensile damage d_t for cross-section of the deformed structure during the time-history analysis for different configurations of the initial model. (a) and (b) are given for time $t = 35$ s, while (c), (d) and (e) correspond to the end of the time-history analysis. E_{pl} refers to the modulus of elasticity assigned to the plinth base. The new-stairs intervention is implemented in (e).

During the time-history analysis, the initial model (Initial_E150_2) suffers excessive damage from the first seconds of the motion (Fig. 15b). Damage occurs to almost the entire structure and accumulates during the earthquake until collapse. It is underlined that excessive relative deformation is observed between the main masonry core and the peripheral wall. This behaviour points out the lack of proper connection among the structural elements which leads to OOP deformations and possible toppling of the peripheral wall.

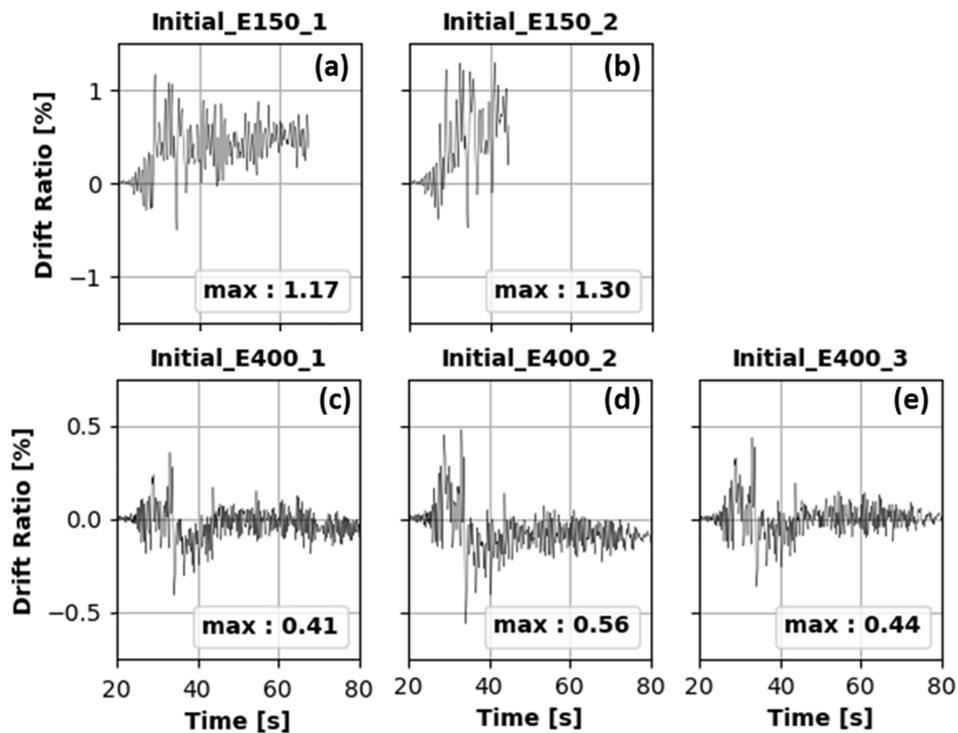
Fig. 16. Time-history of drift ratio at the top of the main core for different configurations of the initial model.

Moreover, an important observation is that the top part of the structure experiences excessive nonlinearity which leads to high drift ratios. In particular, the top of the structure is extremely vulnerable to earthquake vibrations since it does not sit on the main masonry core but is supported by the timber beams. Such failure mode has also been observed in different temples during the Gorkha earthquake (Fig. 7) [54,55]. It is noted that the pushover analysis failed to capture this type of failure which highlights the necessity to perform time-history analysis to accurately evaluate the seismic response of the investigated structural typology. Similar findings were obtained for the initial model with higher material properties (Initial_E400_2) and for the models without the plinth base (Initial_E150_1 and Initial_E400_1); excessive nonlinearity in the temple and thus collapse is inevitable (Fig. 15), while the corresponding drift ratio time-histories are exhibited in Fig. 16. In particular, the maximum drift ratio at the top of the main core for the initial model with low (Initial_E150_2) and higher (Initial_E400_2) material properties reaches 1.30% and 0.56% respectively. Consequently, the initial model of the temple without any enhancements reveals the high vulnerability of the temple in strong seismic excitations such as the Gorkha earthquake. The numerical results coincide with the actual behaviour of the Jaisedwal temple during the Gorkha earthquake, which led to the collapse of the structure.

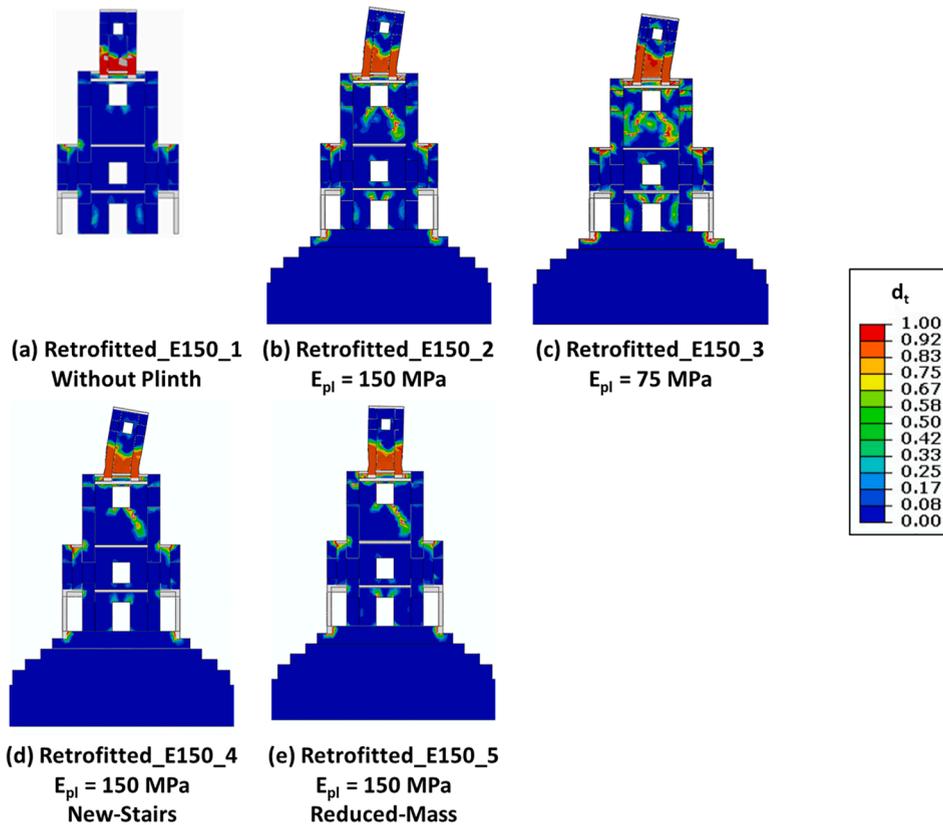
Fig. 17. The distribution of tensile damage d_t for cross-section of the deformed structure during the time-history analysis for different configurations of the retrofitted model with low material properties for the upper structure. (b) and (c) are given for time $t = 35$ s, while (a), (d) and (e) correspond to the end of the time-history analysis. E_{pl} refers to the modulus of elasticity assigned to the plinth base. The new-stairs and reduced-mass interventions are implemented in (d) and (e) respectively.

The deformed shape of the retrofitted model with low properties (Retrofitted_E150_2) at the end of the time-history analysis is displayed in Fig. 17b. It is noted that even after the retrofit has taken place, the top part of the structure deforms excessively and collapse of that part of the structure seems highly likely. Nevertheless, the response of the rest of the structure has been enhanced and the collapse of the temple is avoided. In particular, the structure presents a box-type behaviour with all the structural elements following the motion of the main core. Therefore, concentration of stresses and OOP deformations are less profound, and the cracks caused by these local failure modes are rather limited. In particular, the OOP deformation of the peripheral wall is zero at the retrofitted structure. Overall, the structure exhibits regions of tensile failures which implies that cracks should be expected on the structure during a similar seismic excitation. The drift ratio of the main core for the Retrofitted_E150_2 model is exhibited in Fig. 18b and the maximum recorded drift ratio is 0.47%, a reduction of 64% in comparison to the Initial_E150_2 model. The analysis with the Retrofitted_E150_2 model terminates before the whole record is applied. This is due to excessive nonlinearities at the top part of the

The deformed shape of the retrofitted models without the plinth base (Retrofitted_E150_1 and Retrofitted_E400_1) is presented in Fig. 17a and Fig. 19a respectively. It can be concluded that when the plinth base is neglected, the inflicted nonlinearities are less profound and consequently the damage on the temple is underestimated leading to an unrealistic assessment of the monument.

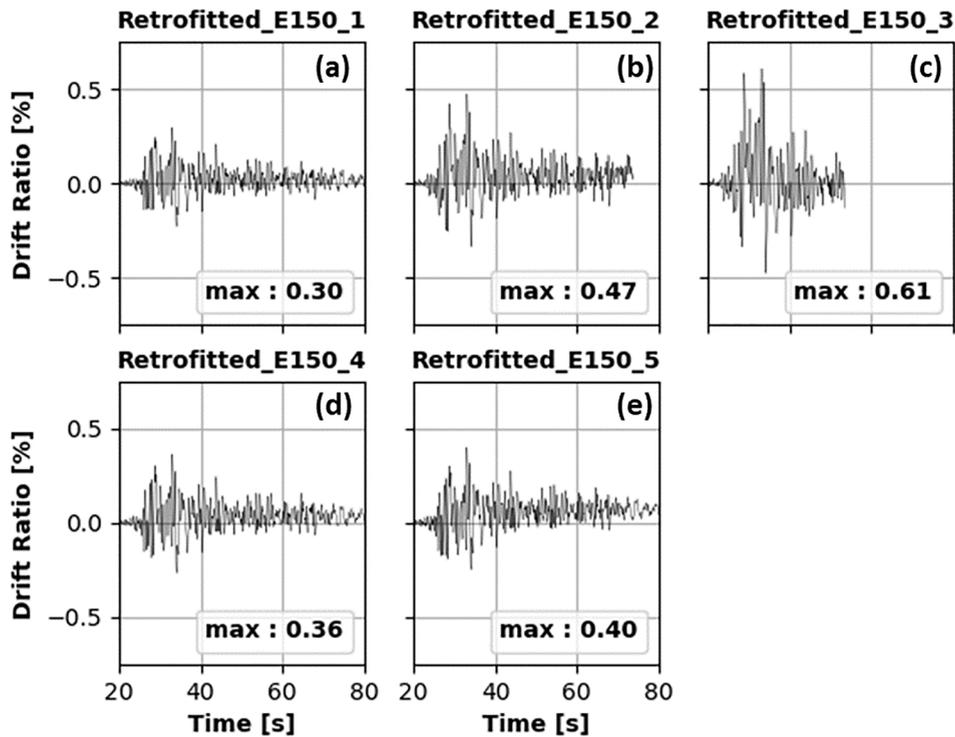
Fig. 18. Time-history of drift ratio at the top of the main core for different configurations of the retrofitted model with low material properties for the upper structure.

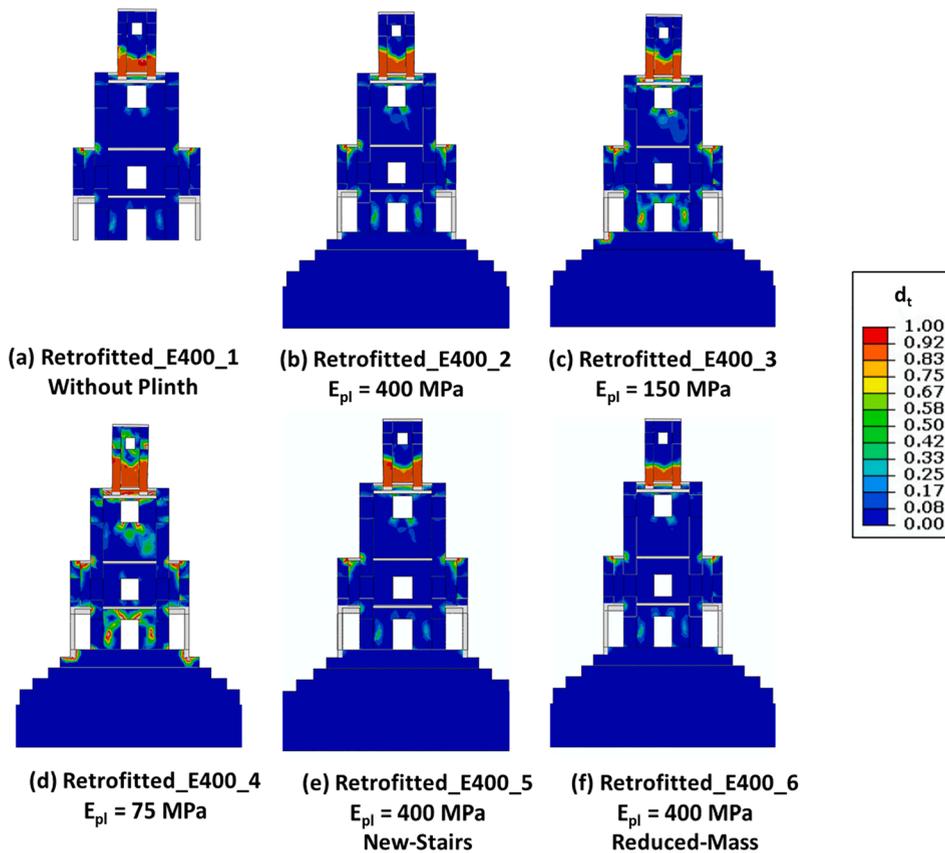
Fig. 19. The distribution of tensile damage d_t for cross-section of the deformed structure at the end of the time-history analysis for different configurations of the retrofitted model with higher material properties for the upper structure. E_{pl} refers to the modulus of elasticity assigned to the plinth base. The new-stairs and reduced-mass interventions are implemented in (e) and (f) respectively.

structure. For the retrofitted model with higher properties (Retrofitted_E400_2), the collapse of the temple is avoided as well (Fig. 19b) and the recorded drift ratio at the top of the main core reduces by 68% with respect to the Initial_E400_2 model. Nevertheless, regions with cracks can still be observed along the structure but are of limited extent.

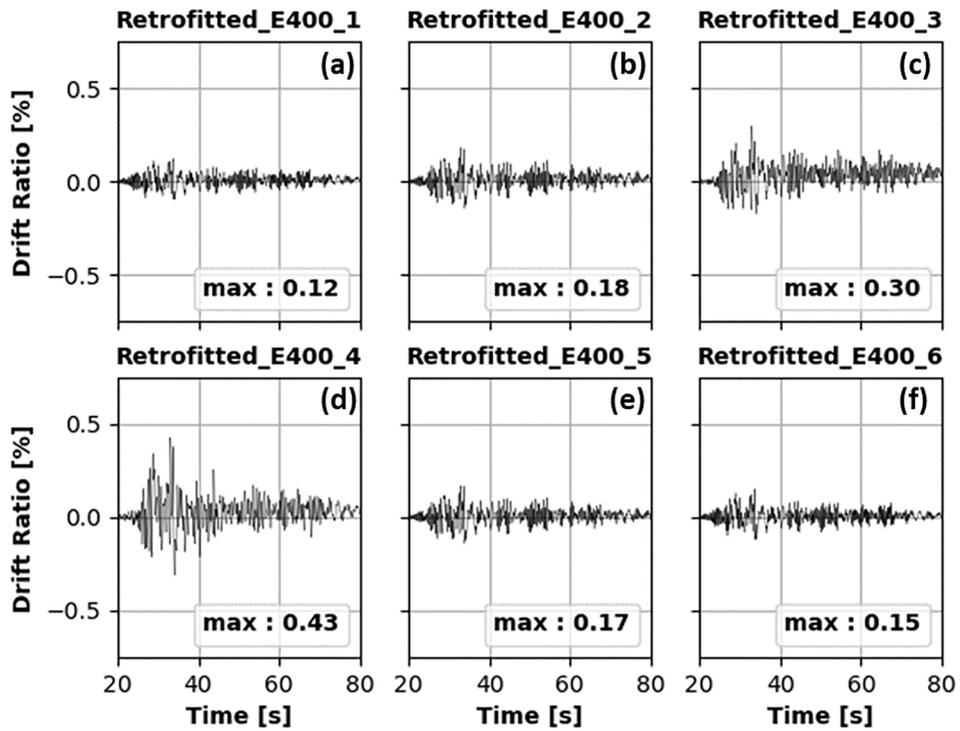
Fig. 20. Time-history of drift ratio at the top of the main core for different configurations of the retrofitted model with higher material properties for the upper structure.

The influence of the properties of the plinth base to the seismic response of the monument was analysed also for the retrofitted model with higher properties. For this purpose, two models were developed, Retrofitted_E400_3 and Retrofitted_E400_4, with the modulus of elasticity of the plinth base being 150 MPa and 75 MPa respectively. It is reminded that the modulus of elasticity of the temple for these two models is 400 MPa. As a matter of fact, the damage extend to a greater range at the temple as the properties of the plinth base drop (Fig. 19c and d). In addition, the drift ratio increases from 0.18% (Retrofitted_E150_2) to 0.30% (Retrofitted_E400_3) and 0.43% (Retrofitted_E400_4) (Fig. 20c and d).

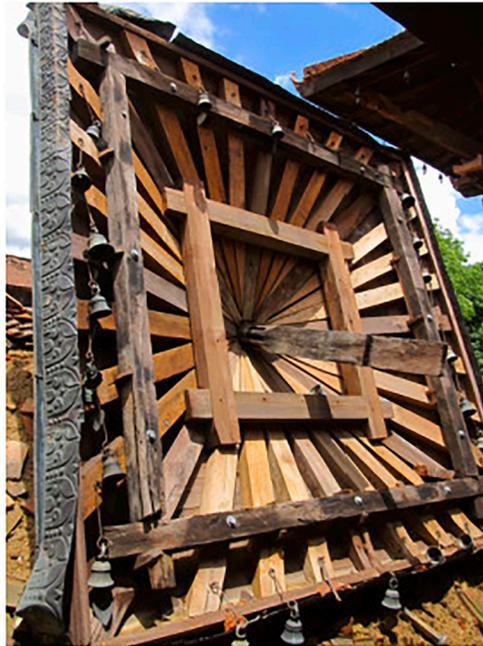
Fig. 21. The top tier roof of the South Taleju Tower toppled during the 2015 Gorkha earthquake [51].

The retrofitted model presented an enhanced seismic response of the Jaisedewal temple. Nevertheless, the effectiveness of the interventions depends on the strength of materials of the temple and the plinth base. In particular, for the temple with higher mechanical strength properties, the proposed retrofit reduced the inflicted damage to a minimum level. On the other hand, for the structure with low strength properties, the applied retrofit prevented the collapse of the temple but still damage is expected for a similar seismic excitation. Special care should be given to the top part of the structure that is not directly connected with the main core and was proven to be extremely vulnerable to seismic motion. For the retrofitted models with stiffened-floors, the collapse of the top of the structure is not prevented and further appropriate interventions ought to be examined. This result is in good agreement with in situ inspections of Nepalese monuments after the 2015 Gorkha earthquake. In particular, the top tier roof of the South Taleju Tower, even though it was earlier stiffened in a previous repair and restoration campaign that took place in the period 2013–2015, toppled during the seismic excitation of April 25, 2015 [51] (Fig. 21).
