Abstract: Unreinforced masonry walls are prone to failure when subjected to out-of-plane loading. This is due to their low performance in bending, and often the lack of appropriate connection to returning walls and floors. This paper investigates the possibility to use oriented strand boards (OSB) panels to improve the out-of-plane performance of brick masonry walls. The proposed technique considers securing OSB type-3 panels behind masonry walls with chemical and mechanical connections. The work presents finite element models to predict their behaviour. The models have been calibrated and validated through a three-phase experimental campaign, aimed at (a) characterizing the main structural components, (b) studying the out-of-plane behaviour of small-scale masonry prisms and (c) studying the behaviour of $1115 \times 1115 \times 215$ mm masonry walls. The finite element models developed are based on a micromodel technique developed in ABAQUS and demonstrated to adequately capture the behaviour of both plain and retrofitted models to the ultimate load. The models also show an excellent correlation of the compressive damage and tensile damage with the experimental failure pattern. Ge

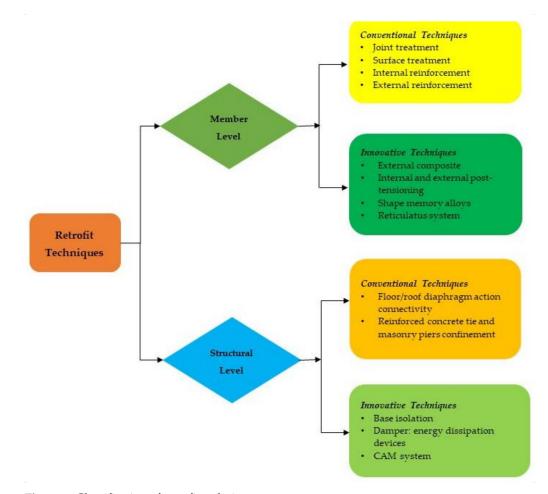
Figure 1. Classification of retrofit techniques.

Within each level of intervention, conventional and innovative techniques can be identified, as shown in Figure 1 [6].

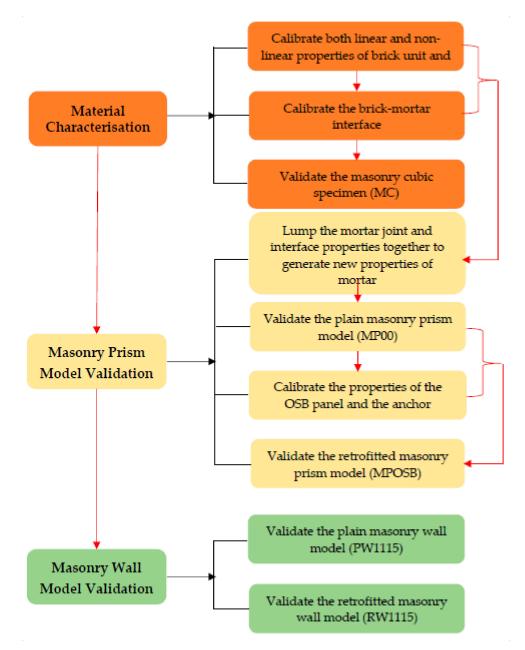
Figure 2. Full numerical analysis program.

Numerical modelling and analysis were developed in ABAQUS/CAE [26]. As formulated for the experimental work, the numerical analysis was also articulated in three stages (Figure 2).

The first stage is the numerical simulation of the compression test on the masonry cubic specimens presented as part of the material characterisation test. The purpose of this stage was to obtain accurate mechanical properties of the unit, mortar and the interfacial properties of the unit-mortar joint that is necessary to produce detailed micromodelling of masonry structures. To achieve this, a complete description of each component was done based on the experimental results of compression tests on brick units, mortar and the masonry cubic assemblage.

Second, numerical simulations of the flexural bond strength tests on small-scale masonry prisms were developed to capture the damage and failure pattern of the masonry prisms (MP) tested. This stage was articulated in two steps, which included (i) validation of

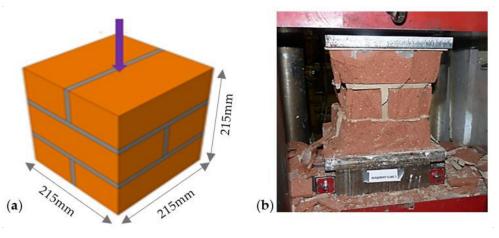
For the masonry cubic specimen, the average compressive strength obtained from the experiments was 46.4 N/mm². Most importantly, the observation shows that the failure modes of both the brick units and MC are brittle. The failures of MC specimens were characterized by vertical splitting cracks appeared first in the central unit and extended to the other units as the stress increased (Figure 4). This failure pattern is due to the presence of the vertical joints and the lateral expansion of the mortar inducing high tensile strength in the bricks.

Figure 4. Masonry cubic: (a) geometry and (b) failure.

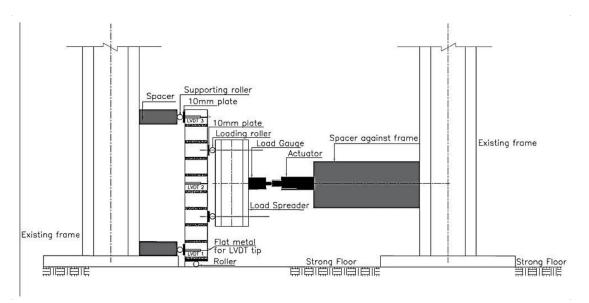
The MP specimens constructed on the 10 mm-thick steel plate were tested adopting the test set up shown in Figure 5. No vertical precompression loads were applied to any of the nine specimens. The specimen on the steel plate was rested on a 25 mm-diameter cylindrical roller with the axis of the roller parallel to the face of the specimen to allow it to freely rotate around its base while deflecting out-of-plane and prevent a restrained end condition. At the back of the specimen, a 25×5 mm-thick metal plate was fixed across the middle of the top and bottom brick unit each. This 5 mm-thick plate provided a smooth contact for the Ø25 mm supporting rollers fixed on an existing steel reaction frame in the laboratory. On the front side of the specimen, two additional 25×5 mm-thick metal plates were fixed at the third and seventh course of the specimen each to provide a contact for the loading rollers.

The loading of the specimens is such of a four-point testing arrangement, where the loads were applied on the specimen using a high-force hydraulic jack and distributed through a spreader beam. The spreader beam spanned between two Ø25 mm cylindrical rollers placed across the third and seventh course of the specimen. The direction of the load application is perpendicular to the specimen surface. The applied load on the masonry prism was monitored using a 200 kN-capacity ring load cell. Simultaneously, four linear variable displacement transducers (LVDTs) were used to record the deflections of the specimen along the centre, mid-top and bottom of the specimen.

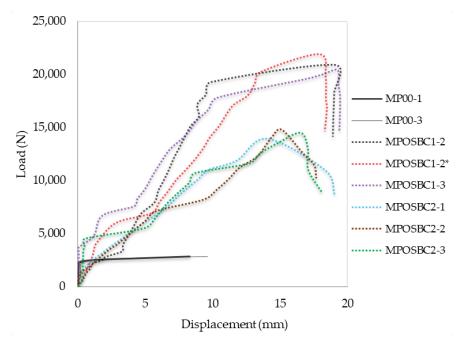
Figure 6. Load displacement curves for MP specimens. MPOSBC1-2* was constructed to replace the damaged MPOSBC1-1.

the observed failure pattern of the MP specimens tested is presented in Figures 7 and 8. The maximum load, corresponding displacement at failure, flexural strength and the toughness of the tested specimens were all determined and are presented in Table 3. The flexural strength was calculated from the bending theory using the maximum failure load. The toughness (i.e., energy absorbed) of the specimens is estimated from the load–displacement curve (Figure 6) using the method based on ASTM 1609. This toughness is estimated as the overall (i.e., the total area under the load–displacement curve) and the limiting toughness. The limiting toughness is the area under the curve up to a limited displacement of span/250 [29]. This is done to understand the toughness gained by the specimens when undergoing an acceptable displacement without adverse effect. Thus, the limiting toughness actually estimates the improvement due to the retrofit application in an acceptable range.

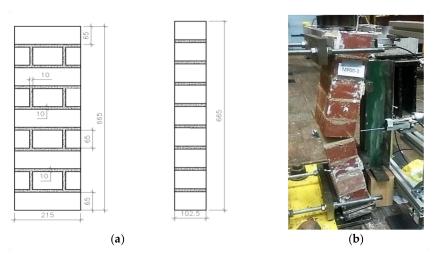
Figure 7. MP specimen: (a) geometry and (b) failure pattern (MP00-3 as an example).

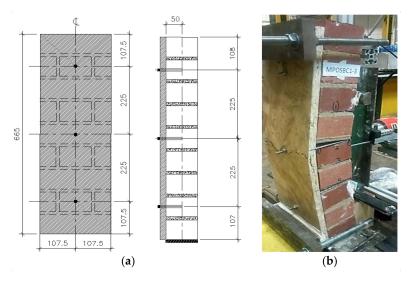
Figure 8. MP specimen with OSB: (a) geometry and (b) failure pattern (MPOSBC1-3 as an example).

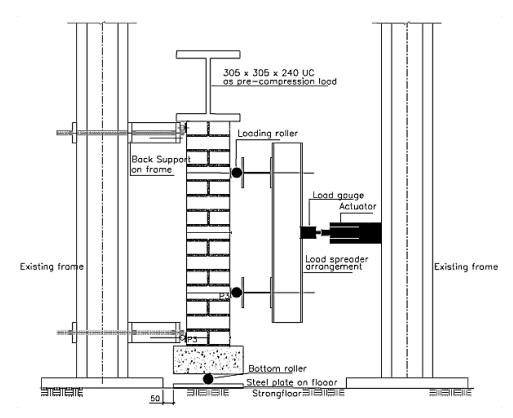
test arrangement (Figure 9) to assess their flexural behaviour. The test was load controlled and the load was applied to each tested specimen using a hydraulic ram and was distributed through a steel spreader arrangement in the central area of the wall. All specimens were tested with a simple supported boundary condition and a vertical precompression load $(305 \times 305 \times 240 \text{ UC}$ section amounting to a 3 kN load) on top of the wall. The specimen constructed on reinforced concrete footing was rested on a 50 mm diameter cylindrical roller with the axis of the roller parallel to the face of the specimen. At the back of the wall, a 5 mm-thick metal plate was fixed across the middle of the top and bottom course of the wall to provide contact for the simple support. Similarly, a 5 mm-thick metal plate was fixed at 1/4th and 3/4th of the specimen height at the front side to provide contact on which the loading roller rests (Figure 9).

The loading scheme was such that an initial load was applied continuously at a rate of 1 kN/min for up to 5 kN and then maintained for a 5 min period. The load steps were repeated continuously for a 10, 15, 20, 25 and 30 kN load and maintained for a 5 min period at each load step. After that, the load was increased continuously to the failure of the specimens. In order to obtain the maximum capacity of the retrofitted walls, the applied load was increased continually after the first crack until additional cracks were formed in the retrofitted specimens and ultimately the timber at the back of the masonry walls was broken. During testing, the applied load on the wall was monitored using a 200 KN-capacity ring load cell. In addition, eight LVDTs were used to record the deflections of the specimen along the wall center, mid top and bottom.

Figure 9. Large-scale test setup.

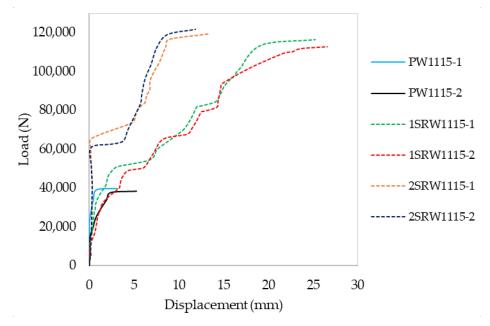
Figure 10. Load vs. displacement curve for large-scale masonry wall specimens.

The analysis of results shows a significant increase in the out-of-plane displacement of retrofitted walls. This is due to the application of the OSB timber panel that offered the masonry wall a significant lateral resistance once the mortar interfaced cracked. As such, the retrofitted specimens were able to take more loads and absorbed more energy by displacing more without sudden failure. The increment in the out-of-plane displacement of the retrofitted walls was 6 times and 3.0 times that of PW for 1SRW and 2SRW, respectively.

Similar to the observation in the small-scale test, the overall toughness gained due to the retrofit application when taken up to the failure of the OSB is such that an improvement of 16 times and 10 times that of the plain wall was estimated for application on single and both sides, respectively. However, the performance of the proposed technique at the limiting displacement was quite different with the double-sided showing more toughness gained than the one-sided application ($2.4 \times PW$ and $1.6 \times PW$ for double and single-sided, respectively). The analysis shows that the double-sided application offers the most improvement in the toughness at the limiting displacement. Thus, the double-sided is the best option when higher energy absorption is required in a real situation.

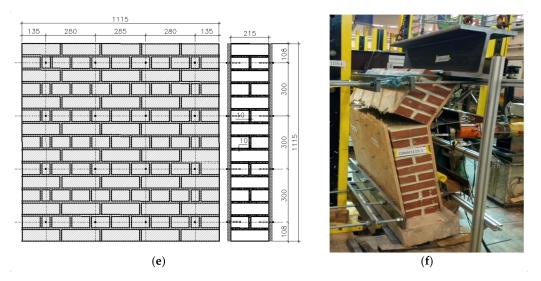
In terms of observed failure pattern (Figure 11), it emerged that the failure of the PW was sudden with the evolution of a crack opening in the mortar bed joint almost at the specimens' mid-height. The failure (cracking) abruptly occurred between the interface of the mortar joint and brick unit, which then cut across the whole specimen thickness. Whereas the application of the OSB type-3 to retrofit the walls shows that the walls were able to take more loads after the first crack, which subsequently led to the formation of other horizontal cracks in the bed joint within the middle third of the walls. The failure/collapse

of the retrofitted specimens occurred when the applied OSB timber reached its ultimate strain and broke. The application ensured that sudden failure was avoided.

Figure 11. Observed failure pattern of a masonry wall: (**a**) plain wall (PW1115) geometry, (**b**) failure pattern (PW1115-1 sample), (**c**) one side retrofitted wall (1SRW1115) geometry, (**d**) failure pattern (1SRW1115-2 sample), (**e**) two side retrofitted wall (2SRW1115) geometry and (**f**) failure pattern (2SRW1115-1 sample).

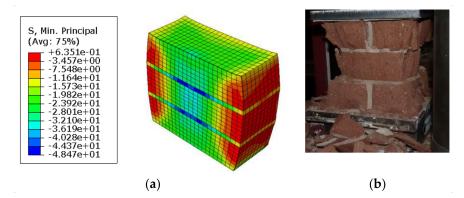
The principal stress obtained from the numerical analysis is compared to the average compressive strength of the specimens obtained experimentally. The maximum stress obtained from the numerical model is 48.7 N/mm². This value is only 5% different from the average compressive strength of masonry obtained from the experiment (46.4 N/mm²). Figure 13 shows the stress contour plots obtained numerically for the MC model compared with the observed failure pattern from the test. Significantly, the failure mode observed in the model output (Figure 13a) is similar to what was observed experimentally (Figure 13b) with the maximum compressive stress occurring at the bottom edges of the model. The cut along the y-plane of the model revealed the tensile stress distribution in the model. The regions showing the highest values (colours tending towards red at edges of the model) can be associated with the maximum stress, which is an indication of where cracks are expected to appear. This shows that higher concentration of the stress is consistent with the portion that split off in the experiment. Therefore, Figure 13b can be likened to the inner region of the stress diagram obtained from the numerical simulation.

Figure 13. Numerical output forMC model(a) vs. experimental observation (b).

The FEs model developed for the masonry cube was able to predict the behaviour and failure of masonry cube with a difference of 5% between numerical value and experimental value. This indicates that the calibrated mechanical properties of the brick unit and mortar joint represent the properties of brick and mortar used in the experiment. Therefore, Table 5 presents the already calibrated properties of the unit and joint for the small- and large-scale simulations used subsequently in Sections 4.2 and 4.3.

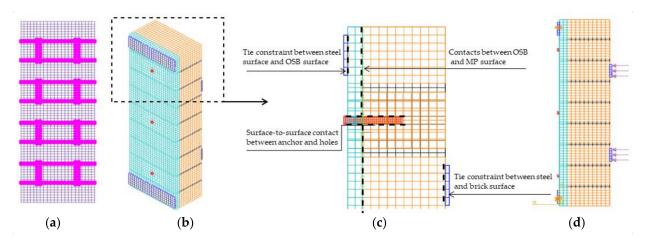
Moreover, proper consideration of the applied boundary conditions in the numerical simulation was taken. The models (MP00-NM and MPOSB-NM) were constrained to replicate what was done experimentally to enable a sound basis for comparison of results. In the developed models, the nodes at the middle of the back-steel plate at the top of the MP were restrained in the x- and z-direction. In addition, the plate at the bottom was restrained in all the three directions (x, y, z) at the middle nodes to replicate the support condition of the tested specimen (Figure 14d).

The loads considered in this analysis are self-weight of the model and applied unit load in the out-of-plane direction at the third and seventh course of the model. This loading and support arrangement is a replica of the four-point bending test carried out in the laboratory. The out-of-plane load is applied as a unit uniform distributed load (UDL) on the steel plate tied to the front face of the model (Figure 14d). The analysis is the static RIKS load control method, similar to the test condition. The total load capacity of the model is measured as the load proportionality factor multiplied by the applied load in Newton (N).

Figure 14. FE model: (**a**) part merging, (**b**) model assembly, (**c**) details of contact interaction between parts, (**d**) loading and boundaries.

In this section, the finite element analysis to simulate the large-scale test on the masonry wall is presented. Similar to the numerical simulation of the small-scale test performed in Section 4.2, the model was created with all the components in the experimental setup included. Three different models were created, each for the plain wall (PW1115-NM), one side retrofitted masonry wall (ISRW1115-NM) and two sides retrofitted masonry wall (2SRW1115-NM). The model creation follows the same process with the brick unit and mortar joint modelled as 3D deformable parts and meshed with a hexahedral 8-node linear brick (C3D8R). The steel plate for load and support application was also modelled using 3D discrete rigid elements (R3D4). The interaction between components and boundary condition is the same as in the MP model (Figure 14).

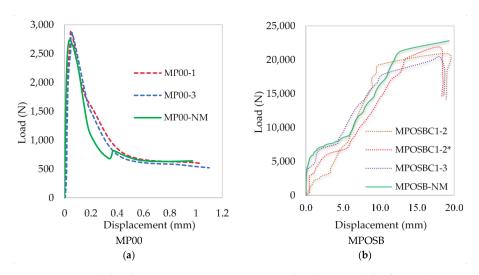
In terms of the load–displacement comparison, Figure 17 shows that the numerical outputs compared well with the graph showing that the numerical model captures the experimental envelope. The model predicted the toughness, peak load and the corresponding failure to within less than 5% of the average results obtained from the test (Table 6). Hence, the simulation process including the input parameter, loading conditions, applied constraints and interaction between parts were fit to extend the numerical study to the large-scale masonry wall, as presented in Section 4.3.

Figure 17. Load–displacement curves (experimental and FE model) of: (**a**) plain MP, (**b**) MP with OSB panels. MPOSBC1-2* was constructed to replace the damaged MPOSBC1-1.

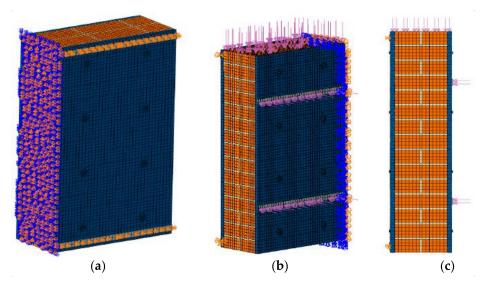
Figure 18 shows the model, boundary condition and loads applied on large-scale models using the 2SRW1115-NM as an example. Due to the symmetry of the wall specimen, only half of the arrangement was modelled. Thus, another boundary condition (i.e., ZSYMM (U3 = UR1 = UR2 = 0)) was placed in the z-axis to replicate the symmetry in the specimen. The analysis was load control, similar to the test condition, and the total load capacity of the model was measured as the load proportionality factor multiplied by the applied load.

Figure 18. Masonry wall model (2SRW1115-NM as an example): (**a**) boundary conditions, (**b**) loading, (**c**) side view with indication of applied loads and boundaries.

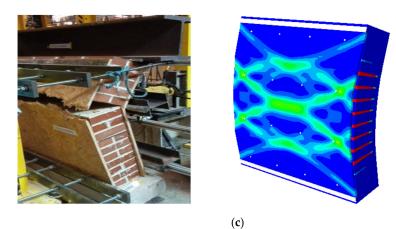
The results obtained from the numerical simulation of the large-scale walls were compared with the test results in terms of both the capacity and failure mode. The comparison shows a relatively good agreement between the numerical and experimental results. Figure 19 shows the failure of the model alongside the actual damaged specimens obtained from the test. For the plain wall (PW1115), the comparison (see Figure 19a) indicates that the specimen failure occurred in similar bed joints, which is in the ninth and tenth row of the experimental specimen. Correspondingly, the tension damage in the model is largest in the tenth row. The failure in the test specimen crossed the perpendicular joint due to the weaker zone in the perpend joint. This weakness was not observed in the numerical model because the property of the mortar joint is the same for the bed joint and perpend joint. Indeed, the bed joint is the one in maximum tension during loading. The experimental failure was only due to variance in the specimen joint during construction, which makes the perpend joint in that zone weaker than the bed joint.

Figure 19. Failure pattern of large-scale wall (experimental and FE model): (**a**) plain wall (PW1115), (**b**) one side retrofitted wall (1SRW1115), (**c**) Double side retrofitted wall (2SRW1115).

Moreover, the numerical failure of the one side retrofitted model (1SRW1115) was compared alongside the damaged specimen from the test (Figure 19b). The damage pattern

shows that the OSB panel at the back of the specimen failed after the mortar joint failed. The location at which the OSB failed in the model is similar to what was observed in the test with the failure point being within two rows of connections.

Similar to the previous two models, the observed failure pattern for both the numerical and experimental specimens was compared for the two-sided retrofitted specimens, as shown in Figure 19c. The failure pattern of the model developed for 2SRW1115 is also in good agreement with the experimental failure. The damage pattern indicates that the OSB panel in the tension side (at the back of the specimen) failed after the mortar joint failed. The location at which the OSB failed in the model is similar to what was observed in the test with the tensile stresses spreading across the middle of the panel. The OSB in the compression face did not fail, as also seen in the experiment. The damage shown on the OSB on the compression side (i.e., loading face) only occurred after the failure and, as such, not replicated in the model.

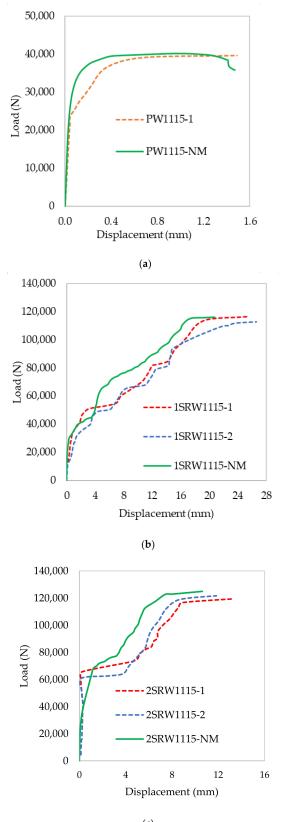
Additionally, the load–displacement curve obtained from both the numerical analysis and experimental test is presented in Figure 20. The toughness, maximum load and corresponding displacement at the failure of the model are within less than 10% of the average results obtained from the test (Table 7). Figure 20a shows that there is a little variance in the displacement for applied load higher than 24,000 N; this variation is due to the movement of the wall during testing at the initiation of the crack. This behaviour was noticed during the experiment ([6]); and it is primarily due to instability of the specimen caused by the test arrangement (as also indicated in [34,35]). However, since the numerical model assumed a perfect arrangement, the response is not captured and will be ignored.

Figure 20. Load–displacement curve for the large-scale model: (**a**) plain wall, (**b**) one-side retrofitted wall, (**c**) two side retrofitted wall.

In addition, the load–displacement curve for both the experimental and numerical model for 2SRW is presented in Figure 20c. Again, the difference between the numerical curve and experimental curve, especially at the dilatant parts of the curve after 65,000 N and subsequent steps, represent the jump in the displacement of the specimen. This jump is attributed to the stability issue in the specimen, which happened after the joint bed failed during testing. The inference from the load–displacement curves means that the model developed agrees with the experimental results. The difference in the maximum load and corresponding displacement of the numerical model and the experimental results is also within less than 10% of the average test results shown in Table 7.
