This is a repository copy of *Investigation of wear mechanics and behaviour of NiCr metallic foam abrasives*.

Liu, A., Marshall, M., Rahimov, E. et al. (1 more author) (2022) Investigation of wear mechanics and behaviour of NiCr metallic foam abrasives. *Proceedings of the Institution of Mechanical Engineers, Part C: Journal of Mechanical Engineering Science*, 236 (9). pp. 4962-4972. ISSN 0954-4062

Investigation of wear mechanics and behaviour of NiCr metallic foam abrasives

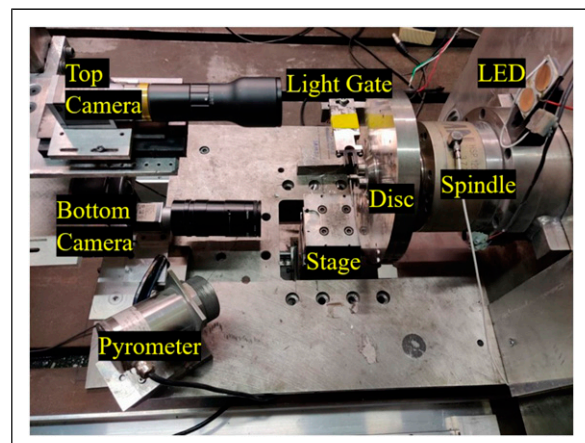
Figure 1. Representative high-speed test rig used for experimentation.

Testing in this work is performed on a scaled test rig at the University of Sheffield which has been previously described extensively¹⁷ and shown in Figure 1. This test rig is comprised of a rotating disc with two blades coupled to it, one a dummy blade and another the wearing blade. The disc is coupled to a spindle which is controlled through use of an inverter controller which enables setting of a constant rotational speed. The abrasivable sample is placed upon a z axis microscope stage which is positioned below the blade; prior to testing, the stage position is adjusted to allow the abrasivable surface and blade tip to touch where the blade position is perpendicular to the rub surface. When starting the test, the stage and sample are offset $500 \mu\text{m}$ from the original location. The spindle is rotated at the desired speed, and the microscope stage is then used to drive the abrasivable sample into the rotating blade at a uniformly set incursion rate. This operation generates an intermittent high-speed contact between the sample and the blade; all tests are carried out in ambient temperature conditions.

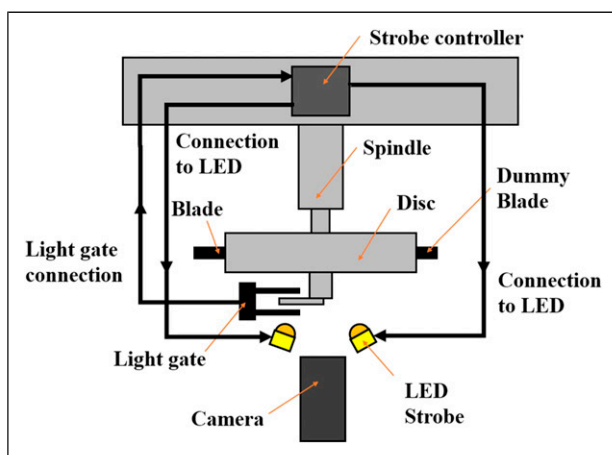
Figure 2. Schematic to show camera set up for DIC technique.

Additionally to this setup, a lower camera (Basler Ace acA1600-60 gm Monochrome GigE) is used to capture images of the abrasible sample side profile throughout the test. LEDs are positioned appropriately in front of the sample to allow sufficient lighting of the sample, and are controlled through a signal delay board to ensure coherence with the blade rotation. This setup allows for further Digital Image Correlation (DIC) processing, calculating strain in the foam as the blade interacts with it; the schematic is shown in Figure 2.

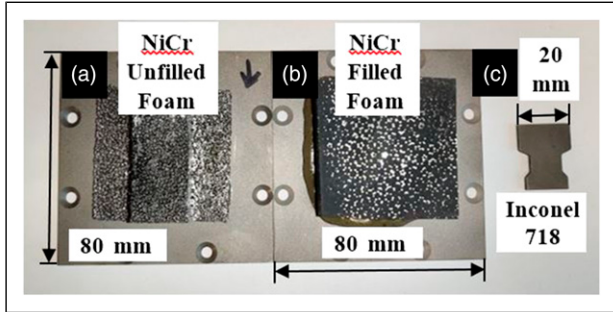
dimensions for testing: (A) example of an abraded unfilled sample, (B) example of a filled foam sample before testing and (C) Inconel 718 Blade.

Figure 3. Samples including dimensions and size.

This study makes use of a NiCr foam; the basic characteristics are outlined in Table 1. Some of the NiCr foams were injected with polyester filler material; the filler has additional amounts of silicon for high temperature applications. Figure 3 shows examples and the relative

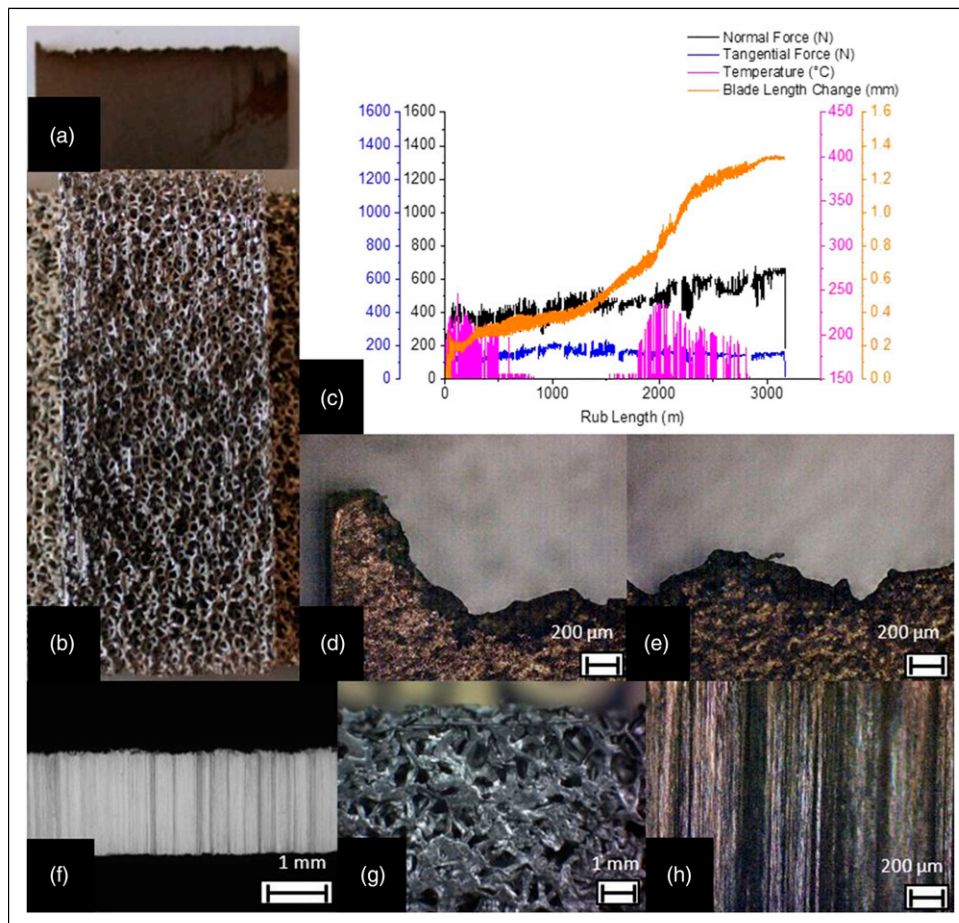
Figure 4. A-H showing examples of blade (a) and abrasable (b) samples, force, temperature and blade length change (c), optical post-test blade wear (d,e), SEM blade tip surface (f), stereoscopic image of abrasable post-test (g) and optical image of blade tip surf (h).

Figure 4 shows results from the test for small cell size (1200) NiCr foam, and at incursion rate of $0.02 \mu\text{m}/\text{pass}$, it shows characterisation of the blade and abrasible as well as forces experienced during the test. Conversely, Figure 5 shows results for larger cell size (3000) NiCr foam under the same testing conditions. Figures 4(d) and (e) and 5(d) and (e) indicate that for open cellular structures a significant

amount of blade wear is observed; this is seen for both foams in the optical images to identify the severity. The depth of blade wear can be approximated to be 900 μm for NiCr 1200 and 400 μm for NiCr 3000; larger pore size is seen to be less; however, the test duration till fracture is

shown in Figures 4(h) and 5(g) and (h). Figure 4(g) shows the compaction and compression that the metal foam experiences during the test; many of the open cellular regions have fractured and are compacted together.

The rubbing forces for small and large nominal pore size are shown in Figures 4(c) and 5(c); the tangential force experienced can be seen to be greater for a larger nominal pore size. The metallic struts are larger as seen in Figures 4(b) and 5(b) and thus require more energy to remove it; for smaller pore size, the relative metallic struts are smaller and therefore less energy is needed to break and fracture these from the rub surface. The normal force for NiCr 3000 is greater in comparison to NiCr 1200; this would imply less compression and more violent wear of the two components. A smaller normal force for NiCr 1200 indicates that it is easier for the ligaments to plastically deform out of the way and compaction of the abrasible material occurs; this is due to the energy being absorbed upon impact by the metallic struts within the top rub surface or breaking earlier.

Observing the rub area seen in Figure 4(b), there are large cavities in the abrasible material surface; this is where dislocation and fracture has caused areas to delaminate and break off. From the imaging as well as characterisation, it can be clearly identified that a large amount of material is removed as well as a substantial amount of blade wear. Stress accumulation from the force applied by the blade which localises in the metallic struts is a point of interest which is detailed fully in the discussion.

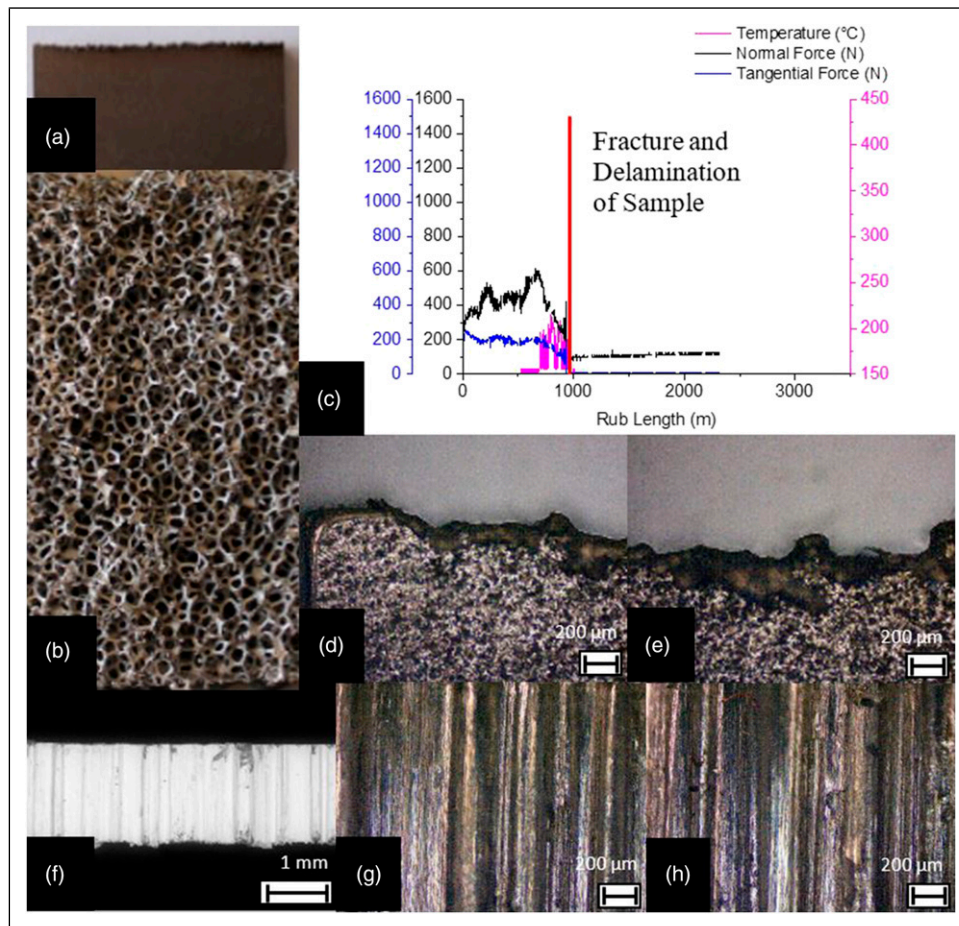
Figure 5. A-H showing examples of blade (a) and abrasible (b) samples, force, temperature and blade length change (c), optical post-test blade wear (d,e), SEM blade tip surface (f), stereoscopic image of abrasible post-test (g) and optical image of blade tip surf (h).

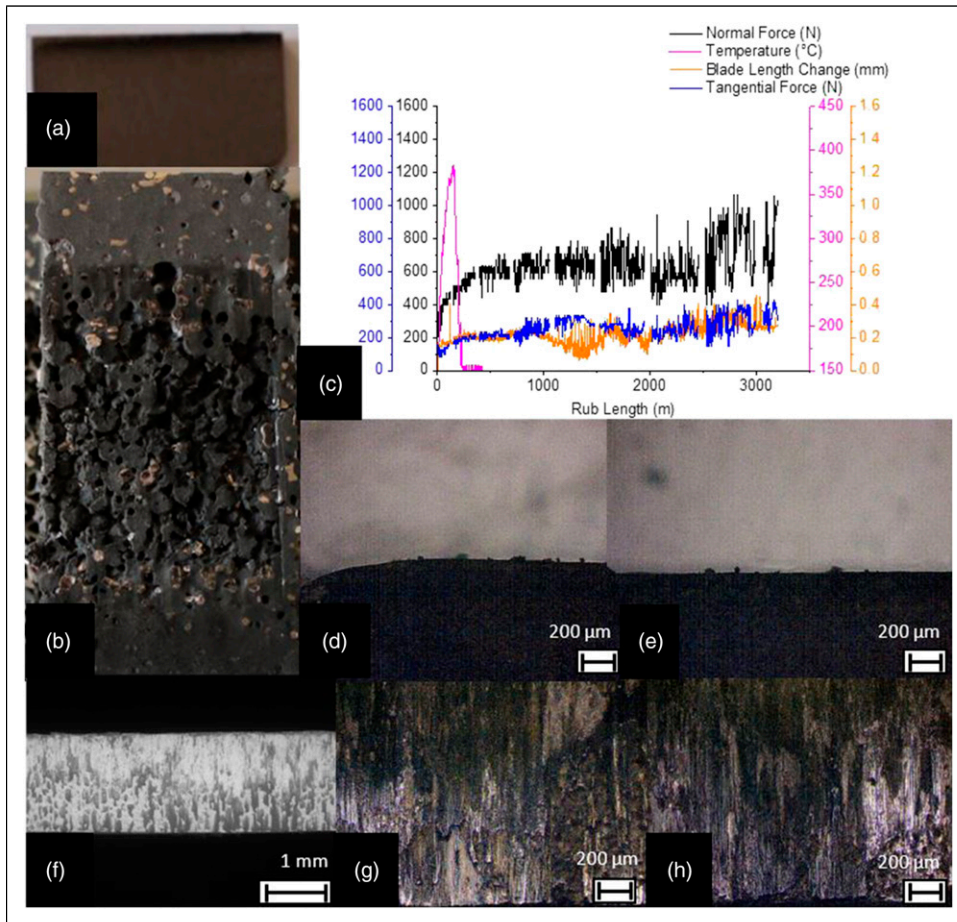
Figure 6. A-H showing examples of blade (a) and abrasible (b) samples, force, temperature and blade length change (c), optical post-test blade wear (d,e), SEM blade tip surface (f), stereoscopic image of abrasible post-test (g) and optical image of blade tip surf (h).

Figure 6 shows the results for a filled foam; it shows characterisation of the blade and abrasible as well as forces experienced during the test. The contact surface for in Figure 6(b) shows a large amount of empty pores; the metallic phase is seen to be removed and pulled out during the test. The abrasible material shows good compaction upon contact which is a desired property; displacement

Figure 6 shows that with filler material there is little to no blade wear; however, there is more material pickup. The optical images 6D,E show that material pickup exists as a thin layer covering the blade tip; small areas exist where the debris formation is seen as small fragments of filler attached. The SEM image shown in Figure 6(f) indicates the location of the debris pickup and adhesion to the blade. The upper part of the blade is the leading edge; most of the pickup can be seen to occur along the trailing edge of the blade as it passes across the sample.

For an incursion rate of 0.02 μm/pass, a lot of material pull out is experienced. Due to this loss of metallic phase, the remaining material revealed at the surface is polyester filler; polyester filler has a low emissivity and is not picked up by the pyrometer as having any temperature. This in turn causes the sudden drop in temperature seen in Figure 6 where there seems to be no apparent temperature data following this anomaly.

Little blade wear is seen through optical imaging of the blade tip face indicated from Figures 6(g) and (h). A few minor chips and breakdown is from the recast layer which is a result of the manufacturing process. The darker areas illustrate where the filler has adhered onto the blade tip surface.

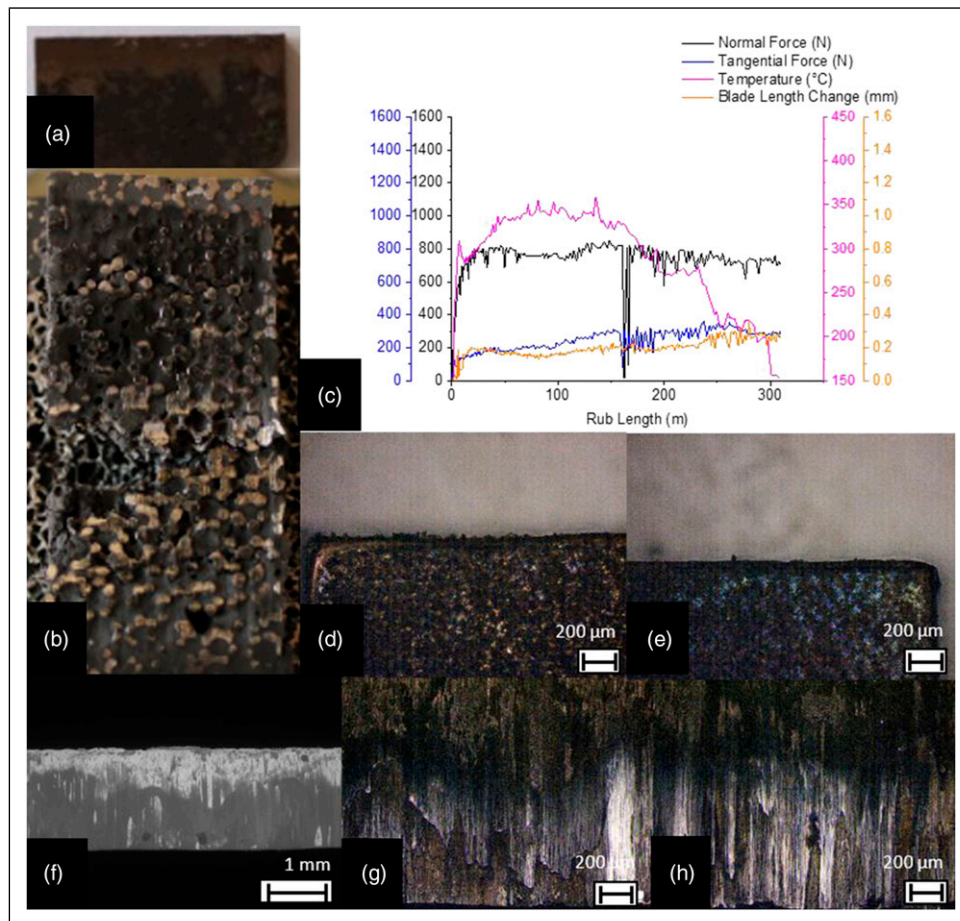
Figure 7. A-H showing examples of blade (a) and abrasible (b) samples, force, temperature and blade length change (c), optical post-test blade wear (d,e), SEM blade tip surface (f), stereoscopic image of abrasible post-test (g) and optical image of blade tip surf (h).

Figure 7 shows the results for NiCr foam at 2 μm/pass; pickup is very low; however, if the incursion rate is decreased by a factor of 10 and 100 to 0.2 and 0.02 μm/pass, pickup starts to increase as shown from the images in Figures 6 and 7; this is seen on the blade tip surface. At higher incursion rates, the rub surface has a smoother morphology with less material pull out. The average and maximum forces acting on the abrasible sample are very similar between the tests in the shear and normal direction; however, the wear mechanics and final morphology are significantly different. A main point of discussion is why

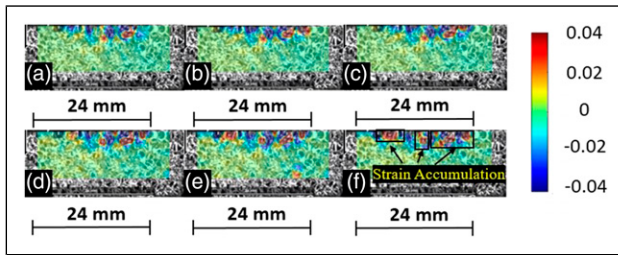
Figure 10. Evolution of strain localisation within the top rub surface for NiCr Foam 1200 0.02 $\mu\text{m}/\text{pass}$.

It is also interesting to note that the strain accumulation can be seen to vary depending on position within the arc of contact. For example, in Figure 10, the strain accumulation can be seen to amass in two main locations. Towards the left side where the blade first enters contact, strain accumulation can be seen, and similarly at the exit of contact. This may well be due to the shock loading of entry and exit when the blade interacts with the sample much in the way seen for a machining insert or tool flute in milling.²⁶

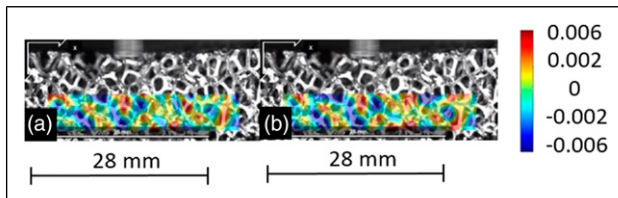
Figure 11. Evolution of strain accumulation in the bottom section of the abrasible for NiCr Foam 3000.

The locations where stress and strain build up are clearly pinpointed within a larger pore size structure since the metallic struts can be identified more easily as shown in Figure 11. Open cellular foam structures always have two

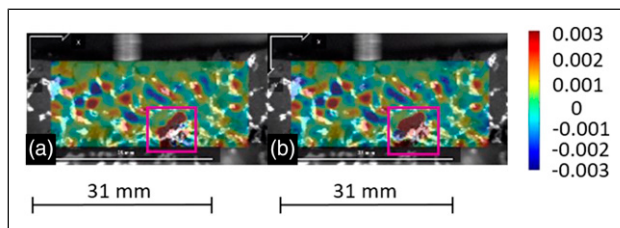
Figure 13. Evolution of strain build up when lack of filler for NiCr – Filled Foam 0.02 $\mu\text{m/pass}$.

As such, a good load transfer mechanism requires an evenly, well-distributed amount of filler in the NiCr metallic foam structure. Figure 13 shows an example of where the strain accumulation builds and will ultimately end in fracture and damage to the abrasible. The evolution of strain accumulation can be captured in these two frames; in these circumstances, this can cause delamination of the abrasible sample. This clearly highlights the importance of the filler to better promote the load transfer mechanism to prevent blade wear and significant damage to the foam.
