Dhimish, Mahmoud and Lazaridis, Pavlos I. (2021) An empirical investigation on the correlation between solar cell cracks and hotspots. Scientific Reports. ISSN: 2045-2322

An empirical investigation on the correlation between solar cell cracks and hotspots

Mahmoud Dhimish¹✉ & Pavlos I. Lazaridis²

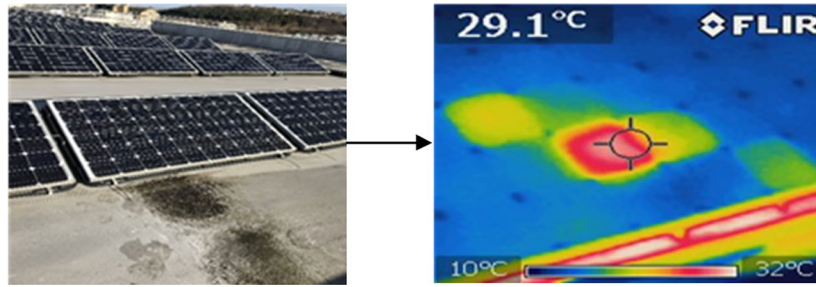
Figure 1. The physical and thermal image of a PV module is affected by hotspots; the thermal image is captured using a FLIR i5 thermal imaging camera, which has a thermal sensitivity of $\pm 1^\circ\text{C}$.

To aid the transition to green energy, there has been a considerable demand to combine more photovoltaic (PV) systems into the electric grid to support the growth of renewable energy sources. As such, PV reliability and durability receives great interest from the industry as there are currently various mismatching conditions affecting these installations^{1–3}. One of the challenges in today's PV modules is the well-known phenomenon called hotspots⁴. A hotspot is a localized heat source that can be present in part(s) of the PV module, leading to locally increased temperature in the solar cells. An example of a PV module affected by hotspots is shown in Fig. 1.

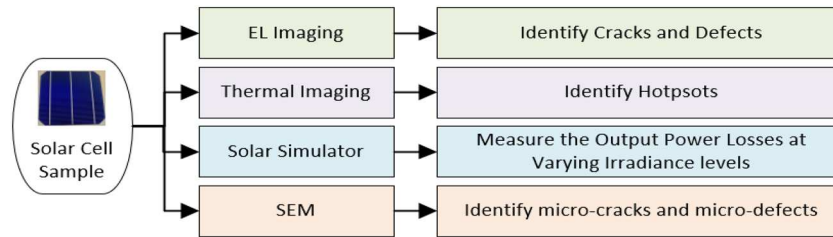
Figure 2. Detection methods used in this study.

Scientific methods and techniques. The scientific methods/techniques to study the solar cell samples are summarised in Fig. 2. EL imaging is used to identify the cracks and defects in the cells^{23,24}, whereas thermal imaging is applied to determine whether the cell sample has a hotspot. The solar cell samples have been tested under the sun simulator at STC conditions, where the cell was illuminated at 1000 W/m^2 light intensity. The temperature of the cell was measured from the rear (non-illuminated) side using a thermal camera. For every sample, the temperature was left to develop for 10 min before measurement. This allowed sufficient time for the hotspots, if any, to reach a steady state with minimal fluctuations observed. And finally, to observe any micro-level fractures and defects in the cells, we have used scanning electron microscopy (SEM).
