Zhong, W. and Walther, T. (2022) Failure analysis of some commercial spotlights based on light emitting diodes. *Electronics*, 11 (1). 48.

Failure Analysis of Some Commercial Spotlights Based on Light Emitting Diodes

Abstract: The failure mechanism of two commercial light-emitting diode (LED)-based spotlights with GU10 form factor is analyzed. Through component testing and comparison to nominal values as well as to simulations, it is found that the cause of both device failures is related to damaged components within the drive circuits rather than the LEDs themselves. Both LED heads work as normal when connected to an external direct current (DC) source. The results show that the lack of light output of one spotlight is related to the open circuit caused by damaged resistors and inductors in its drive circuit, while the flickering of the other is related to the malfunction of the integrated circuit providing constant current output. Therefore, improving the quality of the LED drive circuits is considered the most effective way for manufacturers to reduce catastrophic failures of LED spotlights.

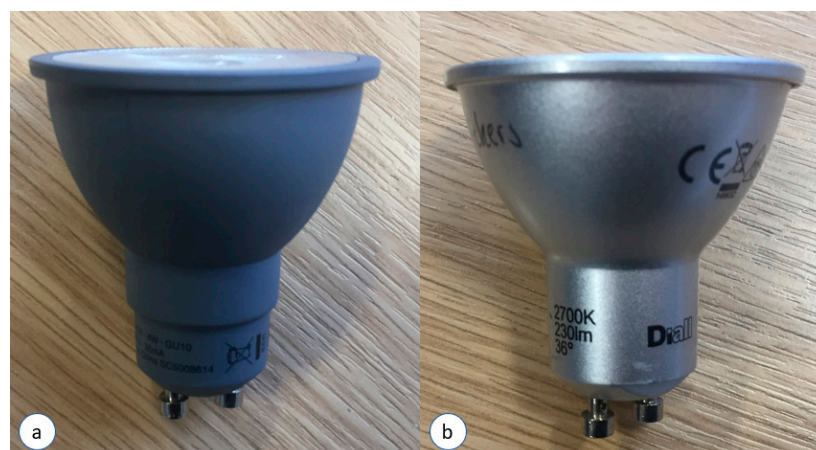
Figure 1. Two failed LED spotlights with GU10 socket. Sample A (a) does no longer emit any light, Sample B (b) flickers.
