Dhimish, Mahmoud and Tyrrell, Andy (2022) Power loss and hotspot analysis for photovoltaic modules affected by potential induced degradation. *npj Materials Degradation*. 11. ISSN: 2397-2106

Power loss and hotspot analysis for photovoltaic modules affected by potential induced degradation

Mahmoud Dhimish¹ and Andy M. Tyrrell¹

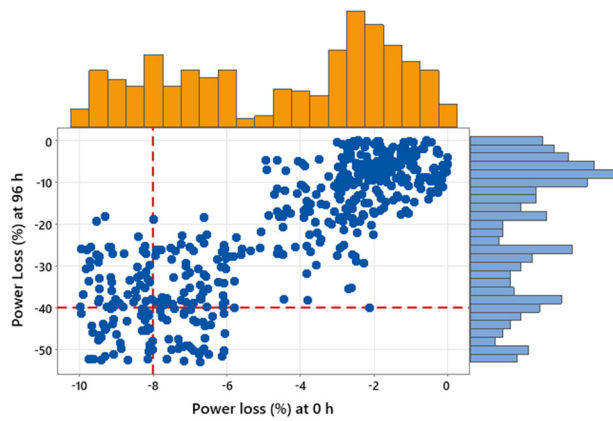
Fig. 4 Marginal plot of the samples taken during the PID test at 0 h and after 96 h. The histogram corresponds to the actual distribution of the data taken during both experiments, PID at 0 h and 96 h.

For all tested PV modules, the correlation between the measured power losses vs irradiance during the PID test at 48 and 96 h were measured (Fig. 3), the values at 0 h have not been considered as the power losses are minimal. The power losses at 50 – 200 W/m^2 is 2–4 times higher than at 1000 W/m^2 . This effect is due to shunting, which increases while irradiance levels are decreasing. This result concurs with the scientific community, where the PID is closely associated with reducing shunt resistance^{29,30}. A marginal plot is a scatterplot that compares two different experiments using the data samples histogram. Accordingly, a marginal plot has been obtained and demonstrated in Fig. 4 using the measurements of the PID experiment at the initial state (0 h) and by the end of the experiment (96 h). The x-axis and y-axis represent the power losses of the examined PV module at 0 and 96 h, respectively.

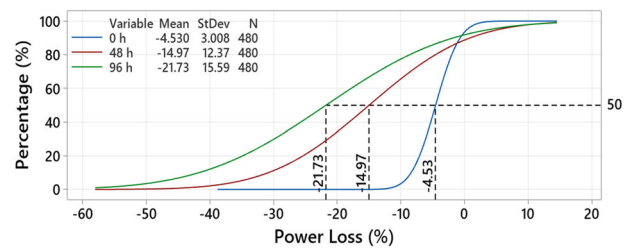
Fig. 5 Cumulative distribution function of all measured samples. The horizontal dashed line at 50% corresponds to the mid-range of the percentile.

This study has considered the cumulative density function (CDF) of all measured samples, as shown in Fig. 5. This plot gives an indication of the PID impact over time. The y-axis represents the percentage of the PV module performing a specific power loss. For example, after 48 and 96 h of PID testing, there is a 50% chance that the power loss of the PV module is -14.97% and -21.73% ,

respectively. On the other hand, there is only -4.53% power loss before the PV module is affected by PID (at 0 h). It is worth noting here that 50% has been applied as it corresponds to the mid-range of the percentile, which provides a more accurate prediction of the power losses.

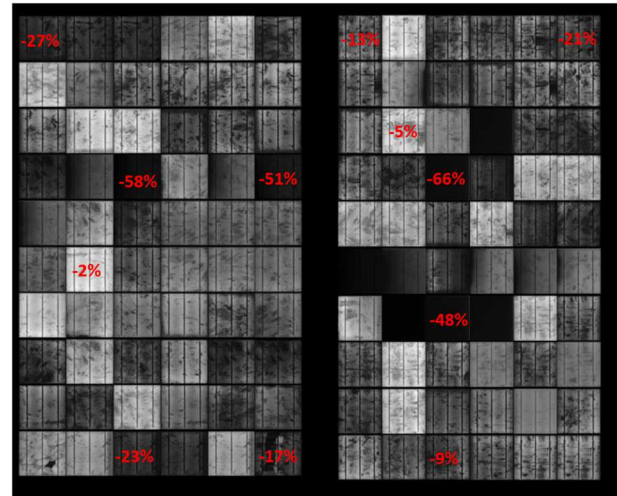
Fig. 6 EL images after PID are completed for two different PV modules. The power loss labelled in red was estimated under the standard test conditions.

The correlation between the EL images and the actual power losses of the solar cells is shown in Fig. 6. Both PV modules EL images were taken after the PID was completed, at 96 h. This feature is already available using the EL software. It uses the difference in the light/spectrum of non-PID versus the PID images; hence, the power losses can be estimated. The “blackout” EL images does not necessarily resemble -100% losses in the output power. This is because they have no illumination under the EL test; however, they still generate current. In contrast, it is relevant to reflect that few solar cells are unaffected after completing the PID test, and their output power losses remain below -5% . This suggests that these cells were influenced by lower shading rates, heat, humidity, or any form of cracks during their working life.

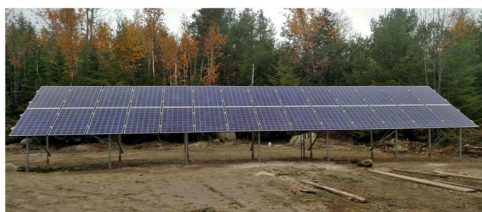
Fig. 12 Examined PV modules placed outdoor after the PID test is completed. The PV system consists of 28 modules distributed among two strings, each string comprising 14 modules.

After the PID tests were performed, the PV modules were placed outdoors to monitor their performance. The PV modules were randomly selected and combined in two strings, each string comprising 12 series-connected modules. On the monitoring side, an inverter (SMA Sunny Tripower 15000TL-30) was used to connect the PV installation to the power grid and act as data acquisition for the system. To estimate the PR ratio using Eq. (2), the reference solar cell to evaluate the P_{STC} is required, and Davis weather station to measure G_{poa} and T_{ref} .

After the PID test was completed, the examined PV modules were placed outdoor (Fig. 12) to analyse their performance ratio and whether any module would develop hotspots. The performance ratio was calculated over 12-months using Eq. (2), and for the thermal imaging inspection, a FLIR E54 thermal camera with thermal sensitivity of ±0.1 °C was utilised.
