Evaluation of the resistance of CAC and BFSC mortars to biodegradation: laboratory test approach

Amr Aboulela^{1,2*}, Matthieu Peyre-Lavigne², Cédric Patapy¹ and Alexandra Bertron¹

Abstract. Biodeterioration of cementitious materials in sewer networks is a major concern for health and economic reasons. Essentially, it is due to the biological oxidation of H_2S into H_2SO_4 leading to a local progressive dissolution of the cementitious matrix and the precipitation of expansive products likely to provoke cracks. However, it is widely known that CAC has a better performance in such environments but the mechanisms are not very well understood. Nevertheless, previous studies focused mainly on measuring the mass loss of the specimens accompanied with little information on the chemical alteration of the cementitious matrix. This study aims to compare the performance of CAC and BFSC mortars in sewer conditions using laboratory test (BAC-test). Leaching kinetics were evaluated by concentrations measurements of cementitious cations in the leached solutions and of sulphate production by the microorganisms. Moreover, SEM observations coupled with EDS analyses allowed the identification of th

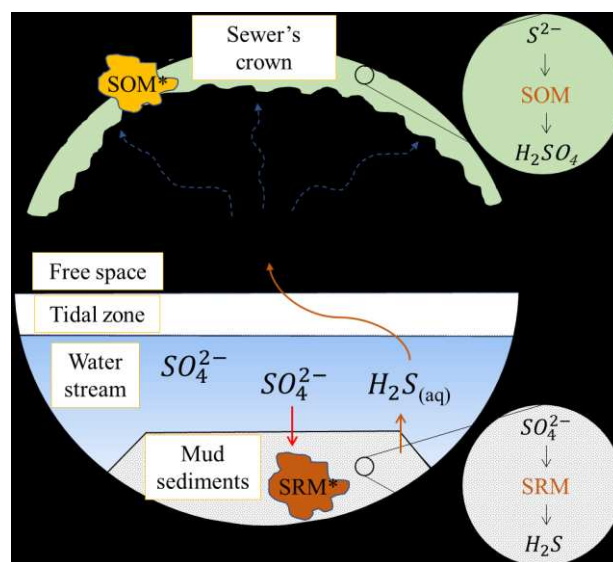
Figure 1. The sulphur cycle in the sewer system. *SRM: sulphate reducing microorganisms; *SOM: sulphur oxidising microorganisms

Around 10% of sewer pipe failures were estimated to be due to microbial induced concrete corrosion (MICC) [1]. This phenomenon causes severe deterioration of the cementitious materials employed in sewer environments. Concrete sewer systems are composed of a lower liquid part and an upper aerial part (Figure 1). In the liquid part anaerobic sulphate reducing microorganisms (SRM) develop and reduce sulphate (SO_4^{2-}) in the wastewater stream to produce hydrogen sulphide (H_2S). In the aerial part H_2S condensates on the concrete surface resulting in a progressive decrease in pH, from 12 to around 9 in a first abiotic stage, leading to the development of aerobic sulphur oxidising microorganisms (SOM) [2,3]. Then, the dissociation of H_2S – due to the high relative humidity – produces sulphide ions which are oxidised into several sulphur species via several bio-chemical reactions. Sulphuric acid (H_2SO_4) is produced as the final product of the oxidising chain reactions of these sulphur species transformations. The H_2SO_4 – produced by microorganisms on the material's surface and possibly inside the cementitious matrix [4] – is at the origin of a severe attack on the cementitious material. The deterioration phenomenon is essentially due to the dissolution of the cementitious phases and to the secondary precipitation of expansive products, such as gypsum and/or ettringite.

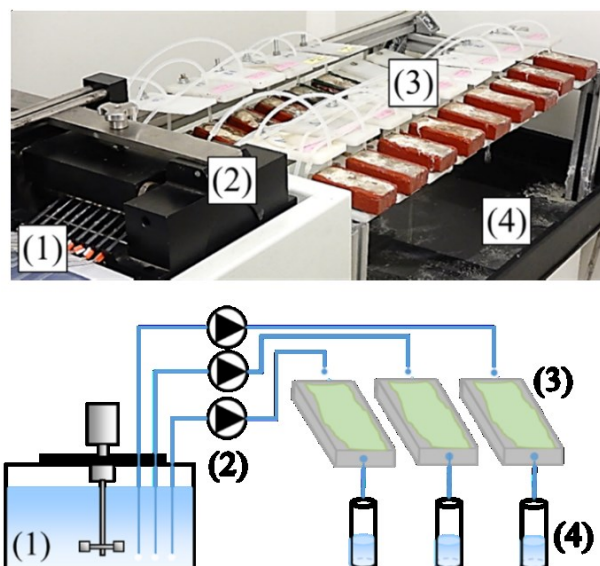
Figure 2. The BAC-test experimental pilot and a schematic layout of the test

The BAC-test, for Biogenic Acid Concrete was developed at INSA Toulouse to assess the resistance of cementitious based materials to biogenic acid attack. Figure 2 shows the BAC-test experimental pilot design [6, 7]. The test pilot was made up from a 200-liter tank (1), connected to the test apparatus by plastic tubes used to transport the solution from the tank via flow pumps (2) and drop it on the top of the specimens (3) which were covered with the inoculum obtained from an activated sludge. The specimens were laid on inclined supports with a low slope to optimize the retention time of the solution in contact with the cementitious material [8].

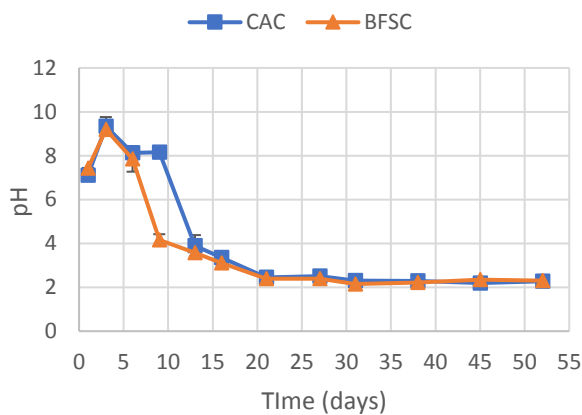
Figure 3. pH evolution of CAC and BFSC leaching solutions exposed to BAC-test

Figure 3 shows the pH evolution of the leaching solutions for the specimens subjected to biogenic sulphuric acid for 52 days. For the first 3 days, the pH increased for both materials because of the leaching of the very outer layer of cement pastes once in contact with the solution. During these 3 days, microorganisms' selection was being done as SOM have found a sulphur substrate ($K_2S_4O_6$) which allowed them to develop and to create the biofilm.

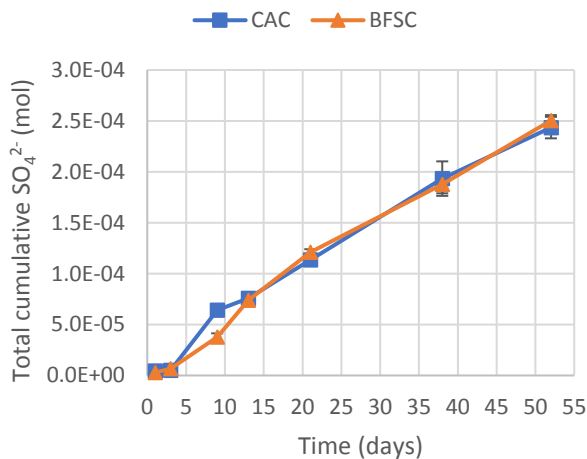
Figure 4. Total cumulative SO_4^{2-} produced by microorganisms on top of CAC and BFSC materials

The first 3 days marked the development of the neutrophilic sulphur oxidizing bacteria (NSOM). The activity of these microorganisms was limited by the high pH and therefore, the amount of produced sulphate was relatively low (Figure 4), leading to a slow progressive decrease of the pH. However, CAC showed a slightly higher buffer effect compared to BFSC as the pH took several additional days to reach acidic values. Nevertheless, starting from 21 days, the pH of both materials stabilised around 2.5 until the end of the test, in accordance with other experimental campaigns [8, 12],

Nonetheless, quantification of sulphate in the leaching solution showed that the amount of sulphate produced by microorganisms on both materials' surface was very similar, as shown on Figure 4.

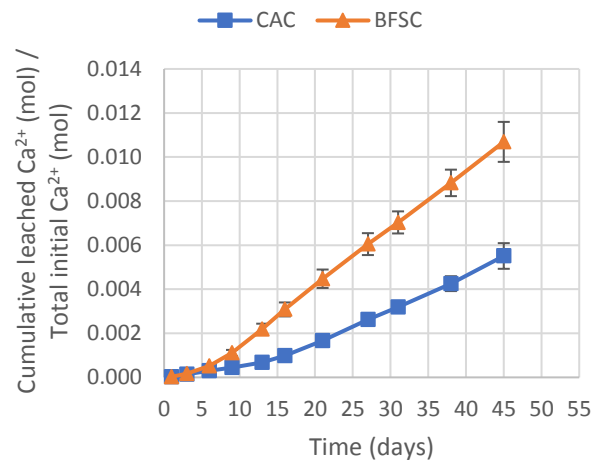
Figure 5. Cumulative leached Ca^{2+} by initial binder content during the exposition of CAC and BFSC to the BAC-test

Figure 5 shows a significant difference in the amount of leached calcium between CAC and BFSC, although, the same amount of sulphate was produced on both materials' surface (Figure 4). The total cumulative leached Ca^{2+} per initial total Ca^{2+} in the BFSC binder was found to be two times higher compared to CAC. The same behaviour was observed on Al^{3+} leaching with 0.002 molCa/molCa and 0.008 molAl/molAl for CAC and BFSC respectively.

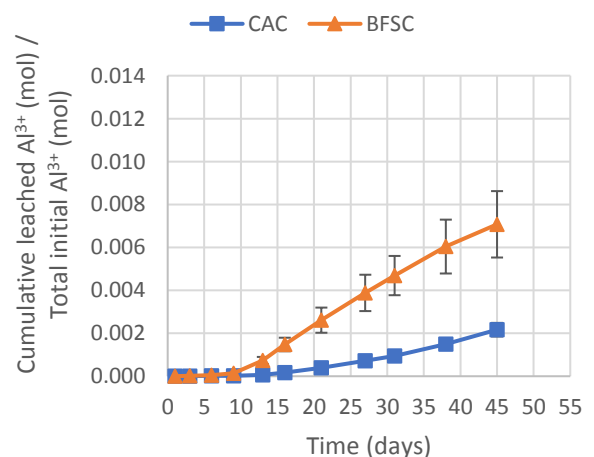
Figure 6. Cumulative leached Al^{3+} by initial binder content during the exposition of CAC and BFSC to the BAC-test

The different behaviour between CAC and BFSC could be explained by the different chemistry of the cement and the chemical stability of their phases. For

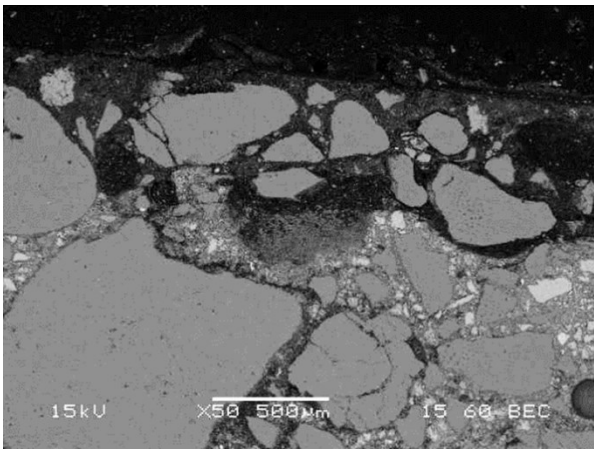
Table 2. Chemical elemental mapping of CAC and BFSC samples after 52 days of exposure to biogenic acid using the BAC-test

Ca	Al

S	Si

At the end of the test, the mortars samples were collected for chemical analyses. Backscattered electron images from SEM observations and chemical elemental (Ca, Si, Al and S) maps of polished sections obtained for CAC and BFSC are shown in Table 2.

Regarding the CAC sample, a relatively homogeneous dark grey zone was observed at the surface which corresponded to a more porous and highly decalcified layer of the specimen. The average thickness of the decalcified layer was approximately 500 μm . However, as this altered layer was enriched in Al, previous works demonstrated that $\text{Al}(\text{OH})_3$ was the main mineral in this zone [7-10]. Also, while CAC mortars did not initially contain any S, the degradation front between the altered layer and the sound zone exhibited local enrichments of S, which confirmed the diffusion of sulphur species inward the cementitious specimen.

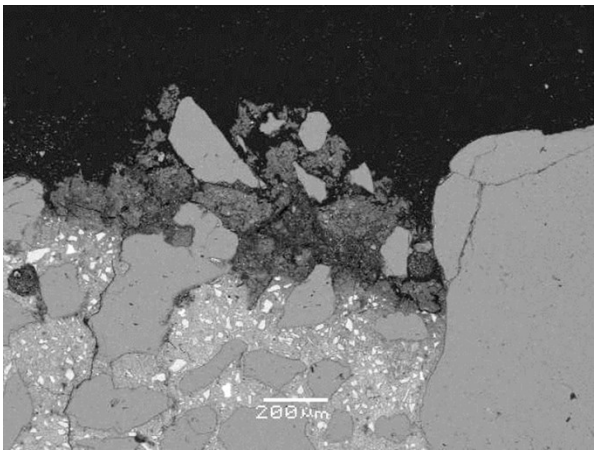
Ca	Al

S	Si

Regarding the BFSC sample, three zones were identified parallel to the surface. The outer zone was completely dissolved due to the high aggressiveness of the acid attack. Also, the silica sand got detached from this zone and felt apart. The totally dissolved zone had an average thickness of 600 μm . The second zone – called degraded zone – had a dark grey shade and corresponded to the highly deteriorated zone at the surface of the specimen. The thickness of this strongly deteriorated zone was estimated at 500 μm . Finally, the inner zone had a similar grey shade as the core of the specimen and corresponded to the sound zone. The degraded zone was highly decalcified and was mainly composed of Si and Al. It might be due to the decalcification of C-(A)-S-H, leading to the precipitation of an amorphous Al-Si gel on the surface. Moreover, S was detected at the degradation front between the degraded zone and the unaltered zone, which could be

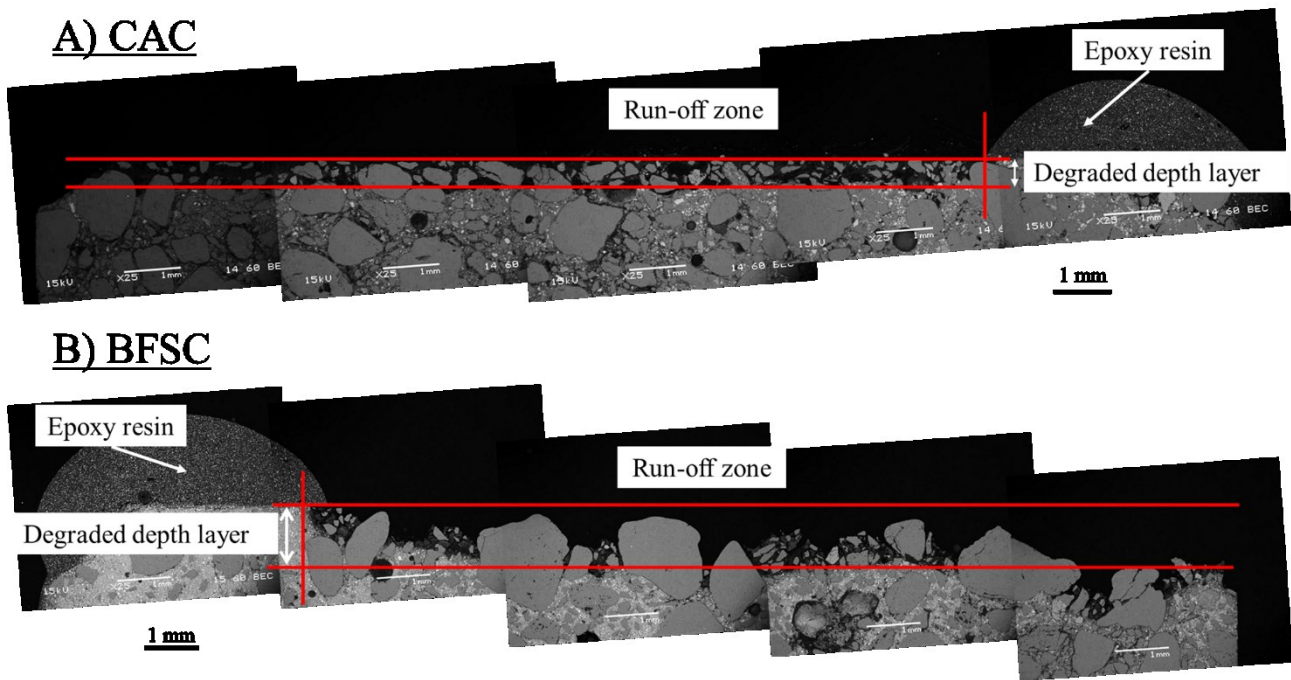
Figure 7. SEM observations (BSE images) of deteriorated mortars sample (A) CAC and (B) BFSC after 52 days of exposure to biogenic acid using the BAC-test

Figure 7 presents the profiles of the cross-sections of CAC and BFSC obtained by SEM. An epoxy resin – on the right and left sides for CAC and BFSC respectively – was used to identify the initial surface of the material which served as a reference for the degraded depths estimations.

The total degraded depth was measured using image analyses techniques and was obtained by averaging the surface of the dissolved and the degraded zones over the initial sound zone surface. The total degraded depths for CAC and BFSC were estimated at 500 μm and 1100 μm respectively.
