Dhimish, Mahmoud and Hu, Yihua (2022) Rapid testing on the effect of cracks on solar cells output power performance and thermal operation. Scientific Reports. 12168. ISSN: 2045-2322

## Rapid testing on the effect of cracks on solar cells output power performance and thermal operation

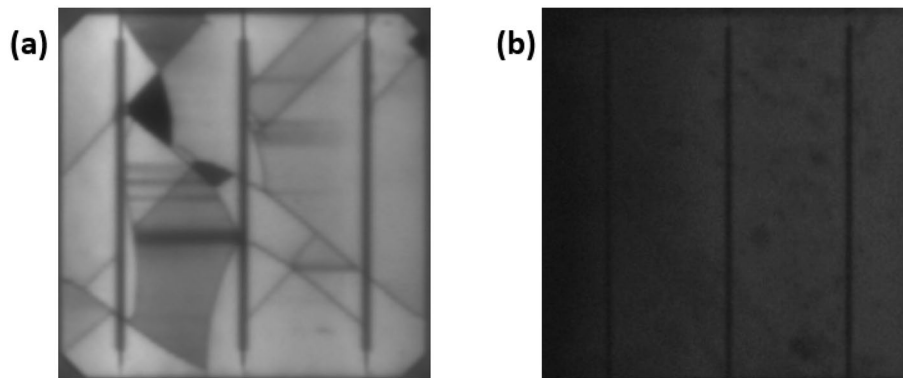
**Figure 1.** EL image of solar cells (a) Affected by cracks and structural defects, (b) affected by PID.

Cracks are often invisible to the bare eye; the current standard cracks detection method uses Electroluminescence (EL) imaging<sup>18–20</sup>. In Fig. 1, the EL image of two different solar cells is presented. Here we show the difference between the EL image when a solar cell is affected by cracking and structural defects (Fig. 1a) and when the cell is affected by PID (Fig. 1b). There has been a limited explanation of the behaviour of these cracks on the actual degradation of the output power and their correlation to the presence of hotspots. In addition, to date, there is a lack of understanding of whether all types (or crack percentages) can lead to a significant drop in the output power generation of solar cells.

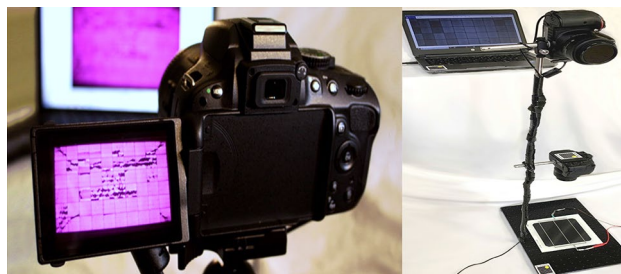
**Figure 2.** EL imaging setup.

To capture the EL images of the examined solar cell samples, we have used the EL imaging setup shown in Fig. 2. The EL comprise a digital camera with a resolution of  $6k \times 4k$  pixels. The used camera lens is 18–55 mm, and the solar cell samples were connected with a power supply for biasing purposes under short circuit conditions.

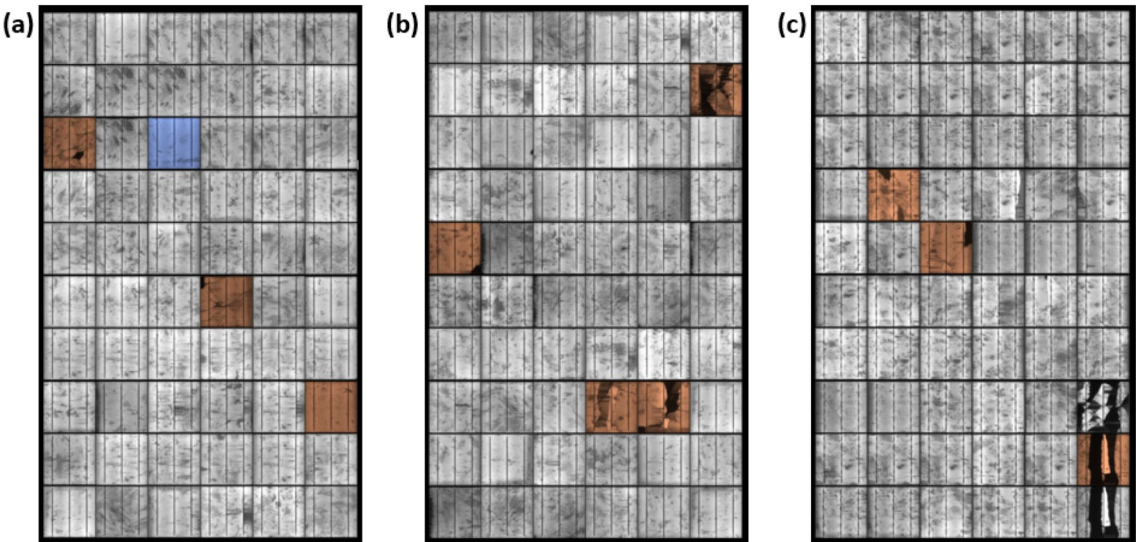
**Figure 3.** Original EL image for the PV modules before the dismounting process (a) PV module #1, (b) PV module #2, (c) PV module #3.

the crack was computed by subtracting a cracked vs crack-free image; this was performed using MATLAB script. The solar cell samples were deliberately dismantled from an original three different PV modules; this process was handled by Solar UK Ltd, an international PV recycling company located in the UK. The EL image of the PV modules before the dismantling process had to happen is shown in Fig. 3. There is no difference in the crack size and orientation before and after the dismantling process was completed. The PV modules examined in this work were exposed to outdoor conditions; therefore, we cannot precisely define the source of the cracks (i.e., caused during the PV installation phase, rapid damage due to hailstorm, snow, etc.).

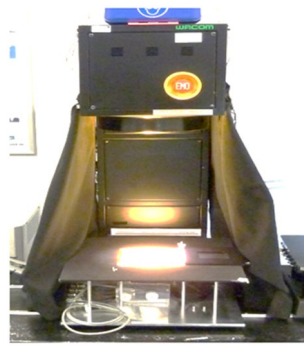
**Figure 4.** PVcomB solar simulator.

The solar simulator tested the performance of the cells, and the output power vs irradiance was taken at each analysed condition. The class A+ solar simulator, shown in Fig. 4, has been used to facilitate the testing of the examined solar cell samples. This instrument has a maximum illumination area of  $155 \times 155 \text{ mm}^2$ , a homogeneity of illumination  $\pm 2 \text{ W/m}^2$  at irradiance intensity range  $0\text{--}1000 \text{ W/m}^2$ . In addition, the solar cell temperature can be controlled from  $15$  to  $200 \text{ }^\circ\text{C}$  via the PVcomB software to maintain a specific temperature level during the experiments. A thermal camera is placed on the back sheet of the solar simulator (solar cell holder) to aid the thermal measurements of the examined samples. The camera has a thermal sensitivity of  $\pm 0.1 \text{ }^\circ\text{C}$ .

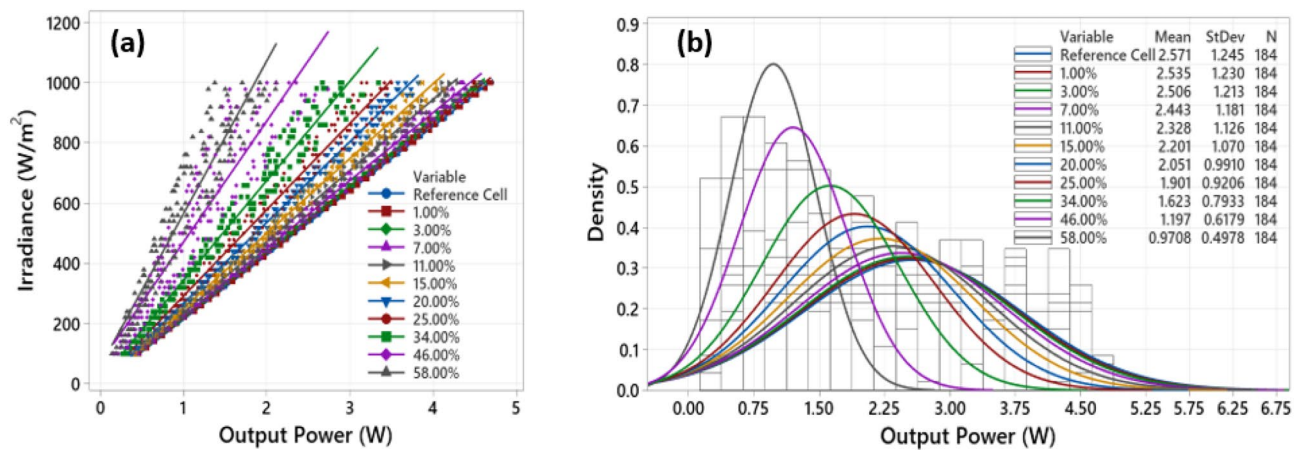
**Figure 5.** (a) Output power vs irradiance for the examined solar cells, (b) Density and the calculated parameters of the collected data; N = 184 represents the number of samples of every experiment.

**Output power measurements.** The tested solar cell samples, including the reference cell, were all subjected to solar illumination under varying irradiance, 100–1000  $\text{W/m}^2$ , the temperature of the cells was maintained at STC conditions, 25 °C. The output power measurements taken from the solar simulator is shown in Fig. 5a. The step-change in the irradiance level is 20  $\text{W/m}^2$ , and for precision targets, we took four different measurements for every irradiance level. Next, we have distributed the measured output power as in histogram (Fig. 5b), and a normal distribution function was selected to observe the mean and the standard deviation (StDev). In this figure, the y-axis denotes the density, which corresponds to the relationship between the observations/measurements and their probability of occurrence. Hence, 0.9 resembles a high probability of occurrence than 0.1, which corresponds to a low probability of occurrence. Using this parameter in the y-axis helps find the rectified mean value of the output power of each tested solar cell, therefore, eliminating any errors in the measurements.

As can be observed in Fig. 5b, there is a significant correlation between the output power of the reference cell and the solar cells affected by 1%, 3%, 7% and 11% crack percentages. The mean output power is approximately equal to the reference cell, 2.571 W. In contrast, we observe a significant decay in the mean of the output power while the crack percentage in the solar cell increases. For example, the solar cell affected by 20% has a mean output power of 2.051 W, compared with 0.9708 W identified from the last solar cell sample with a crack percentage of 58%.

In addition, as the crack percentage increase in the solar cell, it is anticipated that the standard deviation of the output power measurements decreases. A low standard deviation indicated that the values are clustered close to the mean. Hence, even though the irradiance increased while experimenting, there were no significant changes in the output power of the critically cracked solar cells (i.e., 46% and 58% crack percentages).

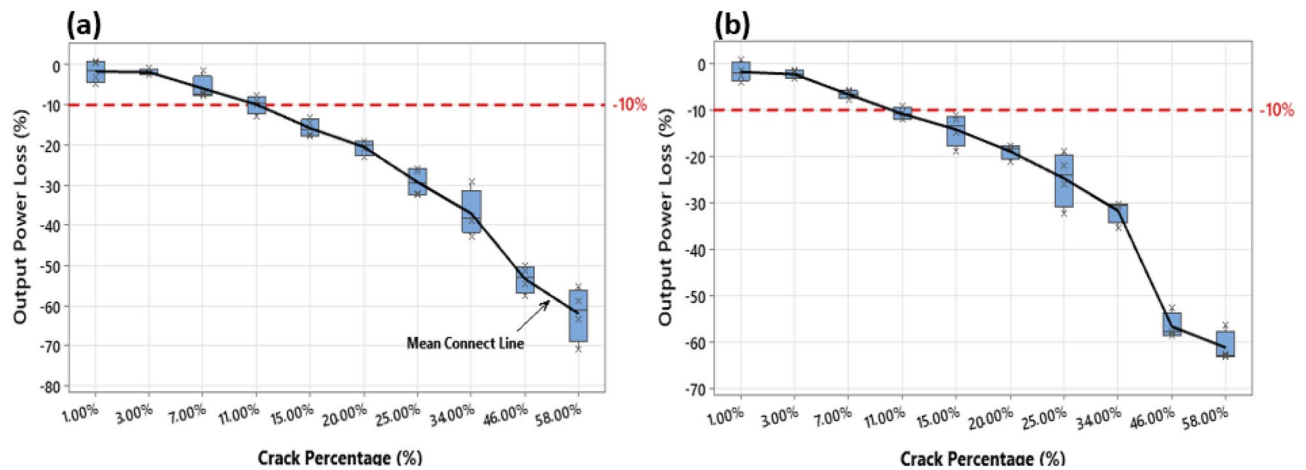
**Figure 6.** Calculation of the output power loss for the tested cracked solar cell samples (a) at 1 Sun, (b) at 0.5 Sun.

The output power loss is calculated using (1), where  $P_{ref}$  is the output measured power of the reference healthy solar cell, the value of  $P_{ref}$  is taken from the manufacturer datasheet, and the  $P_{sample}$  is the output measured power for the selected solar cell samples. The results of the output power loss at 1 Sun (1000  $\text{W/m}^2$ ) and 0.5 Sun (500  $\text{W/m}^2$ ) are presented in Fig. 6.

According to Fig. 6a, the solar cells with crack percentage below 15% are above the  $-10\%$  baseline. This result suggests that the output power losses for the solar cells with crack percentages of 1%, 3%, 7%, and 11% is insignificant. We confirm the same outcome while testing with the solar samples at 0.5 Sun, as shown in Fig. 6b. Accordingly, these results enable us to understand that not all cracks in solar cells could induce output power losses. Small cracks, i.e., below 10%, unlikely influence the output power generation and are relatively equivalent to non-cracked cells. In a comparative evaluation, the output losses (or degradation) are likely to transpire due to other predicaments such as encapsulation, arcing-faults, or PID.

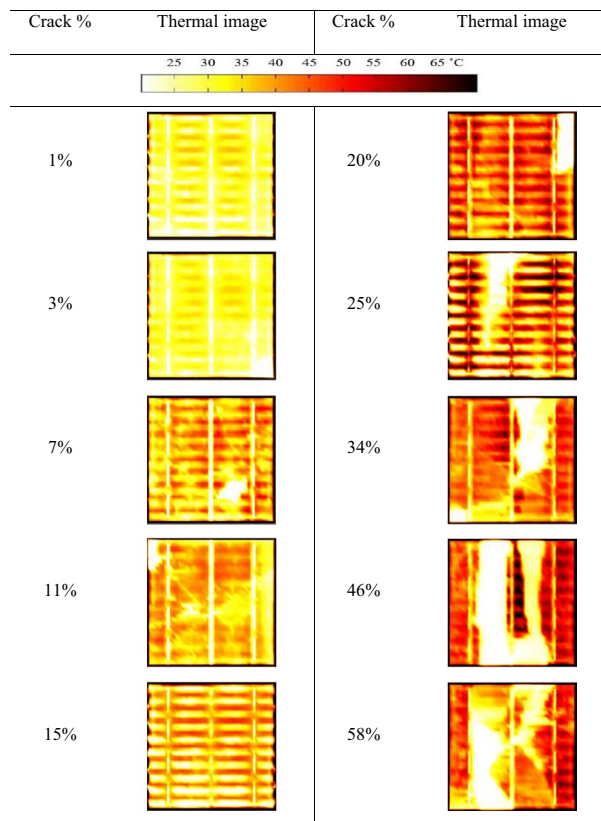
**Table 2.** Thermal images of the examined solar cell samples under STC conditions.

**Thermal performance and hotspots development.** The thermal images of the solar cells, shown in Table 2, have been taken under STC conditions. These images have been captured approximately 2-min when applying the illumination to make sure that the hotspot develops, if any.

Considering the results in Table 2, it is clear that the crack area has no increase in the temperature, always  $25^\circ\text{C}$  or below. This is because the crack represents an inactive state. Hence, no absorption of electrons can be achieved, in other words, the inactive area has a temperature similar to the back or front sheet of the solar cell. Nevertheless, because of the uneven distribution of the current flow in the busbars due to the presence of the cracks, a localized heat (hotspot) can develop. For example, the surface temperature of the solar cell with a 20% crack percentage has increased to approximately  $40^\circ\text{C}$ .

We have discovered that whenever the crack area increase, it is not necessary to develop a hotspot. A good example is given in Table 2 by the last two solar cell samples, 46% and 58%. Because there is a significant inactive area in the cells, the localized heat can be critical, yet there is not enough area to develop a hotspot. Therefore, in this condition, and as seen in Fig. 7, there is assuredly an increase in the temperature in some parts of the cell, yet the average cell surface temperature is below  $30^\circ\text{C}$ .

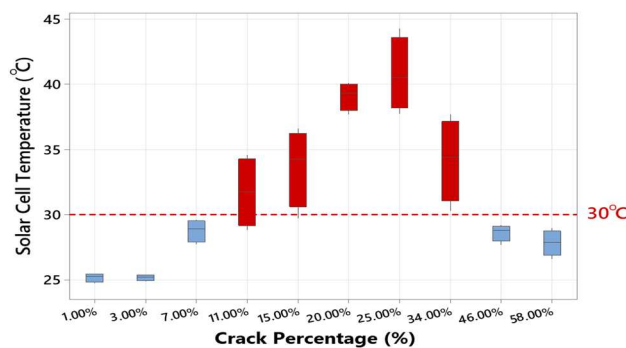
**Figure 7.** Solar cell samples temperature vs crack percentage.

The average surface temperature of the solar cells is then recorded using FLIR software and summarized in Fig. 7. It is recognized that a hotspot is to develop if the crack percentage, which is essentially representing an inactive area in the solar cell, is in the range between 11 and 34%. Considering the IEC61215/61646 standard, all other solar cells affected by either 7% crack size or below, or 45% crack size or more, are below the baseline of  $30^\circ\text{C}$ ; hence, these samples considered not correlate the crack and presence of hotspots.

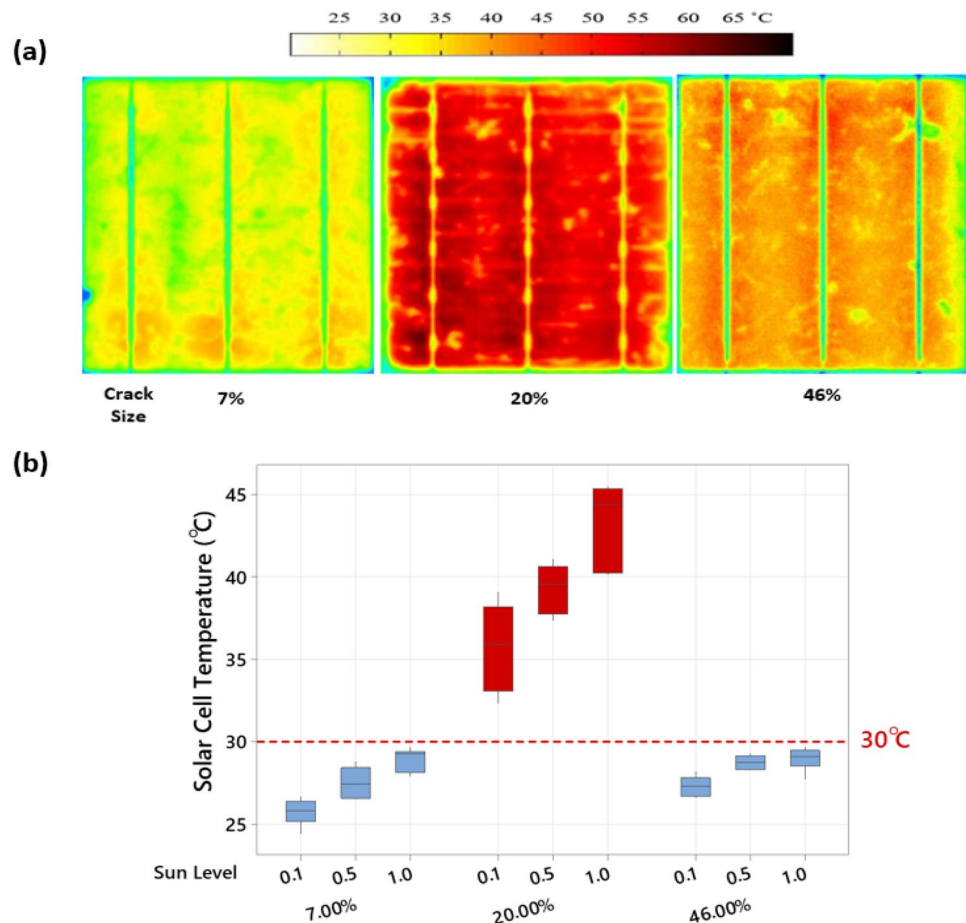
**Figure 8.** (a) Thermal image taken at the end of the experiment of the three tested solar cell samples, (b) Solar cell samples temperature vs Sun level.

To further explain this effect, we have considered experimenting with the solar cells' thermal cycle that is close enough to the baseline temperature, 30 °C. Therefore, both solar cell samples with crack percentages of 7% and 46% have been considered. And then compared with the thermal cycle of the solar cell that has a 20% crack percentage, which develops hotspots. Each cell was subjected to a change in the Sun levels (0.1, 0.5, 1, 0.1, 0.5 and 1), each Sun level (cycle) lasts for 1 min. The variations of the Sun levels ensure that the hotspot develops in the solar cells and certainly impacts the distribution of the heat. As shown in Fig. 8a, at the end of the experiment, the surface temperature has been increased of the three examined solar cell samples.

During the changes of the Sun levels, the average surface temperature was recorded and summarized in Fig. 8b. Here we can confirm no significant increase in the surface temperature across all Sun levels for the solar cells affected by crack percentages 7% and 46%. In contrast, the mean surface temperature is approximately 40 °C for the solar cell affected by a 20% crack percentage. This result verifies our previous remarks that the crack ratio is essential to be considered to explain whether hotspots is expected to develop in solar cells or not.

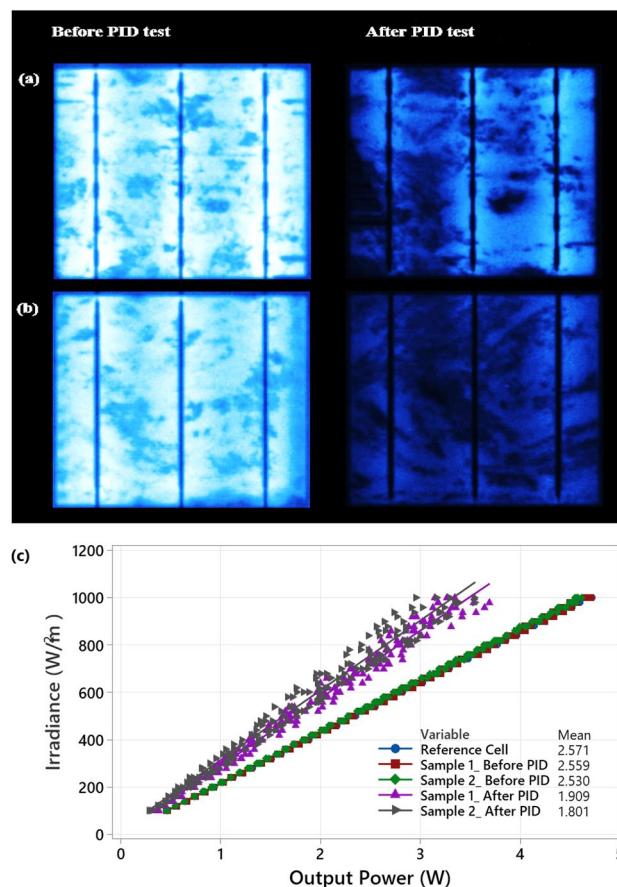
**Figure 9.** PID test output results (a) Sample #1, (b) Sample #2, (c) Output power measurements before and after the PID test was performed.

The PID test was performed using the PIDcon instrument. We have applied the standard PID testing conditions, where the temperature is maintained at 85 °C, the voltage is set to negative 1000 V, and the PID test ran over 96 h<sup>28</sup>. This procedure was performed on two solar cell samples that presents no cracks, shown in Fig. 9a,b. These figures also contain the EL image taken before and after performing the PID test. Apparently, the PID had a significant impact, as expected, toward developing shunted areas in the cells. Furthermore, the output power measurements for the solar cell samples before and after the PID test are presented in Fig. 9c. After the PID experiment was completed, it is seen that the mean output power has significantly dropped for both samples, 1.909 and 1.801 W.

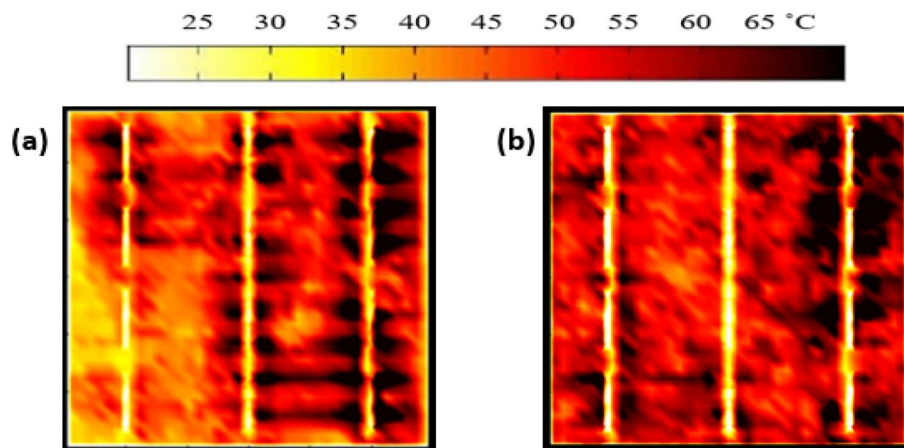
**Figure 10.** Thermal image of the solar cell samples after the PID test was completed (a) Sample #1, (b) Sample #2.

As we have shown earlier in Table 2, some solar cells do not develop hotspots. In this regard, the PID experiment allows us to confirm another compelling conclusion. We have observed that the solar cell samples subjected to the PID test have developed severe hotspots, as can be seen in Fig. 10. The surface temperature of both cells is approximately 50 °C; these images were taken at STC conditions. In comparison, the worst case of an increase in the cell temperature for cracked cells was observed at nearly 43 °C (Fig. 7) when the cell is affected by a 25% crack percentage. Therefore, unlike solar cracking, a PID can critically influence the thermal performance of affected solar cells.

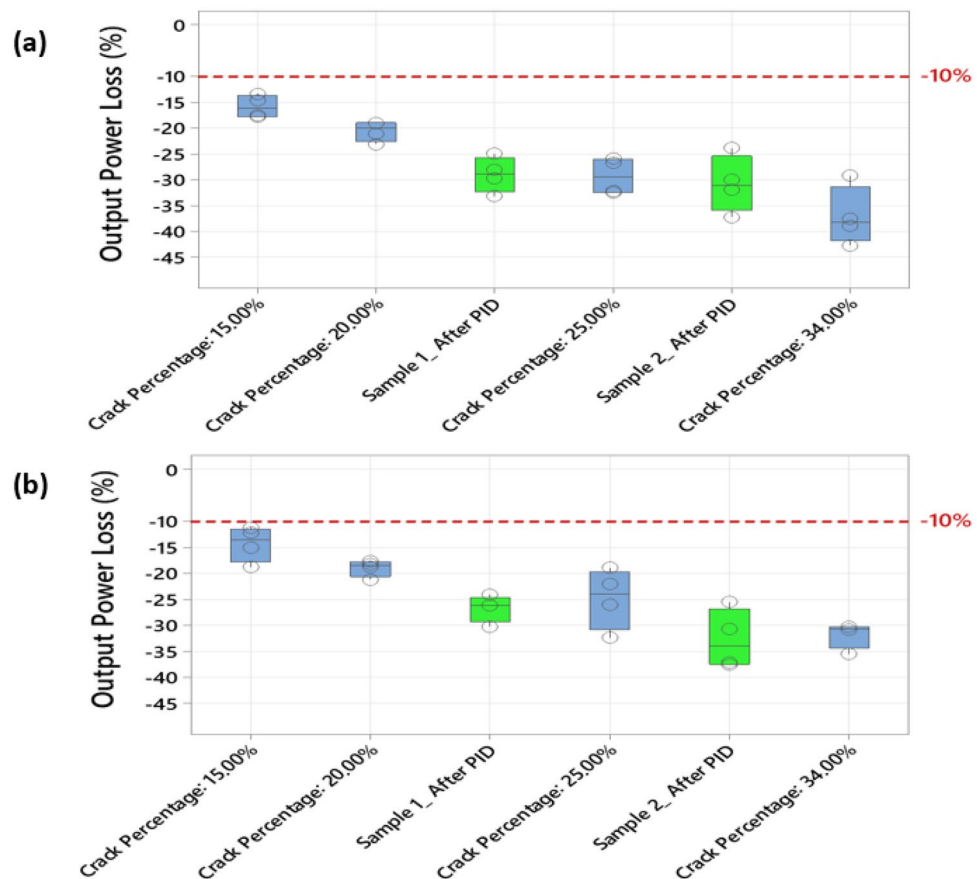
**Figure 11.** Calculation of the output power loss for the solar cell samples after PID test was completed, the results are also compared with the measurements taken from the cracked solar cell samples earlier shown in Fig. 6 (a) at 1 Sun, (b) at 0.5 Sun.

Furthermore, we compared the degree of similarity of the results obtained by the PID experiment against the cracked solar cell samples (Fig. 6). The outcome of this comparison is presented in Fig. 11. According to both Sun levels (1 and 0.5), that the solar cell samples subjected to the PID test are comparable to those with crack percentages of 20–34%. Consequently, the output power loss estimation ranges from –20% to as low as –35%. These results confirm to a certain degree that cracks in solar cells are a form of PID; they affect the output power performance and are unlikely to be mitigated. In summary, this section demonstrates that PID can rigorously
