Dhimish, Mahmoud and Hu, Yihua (2022) Rapid testing on the effect of cracks on solar cells output power performance and thermal operation. *Scientific Reports*. 12168. ISSN: 2045-2322

Rapid testing on the effect of cracks on solar cells output power performance and thermal operation

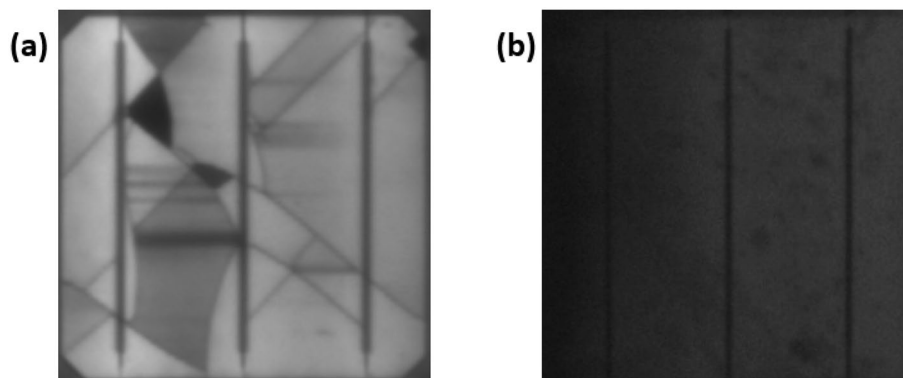
Figure 1. EL image of solar cells (a) Affected by cracks and structural defects, (b) affected by PID.

Cracks are often invisible to the bare eye; the current standard cracks detection method uses Electroluminescence (EL) imaging^{18–20}. In Fig. 1, the EL image of two different solar cells is presented. Here we show the difference between the EL image when a solar cell is affected by cracking and structural defects (Fig. 1a) and when the cell is affected by PID (Fig. 1b). There has been a limited explanation of the behaviour of these cracks on the actual degradation of the output power and their correlation to the presence of hotspots. In addition, to date, there is a lack of understanding of whether all types (or crack percentages) can lead to a significant drop in the output power generation of solar cells.

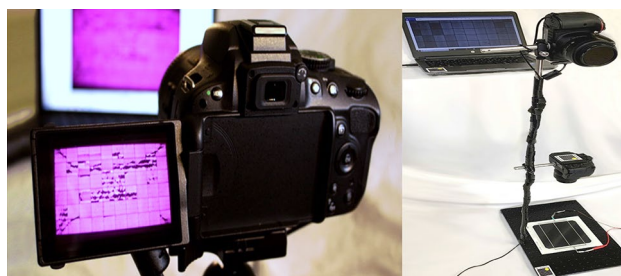
Figure 2. EL imaging setup.

To capture the EL images of the examined solar cell samples, we have used the EL imaging setup shown in Fig. 2. The EL comprise a digital camera with a resolution of $6k \times 4k$ pixels. The used camera lens is 18–55 mm, and the solar cell samples were connected with a power supply for biasing purposes under short circuit conditions.

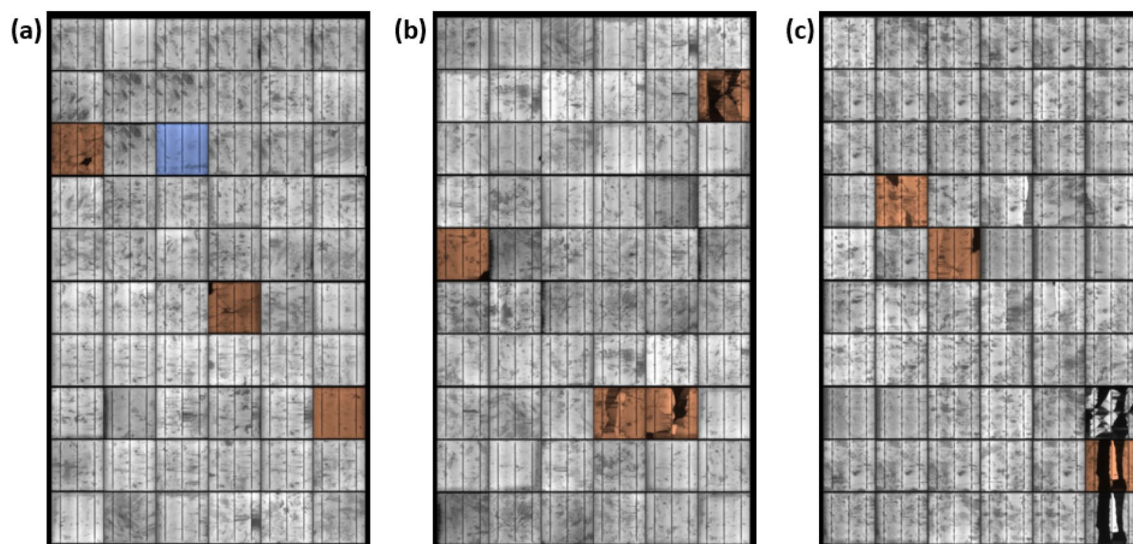
Figure 3. Original EL image for the PV modules before the dismantling process (a) PV module #1, (b) PV module #2, (c) PV module #3.

the crack was computed by subtracting a cracked vs crack-free image; this was performed using MATLAB script. The solar cell samples were deliberately dismantled from an original three different PV modules; this process was handled by Solar UK Ltd, an international PV recycling company located in the UK. The EL image of the PV modules before the dismantling process had to happen is shown in Fig. 3. There is no difference in the crack size and orientation before and after the dismantling process was completed. The PV modules examined in this work were exposed to outdoor conditions; therefore, we cannot precisely define the source of the cracks (i.e., caused during the PV installation phase, rapid damage due to hailstorm, snow, etc.).

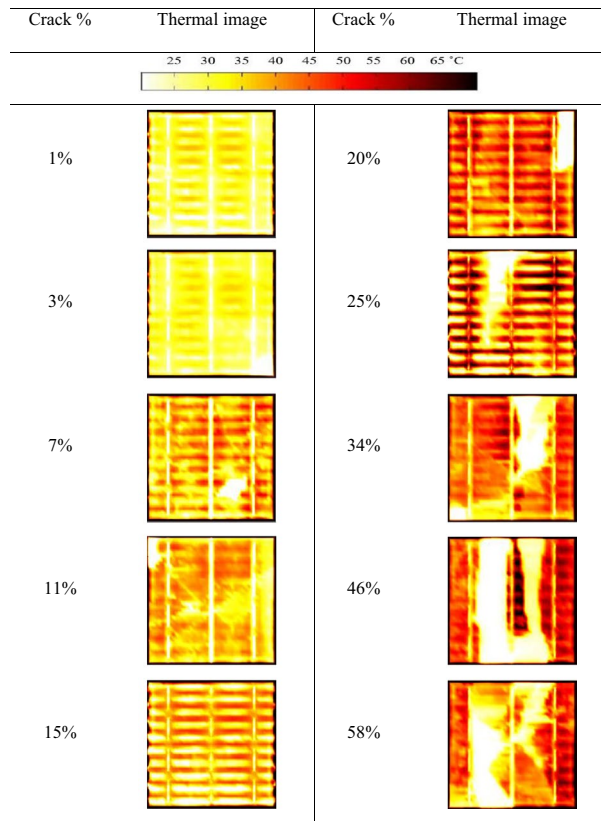
Thermal performance and hotspots development. The thermal images of the solar cells, shown in Table 2, have been taken under STC conditions. These images have been captured approximately 2-min when applying the illumination to make sure that the hotspot develops, if any.

Table 2. Thermal images of the examined solar cell samples under STC conditions.

Considering the results in Table 2, it is clear that the crack area has no increase in the temperature, always 25°C or below. This is because the crack represents an inactive state. Hence, no absorption of electrons can be achieved, in other words, the inactive area has a temperature similar to the back or front sheet of the solar cell. Nevertheless, because of the uneven distribution of the current flow in the busbars due to the presence of the cracks, a localized heat (hotspot) can develop. For example, the surface temperature of the solar cell with a 20% crack percentage has increased to approximately 40°C .

We have discovered that whenever the crack area increase, it is not necessary to develop a hotspot. A good example is given in Table 2 by the last two solar cell samples, 46% and 58%. Because there is a significant inactive area in the cells, the localized heat can be critical, yet there is not enough area to develop a hotspot. Therefore, in this condition, and as seen in Fig. 7, there is assuredly an increase in the temperature in some parts of the cell, yet the average cell surface temperature is below 30°C .

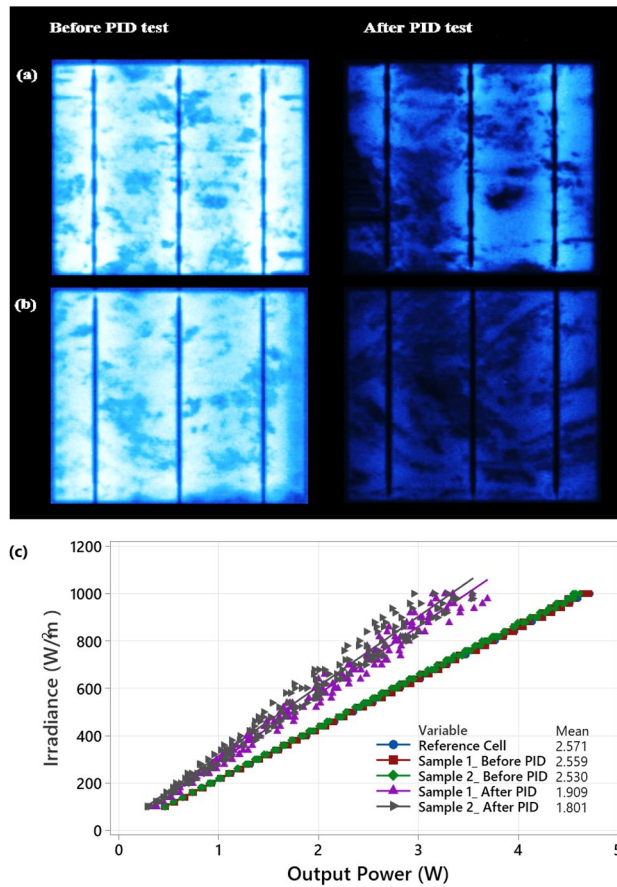
Figure 9. PID test output results (a) Sample #1, (b) Sample #2, (c) Output power measurements before and after the PID test was performed.

The PID test was performed using the PIDcon instrument. We have applied the standard PID testing conditions, where the temperature is maintained at 85 °C, the voltage is set to negative 1000 V, and the PID test ran over 96 h²⁸. This procedure was performed on two solar cell samples that presents no cracks, shown in Fig. 9a,b. These figures also contain the EL image taken before and after performing the PID test. Apparently, the PID had a significant impact, as expected, toward developing shunted areas in the cells. Furthermore, the output power measurements for the solar cell samples before and after the PID test are presented in Fig. 9c. After the PID experiment was completed, it is seen that the mean output power has significantly dropped for both samples, 1.909 and 1.801 W.

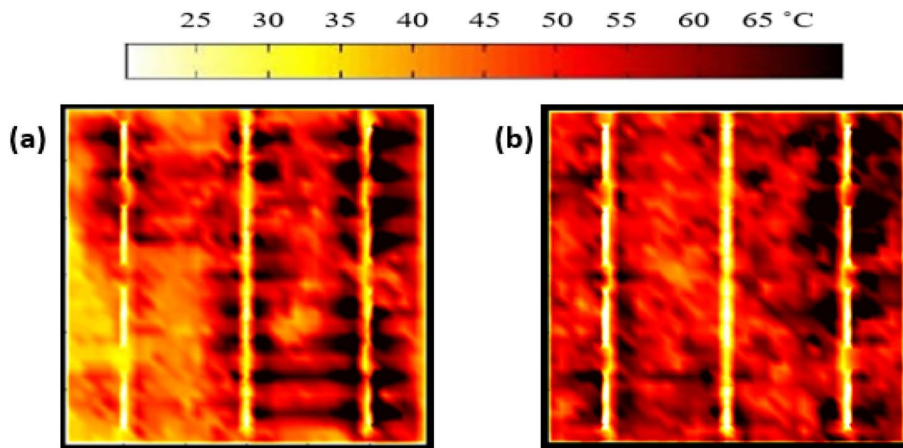
Figure 10. Thermal image of the solar cell samples after the PID test was completed (a) Sample #1, (b) Sample #2.

As we have shown earlier in Table 2, some solar cells do not develop hotspots. In this regard, the PID experiment allows us to confirm another compelling conclusion. We have observed that the solar cell samples subjected to the PID test have developed severe hotspots, as can be seen in Fig. 10. The surface temperature of both cells is approximately 50 °C; these images were taken at STC conditions. In comparison, the worst case of an increase in the cell temperature for cracked cells was observed at nearly 43 °C (Fig. 7) when the cell is affected by a 25% crack percentage. Therefore, unlike solar cracking, a PID can critically influence the thermal performance of affected solar cells.
