White, B., Watson, M. and Lewis, R. (2023) A year-round analysis of railway station overruns due to low adhesion conditions. Proceedings of the Institution of Mechanical Engineers, Part F: Journal of Rail and Rapid Transit, 237 (4). pp. 458-469. ISSN: 0954-4097

# A year-round analysis of railway station overruns due to low adhesion conditions

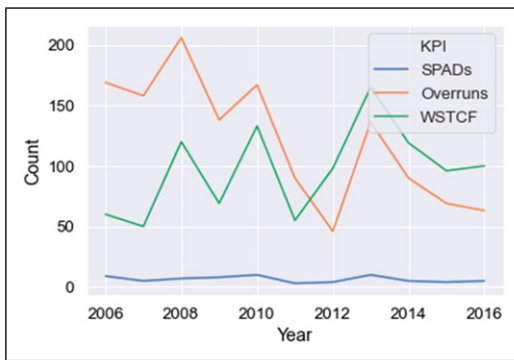
**Figure 1.** Autumn leaf fall related KPI data from 2006 to 2016, reproduced from.<sup>7</sup>

A graph showing the number of three different KPIs (signals passed at danger (SPADs), station overruns and wrong side track circuit failures (WSTCF)) between 2006 and 2016 is shown in [Figure 1](#), reproduced from the data presented in the Seasonal Challenge Working Group handbook.<sup>7</sup> WSTCF occur when a non-conductive contamination layer on the railhead (for instance a leaf layer) causes an interruption of the electrical track circuit, the position of the train can no longer be detected which results in signalling issues. The number of leaf fall related SPADs each year is much lower than the number of WSTCFs and station overruns.

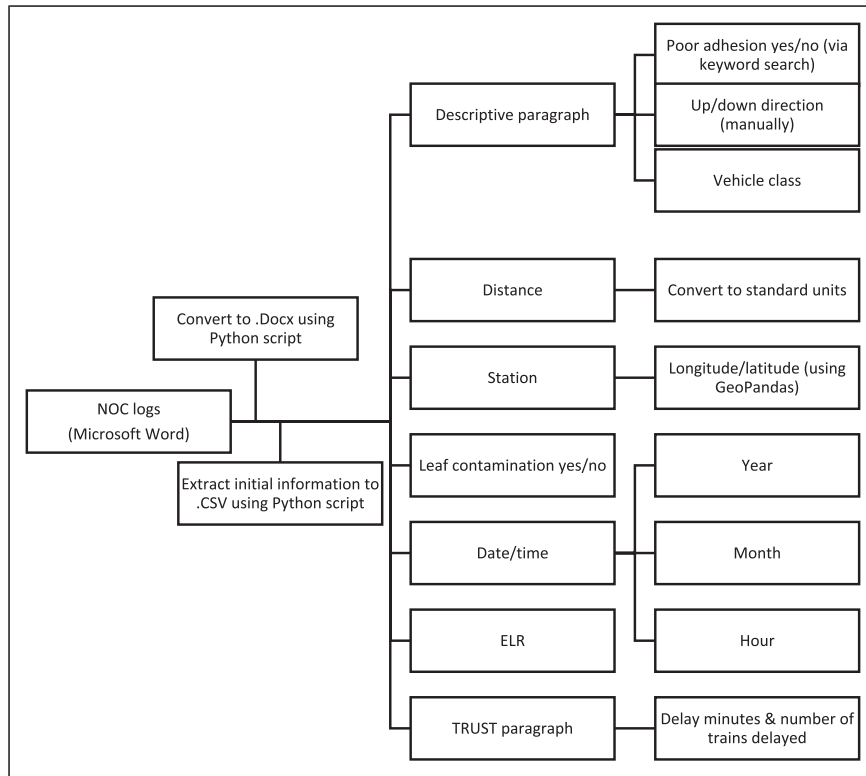
Figure 2. A flow chart showing the steps taken during data extraction.

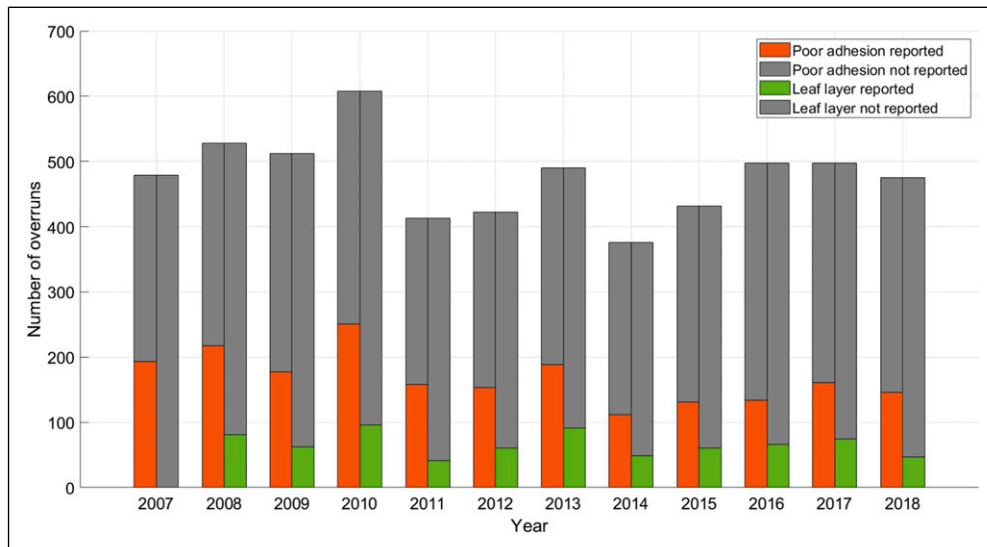
Figure 3. Breakdown of station overruns per year according to whether poor adhesion conditions or leaf layers were observed or not.

Station overruns per year from 2007 to 2018 are shown in Figure 3. The overruns are categorised according to whether there were poor adhesion conditions observed or not (based on

the keywords described previously) and whether leaf contamination was found after the incident or not. There is a mean average of 477 overruns per year. Each year of data analysis has many more incidents where low adhesion conditions were reported, compared to where leaf contamination was reported.

The number of incidents where poor adhesion conditions were reported has fallen in recent years as a proportion of total incidents and a similar pattern is observed for reports of leaf contamination. This may be due to better low adhesion mitigation methods, reporting style, or that the drivers are not informed that low adhesion is occurring due to lack of feedback through the train controls.

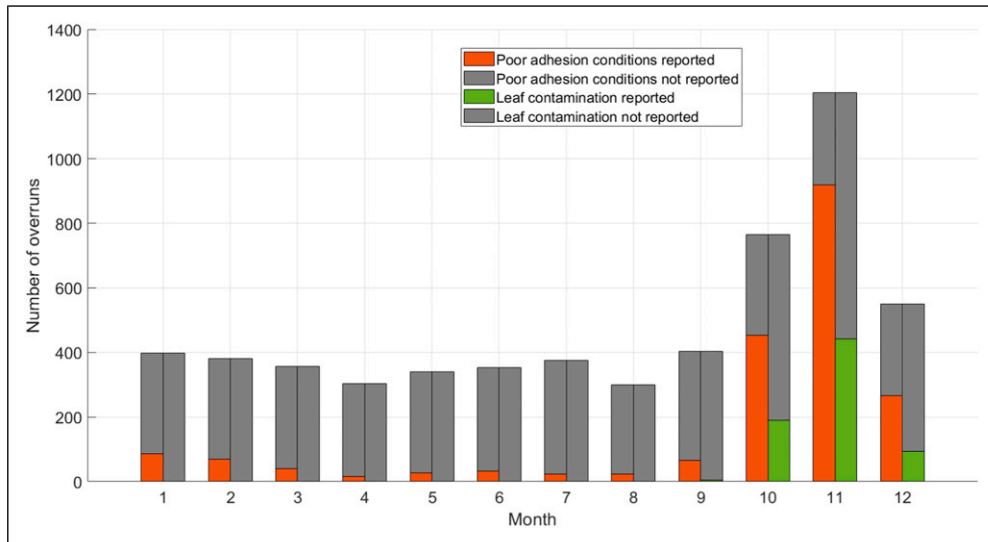
Figure 4. Station overruns per month (2007–2018).

The incident numbers were then split by month (see Figure 4). As expected, the autumn months of October, November and December have by far the highest number of overruns and a larger proportion related to low adhesion than the rest of the year. In January and February there are 86 and 70, respectively, overruns where poor adhesion conditions have been noted which may be due to increased rainfall, snow and ice or unreported organic contamination.

The overruns where low adhesion conditions were not reported remained consistent with an average of 309 overruns per month over the entire dataset. Stated reasons for these include the driver forgetting to stop at the booked stop, misreading the route diagram, late braking, or not seeing the station in poor weather.

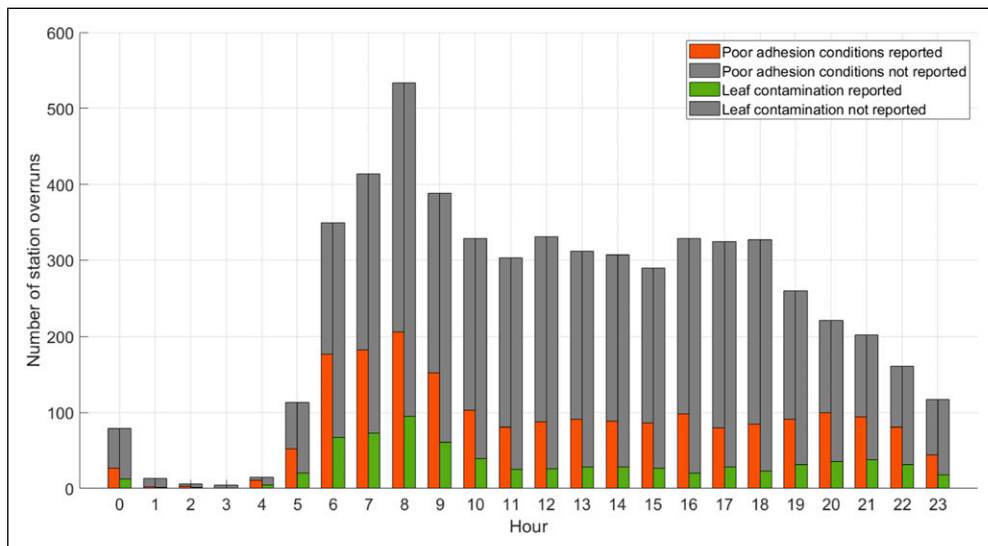
Figure 5. Number of overruns plotted against hour of the day (2007–2018).

The number of station overruns per hour are plotted in Figure 5. The data in Figure 5 was then normalised by average station stops per hour taken from 2013 data collected in an RSSB project,<sup>8</sup> as shown in Figure 6. The low number of station stops per hour between 00:00 and 05:00 h results in a low numbers of overruns plotting high on the Y-axis. The normalisation shows an increase in adhesion related overruns per station stop between

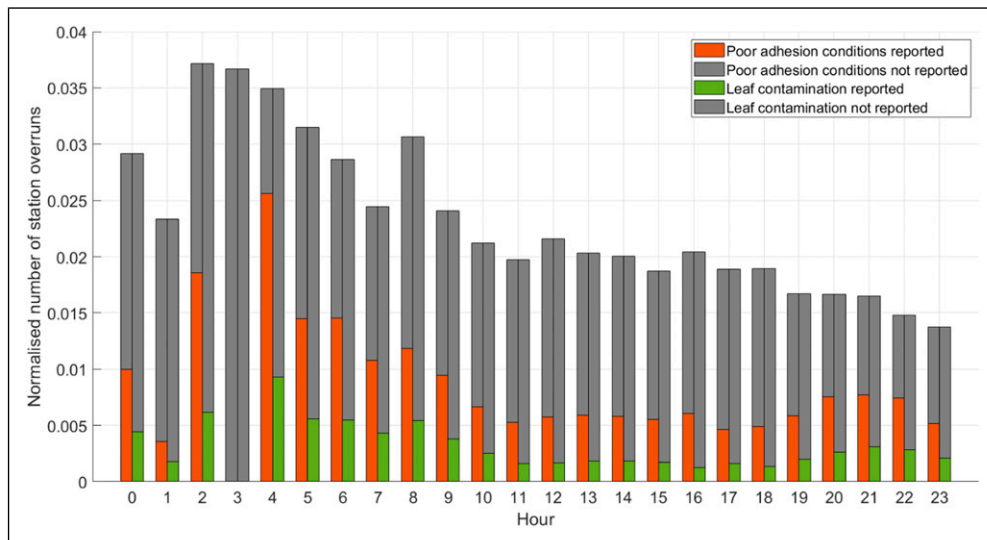
**Figure 6.** Number of overruns per hour, normalised by number of station stops per hour (2007–2018).

05:00 and 08:00 and 20:00 and 22:00, but not during the evening rush hour at 16:00–18:00, supporting previous observations.<sup>6</sup> This could be caused by moisture on the track due to dew formation, leaf or oxide present on the rail for the first train of the day (due to fewer wheel passes overnight) or wetted rail due to overnight passage of water-jetting maintenance trains that are designed to remove organic contamination during the autumn season.

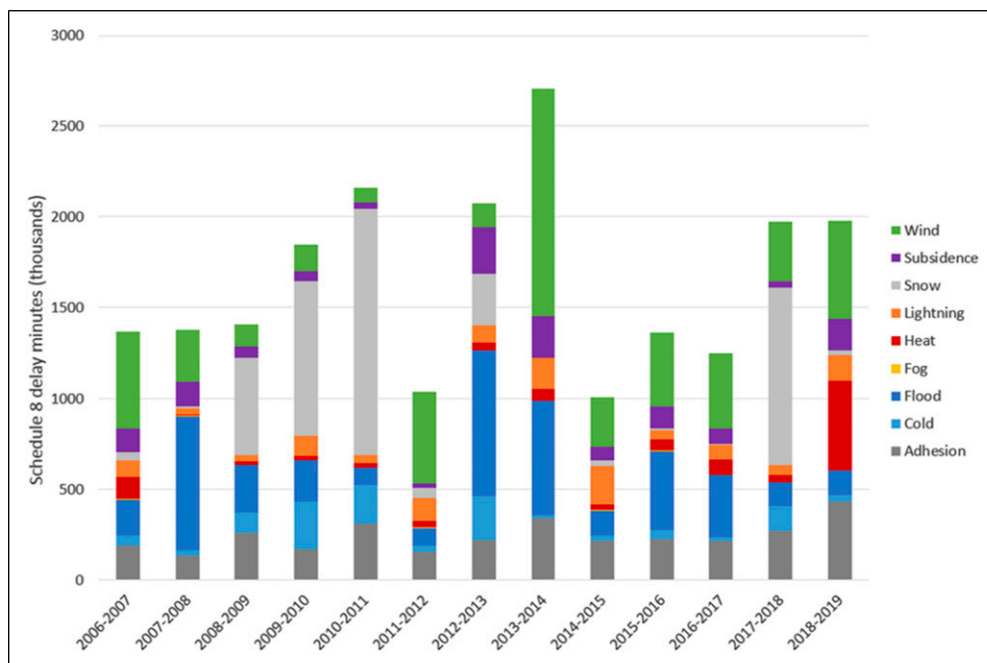
**Figure 7.** Delay minutes per year, due to climate related events.<sup>9</sup>

For context, total delay minutes attributed to climate related low adhesion from 2006-2019, from a Network Rail Weather Resilience report are shown in Figure 7.<sup>9</sup> Box plots of station overrun distance from the NOC log report, separated into the previously described categories of poor adhesion conditions and leaf contamination are shown in Figure 8. The central red bar describes the median, whilst the edges of the box show the 25th and 75th percentiles of data. The whiskers show the 95th percentile, whilst the fliers show any outliers beyond this. The median number of delay minutes for an

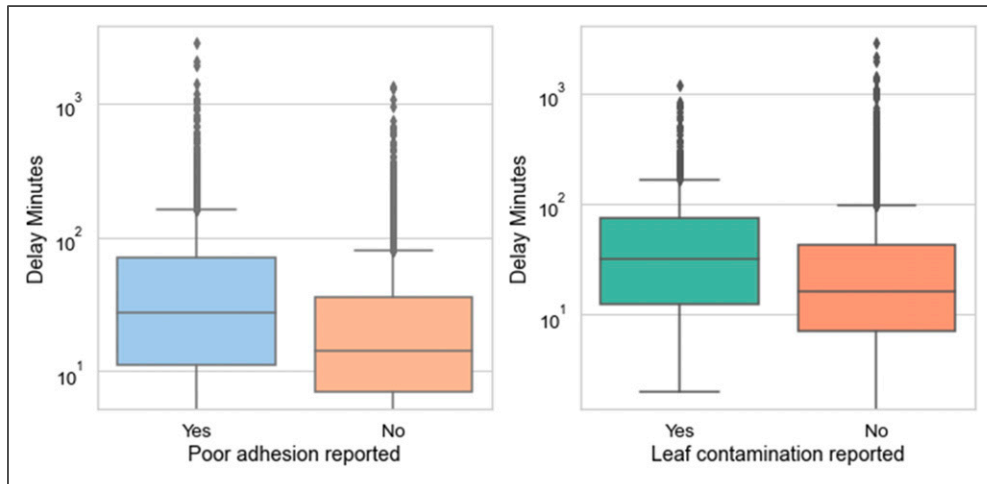
**Figure 8.** Delay minutes per station overrun, split into those where poor adhesion conditions (L) or leaf contamination (R) has been reported.

overrun is higher when low adhesion or leaf contamination is reported, compared to incidents where low adhesion did not appear to occur.

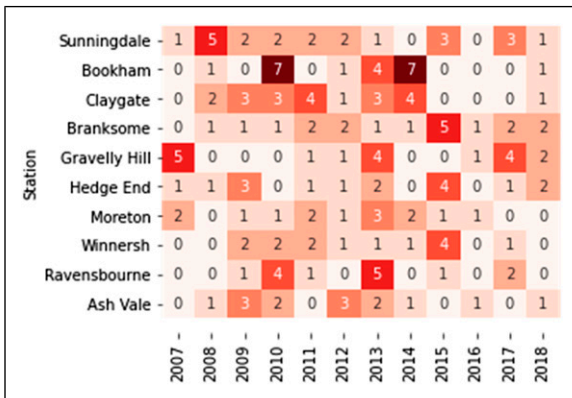
**Figure 9.** The 10 stations with the largest number of overruns.

It was found that 25 out of 843 stations (3%), resulted in 14% of station overruns that involved poor adhesion conditions throughout 2007–2018. A heat-map showing station overruns for the 10 stations with highest numbers of overruns over the 11 year period is shown in Figure 9. The estimated cost of total overruns has been approximated by using the RSSB ADHERE report's approximation of £4000 per overrun,<sup>10</sup> in addition to the

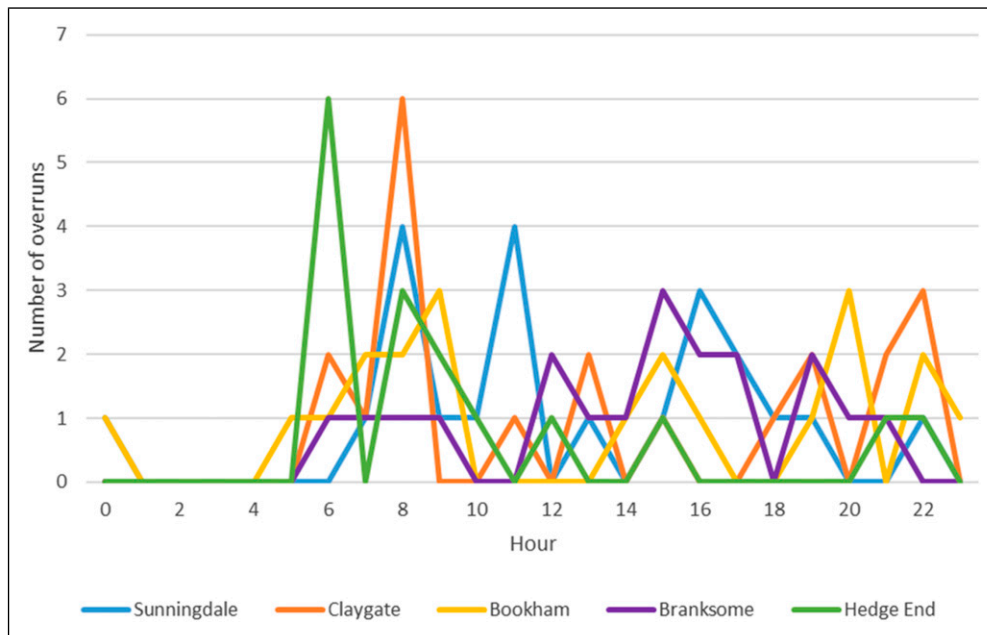
Figure 10. Number of station overruns plotted against hour of the day, for the 5 stations with highest overrun count.

In Figure 10, number of station overruns is plotted against hour of the day, for the 5 stations with highest overrun count. All stations show morning peaks in overruns from 6 to 9, which could be due to accumulated railhead contamination overnight and dew on the railhead. Sunningdale and Branksome have peaks around the evening rush hour at 16–18 h. Claygate and Bookham have evening peaks at 20–22 h, possibly due to dew re-forming on the railhead. These are potential causes, but a larger dataset using a KPI such as delay minutes would be needed for any statistical analysis.

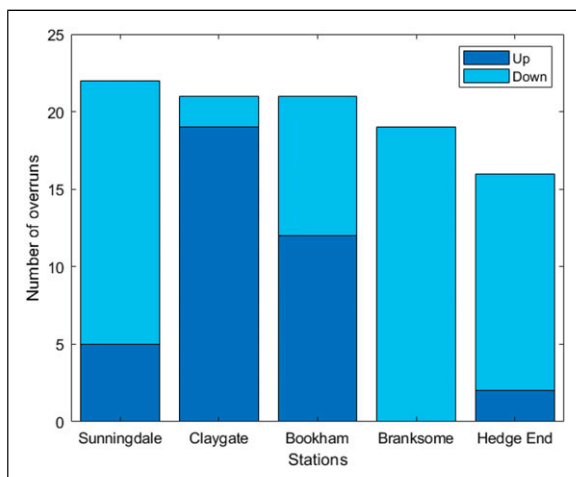
Figure 11. Direction of travel during overrun, for the 5 stations with highest overrun count.

Figure 11 shows the direction of travel (up and down) for each logged overrun that involved poor adhesion, for each of the 5 stations with highest overrun count. All the overruns at Branksome were on the down line (gradient). Hedge End, Claygate and Sunningdale also show a bias

towards overruns in one direction. Branksome station is on a gradient, which would make deceleration more difficult in the down direction and explain the high overrun count.

At its most granular level, the graph comparing overruns in the up and down directions in Figure 11 is an example of how a more localised, site specific case study could be

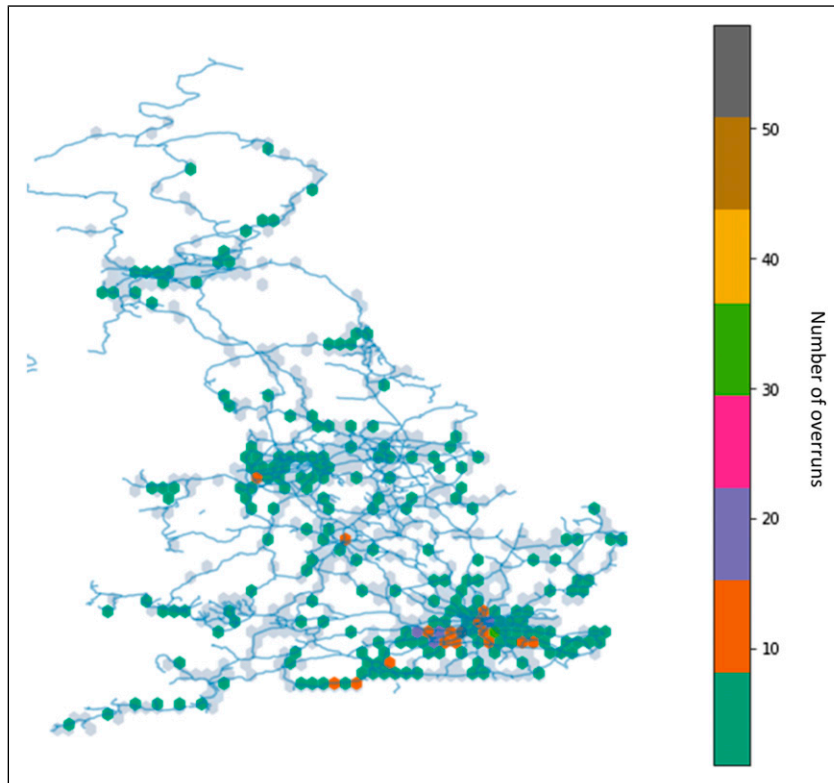
**Figure 12.** Station overruns plotted with the UK rail network from 2007 to 2018. Coloured hexes are where leaf contamination was reported after the incident, with a colour bar showing the concentration of incidents in each hex bin. Transparent blue hexes are where a station overrun occurred and no leaf contamination was found.

Station overruns across the UK have been plotted using Geopandas and shown on a map in Figures 12 and 13. In Figure 12 coloured hexes are where the keyword search highlighted that leaf contamination was found after the overrun, with a colour bar to show the concentration of incidents in each

hex bin. Transparent blue hexes are where a station overrun occurred and no leaf contamination was reported.

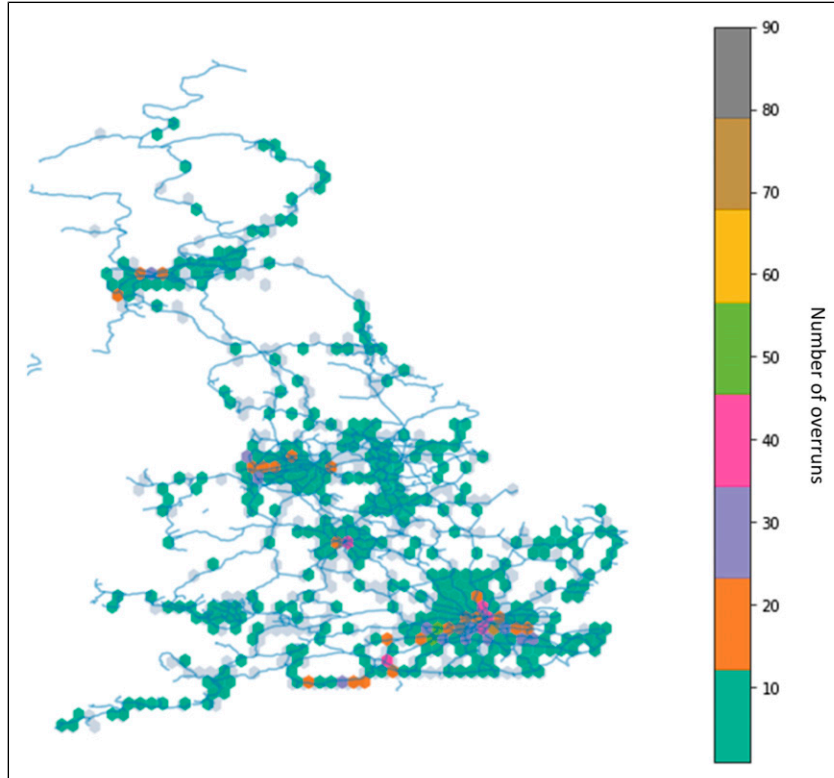
**Figure 13.** Station overruns plotted with the UK rail network from 2007 to 2018. Coloured hexes are where the keyword search highlighted that poor adhesion conditions had been reported, with a colour bar to show the concentration of incidents in each hex bin. Transparent blue hexes are where a station overrun occurred and poor adhesion was not reported.

In Figure 13, the coloured hexes represent the areas where poor adhesion was reported after the incident and the transparent hexes are where poor adhesion was not reported. Both maps have similar overrun hotspots, most of which correlate to busy areas with large numbers of station stops. Both figures show how widespread the low adhesion issue is. Although there are some hotspots, less than 10 station overruns have occurred over the data analysis period in the majority of hex bins, station overruns are useful KPI when location low adhesion hotspots but a more regularly occurring KPI such as delay minutes would also be required for a thorough case study analysis. Even in these low adhesion hotspots, the specific site of low adhesion is likely to vary due to the variabilities in the presence of contamination and water.

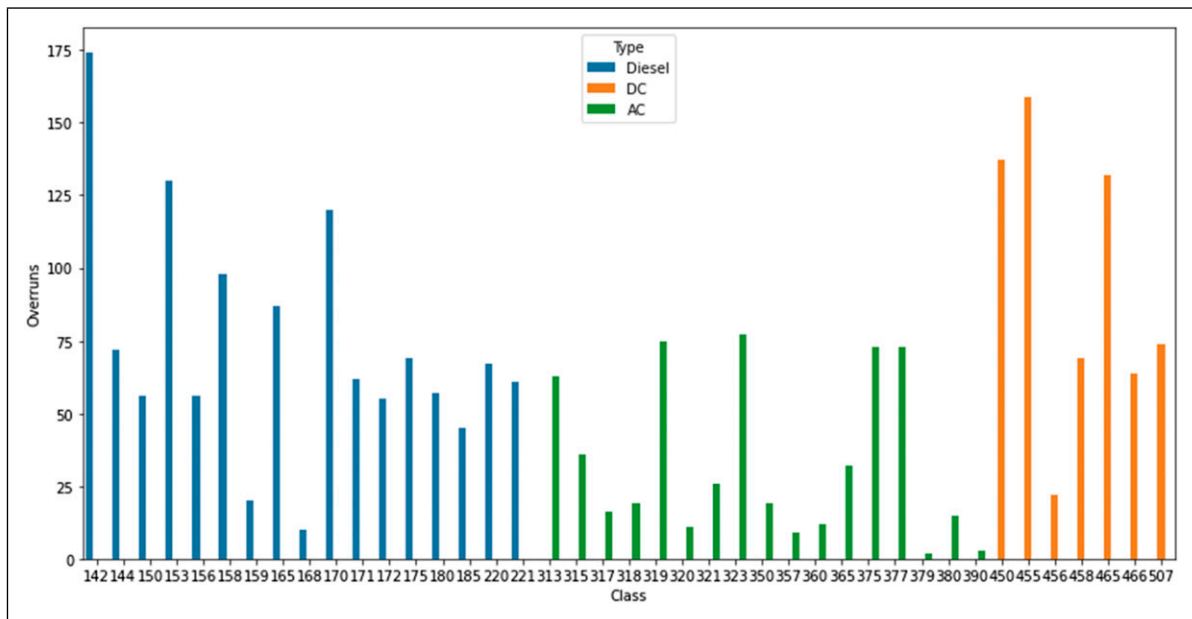
**Figure 14.** Number of station overruns where poor adhesion conditions were reported, split between vehicle class between 2007 and 2018.

The number of overruns where poor adhesion was reported was split by vehicle class. Total overruns per vehicle class are shown in Figure 14 and a heat map of incidents per vehicle class over each year is shown in Figure 17. A similar graph, showing wrong side track circuit failures per vehicle class, is found in RSSB.<sup>12</sup>

It should be noted that this figure is not normalised, data showing the number of station stops for each vehicle class, alongside knowledge of features such as brake type, weight, number of axles and any WSP, would be required to assess any trends in vehicle type. A heat map of number of incidents for each vehicle class per year is shown in the appendix. In more recent years, Class 170, Class 153 (lightweight and often used on rural lines, may not have wheel slide protection, Class 142 (lightweight) and Class 450 vehicles appear to be causing a higher number of station overruns.

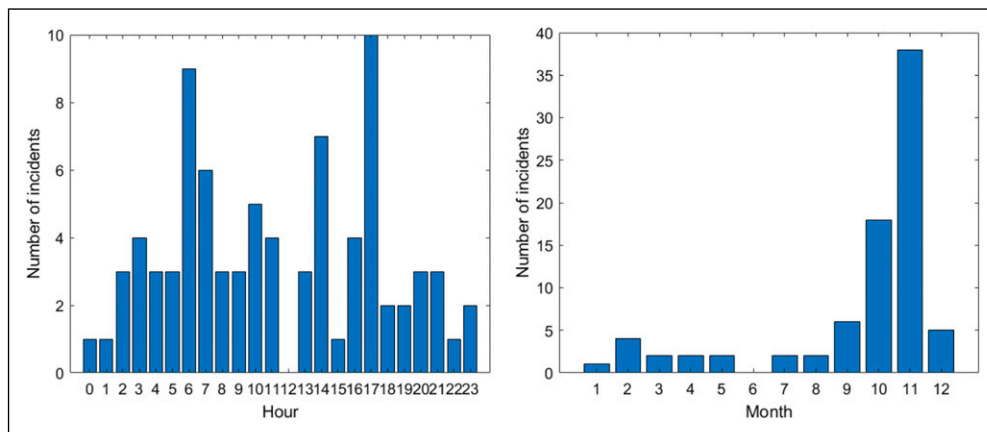
**Figure 15.** Slips to stand per hour (L) and per month (R).

The total number of freight slips to stand per hour is plotted in Figure 15(L) and monthly in Figure 15(R). The hourly graph shows peaks at 0600 and 1700 h. The monthly graph resembles that seen in the station overrun analysis, with an increase in incidents during October and November.

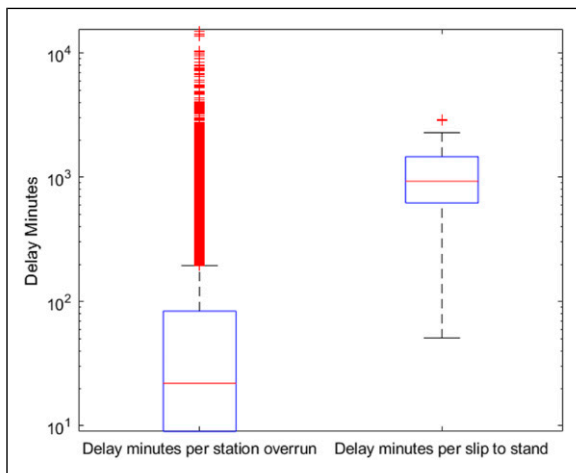
Figure 16. Number of delay minutes per station overrun and slip to stand.

The number of delay minutes for each incident is shown as a boxplot in Figure 16. The median average number of delay minutes per station overrun, where poor adhesion conditions have been reported is 70 with a maximum of 2868 min. The median average delay minutes per slip to stand is 1074, with a maximum of 2902.

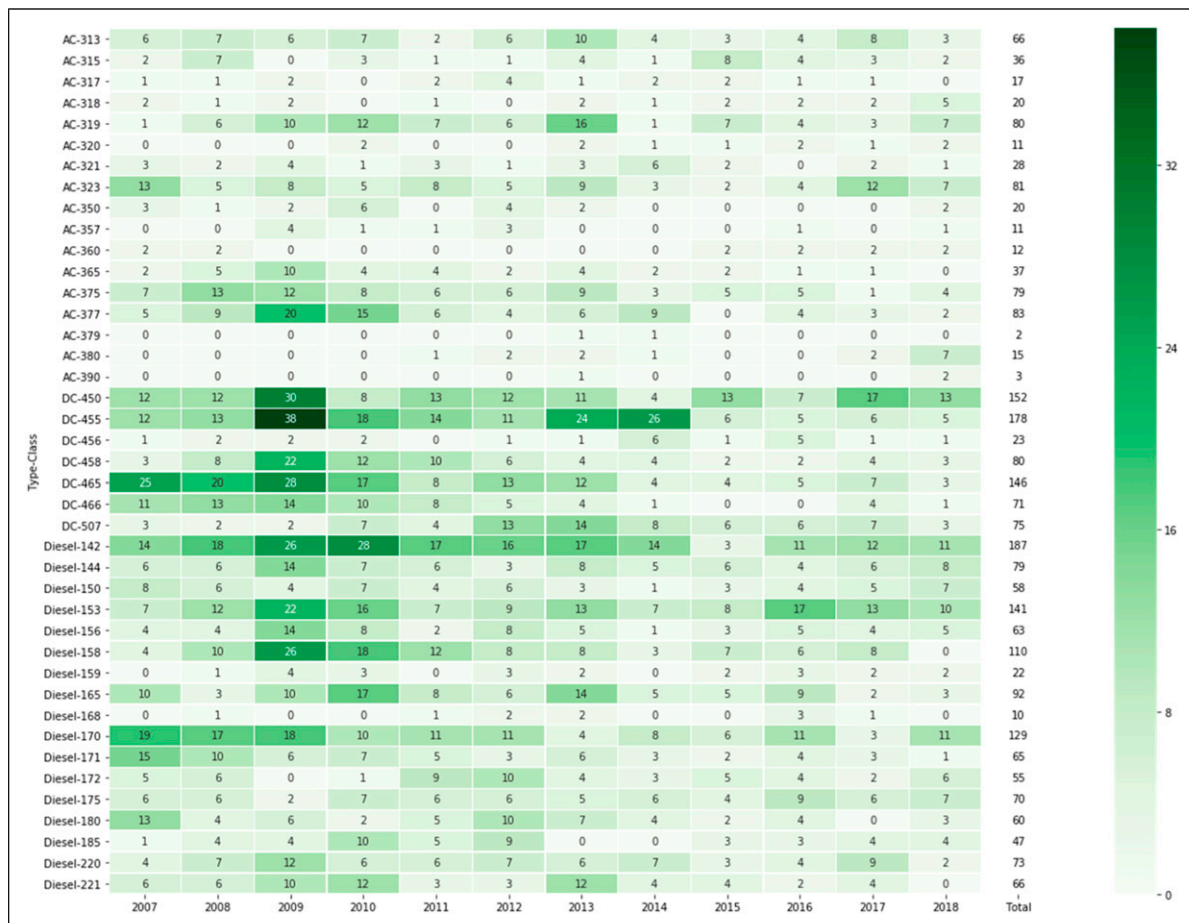
Figure 17. Number of station overruns where poor adhesion conditions were reported, split between vehicle class between 2007 and 2018.
