RESEARCH ARTICLE

Geomorphic effects of natural flood management woody dams in upland streams

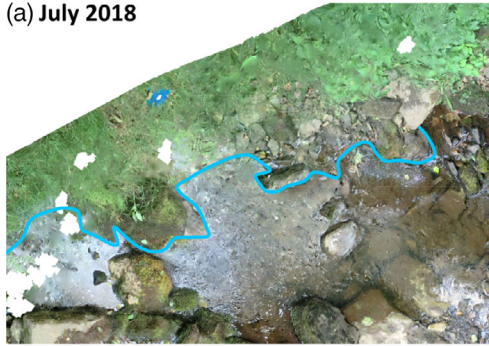
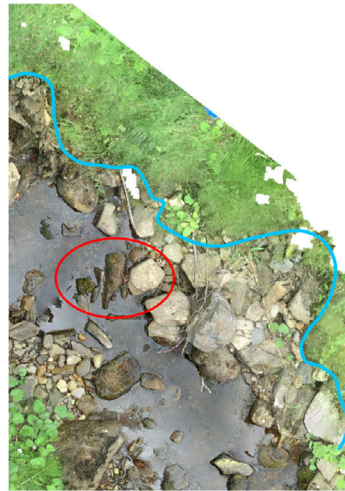
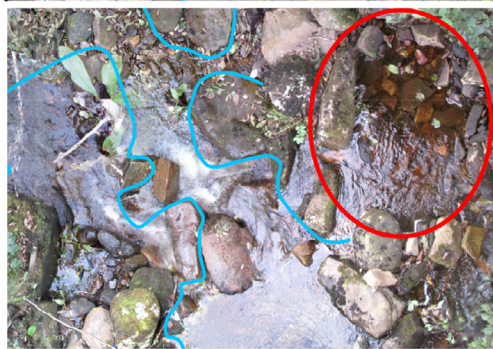
FIGURE 5 Major geomorphic changes along West Gill (the control tributary). Blue lines show bank positions recorded during the baseline survey in July 2018 [Color figure can be viewed at wileyonlinelibrary.com]

the left bank (1.3 m^3) was first observed in DoD 1 and further observed in DoD 3 (Figures 4b and 5a,b: clear retreat of the bank from its original position marked in blue). The average channel width at this site increased by 0.05 m (2.5%) over the study period. The middle control reach (West Gill 2) also experienced pronounced bank erosion during the study period. In DoD 2, the right bank near the upstream end of the study reach and the left bank near the middle of the study reach both experienced some erosion (0.38 m^3 in each area). The right bank recovered in DoD 3 following deposition. In contrast, the left bank continued to retreat after more erosion (0.17 m^3 ; Figure 5c,d). The middle part of the study reach, therefore, became approximately 0.5 m wider at the end of the study period.

A scour hole near the upstream end of West Gill 3 started to develop in DoD 3 (Figure 5f,g: red circle). However, it was smaller (0.21 m^3) than the underflow pools described. It was also shallow, and the stream bed is visible in Figure 5g.

A small pool was formed in West Gill 3 towards the end of the study period. It was shallow because the boulder at its upstream end only provided a small drop in elevation (Mao, Comiti, & Lenzi, 2008).

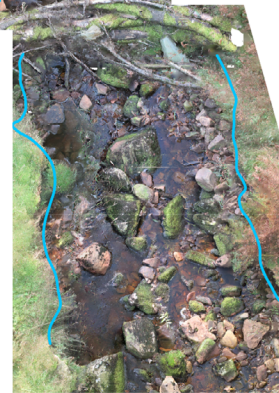
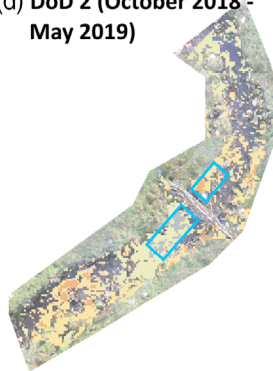
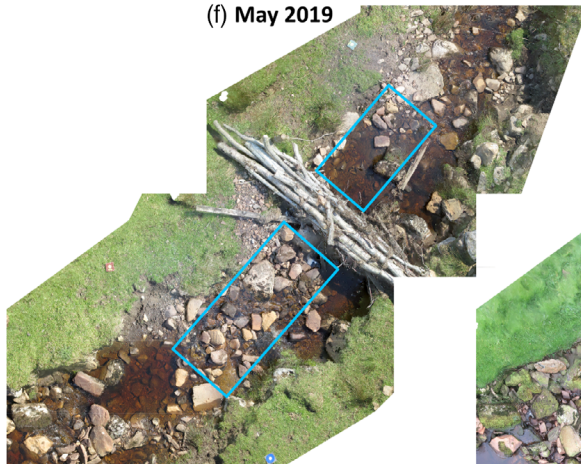
Boulder eroded from the stream bed

Gradual erosion of the left bank after October 2018; exposure of boulders previously buried in the bank

Accumulation of gravels upstream of the dam, near the right bank

Retreat of the right bank between October 2018 and May 2019; but developing outwards to a larger extent between May 2019 and September 2020

FIGURE 6 Major geomorphic changes at the monitored dams on Downs Gill. Blue lines in (b) show bank positions recorded during the baseline survey in July 2018 [Color figure can be viewed at wileyonlinelibrary.com]

Bank erosion was also associated with the NFM woody dams. For instance, at the second dam on Downs Gill, flows were concentrated to the left side of the channel, resulting in the erosion of the left bank within the 3 m immediately downstream of the dam after October 2018 (1 month after dam installation; 0.20 m^3 eroded in DoD 2; 0.17 m^3 eroded in DoD 3; Figure 6b). At the seventh dam on Downs Gill, some localised bank erosion caused by water flowing around the dam was observed in May 2019. This was particularly evident in September 2020, where an accumulation of gravel-sized alluvium was observed on the left bank, at the original location of the dam (Figure 6g: red arrow). Similarly, localised erosion of the right bank was observed at the original location of the third dam on Fall Gill (Figure 7b), which was displaced in DoD 2. Meanwhile, the slightly-rotated fourth dam on Fall Gill diverted water into the left bank and led to the localised erosion observed in DoD 2 (Figure 7f). Finally, the seventh dam on Fall Gill was pushed a few metres downstream by high flows, and it caused erosion of the right bank through abrasion (Figure 7k,l).

accumulation at the toe of the right bank (0.32 m^3 deposited; Figure 6b). Overall, the channel appeared to have shifted 0.2 m laterally towards the left.

By May 2019, accumulation of clasts (0.50 m^3) also clearly took place immediately upstream of the seventh dam on Downs Gill (Figure 6d,f: upstream blue rectangle). At some time before September 2020, the dam was displaced by the flow and became aligned to the right bank (Figure 6g). Some of the sediments previously stored (0.30 m^3) were released (Figure 6e) but were

subsequently retained by a large boulder on the left bank (Figure 6f: downstream blue rectangle), originally around 2 m downstream of the dam. Moreover, some non-closely monitored dams in the study site (e.g., the first dam on Fall Gill; Figure 9) had low clearance heights, and they clearly led to the accumulation of sediments upstream. These observations contrasted the widespread degradation observed in the control tributary (particularly West Gill 3 in DoD 3; Figure 5e–g). No persistent sediment storage zones arose on the control tributary during the study period.

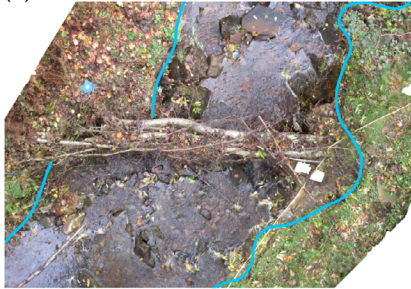
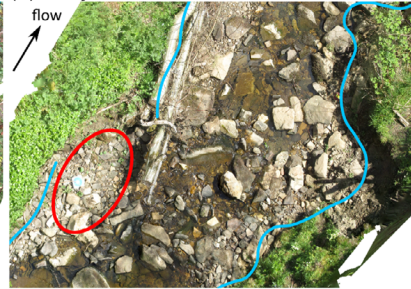
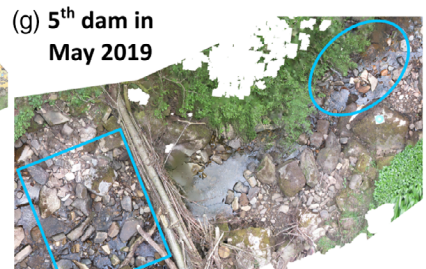
FIGURE 7 Major geomorphic changes at the monitored dams on Fall Gill. Blue lines show bank positions recorded during the baseline survey in July 2018 [Color figure can be viewed at [wileyonlinelibrary.com](https://onlinelibrary.wiley.com/doi/10.1002/ra.4045)]

Two major pools were formed near the fifth dam on Fall Gill between May 2019 and September 2020 – one underflow pool vertically beneath the dam (0.56 m^3 ; Figure 7h: blue rectangle) and another smaller pool 4 m downstream of the dam near the left bank (0.17 m^3 ; Figure 7h: blue ellipse).

At the seventh dam on Fall Gill, an underflow pool started to develop between October 2018 and May 2019, with a boulder originally immediately downstream of the dam near the right bank being displaced to the left side of the channel (Figure 7j: red arrow). By September 2020, after repeated high flows earlier in the year, the pool became well-developed (0.96 m^3), spanning almost the entire channel width (Figure 7k). The clasts displaced during pool formation appeared to be deposited around 3 m downstream of the dam, on the right side of the channel (Figure 7k: green box). This diverted flow to the left side of the channel, resulting in scouring of the stream bed (0.63 m^3 removed) near the left bank (Figure 7k: red box). Based on the orthophotographs, the pool associated with the seventh dam on Fall Gill appeared to be larger than the one associated with the fifth dam (length along the flow direction: 3.5 m vs. 2 m; Figure 7h,k).

It is notable that two of the six dams monitored (i.e., the seventh dam on Downs Gill and the third dam on Fall Gill) had been completely displaced. Furthermore, the fourth dam on Fall Gill had been rotated clockwise by 30° , and the seventh dam had been pushed 0.4 m downstream. As described earlier, the latter two continued to exert geomorphic influence on the channel. However, the former two also served some geomorphic functions. Between May 2018 and May 2019, the outer bank of the bend downstream of the seventh dam on Downs Gill was gradually eroded, but the displaced dam protected it from further erosion in September 2020 (Figure 6d–f). The displaced third dam on Fall Gill allowed the left bank to develop towards the thalweg, resulting in a channel width 0.2 m narrower than the baseline condition (Figure 7b,c).

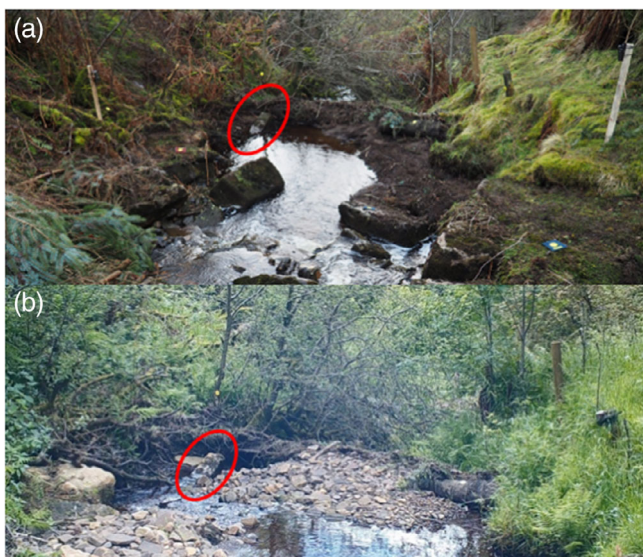
FIGURE 9 Clasts piling up against the most upstream dam on Fall Gill; as captured by a hand-held camera on February 21, 2019 (upper) and a time-lapse camera on June 21, 2019 (lower); both facing downstream; red circles indicate a reference boulder that had remained stationary [Color figure can be viewed at wileyonlinelibrary.com]
