Badran, Ghadeer and Dhimish, Mahmoud (2022) Field study on the severity of photovoltaic potential induced degradation. Scientific Reports. 22094. ISSN: 2045-2322

Field study on the severity of photovoltaic potential induced degradation

Ghadeer Badran✉ & Mahmoud Dhimish

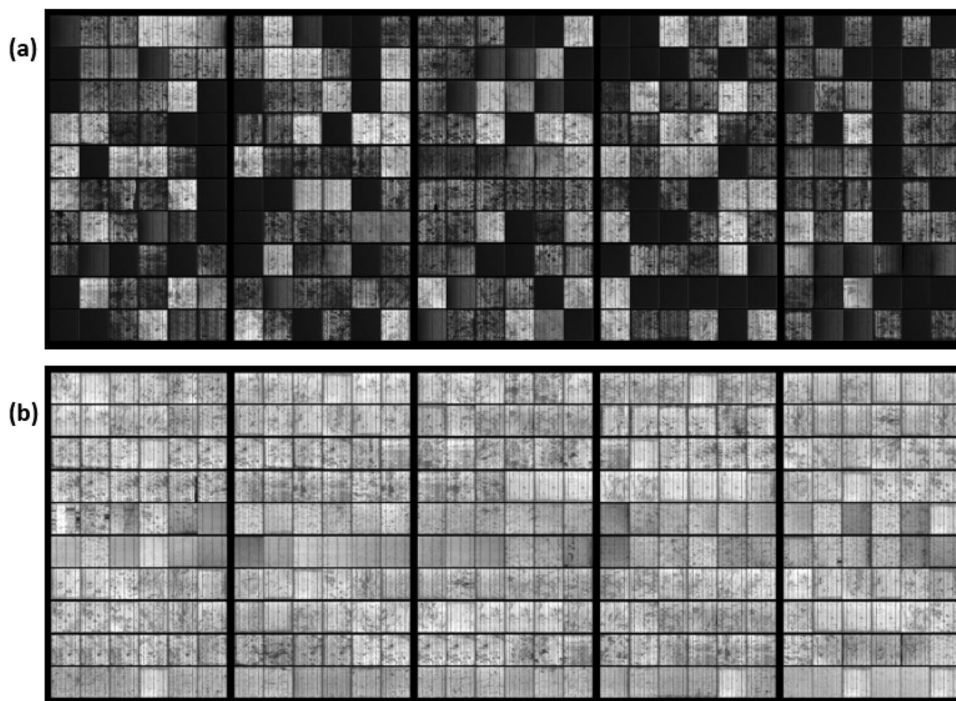
Figure 3. Electroluminescent image of two PV modules. (a) Modules located in a PID affected PV string (string 1). (b) Modules located in the healthy PV string (string 5). The electroluminescent images were taken during night-time, under an ambient temperature of 26 °C, and the modules were running at 90% of their short circuit condition.

PID examination using electroluminescent imaging. The confirmed PID case in the PV strings was also supported by examining several PV modules under EL testing. For example, the output image of five PV modules from PV string 1 vs in the healthy PV string is shown in Fig. 3. Through EL detection, it is clear that the affected modules by PID, Fig. 3a, has low EL intensity compared with the healthy PV modules, Fig. 3b. In addition, the PID affected modules show shunting (blackout) cells that are likely to degrade the module's performance. However, unlike the healthy PV modules with homogenous EL intensity across the solar cells, these only have some micro cracks. Despite that some solar cells in the healthy PV modules have some cracks or minor

shunting, these are typically normal to occur during the first year of operation and they have insignificant impact on the performance of the modules^{22,23}.

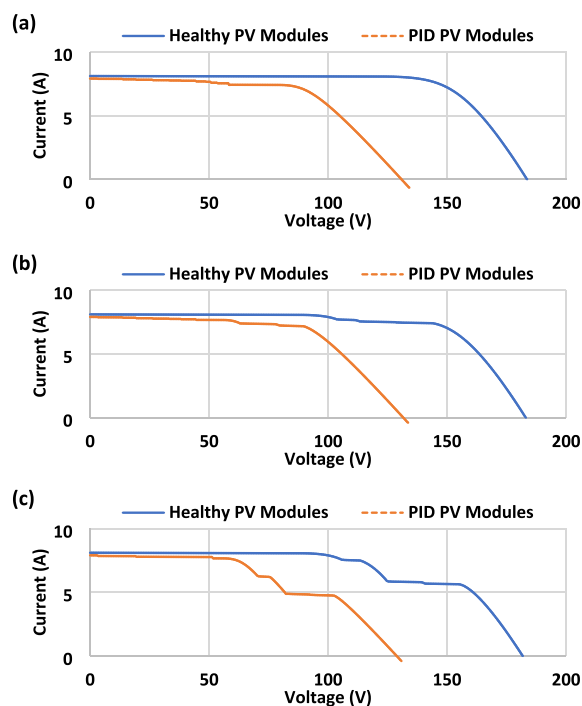
Figure 5. Current–Voltage (I–V) curve measurements of the examined PV modules. (a) Clear sky. (b) Partial shading. (c) Overcasting. The I–V curve tracking accuracy is $\pm 0.5\%$. The blue curves show the healthy PV modules (free PID), and the orange curves show the PID PV modules.

The I-V curves were taken for both the healthy and the PID PV modules during each different sky conditions (Fig. 5). In PID affected modules, I-V curves dropped steeply because PID has a significant impact on output voltage. According to Fig. 5a, the open-circuit voltage dropped from 183.6 V for the healthy modules to 134.1 V for the PID modules. PID-affected PV modules do not show a significant drop in short circuit current. In spite of this, the maximum current that can be extracted from the PID affected modules is less than that from healthy modules. As a result, the PID modules will generate less output power due to the voltage and current drop.

Table 2 summarizes the electrical output parameters (compiled from Fig. 5) for the tested PV modules. Due to the reduced current and voltage, the PID modules had a significant drop in power at maximum power point (MPP). PID accelerates the power decrease (−39.69%) due to reduced shunting resistance at lower irradiance conditions (overcast, 408 W/m²). During clear sky and partial shading conditions, respectively, the output power of the PID-affected modules decreases by −37.15 and −36.29%. The I-V curve tracer endeavoured to track approximately the same current at I_{MPP} for the PID compared with the healthy modules at the clear sky and partial shading because the modules are relatively affected by high irradiance (> 650 W/m²). However, at low irradiance

conditions (overcasting), there is a -8.54% loss in tracking the I_{MPP} . On the contrary, it is incomprehensible to track the identical V_{MPP} due to the PID and the reduction in the shunt resistance.

These results explain the differences between healthy and PID modules under different environmental conditions. As a result, the power reduction of the PID affected modules is very high ($> 36\%$), even under high irradiance conditions. Furthermore, under low-irradiance conditions, the output power of the PID-affected PV modules may be further reduced due to reduced shunting resistance.

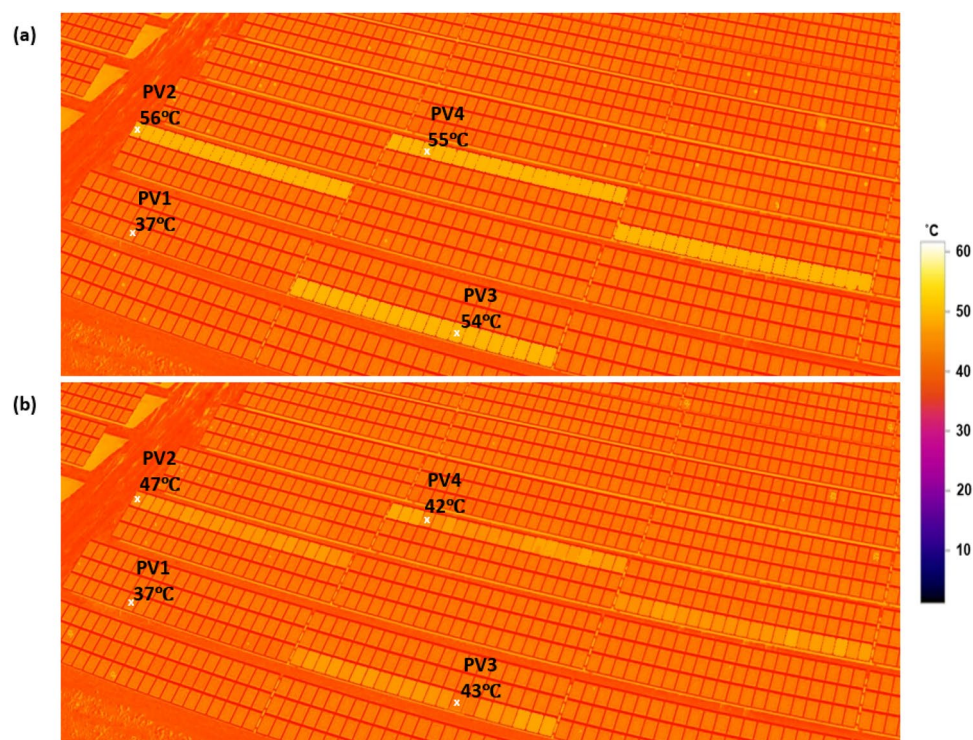
Figure 6. Thermography image of the tested PV strings during night-time. (a) Image taken on 03/08/2020, after one year of PV operation (ambient temperature 35 °C). (b) Image taken on 10/08/2021, after 1-year of fitting the anti-PID box on the PV strings (ambient temperature 35 °C). The thermal image is taken using DJI Mavic 2 Enterprise Advanced drone with thermal sensitivity ± 2 °C, the selected points on the figure are rounded to the nearest integer.

Figure 6 shows thermal images of PV strings after PID was confirmed (Fig. 6a) and after fitting the anti-PID box for a year (Fig. 6b). During the daytime, both images were taken under relatively the same ambient temperature.

As shown in Fig. 6b, the anti-PID box has partly improved the thermal performance of the PV modules. Three different instances were emphasised, where the PV surface temperature has dropped by nearly 9–13 °C; a summary of the results is presented in Table 3.

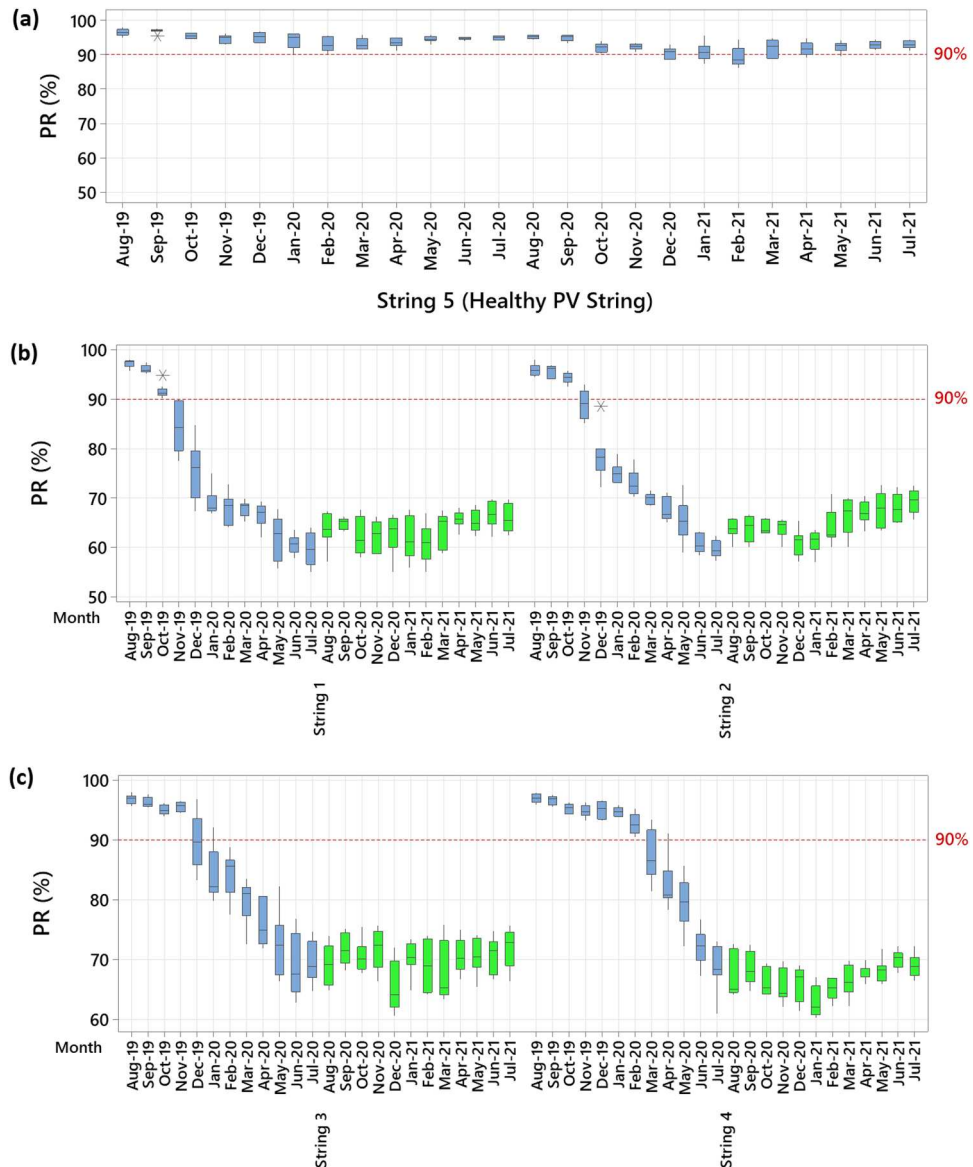
**Figure 7.** Performance ratio of the tested PV strings. (a) Healthy PV string (PV string 5). (b) PV strings 1 and 2. (c) PV string 3 and 4. The y-axis presents the PR ratio, and the baseline of 90% was selected to indicate low performance; the x-axis gives the month and the PV string number. This chart shows the PR ratio for the PV strings during their two years in the field, as well as the PR ratio after the anti-PID box is fitted.

Fig. 7, you can see the monthly PR ratio of the PV strings for each month. As shown in Fig. 7a, the healthy PV module maintains a superior performance over a period of two years, with a PR ranging from 88 to 96%. PV strings (1, 2, 3 and 4) that were confirmed to have PID had exactly the same PR ratio, even when the anti-PID box was installed, their PR remained consistently below 75% even after the anti-PID box was installed, as shown in Fig. 7b,c.

The anti-PID recovery, however, stops the acceleration of power losses for the affected PID modules. Figure 7b,c demonstrate a virtually constant PR ratio after fitting the anti-PID box (see green highlighted boxplots), and no further reductions (i.e., below 50% PR ratio) have been observed. The results suggest that the anti-PID box has a positive impact on already PID-affected modules, which delays the recycling of the modules when a suitable detection mechanism is in place.

Figure 7 illustrates another conclusion about the long-term impact of PID on PV modules. The study shows that PID can severely affect modules, resulting in a 25% to 40% reduction in output power. Sadly, unidentified PIDs can cause rapid power losses, and we see this frequently in large industrial PV assets. Thus, our results highlight the importance of regularly inspecting PV systems to avoid system complications, particularly those related to PID.

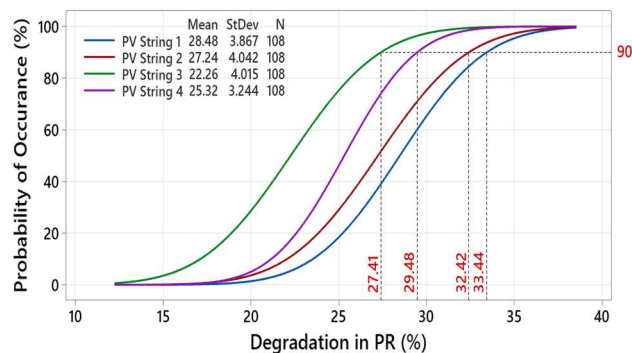
Figure 8. Plot of probability distribution functions for PV strings affected by PID. Probability of occurrence (in percentage) is represented by the y-axis, and degradation (in percentage) is represented by the x-axis. Plotting this figure requires data from Figs. 7b,c. N stands for the number of samples, and StDev for the standard deviation.

CDF is a widely used statistical analysis function that describes the probability of discovery of an investigated variable^{27,28}. To explore the degradation in PR, we plotted the CDF for the affected PID PV strings as shown in Fig. 8. There is a 90% probability that a PV string affected by PID will have a PR degradation between 27.41 and 33.44%. Nevertheless, this assumption is only valid if the PID affected the modules for at least six months, as our previous data shows.

Also shown in Fig. 8 is the standard deviation (StDev) and the mean of the samples. According to the PR, the mean degradation ranges from 22.26 to 28.48%. A low StDev (3 to 4) indicates that the data are clustered around the mean. In summary, the CDF plot shows a degradation in PR for PV strings with affected PIDs. The probability of accelerated power losses in a PV string affected by at least 6-months of PID is approximately 27% to 33% with 90% confidence. Due to the location of our investigated PV system in Spain, Barcelona, these results may also be more accurate during hot summers and cold winters.
