Field study on the severity of photovoltaic potential induced degradation

Ghadeer Badran & Mahmoud Dhimish

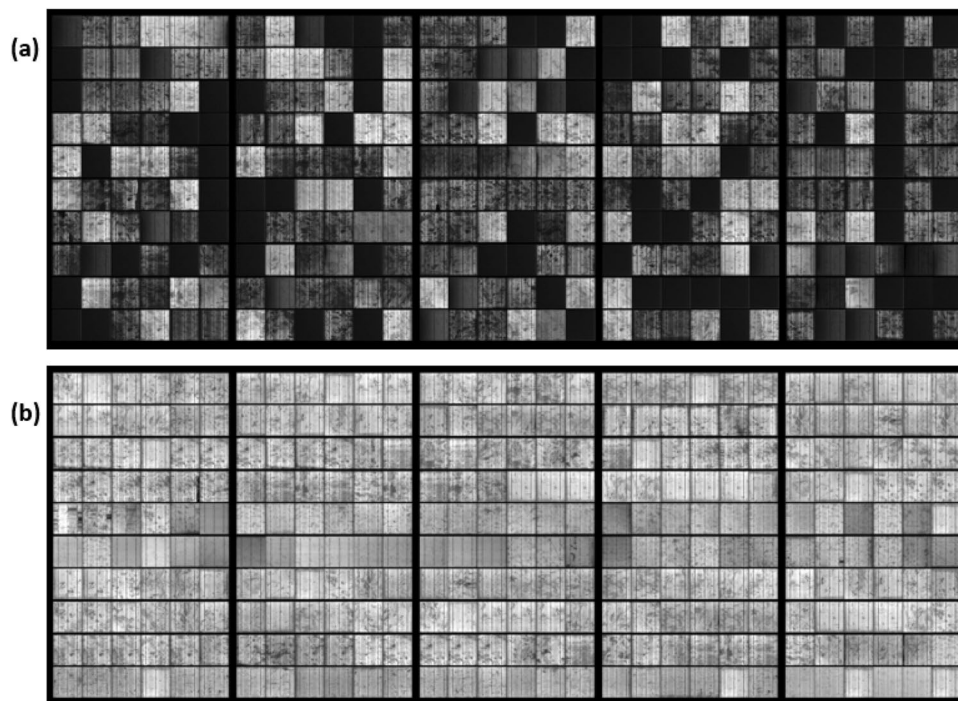
PID examination using electroluminescent imaging. The confirmed PID case in the PV strings was also supported by examining several PV modules under EL testing. For example, the output image of five PV modules from PV string 1 vs in the healthy PV string is shown in Fig. 3. Through EL detection, it is clear that the affected modules by PID, Fig. 3a, has low EL intensity compared with the healthy PV modules, Fig. 3b. In addition, the PID affected modules show shunting (blackout) cells that are likely to degrade the module's performance. However, unlike the healthy PV modules with homogenous EL intensity across the solar cells, these only have some micro cracks. Despite that some solar cells in the healthy PV modules have some cracks or minor

Figure 3. Electroluminescent image of two PV modules. (a) Modules located in a PID affected PV string (string 1). (b) Modules located in the healthy PV string (string 5). The electroluminescent images were taken during night-time, under an ambient temperature of 26 °C, and the modules were running at 90% of their short circuit condition.

shunting, these are typically normal to occur during the first year of operation and they have insignificant impact on the performance of the modules^{22,23}.

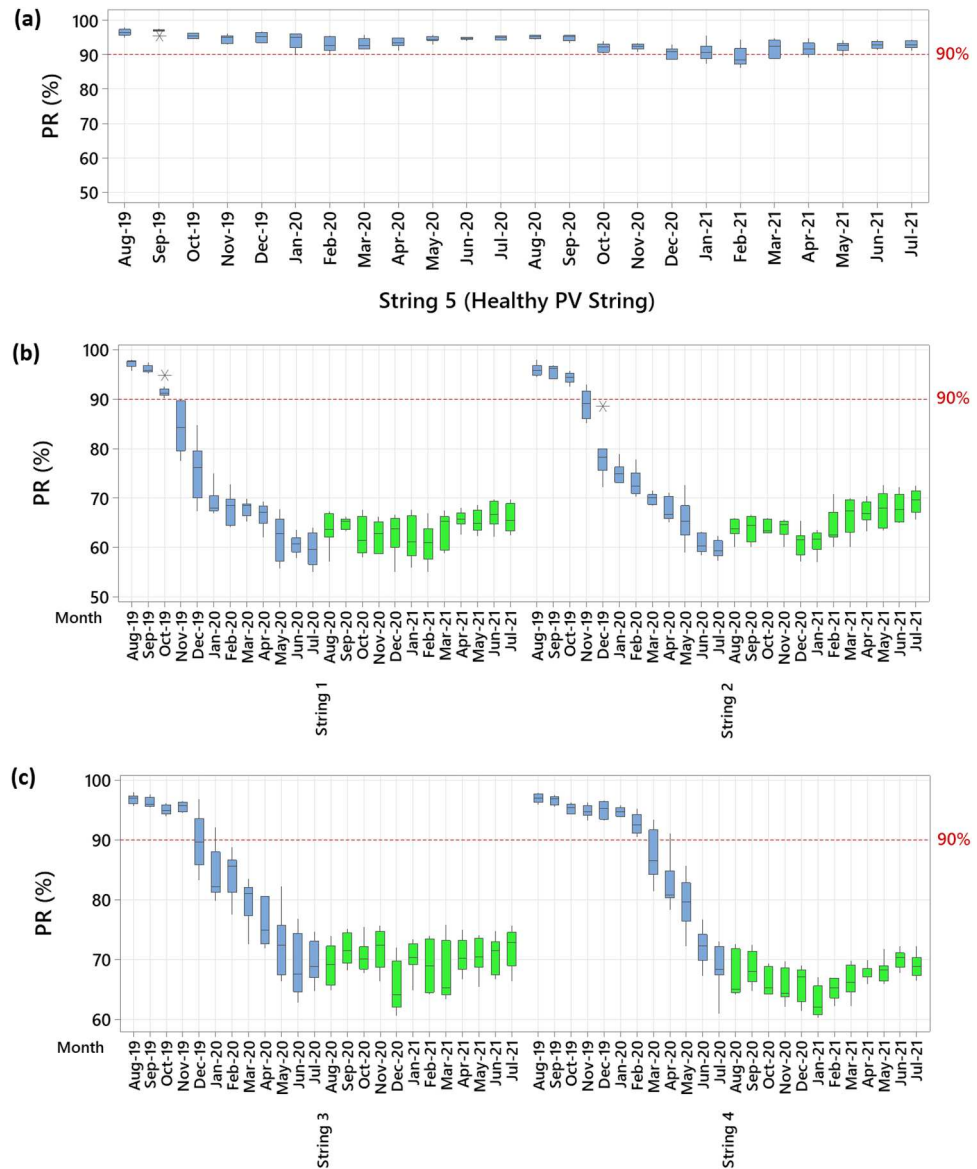
Figure 7. Performance ratio of the tested PV strings. (a) Healthy PV string (PV string 5). (b) PV strings 1 and 2. (c) PV string 3 and 4. The y-axis presents the PR ratio, and the baseline of 90% was selected to indicate low performance; the x-axis gives the month and the PV string number. This chart shows the PR ratio for the PV strings during their two years in the field, as well as the PR ratio after the anti-PID box is fitted.

Fig. 7, you can see the monthly PR ratio of the PV strings for each month. As shown in Fig. 7a, the healthy PV module maintains a superior performance over a period of two years, with a PR ranging from 88 to 96%. PV strings (1, 2, 3 and 4) that were confirmed to have PID had exactly the same PR ratio, even when the anti-PID box was installed, their PR remained consistently below 75% even after the anti-PID box was installed, as shown in Fig. 7b,c.

The anti-PID recovery, however, stops the acceleration of power losses for the affected PID modules. Figure 7b,c demonstrate a virtually constant PR ratio after fitting the anti-PID box (see green highlighted boxplots), and no further reductions (i.e., below 50% PR ratio) have been observed. The results suggest that the anti-PID box has a positive impact on already PID-affected modules, which delays the recycling of the modules when a suitable detection mechanism is in place.

Figure 7 illustrates another conclusion about the long-term impact of PID on PV modules. The study shows that PID can severely affect modules, resulting in a 25% to 40% reduction in output power. Sadly, unidentified PIDs can cause rapid power losses, and we see this frequently in large industrial PV assets. Thus, our results highlight the importance of regularly inspecting PV systems to avoid system complications, particularly those related to PID.
