Investigating defects and annual degradation in UK solar PV installations through thermographic and electroluminescent surveys

Mahmoud Dhimish¹ and Ghadeer Badran¹

npj Materials Degradation (2023)7:14; <https://doi.org/10.1038/s41529-023-00331-y>

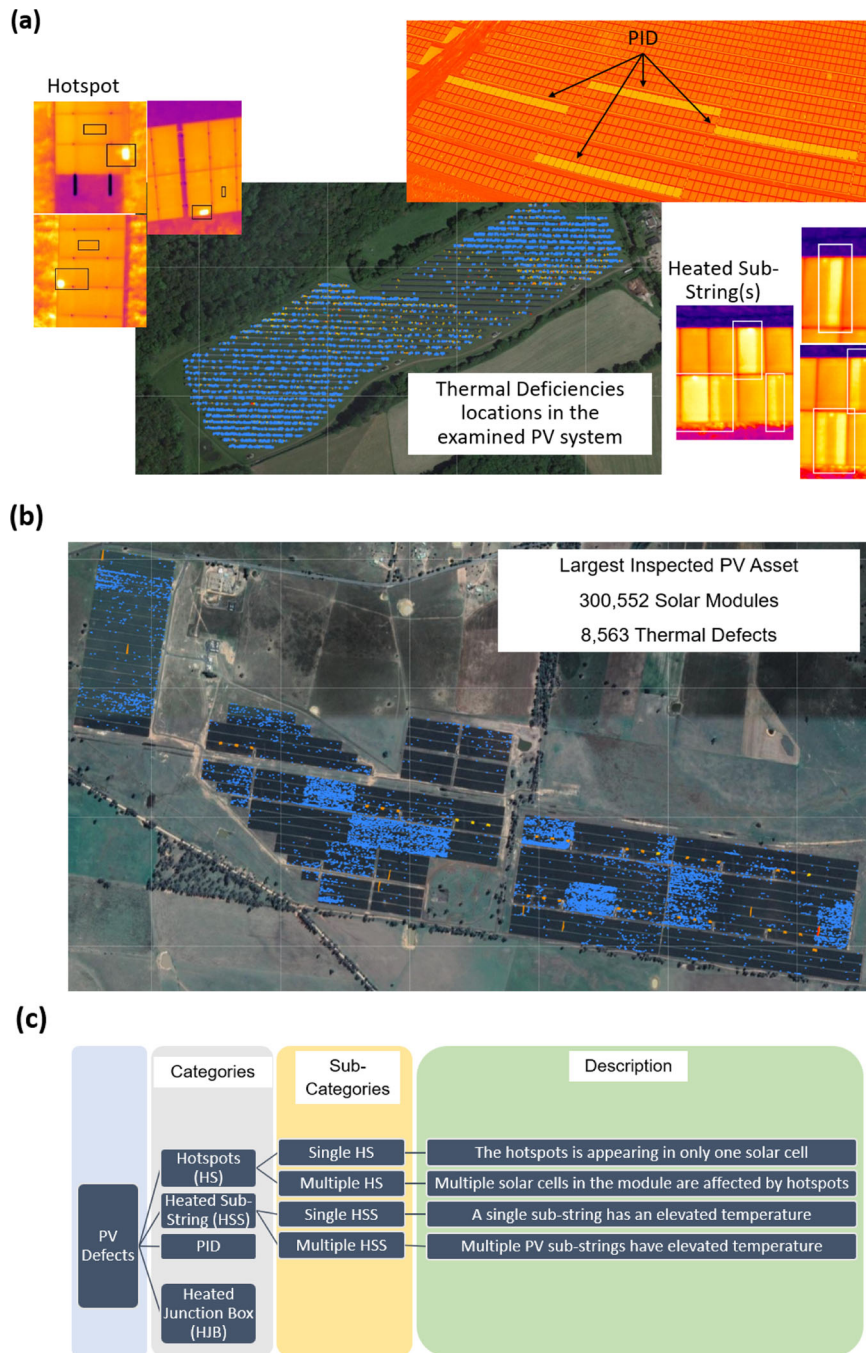
Two different examples of the thermal defects of PV assets are shown in Fig. 1. The red/yellow/blue dots represent the location of the thermal deficiency, which is identified and analysed using the thermal camera. For example, in Fig. 1a, A total of 4993 thermal defects were found in all 20,570 solar modules available for this PV asset (24.27% defective cases). Installation of this PV system is approximated at a title of 37° and a azimuth of -7°. Figure 2b shows our largest inspected solar asset, comprising 300,552 solar modules with 8563 thermal defects. PV modules in this installation have different azimuths (+13° to -25°) and titles (27° to 33°). Due to prior agreements with local authorities, the precise locations of PV assets are kept confidential.

A summary of PV defect categories/subcategories can be found in Fig. 1c. We analysed all PV system defects, including hotspots (Single HS or Multiple HS), heated substrings (Single HSS or Multiple HSS), PID, and heated junction boxes (HJB). To compare and analysed data, these defects were populated for each inspected PV installation.

Fig. 1 Example of the analysis of the thermal efficiencies for two different PV assets. **a** A PV asset with 20,570 solar modules containing 4993 thermal defects. In this installation, hotspots, PIDs, and heated sub-strings are examples of thermal problems. Thermal defects are indicated by red, yellow, and blue dots. According to the “confidentiality agreement” with the PV asset owners, the precise geographical location of these assets is confidential. **b** Here is another example showing the locations where thermal anomalies were detected in one of the largest PV assets inspected, with 300,552 solar modules and 8563 thermal defects found. **c** Categories of the PV thermal anomalies investigated/analysed in this work.

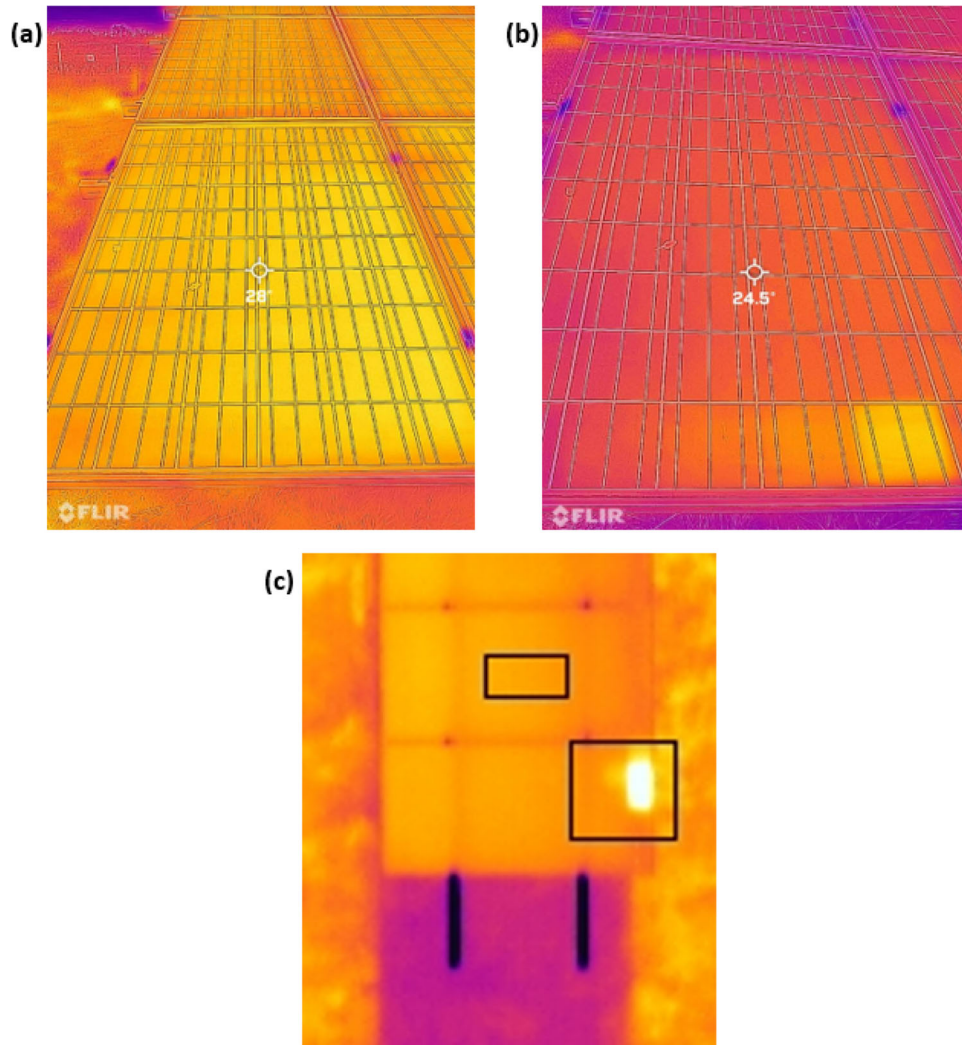
This section summarises the results of the thermal deficiencies in the inspected PV modules. For example, Fig. 2a, b shows a defective-free module and a PV module with a single HS, respectively. The thermal defect categorisation of several thousands of PV modules was also challenging; for example, in Fig. 2c, two or three solar cells and the junction box of the PV module have an elevated temperature. We, therefore, report such cases as "others" rather than classifying them into one of the identified PV deficiencies. Additionally, every thermal defect's median temperature was recorded; this will assist in determining how much temperature elevation has occurred in the different defects.

Fig. 2 Thermal image of PV modules. a Defective-free. **b** Single HS thermal defect. **c** Unclassified thermal defect on PV module (this could be HJB or multiple HS). These cases are reported as “others” in the thermal defect summary.

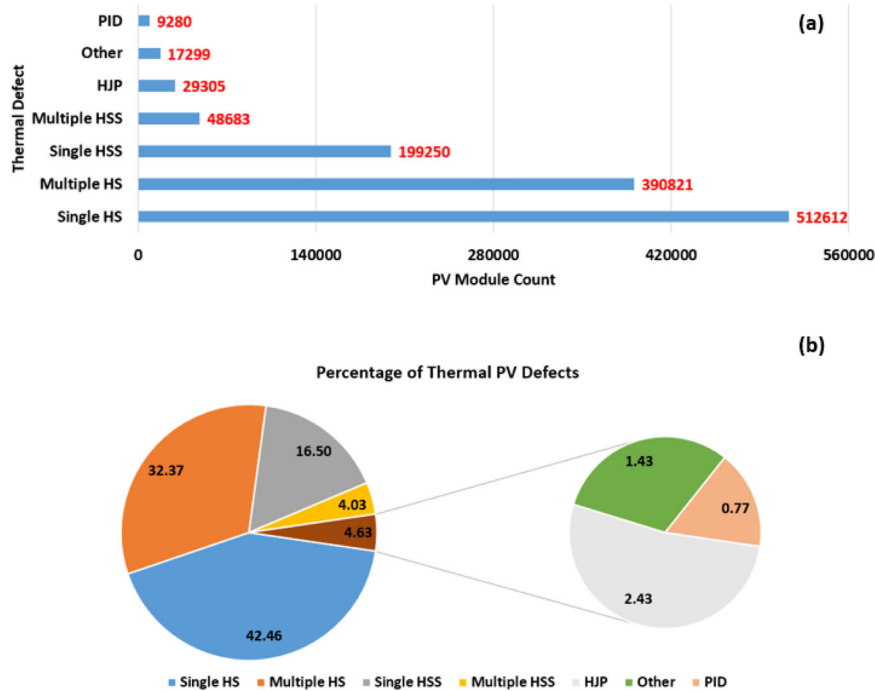
A summary of all thermal defects found in inspected PV modules can be found in Fig. 3. According to the inspection, 36.6% of 3,300,000 modules were defective, while 63.4% were defect-free. As shown in Fig. 3a, with 512,612 reported cases, the single HS is the most common thermal defect. PID is the least common thermal fault; however, previous research^{29,30} has demonstrated that it can adversely affect PV modules and lead to 25–50% power losses. Compared with single HS, which are most likely to affect PV

According to Fig. 3b, 42.46% of all thermal defects are caused by a single HS, and 32.27% by multiple HS. A remarkable observation is that 16.5% of all faults are caused by one HSS. Consequently, defective bypass diodes or soldering defects are likely to cause PV module failures. A second interesting observation is that only 2.43% of PV modules are affected by an HJB. In light of recent papers³¹, it is surprising that this result emerged,

Fig. 3 Summary of the thermal efficiencies of the inspected PV modules. **a** PV count of thermal defects. **b** Percentage of PV defects.

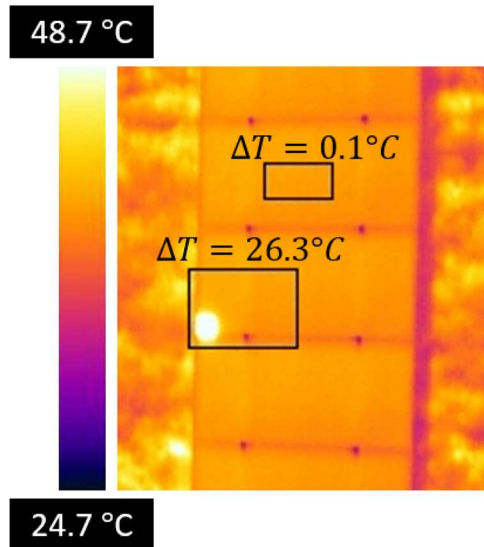
For example, Fig. 4 shows two PV modules with recorded ΔT . For the upper PV module with no hotspots, the $\Delta T = 0.1^\circ\text{C}$, whereas the single HS in the lower PV module shows an elevated

temperature of $\Delta T = 26.3^\circ\text{C}$. The operating voltage loss, V_{loss} , of the PV module with $\Delta T = 0.1^\circ\text{C}$ is 0.03 V , and for the module with $\Delta T = 0.1^\circ\text{C}$ is equal to 30.7 V . The operating voltage of the thermally defective module is found using (4), where $V_{non-defective}$ and $V_{defective}$ represents the operating voltage of the adjacent non-defective PV module, and the module with thermal defect, respectively:

Fig. 4 An example of a thermal image taken for PV modules with different ΔT variations. In the example, we show that a PV module without hotspots has $\Delta T = 0.1^\circ\text{C}$ while it is equal to $\Delta T = 26.3^\circ\text{C}$ when a module is affected by a single HS.

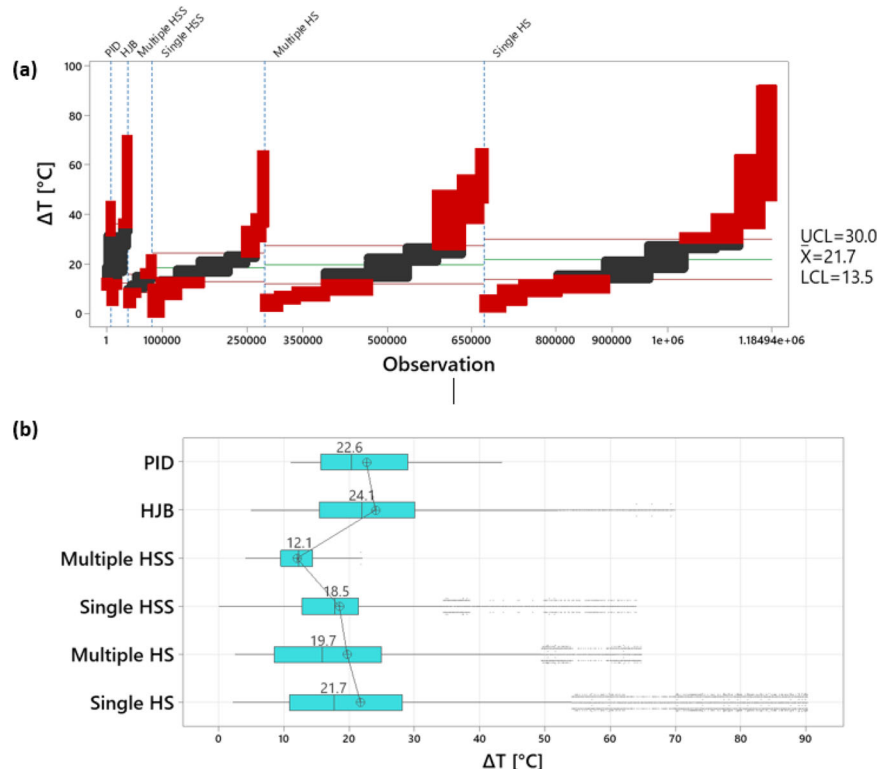
Compare the mean and variation for data that has been collected under different conditions, typically after the ΔT calculation. Figure 5a plots the individual data values to look for differences in the centre line and the control limits (upper control limit (UCL) and lower control limit (LCL), which are calculated independently for each stage, to determine how ΔT changes. For all the considered thermal defects, the UCL is 30.0°C and the LCL is 13.5°C , and the mean value is 21.7°C . This result shows the significant temperature elevation for the PV modules affected by thermal defects.

The second plot, Fig. 5b, shows the boxplot, which can indicate the differences in the mean or variability of the data for the individual thermal defect. HJB has the most effect on the PV modules temperature, with averaged $\Delta T = 24.1^\circ\text{C}$, and the $\Delta T = 12.1^\circ\text{C}$ is observed from the PV modules affected by multiple HSS. It is

interesting to notice that in almost all cases, there are some PV modules were operating under severe temperature levels $\Delta T > 50^\circ\text{C}$, which ultimately risks the PV system with a potential fire hazard.

Fig. 5 Analysis of the datapoint of the temperature variations. **a** Distribution of all observations/samples vs. ΔT . **b** Boxplot of ΔT vs. explored thermal PV defects.

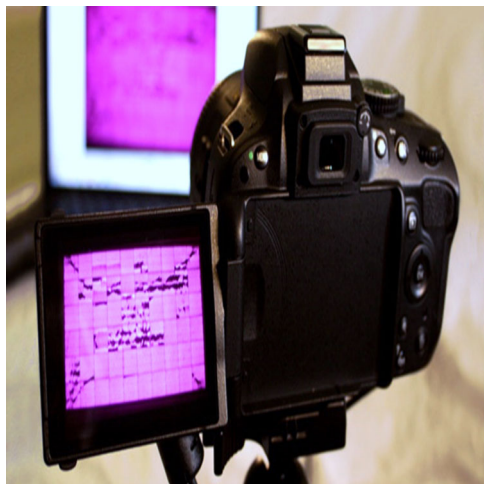
In this section, we discuss the correlation between thermal and EL imaging for PV modules. Thermal images are known to aid in identifying PV faults^{32,33}, but EL images can also be used for determining solar cell health. Therefore, we have used an EL testing setup, as shown in Fig. 6 to test PV modules with different thermal defects.

Fig. 6 EL imaging setup used to test the PV module. The EL camera is brought by Brightspot Automation, USA-based company.

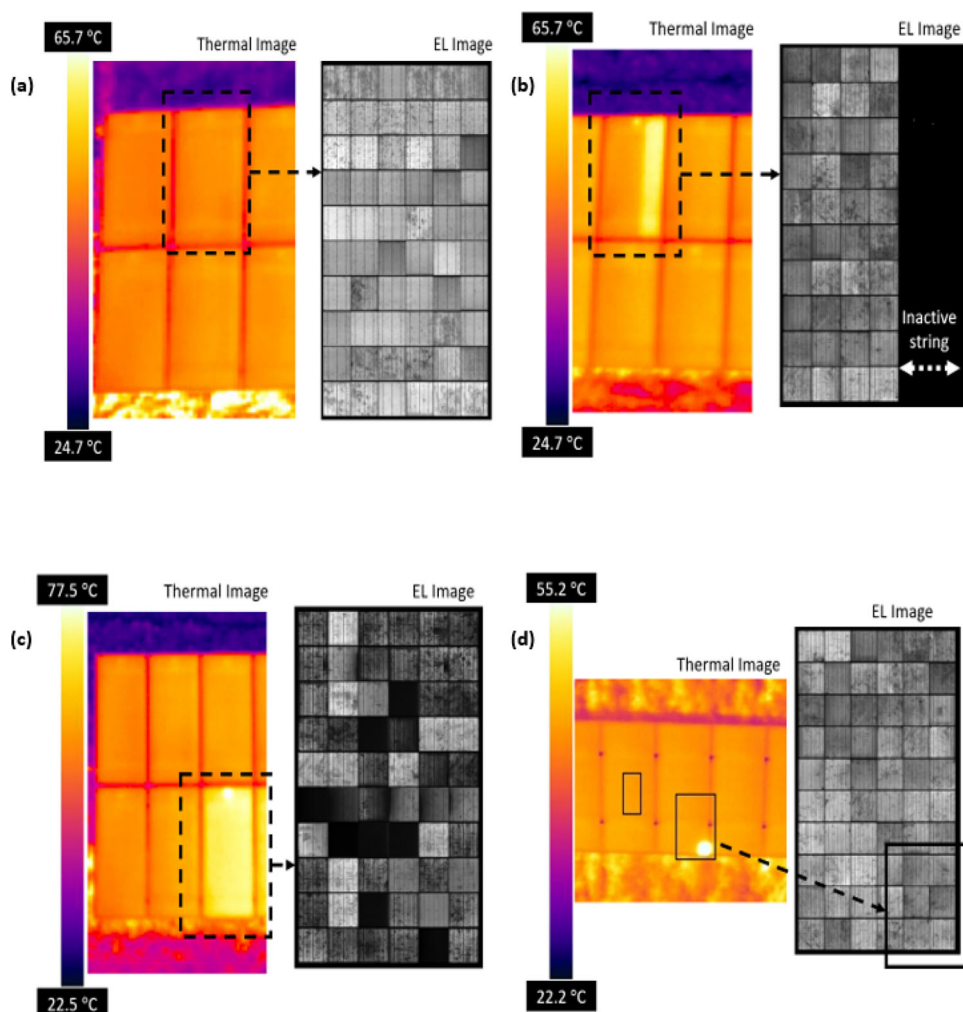
The output thermal vs. EL images of the examined PV modules are shown in Fig. 7. The output thermal vs. EL images of the PV modules examined are shown in Fig. 7. In each case, the EL image intensity decreases (white represents high intensity, and black represents low intensity), indicating that the solar cell is affected by some anomaly:

- (1) According to Fig. 7a, a healthy PV module shows no anomalies the thermal image. The temperature is equally distributed across the surface of the PV modules, with $\Delta T \approx 0^\circ\text{C}$. Consequently, the EL image shows a uniform solar cell structure without any apparent defects/cracks/abnormalities.
- (2) The thermal image presented in Fig. 7b demonstrates a PV module with a heated sub-string with $\Delta T = 17.3 \pm 0.9^\circ\text{C}$. This heated sub-string is mainly due to a faulty bypass diode in the module. It is evident from the EL image that the affected sub-string exhibits no electroluminescent exposure (EL intensity is zero, complete black), providing a complete black-out (inactive) sub-string.
- (3) Figure 7c shows an example of a PV module with a PID with $\Delta T = 21.4 \pm 1.8^\circ\text{C}$. The EL image shows the low intensity of

almost all solar cells, which suggests that the PV module is badly affected by PID.

- (4) Finally, Fig. 7d presents the thermal and EL image of a PV module with a single hotspot, with $\Delta T = 28.7^\circ\text{C}$. The hot spotting problem is evident when examining the thermal image. However, there is no marker of defects when investigating the EL image. This is usually why thermal inspection, not EL, in such cases warrants PV hot spots.

Fig. 7 Different examples of thermal vs. EL images of PV modules. **a** Defect-free PV module. **b** Inactive sub-string due to faulty bypass diode on PV module. **c** PV module is affected by PID. **d** PV module affected by single HS.

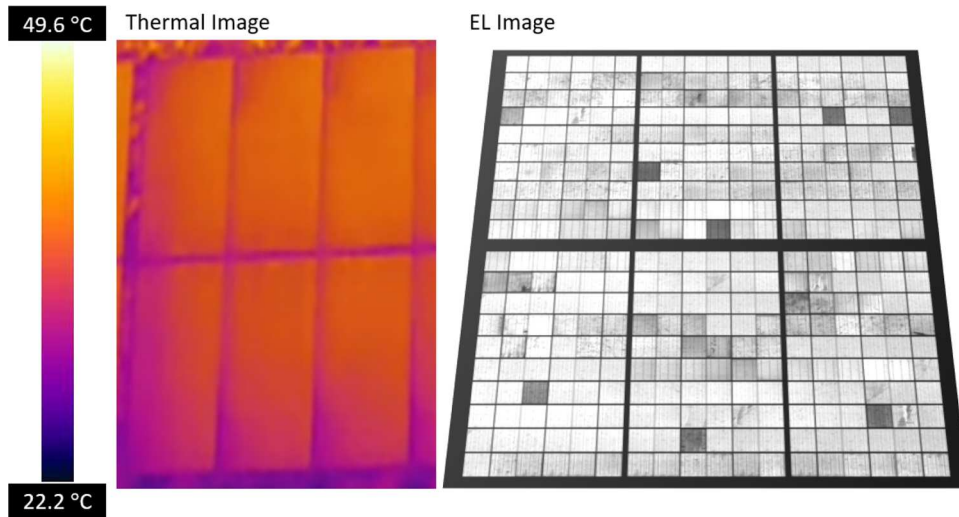
Another comparative example of PV thermal vs. EL image is shown in Fig. 8. When observing the thermal image, no anomalies can be detected. However, almost all six PV modules developed cracks after completing the EL inspection. In addition, multiple solar cells exhibit low EL intensity, which could be due to early PID, shunting, or breakdown regions in the cells. As a result, the EL image assures that if these modules keep operating under field conditions, the cracks will deteriorate, creating hotspots, and thus reducing their power output.

Fig. 8 Another two examples of thermal vs. EL images of PV modules. In spite of the fact that the EL images show that the PV modules have multiple cracks, there is no thermal defect in the modules (the solar cells are not becoming hotter).

This example illustrates the significance of conducting EL inspection on PV modules to observe any early-stage development of defects, cracks, shunting, etc., with the aim of assisting in proposing an early-stage prevention plan to overcome any possible future major breakdown in the modules.

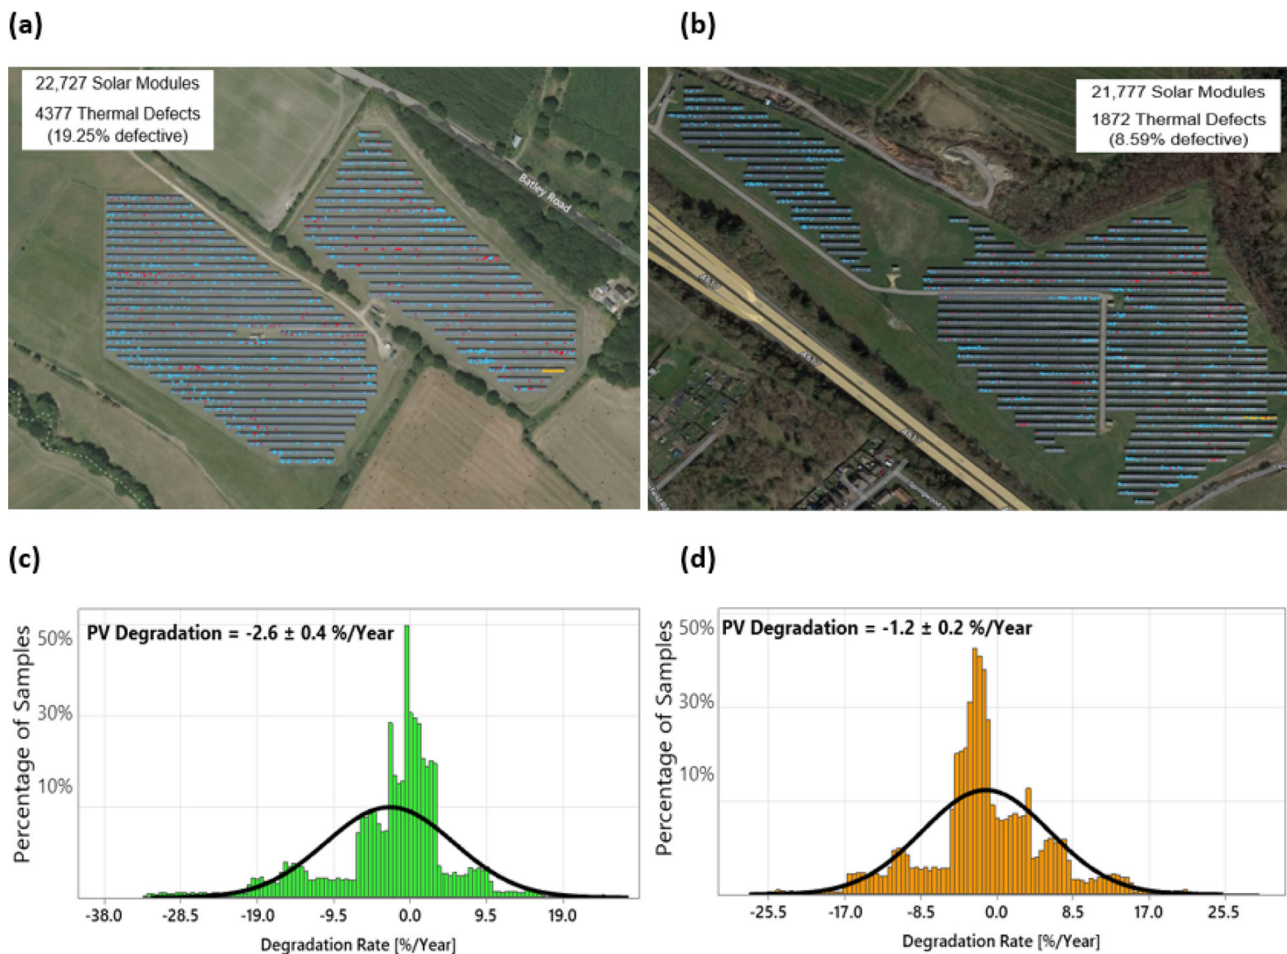
This section demonstrates a comparative analysis of two utility-scale PV installations with a net capacity of 5 MW and 4.9 MW, both commissioned in January 2017. After thermal inspection, the first PV installation (PV installation #1) was found to have 4377 thermal defects (19.25%), whereas 1872 thermal defects (8.59%) were observed in the second PV installation (PV installation #2).

The output energy of both installations was analysed, and the PV degradation was estimated using NREL RdTools¹⁰. The PV degradation for PV installation #1 is equal to $-2.6 \pm 0.4\%$ /year, as shown in Fig. 9c. In comparison, in Fig. 9d, it is shown that the PV installation #2 has less annual PV degradation of $-1.2 \pm 0.2\%$ /year due to being affected by fewer defects. However, the degradation rate of both PV installations is higher than the UK degradation rate estimated previously by², with an average between -0.8% /year or

Fig. 9 A spotlight on two PV installations that have thermal defects. **a** A 5 MW PV installation with 19.25% thermal defects (referred to as PV installation 1). **b** A 4.9 MW PV installation with an identified thermal defect of 8.59% (known as PV installation #2). **c** Estimation of PV degradation for PV installation #1. **d** Estimation of PV degradation for PV installation #2. In January 2017, both PV installations went into operation after being constructed in 2016. A normal distribution fit curve (black curve in the histogram) shows the distribution of the samples.

−0.9%/year. This comparison demonstrates the substantial effect of thermal defects on PV installation's yearly output power. Thus, thermal and EL inspection procedures must be considered, particularly for large-scale PV assets, to determine early-stage anomalies and prevent consequential future PV faults.

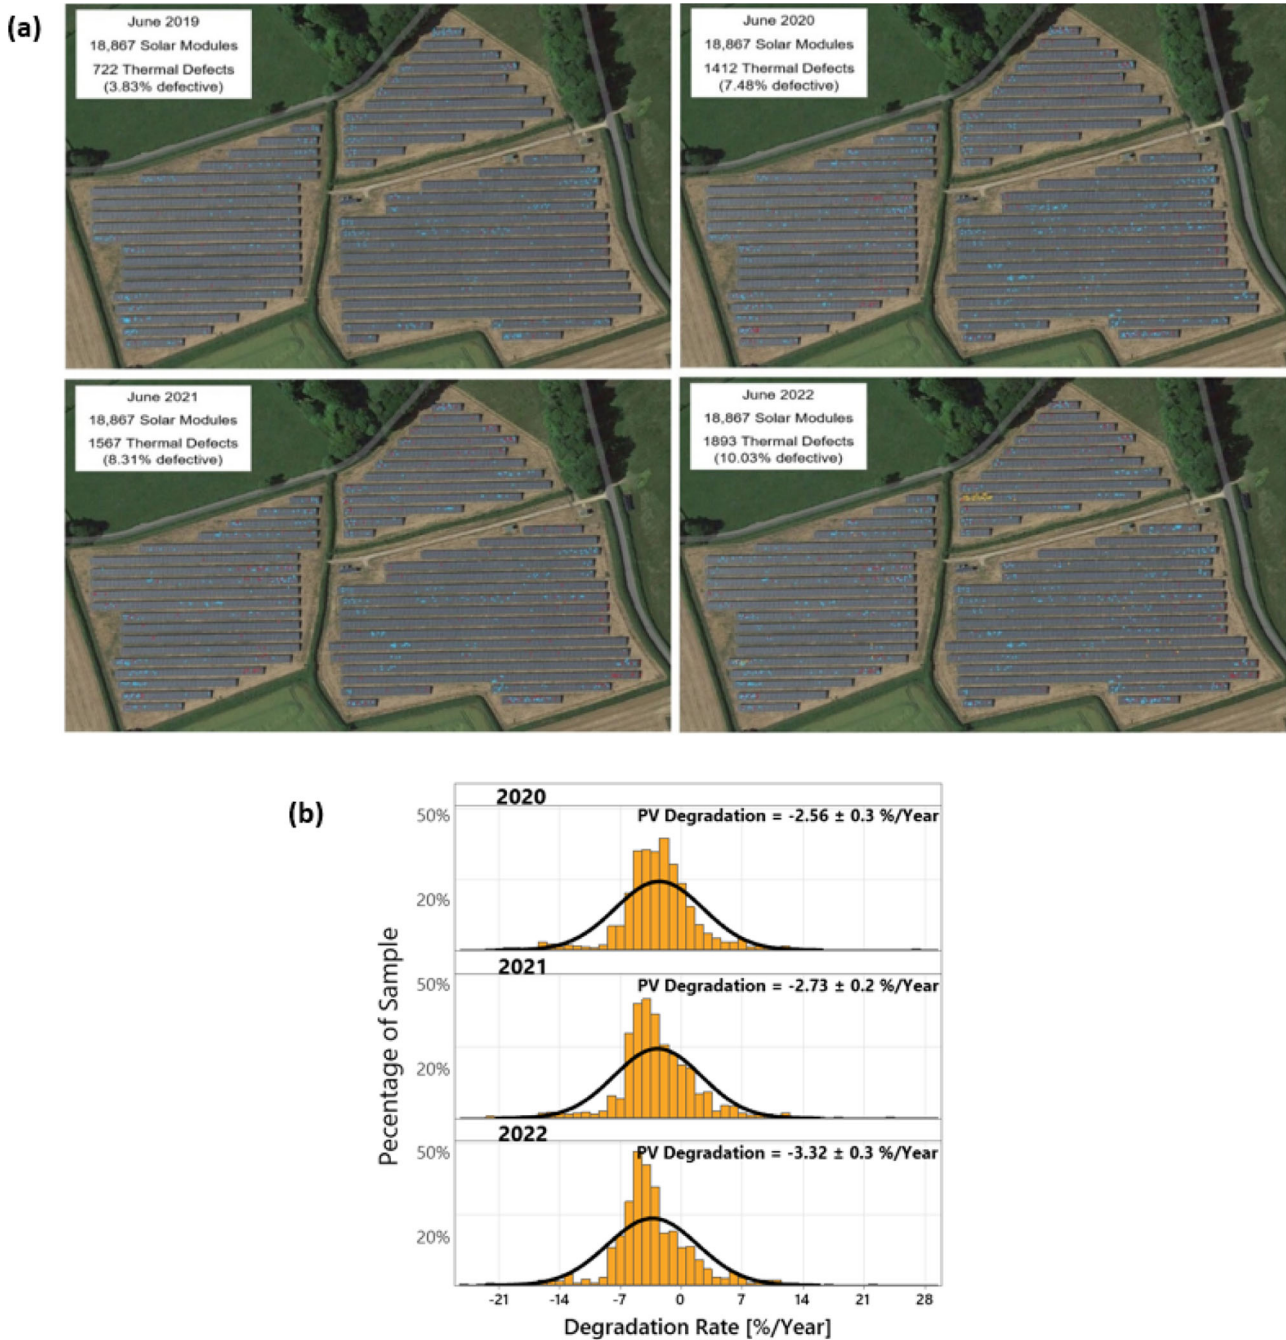
The evolution of thermal defects can accelerate year-to-year, as evidenced by a PV installation in Fig. 10a. The 5 MW PV installation was operational in March 2019, and the first inspection was

completed in June 2019 to find 3.83% thermal defects. These defects grew to 7.48% in the following year. There were 8.31% and 10.03% thermal defects in June 2021 and 2022, respectively. The evolution of thermal anomalies in the system resulted in an additional degradation rate. Figure 10b shows the degradation rate estimation for the three years, 2020 to 2022; obviously, there needed to be more data samples to be analysed in June 2019 due to the PV system being operational for only 3-months since then.

The PV degradation is equal to $-2.56 \pm 0.3\%$ /year in June 2020, and for the subsequent years the degradation is $-2.71 \pm 0.2\%$ /year and $-3.32 \pm 0.3\%$ /year, in June 2021 and 2022, respectively. The data analysed for the degradation calculation was the “total” data gathered for the system. For example, in June 2021, the data used is the cumulation of the data samples taken from day one of operation until June 2021. This result demonstrates how severely the thermal defects affect PV energy generation and would subsequently impact the system with further degradation and reduce its life expectancy.

Fig. 10 Thermal defect evolution in a 5 MW PV installation. **a** Evolution of thermal defect locations over the period 2019–2022. **b** Estimated degradation rate for PV systems over time. The PV system consists of 18,867 solar modules and has been operational since March 2019. It took 3 months after the PV installations were commissioned to complete the first inspection, in June 2019.

In light of the above results, regular thermal inspection of PV installations is essential to prevent the accumulation of thermal defects and implement a recovery plan later. We also show in this paper that EL inspection can be used to identify “hidden” defects that are not yet fully apparent, such as thermal defects in modules.
