Dhimish, Mahmoud and Badran, Ghadeer (2023) Investigating defects and annual degradation in UK solar PV installations through thermographic and electroluminescent surveys. *npj Materials Degradation*. 14. ISSN: 2397-2106

Investigating defects and annual degradation in UK solar PV installations through thermographic and electroluminescent surveys

As the adoption of renewable energy sources, particularly photovoltaic (PV) solar, has increased, the need for effective inspection and data analytics techniques to detect early-stage defects, faults, and malfunctions has become critical for maintaining the reliability and efficiency of PV systems. In this study, we analysed thermal defects in 3.3 million PV modules located in the UK. Our findings show that 36.5% of all PV modules had thermal defects, with 900,000 displaying single or multiple hotspots and ~250,000 exhibiting heated substrings. We also observed an average temperature increase of 21.7 °C in defective PV modules. Additionally, two PV assets with 19.25 and 8.59% thermal defects were examined for PV degradation, and results revealed a higher degradation rate when more defects are present. These results demonstrate the importa

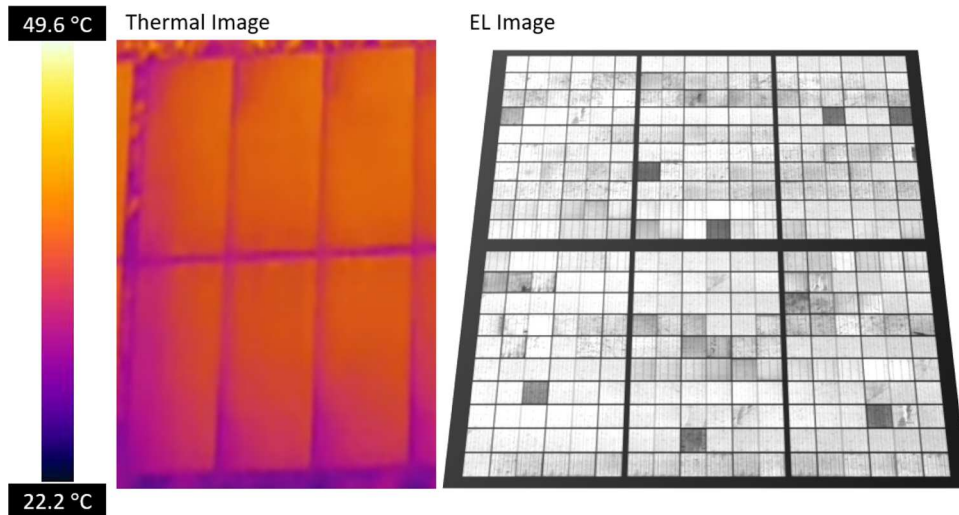
Fig. 8 Another two examples of thermal vs. EL images of PV modules. In spite of the fact that the EL images show that the PV modules have multiple cracks, there is no thermal defect in the modules (the solar cells are not becoming hotter).

Another comparative example of PV thermal vs. EL image is shown in Fig. 8. When observing the thermal image, no anomalies can be detected. However, almost all six PV modules developed cracks after completing the EL inspection. In addition, multiple solar cells exhibit low EL intensity, which could be due to early PID, shunting, or breakdown regions in the cells. As a result, the EL image assures that if these modules keep operating under field conditions, the cracks will deteriorate, creating hotspots, and thus reducing their power output.

This example illustrates the significance of conducting EL inspection on PV modules to observe any early-stage development of defects, cracks, shunting, etc., with the aim of assisting in proposing an early-stage prevention plan to overcome any possible future major breakdown in the modules.
