Doronina, A., Husband, P., Boxall, J. et al. (2023) Influence of service reservoir construction age on the likelihood of bacteriological failure occurrence. Institute of Water Journal (8). pp. 22-25.

# Influence of Service Reservoir Construction Age on the Likelihood of Bacteriological Failure Occurrence

**A.V. Doronina<sup>a</sup>, S. P. Husband<sup>b</sup>, J. B. Boxall<sup>b</sup>, and V. L. Speight<sup>b</sup>**

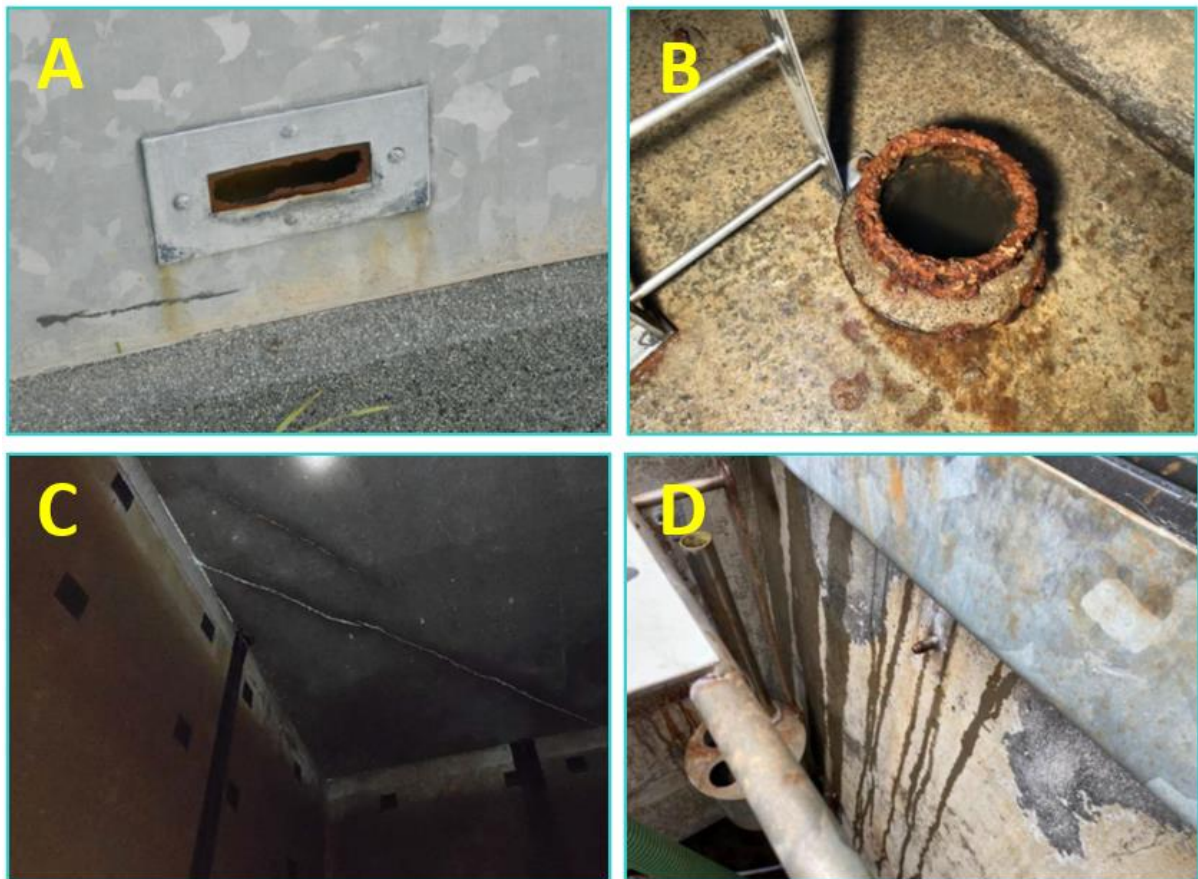
**Figure 1** – A collection of photos showing some common issues seen in service reservoirs: A broken and corroded air vent (A), corrosion of internal structures (B), staining on walls and cracks in the roof (C), and ingress through the seam of an access hatch (D).

There is an assumption in the water industry that the likelihood of occurrence of bacteriological failures is higher in older SRs. Old or poorly constructed SRs can be prone to structural issues, which can lead to ingress and contamination of the stored water with pollutants and bacteria (Craun and Calderton, 2001; Brandt et al., 2016). For example, a *Salmonella* outbreak in Alamosa, Colorado, which resulted in 434 cases, 20 hospitalisations, and 1 death, was linked to animal contamination of a SR that had numerous cracks and inadequately protected entry points (Ailes et al., 2013). Washouts, drainage, overflows, and access hatches in particular present a high contamination risk as they are exposed to the outside environment (DWI, 2018). Protective entry mesh and sealants can become damaged through excessive hydrostatic pressure, corrosion, poor workmanship, age related deterioration, and vermin (UKWIR, 2019). Ensuring water tightness of the SR is difficult and SR components such as roof membranes and wall and floor joints are often the sources of ingress (Hope, 2016). Cracks can form in the walls, roof, and floor of concrete SRs as a result of structural and operational defects like corrosion, thermal contraction, overloading, and poor construction (UKWIR, 2019). Some examples of the aforementioned issues and defects can be seen in Figure 1.
