# Fatigue-Crack Detection in a Multi-Riveted Strap-Joint Aluminium Aircraft Panel Using Amplitude Characteristics of Diffuse Lamb Wave Field

**Abstract:** Structural health monitoring of riveted aircraft panels is a real challenge for maintenance engineers. Here, a diffused Lamb wave field is used for fatigue-crack detection in a multi-riveted strap-joint aircraft panel. The panel is instrumented with a network of low-profile surface-bonded piezoceramic transducers. Various amplitude characteristics of Lamb waves are used to extract information on fatigue damage. A statistical outlier analysis based on these characteristics is also performed to detect damage. The experimental work is supported by simplified modelling of wave scattering from crack tips to explain complex response features. The Local Interaction Simulation Approach (LISA) is used for this modelling task. The results demonstrate the potential and limitations of the method for reliable fatigue-crack detection in complex aircraft components.

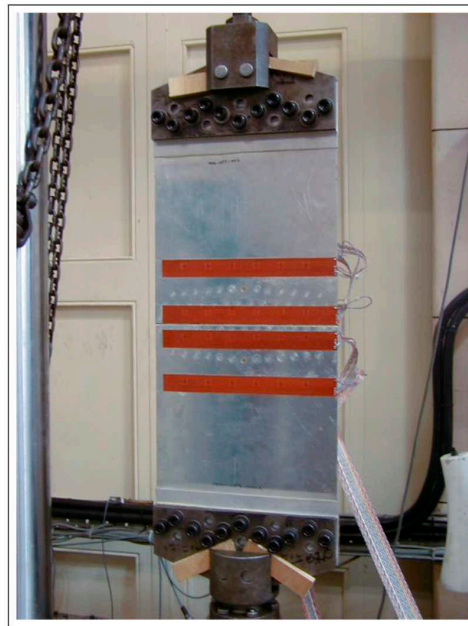
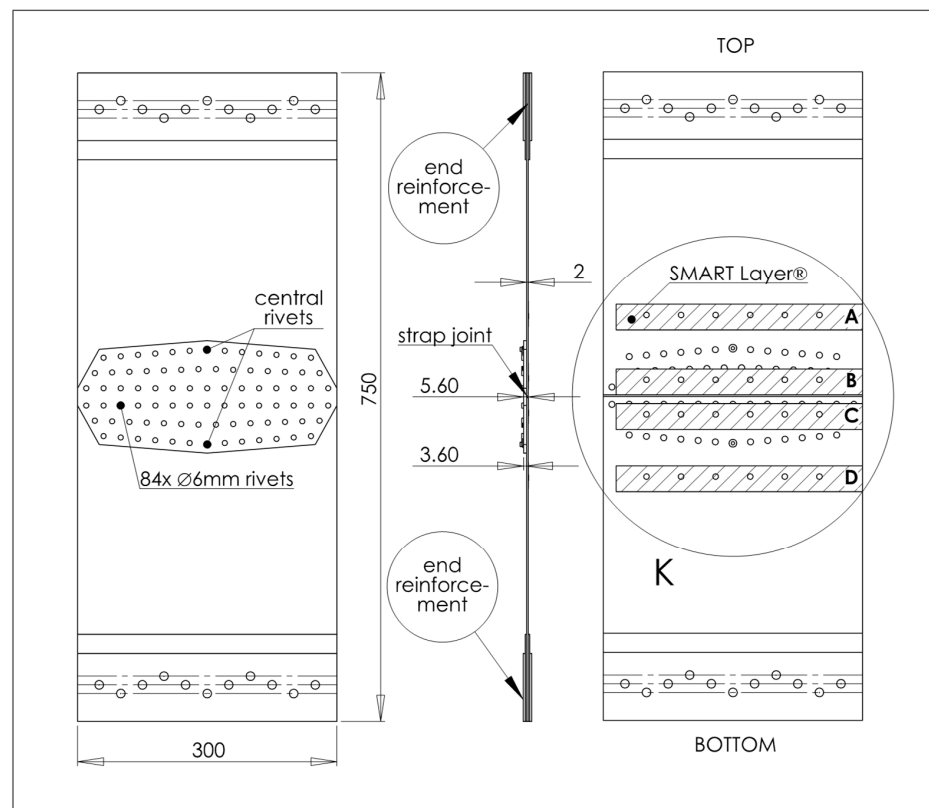
**Figure 1.** Multi-riveted strap joint aluminium panel with bonded A, B, C and D SMART Layer<sup>®</sup> transducers: (a) general view; (b) geometry and dimensions; circle K gives transducer locations that are given in details in Figure 2.

The complex metallic specimen used for the fatigue experiment consisted of two symmetrical aluminium alloy multi-riveted plates that were connected through a strap joint with overall dimensions of  $750 \times 300 \times 2$  mm (Figure 1). The splice joint was fastened to either side by three rows of rivets, adding up to a total of 6 rows with 84 rivets. The specimen was specially designed and manufactured in such a way that it was representative of a standard aircraft splice joint. The only difference to a standard aircraft joint was the intentionally introduced 1.8 mm-long notches on either side of the central rivets by means

of spark erosion. Furthermore, for the central rivets, slightly larger and stiffer rivets were used to ensure that cracks were initiated at those points.

The SMART Layers<sup>®</sup> were symmetrically aligned to the predicted crack propagation path, as shown in Figure 1. Altogether 12 transducer (actuator-sensor) pairs were used to monitor the upper and lower cracks. Figures 1b and 2 label the transducer layers as A, B, C and D. The transducer layers A and B monitored the crack initiated by the upper central rivet while the layers C and D were arranged to monitor the crack emerging from the lower central rivet. The layers A and D were used for excitation, whilst the layers B and C were utilised for reception.

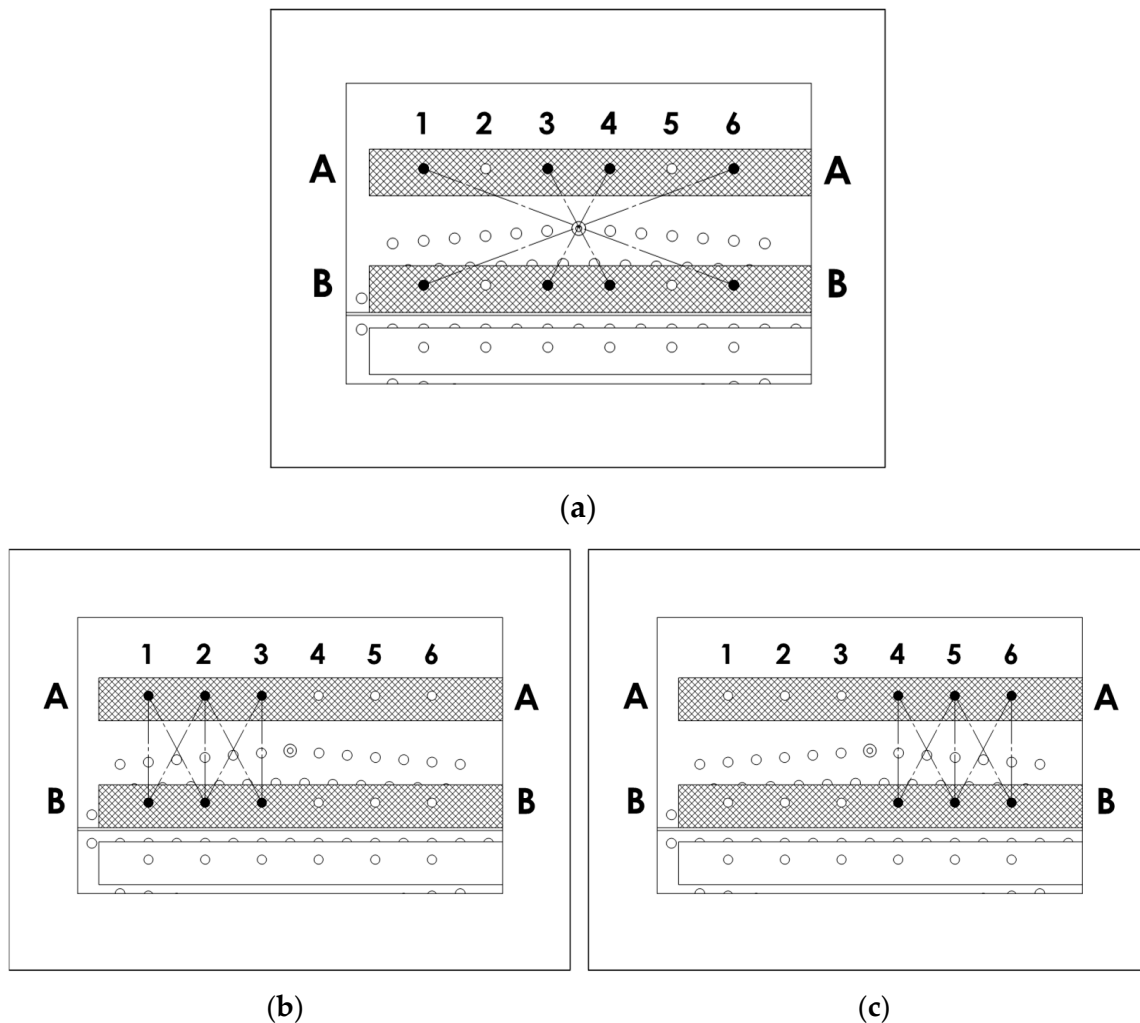
**Figure 2.** SMART Layer<sup>®</sup> transducer locations and wave propagation paths: (a) paths crossing the central rivet—referred to as CENTRAL paths; (b) paths on the LEFT of the central rivets; (c) paths on the RIGHT of the central rivet. A and B indicate two SMART Layers<sup>®</sup> used.

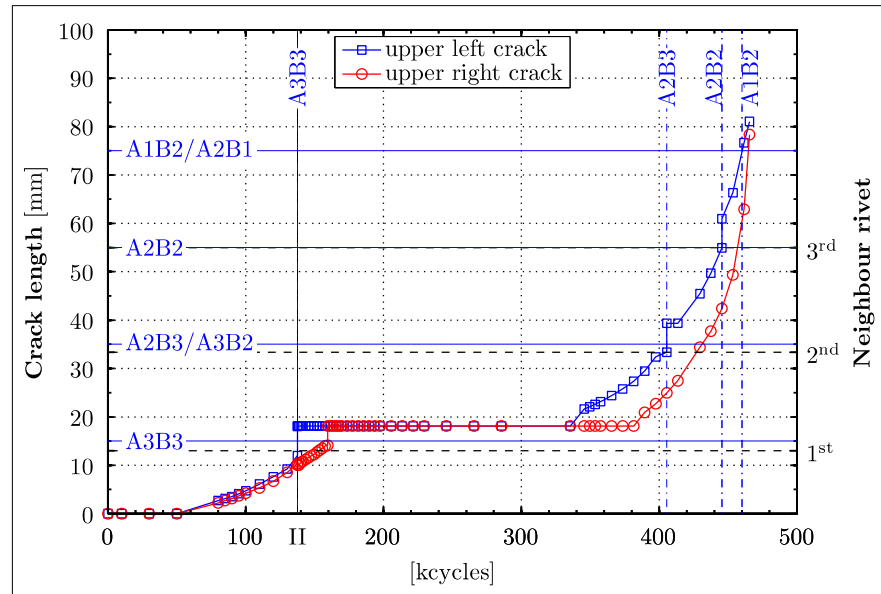
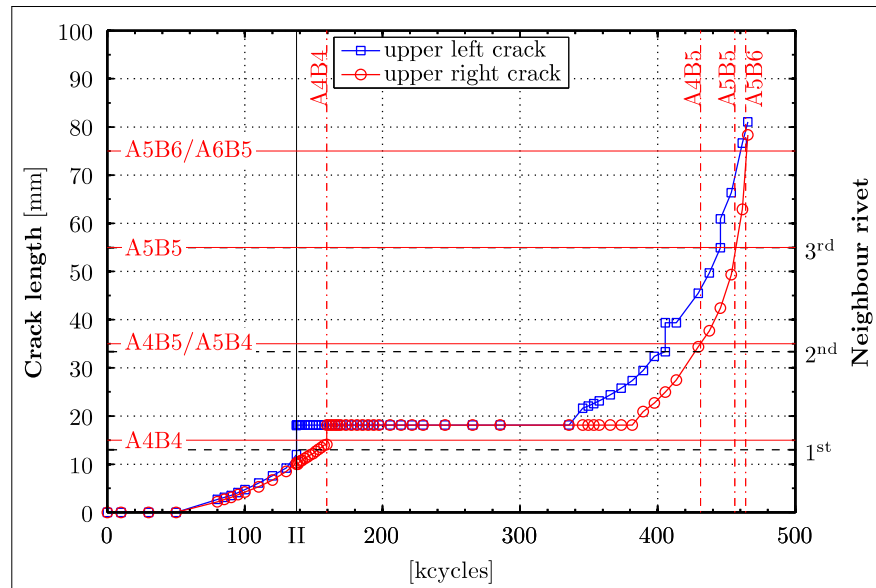
**Figure 3.** Crack propagation curves. The thin vertical solid line (described by the symbol “II”) separates the two experimental tests (PHASE 1 and PHASE 2) investigated. The other lines indicate at which point in time (or after how many fatigue cycles) the cracks intersected the respective wave propagation paths. These other lines are plotted for: (a) LEFT wave propagation paths; (b) RIGHT wave propagation paths.

Figure 3 shows the crack propagation curves. Here, the descriptions “upper crack” (blue line with squares) and “lower crack” (red line with circles) stand synonymously for the cracks in the upper (monitored by the A and B transducer layers), and lower (monitored by the C and D transducer layers) parts of the aluminium panel, respectively. The vertical line (described by the symbol “II”) separates the two experimental tests (PHASE I and PHASE II) investigated. The PHASE I test was completed after 137,500 cycles. Rivets located in the neighbourhood of the central rivet are labelled on the right-hand side vertical axis according to their order of appearance in the crack propagation paths. Only rivets that the crack intersected are described, i.e., the upper left crack propagated through the neighbour rivets 1, 2 and 3 before it left the overlapping area of the splice joint.

The crack measurements only present visible crack lengths on the reachable outer surface of the specimens. The vertical leaps in the crack length of Figure 3 only indicate that the respective cracks intersected rivets, leading to a sudden increase in the crack length, since the far side of the rivet hole with respect to the central rivet becomes suddenly relevant.

The crack lengths presented in Figure 3 show unambiguously that the PHASE I test was stopped when only the upper left crack reached the first neighbour rivet hole. Figure 3 demonstrates that the upper right crack required 22,000 load cycles more to reach its first neighbour rivet; it also shows that the crack lengths remained constant for a considerable number of cycles in the PHASE II test. This behaviour arose as the propagating cracks encountered rivet holes which have—because of their perfectly circular-shaped rivet diameter—a significantly lower crack intensity factor than the original crack. Thus, once a crack has reached a rivet, a new crack had to be initiated, hence slowing down and

The vertical auxiliary lines in Figure 3 indicate where the left and right crack intersected the corresponding wave propagation paths. These vertical auxiliary lines will be shown in subsequent damage detection graphs, providing a visual aid for the performance analysis of the features relevant to damage detection.

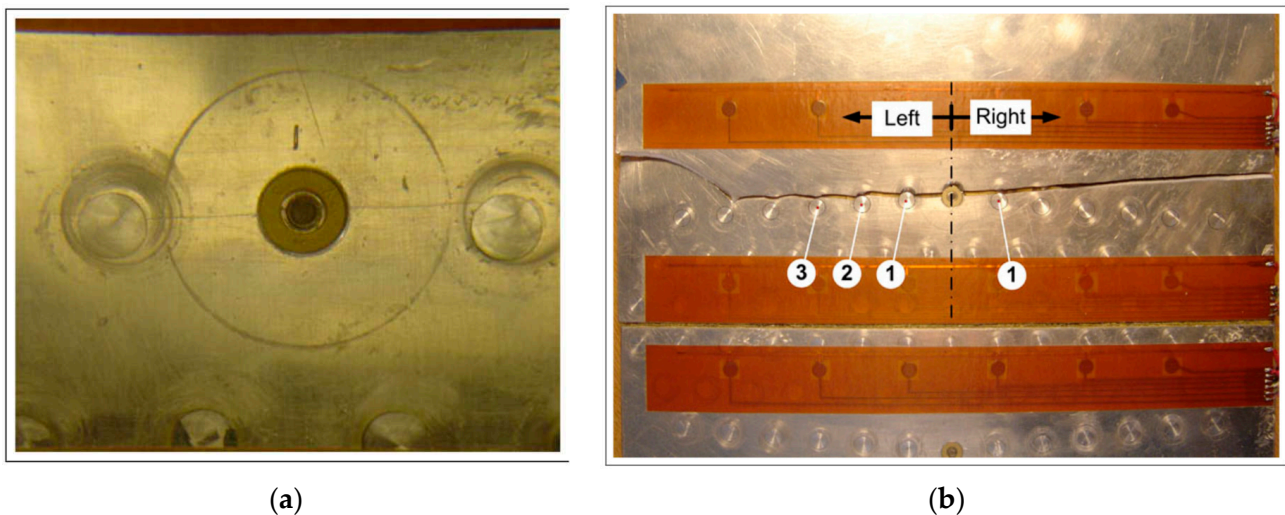
**Figure 4.** Monitored fatigue crack: (a) after 347,500 fatigue cycles; (b) completely fractured panel after 465,500 fatigue cycles. Numbers indicate consecutive rivets to the left and right side from the central rivet.

The first nearly 5 mm crack was measured after 80,000 cycles. Figure 4a shows the photograph of the upper crack after 347,500 cycles, whereas Figure 4b gives the photographs of the fractured metallic panel after 465,500 cycles.

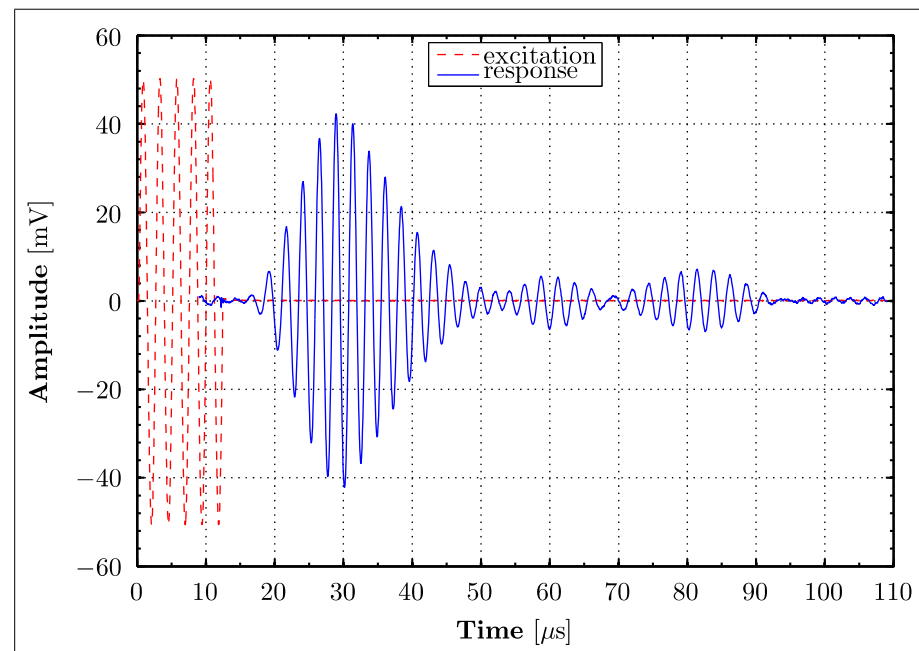
**Figure 5.** Excitation signal (scaled 1:100) and an example of the Lamb wave response for the A5B4 wave propagation path (undamaged condition).

A burst signal consisting of five cycles of sine waves was used for Lamb wave generation. The amplitude of excitation was equal to 10 V. An excitation frequency of 410 kHz was applied for Lamb wave generation. Since a diffuse Lamb wave field was used for damage detection, this frequency was selected experimentally using a trial-and-error approach to generate responses with the best SNR. The excitation signal was generated using TTi TGA1230 and TGA1242 waveform generators in the PHASE I and PHASE II tests, respectively. The data acquisition was accomplished using a LeCroy 9304 AM and LeCroy Waverunner LT264 oscilloscopes in the PHASE 1 and PHASE 2 tests, respectively. Signals were sampled at 25 MS/s in both tests. When the PHASE 1 test was performed each signal consisted of 2500 samples, giving the time span of 100  $\mu$ s. The number of samples and time span were increased to 5000 and 200  $\mu$ s, respectively, in the PHASE 2 test. Final responses for each investigated sensor path were averaged 10 and 50 times in the PHASE I and PHASE II tests, respectively. Data averaging was used to improve the Signal-to-Noise-Ratio (SNR). Signal responses were saved to the built-in disk drive of the oscilloscope and transferred to a PC for further analysis. Initial data acquisition tests were performed to show redundancy and repeatability, and hence to eliminate possibly erroneously measured data sets. All Lamb wave signals were taken while the specimen was exposed to a static load of 22 kN in the servo-hydraulic test machine. Figure 5 gives an example of the excitation and response signals.

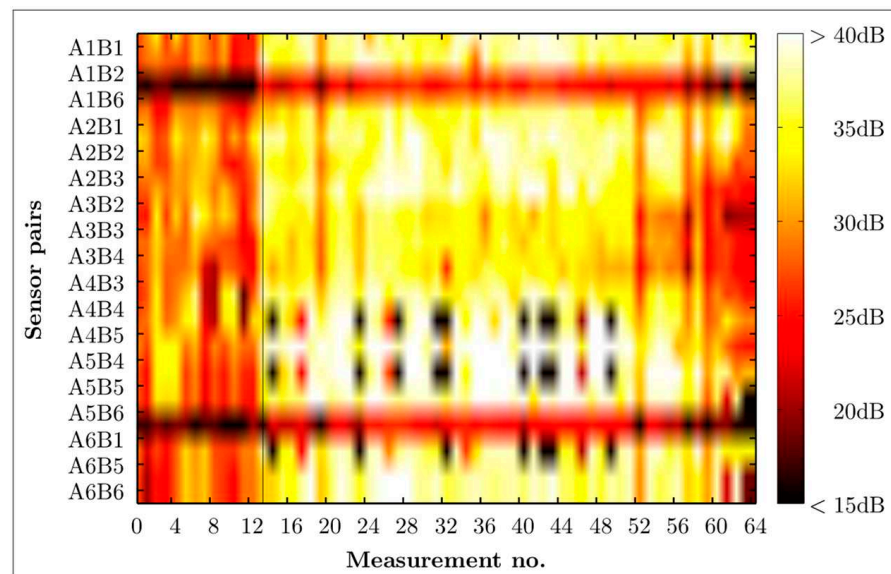
**Figure 6.** Matrix of SNR estimates for all transducer combinations in the AB layout AB. The vertical thin black line indicates the separation of Phase 1 and Phase 2 experimental tests.

Figure 6 gives a matrix of the SNR estimates for the number of measurements versus the utilised wave propagation path (transducer pair). Two different areas can be identified in Figure 6. Firstly, a generally darker area (mainly around 30 dB) comprising measurements from the beginning until the measurement number 13 for all transducer pairs, and secondly, all remaining measurements which appear generally in brighter colours (principally around 35 dB), hence exhibiting higher SNR. Those two areas demonstrate nicely the influence of the number of averages taken for one measurement, because only 10 averages built the basis for each measurement in the PHASE I test, while a recorded acoustic signal in the PHASE II test was the result of 50 averages. In other words, ensemble averaging is a simple and practical method to reduce the effect of noise in measured signals, and thus improves the SNR, as expected. Moreover, the results show that the transducer combinations A1B6 and A6B1 have low SNR—as indicated by a darker colour (horizontal bars)—compared to the SNR estimates of the remaining measurements.

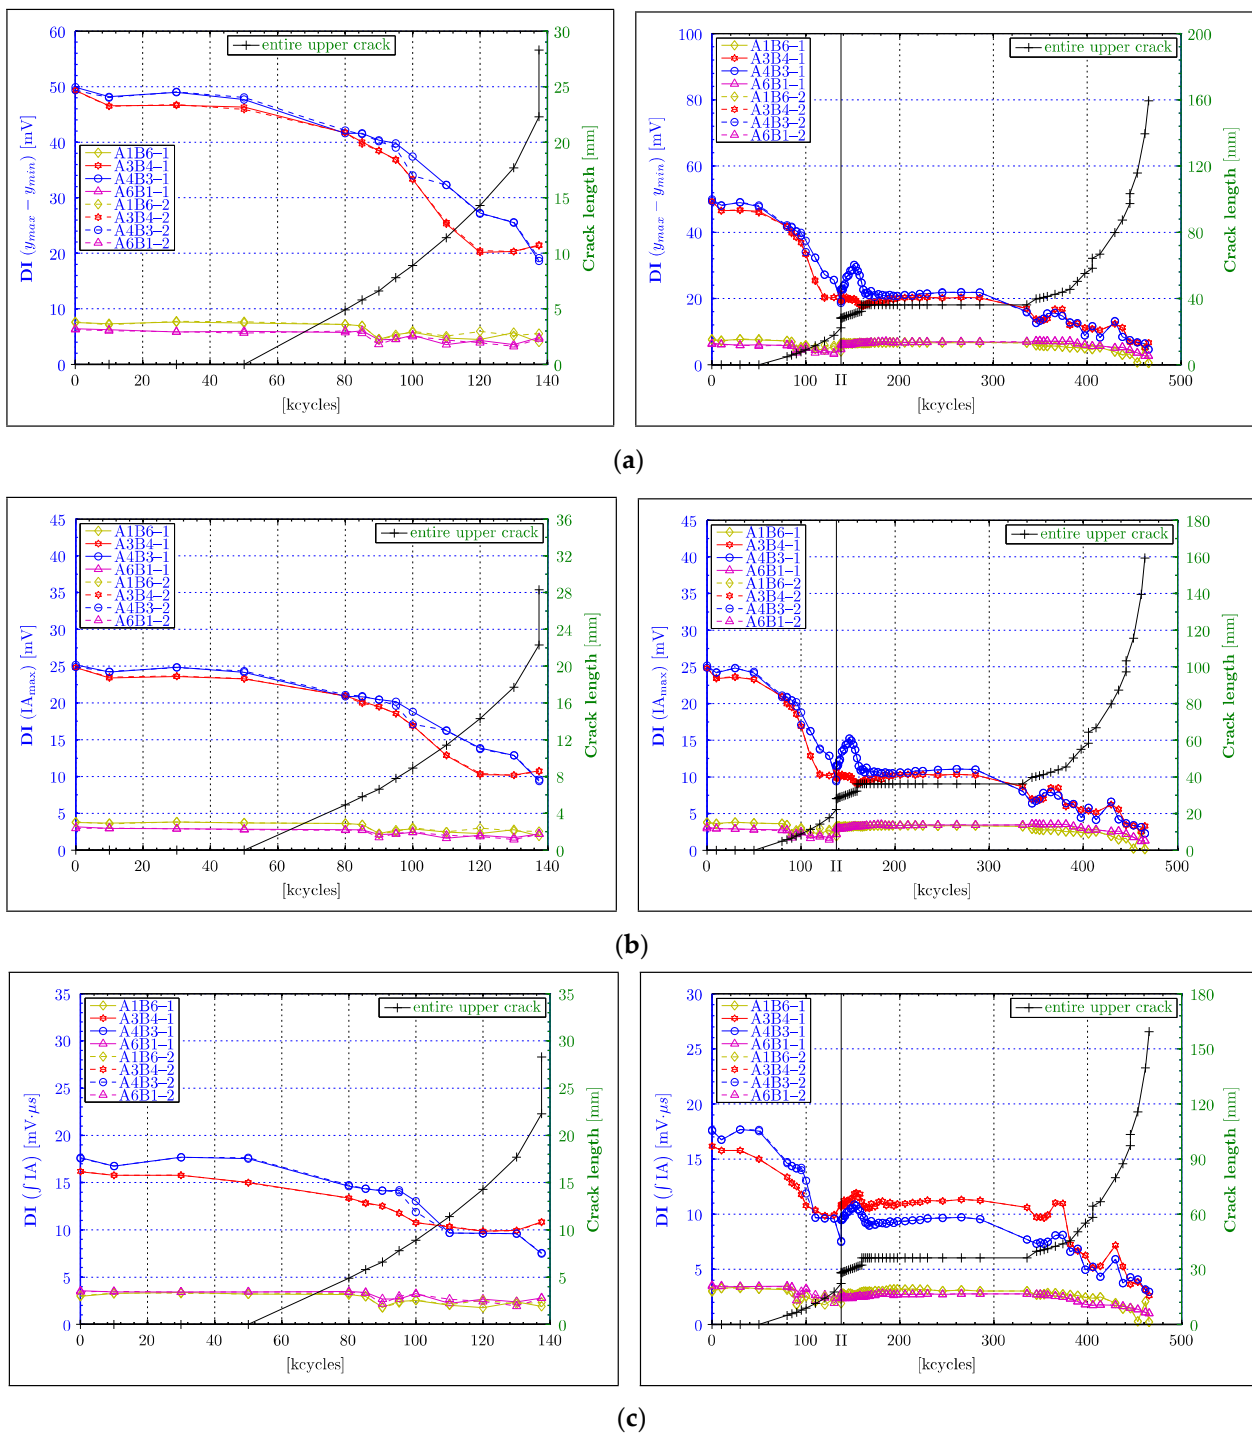
**Figure 7.** Crack detection results for the CENTRAL wave propagation paths. Damage indices are based on: (a) maximum peak-to-peak amplitude; (b) maximum instantaneous amplitude (envelope); (c) integrated instantaneous amplitude. The left column gives the results corresponding to only the PHASE 1 experimental test (from 0 to 147,500 fatigue cycles only) whereas the right column presents the results for the PHASE 1 and PHASE 2 experimental tests. The thin vertical solid line (described by the symbol “II”) separates the two experimental tests (PHASE 1 and PHASE 2) investigated.

Figures 7a, 8a and 9a shows the results for the peak-to-peak amplitude calculated for all Lamb wave responses for the CENTRAL, LEFT and RIGHT wave propagation paths respectively, as defined in Section 2.2. The left column in these figures presents the results for the PHASE 1 experimental test (i.e., up to 137,000 fatigue cycles), whereas the right column gives the overall results for the PHASE I and PHASE II experimental tests (i.e., up to 465,500 cycles). The beginning of the PHASE II experimental test (after 137,500 cycles) is indicated by the black vertical line labelled with the Roman numeral “II”. The results are plotted versus load cycles. In order to uncover any correlation between the analysed damage index and crack length, two separate vertical axes are used. The blue ordinate axis on the left is dedicated to the peak-to-peak amplitude, and the green ordinate axis on the right describes the crack length. The black line with “+” symbols gives the crack propagation curve. Two sets of results for each analysed transducer pair are presented to give an indication of the variation of measurements when subsequent actuators are swapped with sensors. Additional numbers, i.e., 1 and 2, are attached to the transducer labels in the legends to account for these two data sets.

The results for the A3B4 and A4B3 wave propagation paths in Figure 7a monotonically decrease with increasing crack length. As the wave propagation length for the A1B6 and A6B1 paths is considerably longer (more than 2.5 times of A3B4 or A4B3), the attenuation of the waves increases, resulting in relatively low amplitude values ( $\pm 5$  mV) in the waveforms, and hence low peak-to-peak values ( $< 10$  mV). For that reason, their respective damage indices can only show small reductions throughout the entire experiment. Those reductions can only be really noticeable towards the end of the experiment (i.e., after 340,000 cycles). After the experiment was resumed (after 137,500 cycles), a localised peak—that is difficult to explain—can be observed around 162,500 cycles for the A4B3 path. Nevertheless, the results for the A3B4 and A4B3 paths demonstrate a good correlation with damage severity, as they remain constant, following the constant size of the crack and reducing further as soon as the crack continued to grow (after approximately 340,000 cycles). However, this reduction is not monotonic, as small oscillations can be observed in this range of cycles. This particular behaviour is further examined in Section 5.

As the instantaneous amplitude only generates a one-sided (positive ordinate) envelope function, the correspondingly extracted maximum values should generally only represent half the magnitude of the corresponding peak-to-peak values. Figure 7b is indeed a scaled version of Figure 7a with a scale factor of 0.5. Even in the area of transition at 137,500 cycles, no differences (apart from scaling) can be observed. This finding can be extended to the PHASE II experimental test, as no new results or insight are gained from those diagrams. Equally to the central paths, the DI based on the maximum instantaneous amplitude on the left (Figure 8b) and right (Figure 9b) paths just embodies scaled versions of the respective peak-to-peak DI for all the phases of the experiment. For the left path, this outcome can be observed in Figure 8b and compared with Figure 8a. The respective figures for the right paths are displayed in Figure 9b and can be compared with Figure 9a.

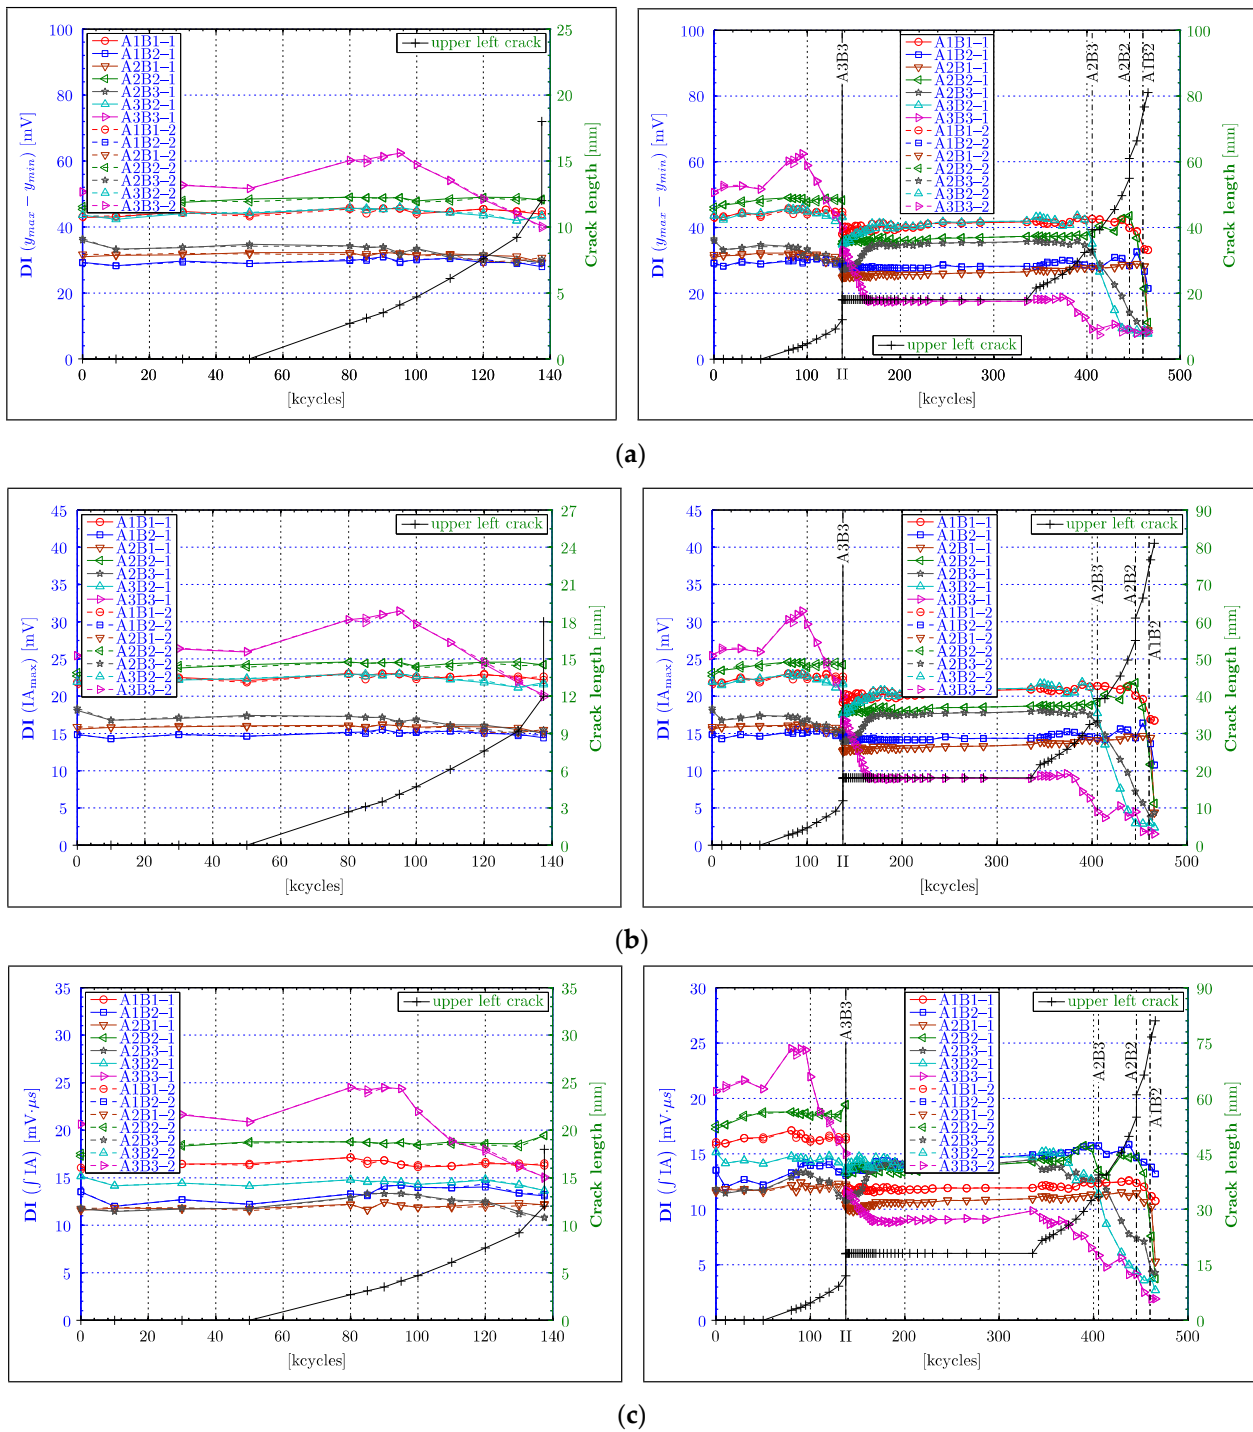
**Figure 8.** Crack detection results for the LEFT wave propagation paths. Damage indices are based on: (a) maximum peak-to-peak amplitude; (b) maximum instantaneous amplitude (envelope); (c) integrated instantaneous amplitude. The left column gives the results corresponding to only the PHASE 1 experimental test (from 0 to 147,500 fatigue cycles only) whereas the right column presents the results for the PHASE 1 and PHASE 2 experimental tests.

Unlike the graphs in Figure 7a, the majority of graphs in Figure 8a for the LEFT paths exhibit the expected constant values throughout the PHASE I experimental test. Only the characteristics for the A3B3 path diverge from this behaviour. These characteristics demonstrates considerably elevated peak-to-peak values between 80,000 and 95,000 cycles despite the continuously growing crack. However, after 100,000 cycles, the same charac-

teristics exhibit an almost perfect linearly decreasing damage index, until the end of the PHASE I experimental test. This behaviour coincides with theoretical expectations, as the A3B3 path is supposed to indicate the occurrence of damage amongst the LEFT paths first. Furthermore, Figure 8a confirms the dependence between amplitude and the propagation length, as the direct paths AnBn (for  $n = 1, 2$  or  $3$ ), with the length of 75 mm, generally demonstrate higher peak-to-peak values compared to the diagonal paths with the length of 85 mm. In the transition from the PHASE I to the PHASE II experimental tests in Figure 8a, misalignments in damage indices can be noticed. However, these differences seem to be only really obvious for the group of paths that exhibit generally high amplitudes (i.e., A2B2, A1B1, A3B2, A3B3), in the PHASE I experimental test. Similar to the observation made for the A4B3 path (Figure 7a), undesired effects appear to obscure the course of the damage index at the beginning of the PHASE II experimental test in Figure 8a. Those effects are particularly apparent for the A3B3, A2B3 and A3B2 wave propagation paths from 137,500 to 175,000 fatigue cycles. The continuing reduction of the DI for the A3B3 path in this range, despite the constant crack length, can probably be explained by a subsurface crack growth or another form of material deterioration affecting wave propagation. However, the DIs for the A2B3 and A3B2 paths demonstrate an increase in amplitude in this particular range of cycles (i.e., 137,500–175,000 cycles). This effect is difficult to explain. A reversible ageing effect of the piezoelectric material—described in transducers (*Physik Instrumente GmbH & Co. KG*, 2008, Karlsruhe, Germany)—is a possible explanation. However, this needs further investigation. The DIs of all the LEFT paths remain constant after 175,000 cycles until 380,000 cycles, which is beyond the point (approx. 335,500 cycles) when the upper left crack continued growing again. Clearly, the continuous growth of the upper left crack (after 335,500 cycles), for a duration of circa 40,000 cycles, is worryingly not reflected by any DI. A further reduction in the amplitude is exhibited only by the A3B3 characteristic at about 380,000 cycles. At about 400,000 cycles, the DIs for the A2B3 and A3B2 paths commence detecting the crack. This instance almost coincides with the crack intersecting the A2B3 and A3B2 paths, indicated by the vertical line labelled as “A2B3”. Furthermore, these characteristics demonstrate an ideal monotonically decreasing behaviour until the end of the experiment. Following the transducer layout, the A2B2 path, followed by A1B2 and A2B1 paths, are supposed to indicate a reduction in the DI at the correspondingly labelled vertical lines. The A2B2 path shows a steep drop after 445,500 cycles, which is in good agreement with crack propagation, despite unexplainable oscillations beforehand. A similar unexpected increase in the DI is exhibited by the result for the A1B2 path. However, the A1B2 and A2B1 paths demonstrate a considerable reduction in peak-to-peak amplitude after 453,500 cycles, allowing the conclusion that they detect the crack. For some unapparent reason, the DI of the A1B1 path seems to outperform those of the A1B2 and A2B1 paths, as it shows a nice monotonically declining characteristic, starting from 437,500 cycles, while the A1B2 and A2B1 paths exhibit the previously mentioned oscillations.

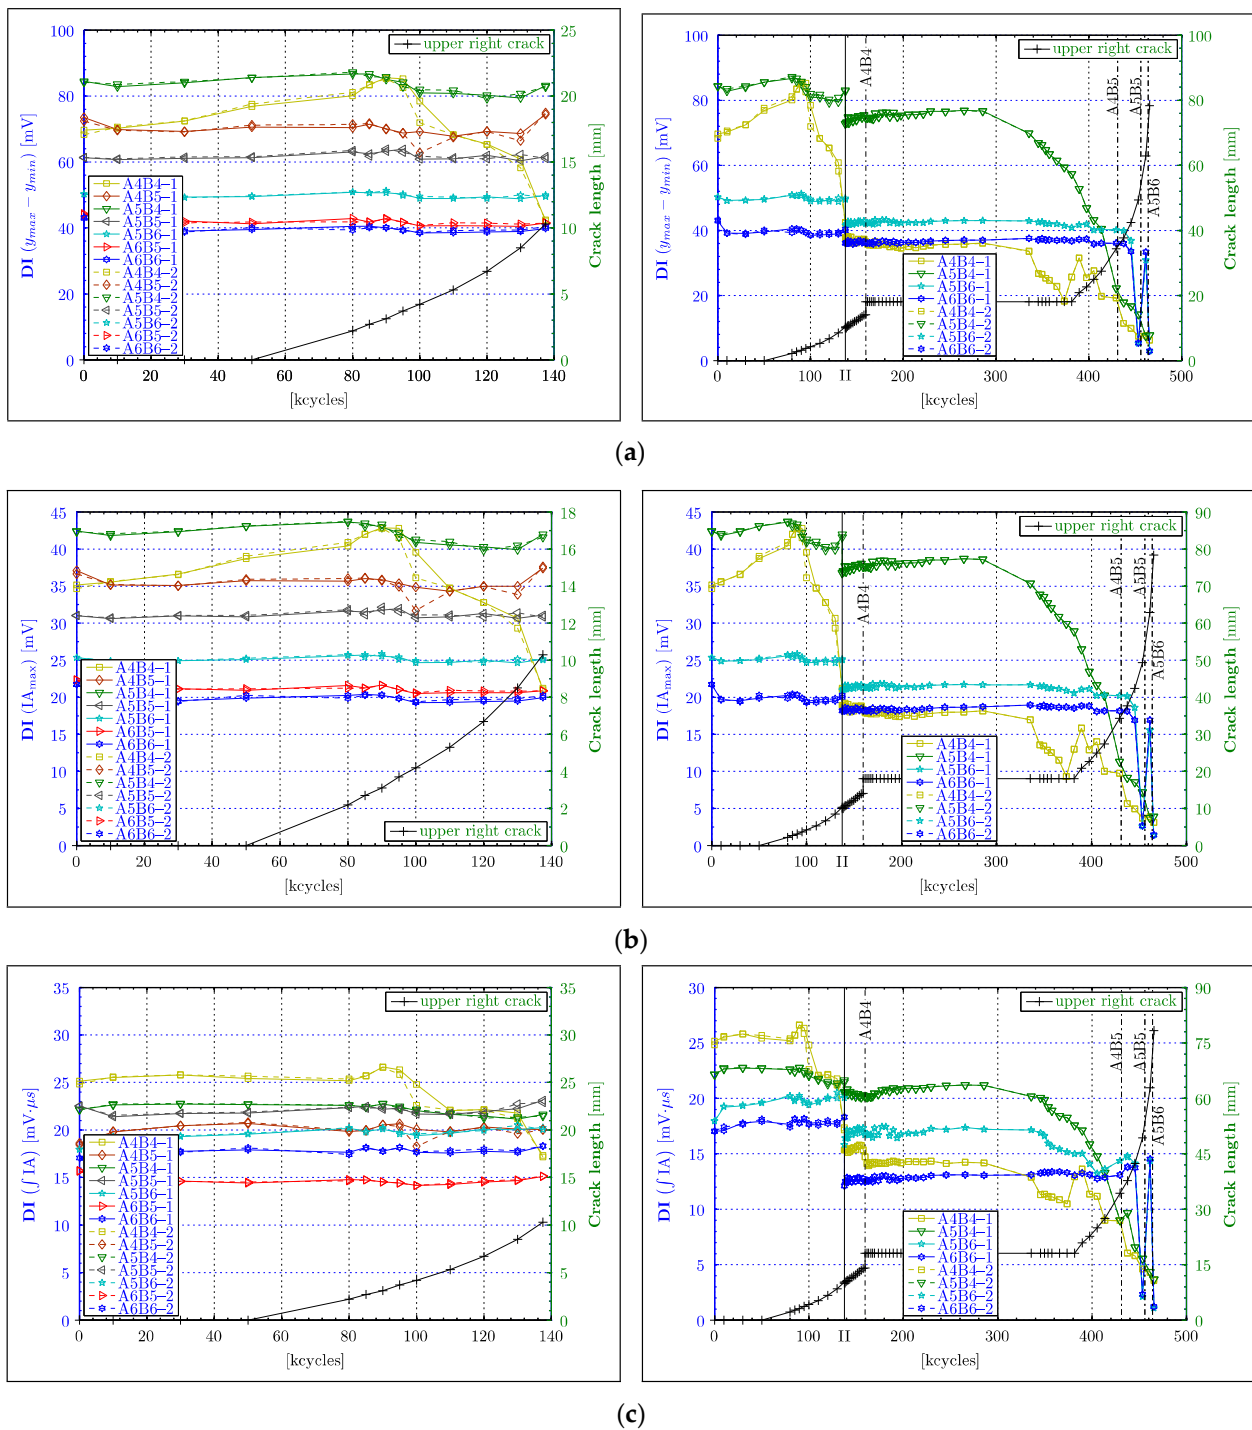
**Figure 9.** Crack detection results for the RIGHT wave propagation paths. Damage indices are based on: (a) maximum peak-to-peak amplitude; (b) maximum instantaneous amplitude (envelope); (c) integrated instantaneous amplitude. The left column gives the results corresponding to only the PHASE 1 experimental test (from 0 to 147,500 fatigue cycles only) whereas the right column presents the results for the PHASE 1 and PHASE 2 experimental tests.

Similar to the observation made for the DIs of the LEFT paths, the majority of characteristics for the RIGHT paths remain relatively constant in Figure 9a. Moreover, the A4B4 path, which is the analogue of the A3B3 path but on the right of the central rivet, exhibits equally increasing peak-to-peak amplitude before it starts to decline. However, in contrast to the LEFT paths, a correlation between wave propagation length and signal strength (i.e., amplitude) cannot be found, as even diagonal paths with slightly longer propagation lengths demonstrate a high level of peak-to-peak values. In fact, the DI for the A5B4 path appears to have by far the highest level of amplitude from all the paths used in the experiment, surmounting the amplitudes of the A4B4 and A4B5 paths. In the analysis so far, almost no, or only very small, deviation between the two data sets, taken for each acoustic path and damage state, could be observed. This observation, however, is different for the DIs for the A4B4 and A4B5 paths at 100,000 cycles, as the two respective measurements demonstrate a considerable deviation from each other by almost 10% (Figure 9a). The reason for these considerable deviations could not be established. An offset between all the DI traces in the transition from the PHASE I to the PHASE II experimental tests in Figure 9a can be noticed,

as was discernible for the LEFT paths. However, the offsets between the characteristics seem to be rather consistent, showing an almost proportional reduction with respect to the value of amplitude. The analysis of the peak-to-peak data for the PHASE II experimental test in Figure 9a (right column) seems to be rather complicated. Firstly, the DI for the A5B4 path significantly decreases monotonically after 285,500 cycles, even though the crack remains constant for nearly another 100,000 cycles (i.e., up to 381,500 cycles). Secondly, the peak-to-peak values for the A4B4 path begin to decline at the same cycle count, but they behave highly non-monotonically because of an incomprehensible zigzag pattern in the course of the presented characteristic. Thirdly, the graphs for the A5B6 and A6B6 paths remain constant with no indication of damage, almost until the end of the experiment, before they synchronously exhibit an even more volatile behaviour than observed from the characteristic for the A4B4 path. The supposedly premature detection of damage from the results for the A5B4 and A4B4 paths can be explained by unnoticed or subsurface crack growth beginning at 285,500 cycles. However, the highly volatile course of the DIs spoils the analysis of the A4B4 path at least after 381,500 cycles. Equally questionable and less useful are data obtained for the A5B6 and A6B6 paths after 445,500 cycles.

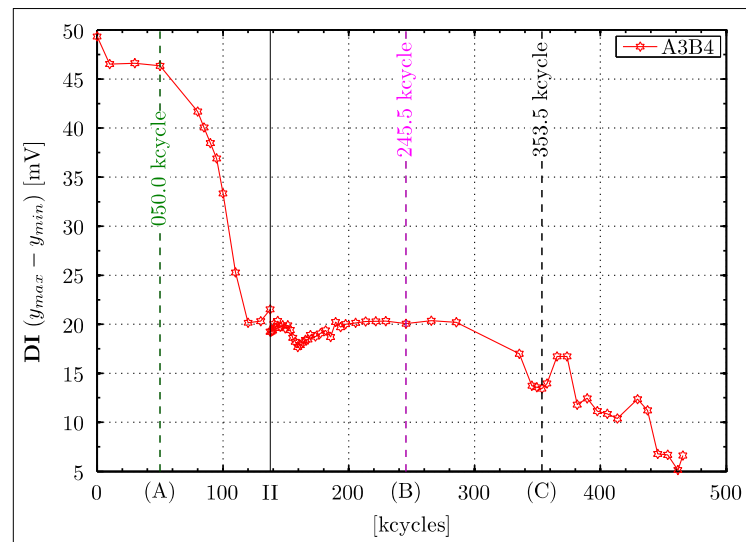
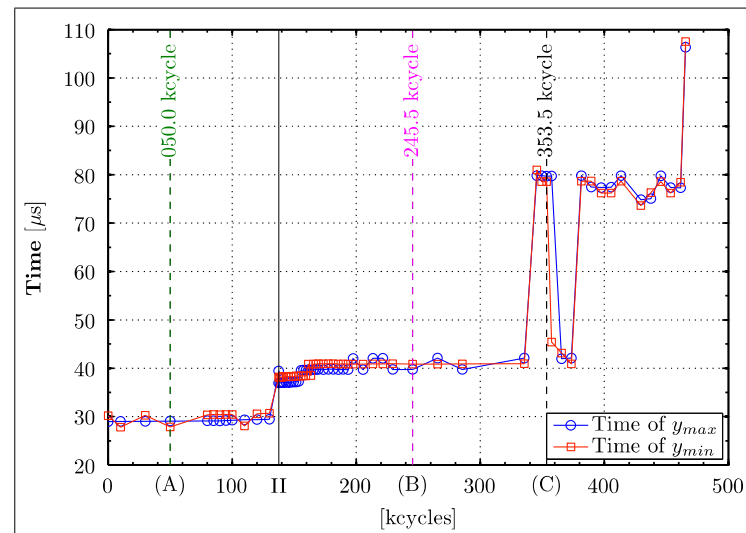
**Figure 10.** Extraction of peak-to-peak values for the A3B4 wave propagation path for consecutive fatigue cycles: (a) damage index based on the peak-to-peak value; (b) temporal location of respective maxima and minima used for peak-to-peak amplitude evaluation.

The peak-to-peak value estimation involves the extraction of the global maximum and minimum of the entire Lamb wave response. The question is why the peak-to-peak value sometimes exhibits an undesired unsteady behaviour, as for example the DI characteristics—based on the A3B4 and A4B3 wave propagation paths (Figure 7a between 105,000 and 135,000 fatigue cycles, and after 330,000 cycles). Figure 10 sheds some light on this particular issue, as the DI based on the Lamb wave response for the A3B4 wave propagation path (Figure 10a) is contrasted with the time coordinates of the extracted maximum and minimum (Figure 10b). This analysis—equivalent to the time-of-flight based on respective extreme values—demonstrates very nicely that the order in which the maxima and minima are extracted constantly changes throughout the experiment. This issue is particularly relevant to the behaviour exhibited in Figure 10b around 120,000 and after 335,000 fatigue cycles, where large disturbances can be observed. One possible solution to this problem is the analysis of the instantaneous amplitude (envelope function). This instantaneous characteristic was calculated for all Lamb wave responses following the procedure described in Section 3. The maximum of the instantaneous amplitude was calculated for all Lamb wave responses. Figures 7b, 8b and 9b give the results, the DI characteristics based on the maximum of the instantaneous amplitude.

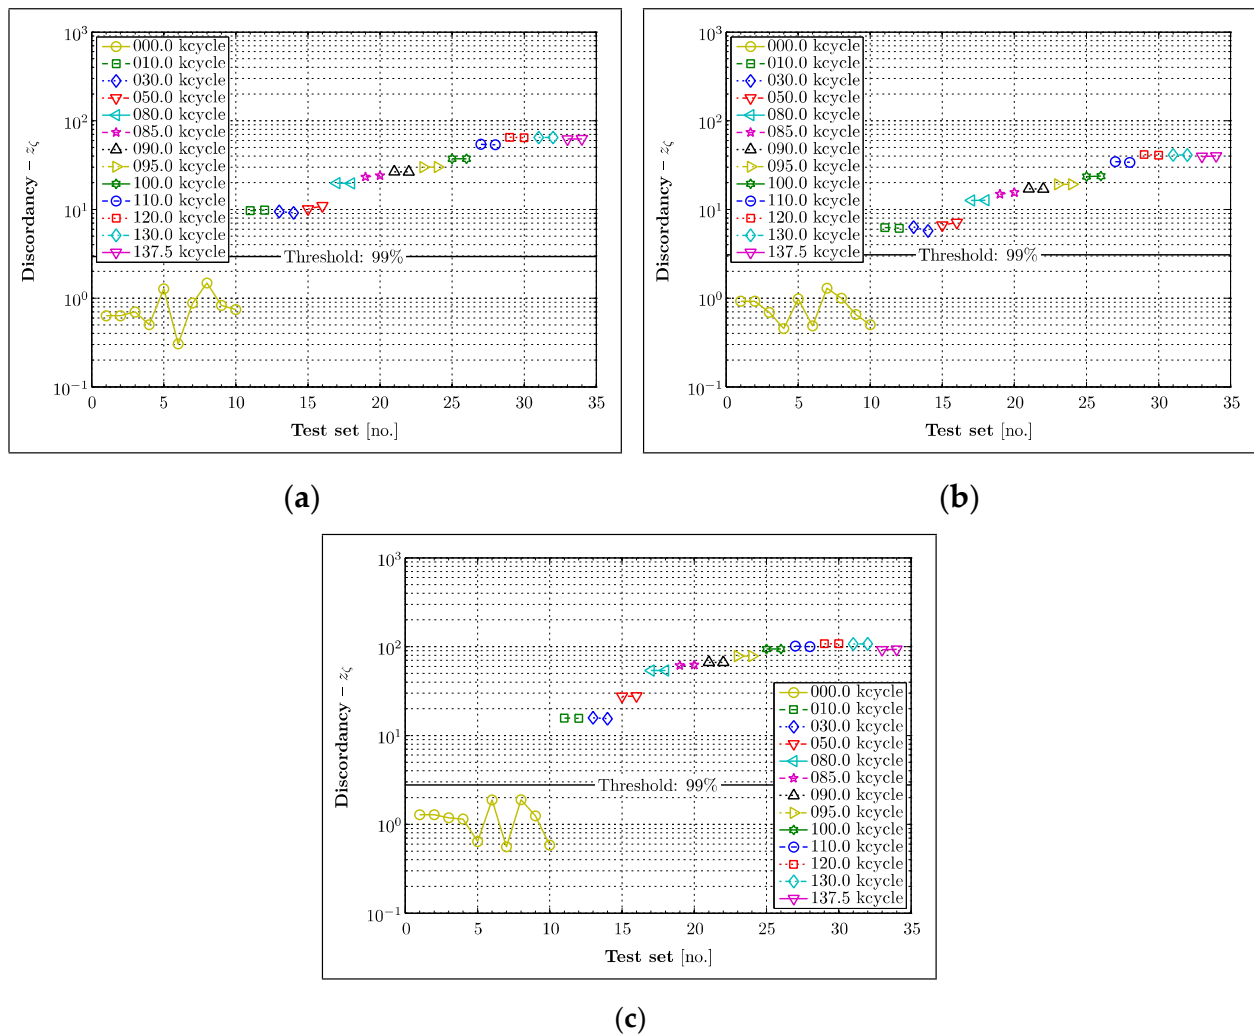
**Figure 11.** Univariate outlier analysis for analysed damaged indices based on: (a) peak-to-peak value; (b) maximum of envelope function; (c) integrated envelope function.

The outlier analysis was performed for the A3B4 Lamb wave responses as an example. The results for the peak-to-peak value, maximum envelope and integrated envelope are given in Figure 11a–c, respectively. The outlier analysis of these parameters reveals no false positives, confirming their validity in this statistical approach. The results also show that the clearance between the threshold and the outliers exhibits the largest value for the integrated envelope parameter, indicating the best statistical confidence with which an actual outlier (fatigue crack) is identified. The analysed parameters increase with the crack length and therefore could potentially be used for the estimation of damage severity, given an appropriate means of calibration.

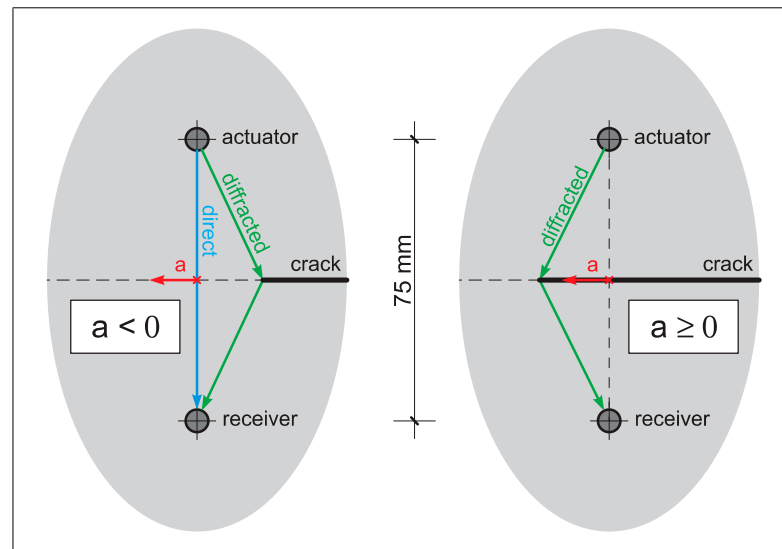
**Figure 12.** Wave propagation model near the crack tip—short (direct) and long (diffracted) wave propagation paths—for two different crack lengths, illustrating how the amplitude of the response wave is affected by diffraction.

A simple wave propagation model was used. The focus of this modelling effort was on the simulation of Lamb wave response changes resulting from advancement of a bisecting crack, perpendicular to the acoustic propagation path since the other—i.e., CENTRAL wave propagation paths—do not cross the crack. The relevant model is illustrated in Figure 12. The Local Interaction Simulation Approach (LISA)—presented in [57,58]—was implemented for this simulation. MATLAB software based on the semi-analytical Lamb wave propagation solution [59] was used to validate numerical simulation results.

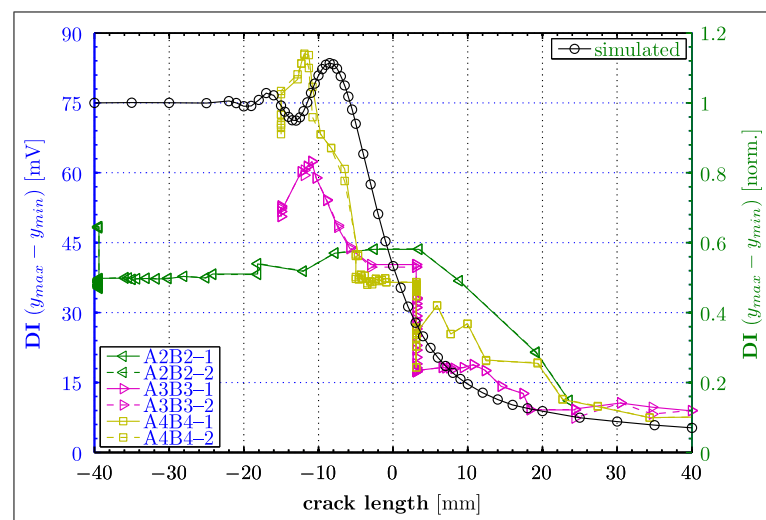
**Figure 13.** Experimental and simulated damage indices based on the peak-to-peak values for various crack tip positions “ $a$ ” defined in Figure 11. Left and right vertical axes are given for the experimental and simulated results, respectively.

Figure 13 summarises all numerical simulation results. Here, simulated (right vertical axis) and experimental (left vertical axis) DIs—based on peak-to-peak values—are compared for various crack-tip positions. The constant trend of the DI simulated characteristics in Figure 13 between  $-40$  and  $-25$  mm demonstrates that the analysed crack-tip positions do not affect Lamb wave propagation at all. For that reason, the entire graph was

normalised by the result of the model for  $a = -40$  mm, permitting the analysis relative to a presumably pristine condition (i.e., no crack condition). Figure 13 unambiguously demonstrates an increasingly oscillatory behaviour of the DI (between  $a = -25$  and  $a = -5$ ) before the crack intersects the acoustical path (the line-of-sight) and the peak-to-peak values expectably reduces because of the presence of the crack. The graph at those oscillations reveals amplitudes exceeding the initial values, i.e.,  $DI > 1$ . This oscillatory behaviour is the result of constructive and destructive interference between the wave diffracted from the crack and the wave propagating alongside the direct path (Figure 12). The simulation results are in relatively good agreement with the experimental behaviour observed in the standard aircraft splice joint. The graphs for the A3B3 and A4B4 wave propagation paths in Figure 13 demonstrate unambiguously an increased peak-to-peak value when the crack approached the acoustic path. This behaviour is less obvious for the A2B2 wave propagation path. However, the DI graph for the same propagation path—but plotted versus number of cycles—in Figure 8a indicates an increased peak-to-peak value before the crack intersects the acoustical path.
