Fatigue-Crack Detection in a Multi-Riveted Strap-Joint Aluminium Aircraft Panel Using Amplitude Characteristics of Diffuse Lamb Wave Field

Abstract: Structural health monitoring of riveted aircraft panels is a real challenge for maintenance engineers. Here, a diffused Lamb wave field is used for fatigue-crack detection in a multi-riveted strap-joint aircraft panel. The panel is instrumented with a network of low-profile surface-bonded piezoceramic transducers. Various amplitude characteristics of Lamb waves are used to extract information on fatigue damage. A statistical outlier analysis based on these characteristics is also performed to detect damage. The experimental work is supported by simplified modelling of wave scattering from crack tips to explain complex response features. The Local Interaction Simulation Approach (LISA) is used for this modelling task. The results demonstrate the potential and limitations of the method for reliable fatigue-crack detection in complex aircraft components.

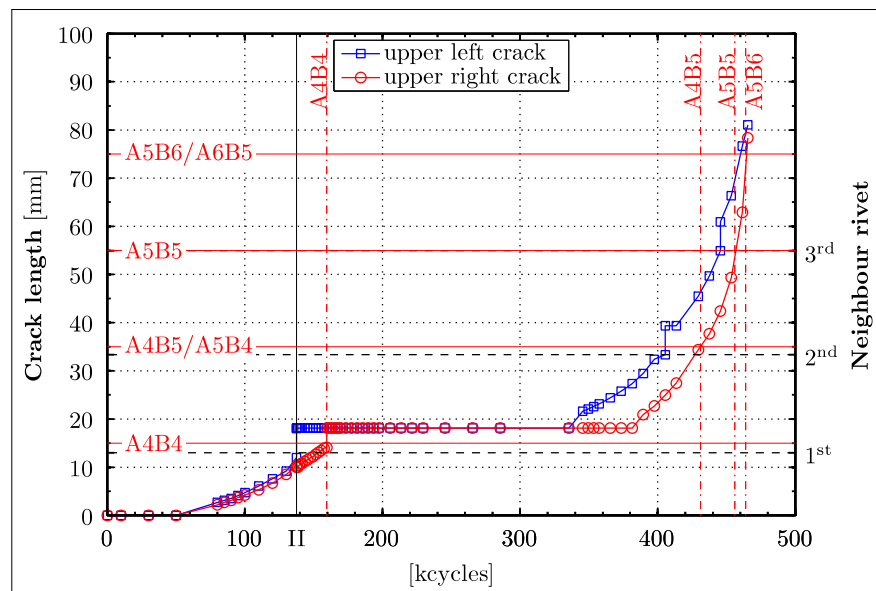
Figure 3. Crack propagation curves. The thin vertical solid line (described by the symbol “II”) separates the two experimental tests (PHASE 1 and PHASE 2) investigated. The other lines indicate at which point in time (or after how many fatigue cycles) the cracks intersected the respective wave propagation paths. These other lines are plotted for: (a) LEFT wave propagation paths; (b) RIGHT wave propagation paths.

Figure 3 shows the crack propagation curves. Here, the descriptions “upper crack” (blue line with squares) and “lower crack” (red line with circles) stand synonymously for the cracks in the upper (monitored by the A and B transducer layers), and lower (monitored by the C and D transducer layers) parts of the aluminium panel, respectively. The vertical line (described by the symbol “II”) separates the two experimental tests (PHASE I and PHASE II) investigated. The PHASE I test was completed after 137,500 cycles. Rivets located in the neighbourhood of the central rivet are labelled on the right-hand side vertical axis according to their order of appearance in the crack propagation paths. Only rivets that the crack intersected are described, i.e., the upper left crack propagated through the neighbour rivets 1, 2 and 3 before it left the overlapping area of the splice joint.

The crack measurements only present visible crack lengths on the reachable outer surface of the specimens. The vertical leaps in the crack length of Figure 3 only indicate that the respective cracks intersected rivets, leading to a sudden increase in the crack length, since the far side of the rivet hole with respect to the central rivet becomes suddenly relevant.

The crack lengths presented in Figure 3 show unambiguously that the PHASE I test was stopped when only the upper left crack reached the first neighbour rivet hole. Figure 3 demonstrates that the upper right crack required 22,000 load cycles more to reach its first neighbour rivet; it also shows that the crack lengths remained constant for a considerable number of cycles in the PHASE II test. This behaviour arose as the propagating cracks encountered rivet holes which have—because of their perfectly circular-shaped rivet diameter—a significantly lower crack intensity factor than the original crack. Thus, once a crack has reached a rivet, a new crack had to be initiated, hence slowing down and

The vertical auxiliary lines in Figure 3 indicate where the left and right crack intersected the corresponding wave propagation paths. These vertical auxiliary lines will be shown in subsequent damage detection graphs, providing a visual aid for the performance analysis of the features relevant to damage detection.

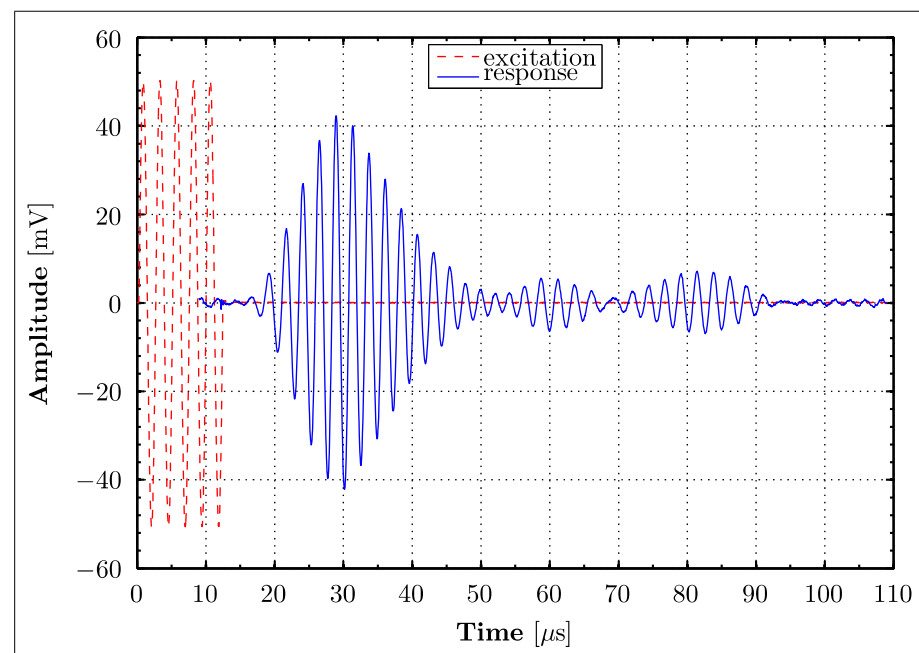
Figure 5. Excitation signal (scaled 1:100) and an example of the Lamb wave response for the A5B4 wave propagation path (undamaged condition).

A burst signal consisting of five cycles of sine waves was used for Lamb wave generation. The amplitude of excitation was equal to 10 V. An excitation frequency of 410 kHz was applied for Lamb wave generation. Since a diffuse Lamb wave field was used for damage detection, this frequency was selected experimentally using a trial-and-error approach to generate responses with the best SNR. The excitation signal was generated using TTi TGA1230 and TGA1242 waveform generators in the PHASE I and PHASE II tests, respectively. The data acquisition was accomplished using a LeCroy 9304 AM and LeCroy Waverunner LT264 oscilloscopes in the PHASE 1 and PHASE 2 tests, respectively. Signals were sampled at 25 MS/s in both tests. When the PHASE 1 test was performed each signal consisted of 2500 samples, giving the time span of 100 μ s. The number of samples and time span were increased to 5000 and 200 μ s, respectively, in the PHASE 2 test. Final responses for each investigated sensor path were averaged 10 and 50 times in the PHASE I and PHASE II tests, respectively. Data averaging was used to improve the Signal-to-Noise-Ratio (SNR). Signal responses were saved to the built-in disk drive of the oscilloscope and transferred to a PC for further analysis. Initial data acquisition tests were performed to show redundancy and repeatability, and hence to eliminate possibly erroneously measured data sets. All Lamb wave signals were taken while the specimen was exposed to a static load of 22 kN in the servo-hydraulic test machine. Figure 5 gives an example of the excitation and response signals.

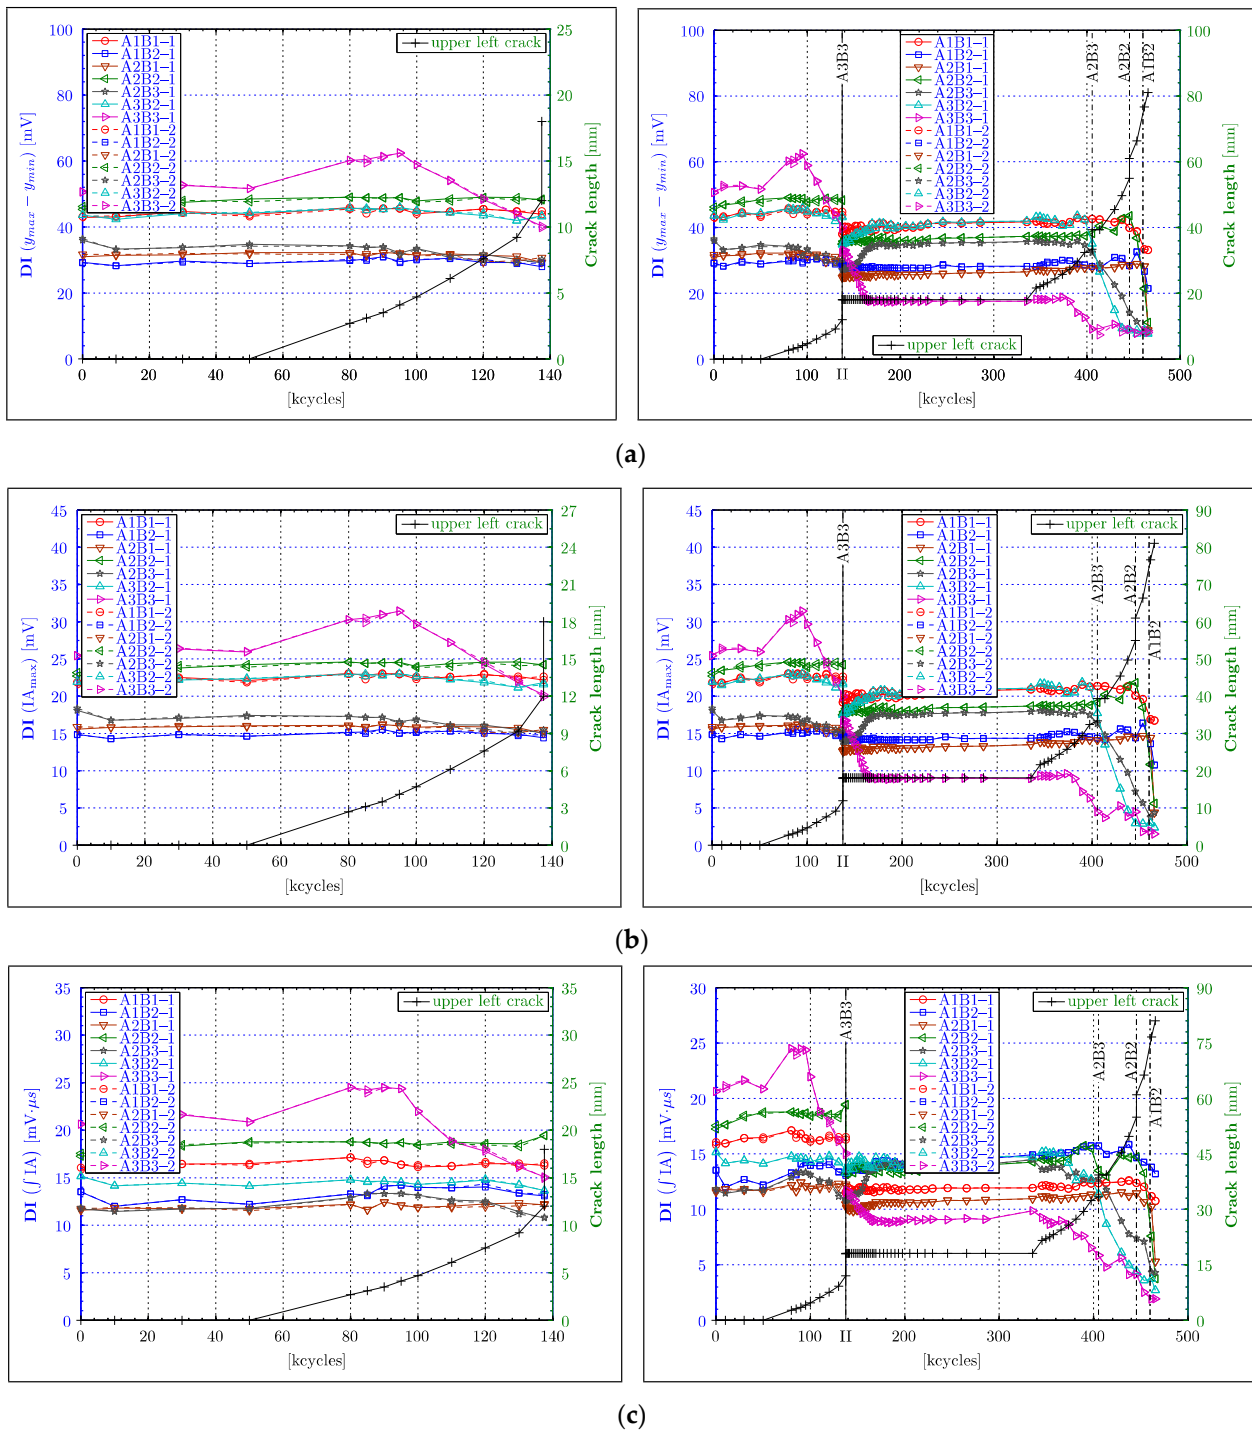
Figure 8. Crack detection results for the LEFT wave propagation paths. Damage indices are based on: (a) maximum peak-to-peak amplitude; (b) maximum instantaneous amplitude (envelope); (c) integrated instantaneous amplitude. The left column gives the results corresponding to only the PHASE 1 experimental test (from 0 to 147,500 fatigue cycles only) whereas the right column presents the results for the PHASE 1 and PHASE 2 experimental tests.

Unlike the graphs in Figure 7a, the majority of graphs in Figure 8a for the LEFT paths exhibit the expected constant values throughout the PHASE I experimental test. Only the characteristics for the A3B3 path diverge from this behaviour. These characteristics demonstrates considerably elevated peak-to-peak values between 80,000 and 95,000 cycles despite the continuously growing crack. However, after 100,000 cycles, the same charac-

teristics exhibit an almost perfect linearly decreasing damage index, until the end of the PHASE I experimental test. This behaviour coincides with theoretical expectations, as the A3B3 path is supposed to indicate the occurrence of damage amongst the LEFT paths first. Furthermore, Figure 8a confirms the dependence between amplitude and the propagation length, as the direct paths AnBn (for $n = 1, 2$ or 3), with the length of 75 mm, generally demonstrate higher peak-to-peak values compared to the diagonal paths with the length of 85 mm. In the transition from the PHASE I to the PHASE II experimental tests in Figure 8a, misalignments in damage indices can be noticed. However, these differences seem to be only really obvious for the group of paths that exhibit generally high amplitudes (i.e., A2B2, A1B1, A3B2, A3B3), in the PHASE I experimental test. Similar to the observation made for the A4B3 path (Figure 7a), undesired effects appear to obscure the course of the damage index at the beginning of the PHASE II experimental test in Figure 8a. Those effects are particularly apparent for the A3B3, A2B3 and A3B2 wave propagation paths from 137,500 to 175,000 fatigue cycles. The continuing reduction of the DI for the A3B3 path in this range, despite the constant crack length, can probably be explained by a subsurface crack growth or another form of material deterioration affecting wave propagation. However, the DIs for the A2B3 and A3B2 paths demonstrate an increase in amplitude in this particular range of cycles (i.e., 137,500–175,000 cycles). This effect is difficult to explain. A reversible ageing effect of the piezoelectric material—described in transducers (*Physik Instrumente GmbH & Co. KG*, 2008, Karlsruhe, Germany)—is a possible explanation. However, this needs further investigation. The DIs of all the LEFT paths remain constant after 175,000 cycles until 380,000 cycles, which is beyond the point (approx. 335,500 cycles) when the upper left crack continued growing again. Clearly, the continuous growth of the upper left crack (after 335,500 cycles), for a duration of circa 40,000 cycles, is worryingly not reflected by any DI. A further reduction in the amplitude is exhibited only by the A3B3 characteristic at about 380,000 cycles. At about 400,000 cycles, the DIs for the A2B3 and A3B2 paths commence detecting the crack. This instance almost coincides with the crack intersecting the A2B3 and A3B2 paths, indicated by the vertical line labelled as “A2B3”. Furthermore, these characteristics demonstrate an ideal monotonically decreasing behaviour until the end of the experiment. Following the transducer layout, the A2B2 path, followed by A1B2 and A2B1 paths, are supposed to indicate a reduction in the DI at the correspondingly labelled vertical lines. The A2B2 path shows a steep drop after 445,500 cycles, which is in good agreement with crack propagation, despite unexplainable oscillations beforehand. A similar unexpected increase in the DI is exhibited by the result for the A1B2 path. However, the A1B2 and A2B1 paths demonstrate a considerable reduction in peak-to-peak amplitude after 453,500 cycles, allowing the conclusion that they detect the crack. For some unapparent reason, the DI of the A1B1 path seems to outperform those of the A1B2 and A2B1 paths, as it shows a nice monotonically declining characteristic, starting from 437,500 cycles, while the A1B2 and A2B1 paths exhibit the previously mentioned oscillations.

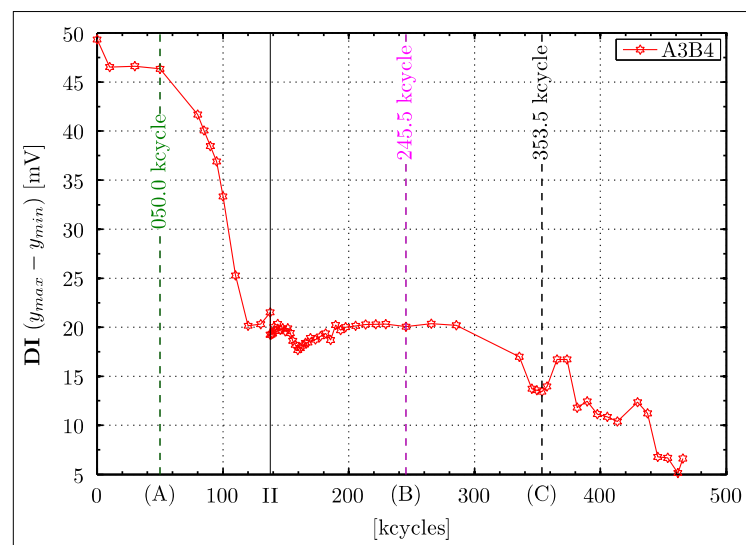
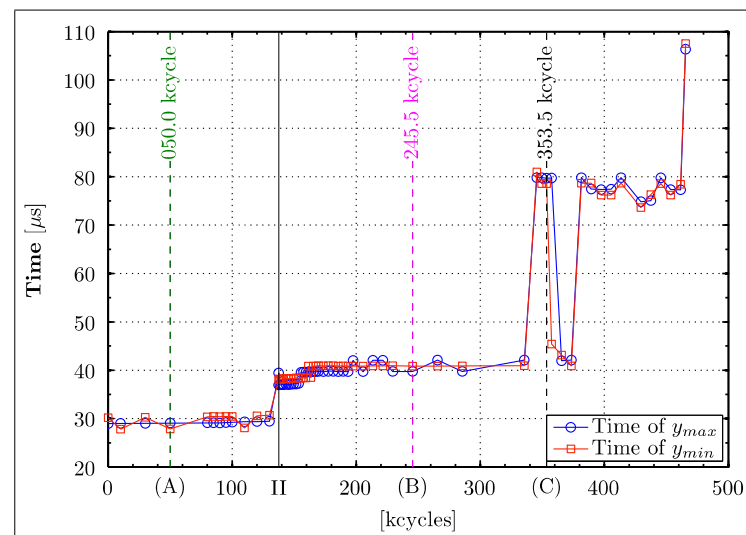
Figure 10. Extraction of peak-to-peak values for the A3B4 wave propagation path for consecutive fatigue cycles: (a) damage index based on the peak-to-peak value; (b) temporal location of respective maxima and minima used for peak-to-peak amplitude evaluation.

The peak-to-peak value estimation involves the extraction of the global maximum and minimum of the entire Lamb wave response. The question is why the peak-to-peak value sometimes exhibits an undesired unsteady behaviour, as for example the DI characteristics—based on the A3B4 and A4B3 wave propagation paths (Figure 7a between 105,000 and 135,000 fatigue cycles, and after 330,000 cycles). Figure 10 sheds some light on this particular issue, as the DI based on the Lamb wave response for the A3B4 wave propagation path (Figure 10a) is contrasted with the time coordinates of the extracted maximum and minimum (Figure 10b). This analysis—equivalent to the time-of-flight based on respective extreme values—demonstrates very nicely that the order in which the maxima and minima are extracted constantly changes throughout the experiment. This issue is particularly relevant to the behaviour exhibited in Figure 10b around 120,000 and after 335,000 fatigue cycles, where large disturbances can be observed. One possible solution to this problem is the analysis of the instantaneous amplitude (envelope function). This instantaneous characteristic was calculated for all Lamb wave responses following the procedure described in Section 3. The maximum of the instantaneous amplitude was calculated for all Lamb wave responses. Figures 7b, 8b and 9b give the results, the DI characteristics based on the maximum of the instantaneous amplitude.
