A full-scale wind turbine blade monitoring campaign: Detection of damage initiation and progression using medium-frequency active vibrations

Abstract

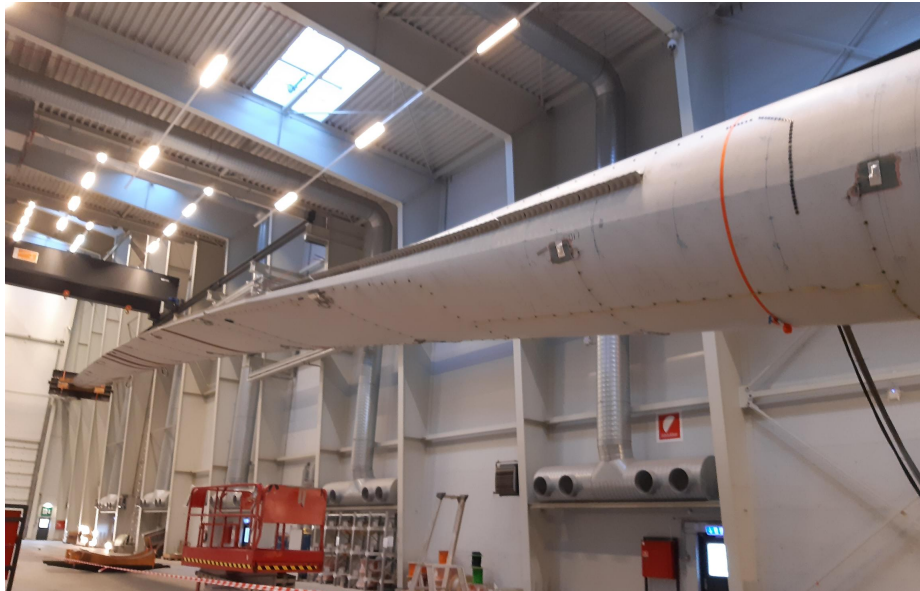
Figure 1. Wind turbine blade mounted on a test stand at Siemens Gamesa Blade Test Center in Aalborg, Denmark.

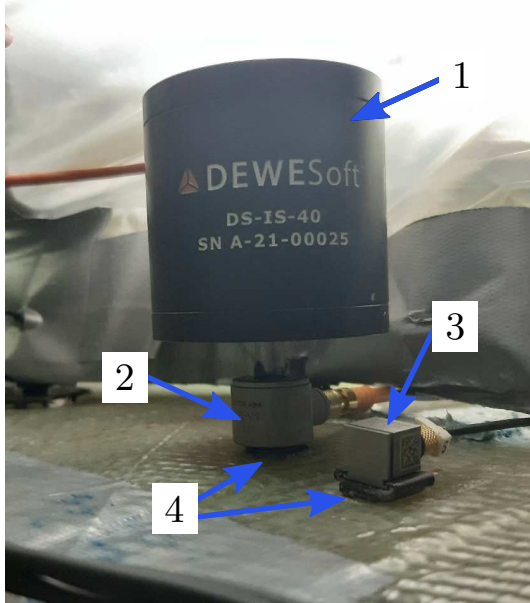
Figure 7. Electrodynamic vibration shaker (1) mounted on shear web laminate inside wind turbine blade, collocated force transducer (2), accelerometer (3), and mounting plates (4).

To facilitate SHM of wind turbine blades, the previous section shows that low-frequency passive vibration systems, such as systems relying on natural vibration modes, are not reliable for detection of damages in due time before they become critical to the structural integrity of blades. As such, it has been proposed to employ active vibration systems, which ideally provide an appropriate compromise between monitoring range and detectable damage size. The active vibration monitoring system used in this work is shown mounted inside the test blade on the shear web laminate in Figure 7. The active vibration monitoring system consists
