Tool life and wear mechanisms of CVD coated and uncoated SiAlON ceramic milling inserts when machining aged Inconel 718

Proc IMechE Part B:
J Engineering Manufacture
1–15

Luke Osmond^{1,2}, Ian Cook³, David Curtis³ and Tom Slatter²

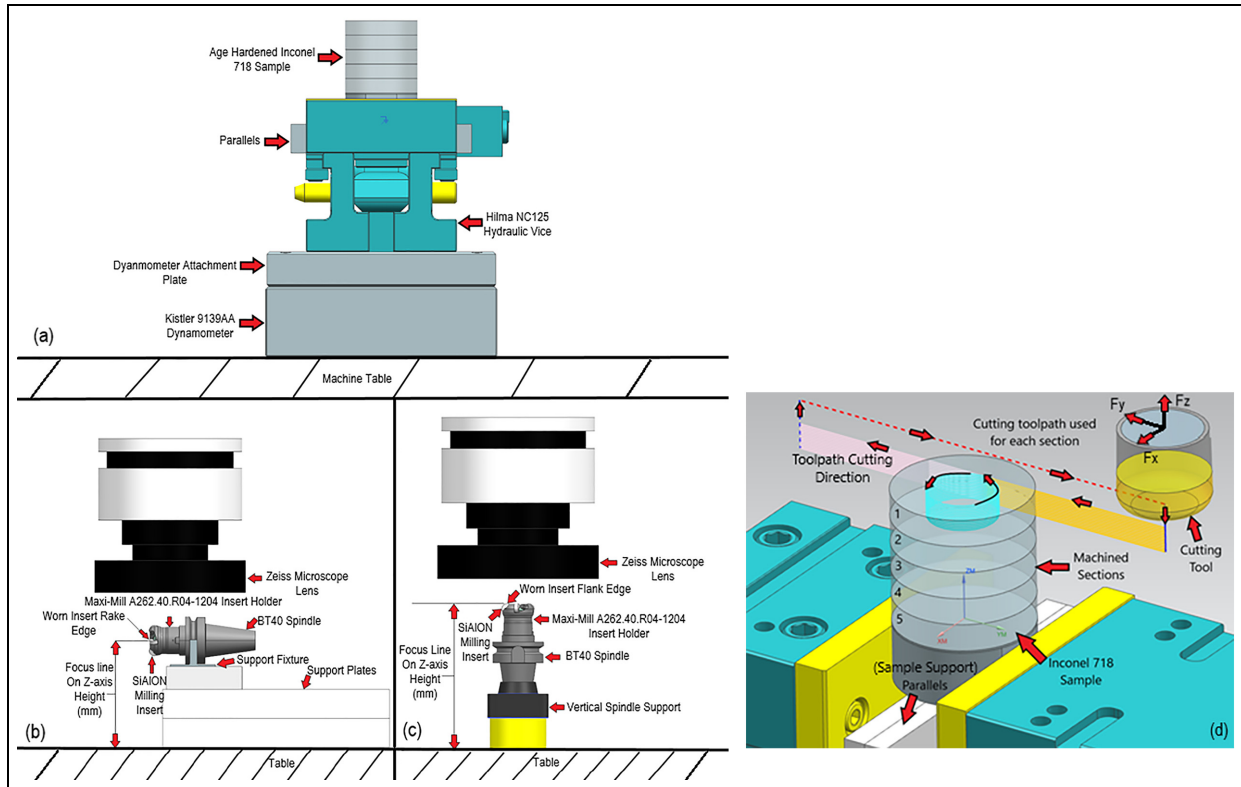
Figure 1. (a) Machine trial work-piece setup on the DMG Mori NVX5080 machining centre, (b and c) Zeiss set-up for rake and flank wear measurement and (d) Siemens NX CAM model assembly 3D view of cutting tool path and the five sections (e.g. 1-1-1-5 in Table 1) of the sample bar.

shown in Figure 1(a). Figure 1(b) and (c) shows the Zeiss V8 Discovery microscope set-up that was utilised to capture rake and flank wear (V_{bb}) measurements.

The material was machined away in five 12.0 mm long sections as seen in Figure 1(d). Once the section had been successfully machined away, the tool was removed from the machine and the inserts kept in position so that insert flank and rake face wear measurement data could be gathered using the optical microscope. Each of the five sections of material that were removed accounted individually for 33.929 cm³ of the total volume of material removed.

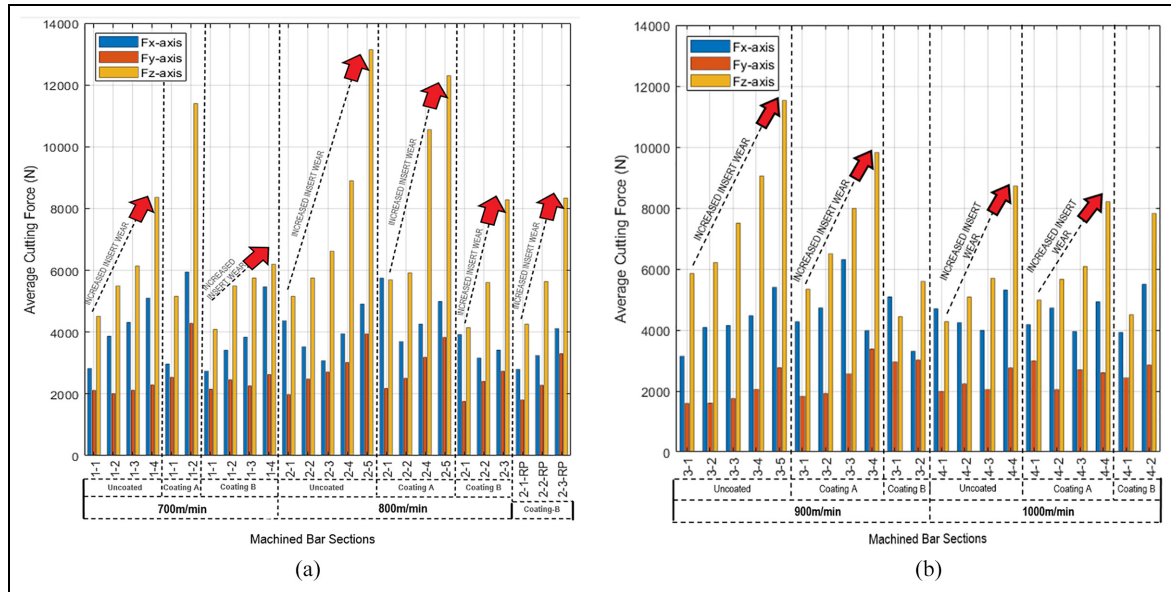
Figure 2. (a) Average cutting force versus machined bar section at 700 and 800 m/min and (b) average cutting force versus machined bar section at 900 and 1000 m/min.

amounts of wear in the early stages of the test. Figure 2(a) and (b) shows the level of average cutting force in the Fx-axis, Fy-axis and Fz-axis throughout the machining trial.

Throughout the machining trial there has been a gradual increase in cutting force during the machining the bar sections which is presented in Figure 2(a) and (b). The gradual increase in cutting force correlates with the progressive level of wear which the inserts have sustained when machining each bar section. The gradual increase in insert flank face wear is represented in Figures 4(a–h), 5(a–l), 6(a–h) and 7(a–h). At the lower cutting speeds of 700 and 800 m/min the workpiece material maintains higher hardness during the cutting process, as the workpiece has not undergone sufficient thermal softening in the chip/tool interface to reduce the yield strength of the workpiece material. The lack of thermal softening is shown in both Figures 2(a and b) and 3, where the uncoated and Coating A inserts required more cutting force to remove each cut and meant that the uncoated inserts and the Coating A inserts experienced higher mechanical shock between the tool and the workpiece. The Coating B inserts experienced lesser fluctuations in the average resultant cutting force at cutting speeds ranging from 700 to 900 m/min, which is likely due to the low friction characteristics of the titanium nitride outer coating. However, this lower cutting force requirement changed when the cutting speed was increased from 900 to 1000 m/min. Figures 2(a and b) and 3 highlights the impact of the thermal softening effect in the chip/tool interface, which led to a large reduction in the hardness and the shear stress which is necessary to remove each cut of workpiece material. This in turn also led to large reductions in the level of mechanical shock between the tool and workpiece which was evident by the sound of each cut.

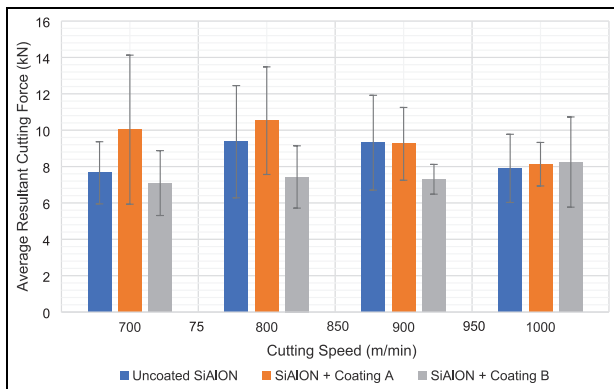
Figure 3. Resultant cutting force versus cutting speed (m/min) for uncoated SiAlON milling inserts and for Coating A and Coating B.

The other reason for the high cutting forces in the Fx, Fy and especially the Fz axis when compared to other research conducted by Molaiekiya et al.⁹ and Tian et al.,⁵ is down to the size of cut and radial engagement (ae). All the bar sections were machined with an initial full radial engagement of 30.0 mm, which stays constant for about two-thirds of the cut and then the radial immersion reduces as each test cut travels through a full 360° and exits out of cut in the Fy-axis direction. The levels of resultant cutting force which the three types of SiAlON experienced, and the relationship between the average resultant cutting force and the change in cutting speed is also shown in Figure 3.

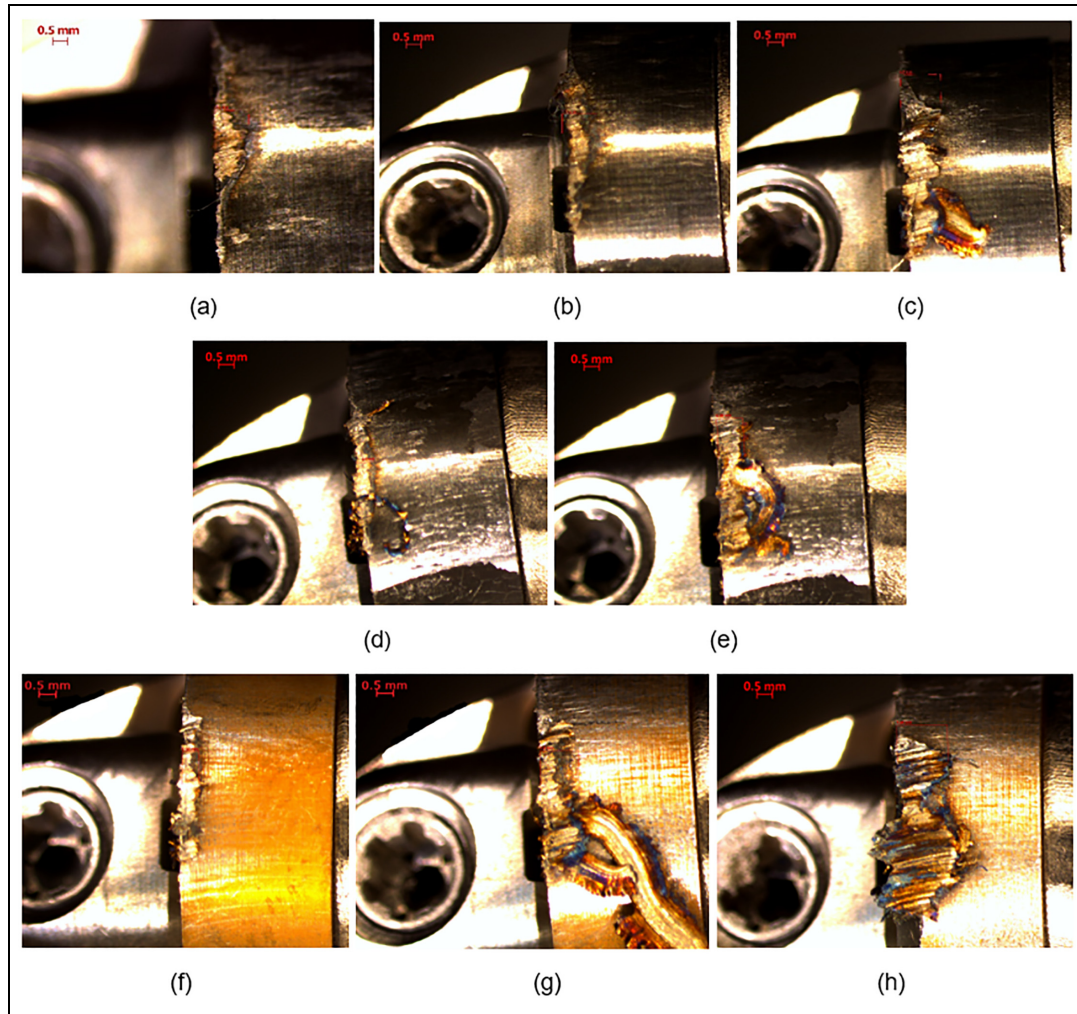
Figure 4. Flank wear visible (a-c) 700 m/min-Bar-Section-1.1-1-3-insert-Uncoated-insert-1 flank face the material removed is 101.80 cm^3 , flank wear visible (d-e) 700 m/min-Bar-Section-1.1-1-2-insert-Coating-A-insert-3 flank face the material removed is 67.86 cm^3 , flank wear visible (f-h) 700 m/min-Bar-Section-1.1-1-3-insert-Coating-B-insert-4 flank face the material removed is 101.80 cm^3 .

The types of tool failure patterns for the rake and flank faces are shown in Figures 4 to 7 and show that the wear mechanisms at high cutting speeds on the flank and rake face are flaking, chipping, notch wear and adhesive wear. These types of rake and flank face wear patterns has taken place at a cutting speed of 700, 800, 900 and 1000 m/min, when high-speed face-milling of Inconel 718 at $f_z = 0.1 \text{ mm/tooth}$, $A_p = 1.0 \text{ mm}$ and $a_e = 30.0 \text{ mm}$. It is clearly evident in Figure 5(a-l) that Coating A has poor adhesion to the CTIS710 SiAlON substrate (insert). The main reason for the poor adhesion is likely down to the bonding interlayer being titanium nitride (TiN) the metallic bonding structure of which has created a weak interfacial bond with the covalent SiAlON substrate microstructure. As a result, Coating A degrades and chips off the flank face a higher rate than that has been demonstrated by Coating B. The thermal stability and adhesive properties of Coating B originate from the high strength ionic

bonding characteristics of aluminium oxide Al_2O_3 interfacial layers with the covalent microstructure of SiAlON substrate, which create a stable foundation for the outer layer of titanium nitride to be deposited onto. The higher stability and superior adhesive characteristics of Coating B can be seen in Figures 4(f) and 5(g).

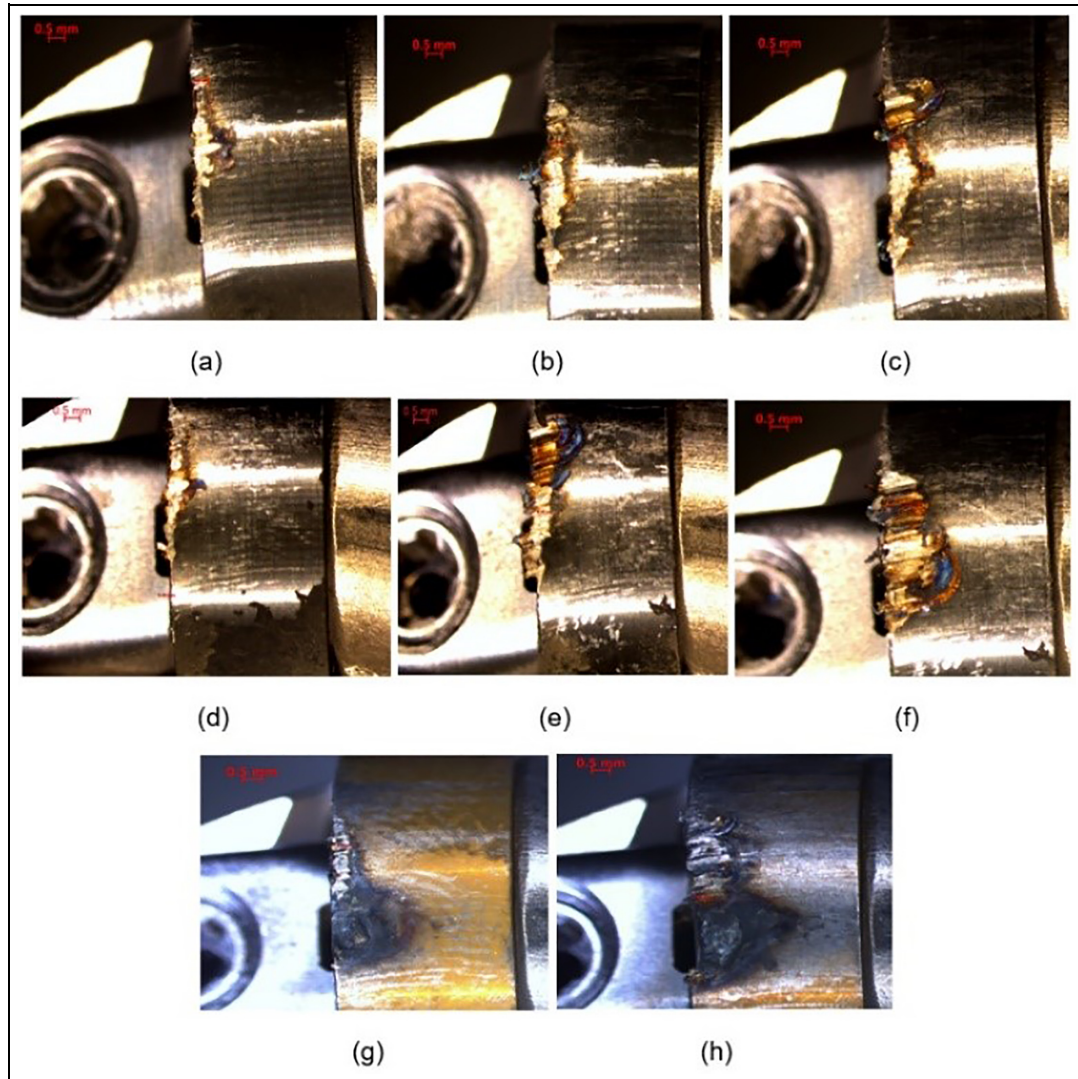
Figure 6. Flank wear visible (a–c) 900 m/min-Bar-Section-3.1-3-3-insert-Uncoated-insert-2 flank face the material removed is 101.80 cm^3 , flank wear visible (d–f) 900 m/min-Bar-Section-3.1-3-3-insert-Coating-A-insert-2 flank face the material removed is 101.80 cm^3 , flank wear visible (g and h) 900 m/min-Bar-Section-3.1-3-2-insert-Coating-B-insert-2 flank face the material removed is 67.86 cm^3 .

the heating and cooling of the cutting tool through each cutting cycle. The effects of the heat and cooling cycles were evident when the Coating B inserts could not complete bar sections (3-3-3-5) and (4-3-4-4) due to the quantity of wear that had been sustained by the Coating B inserts after machining bar sections (3-1-3-2) in Figure 6(g) and (h) (4-1-4-2) and in Figure 7(g).

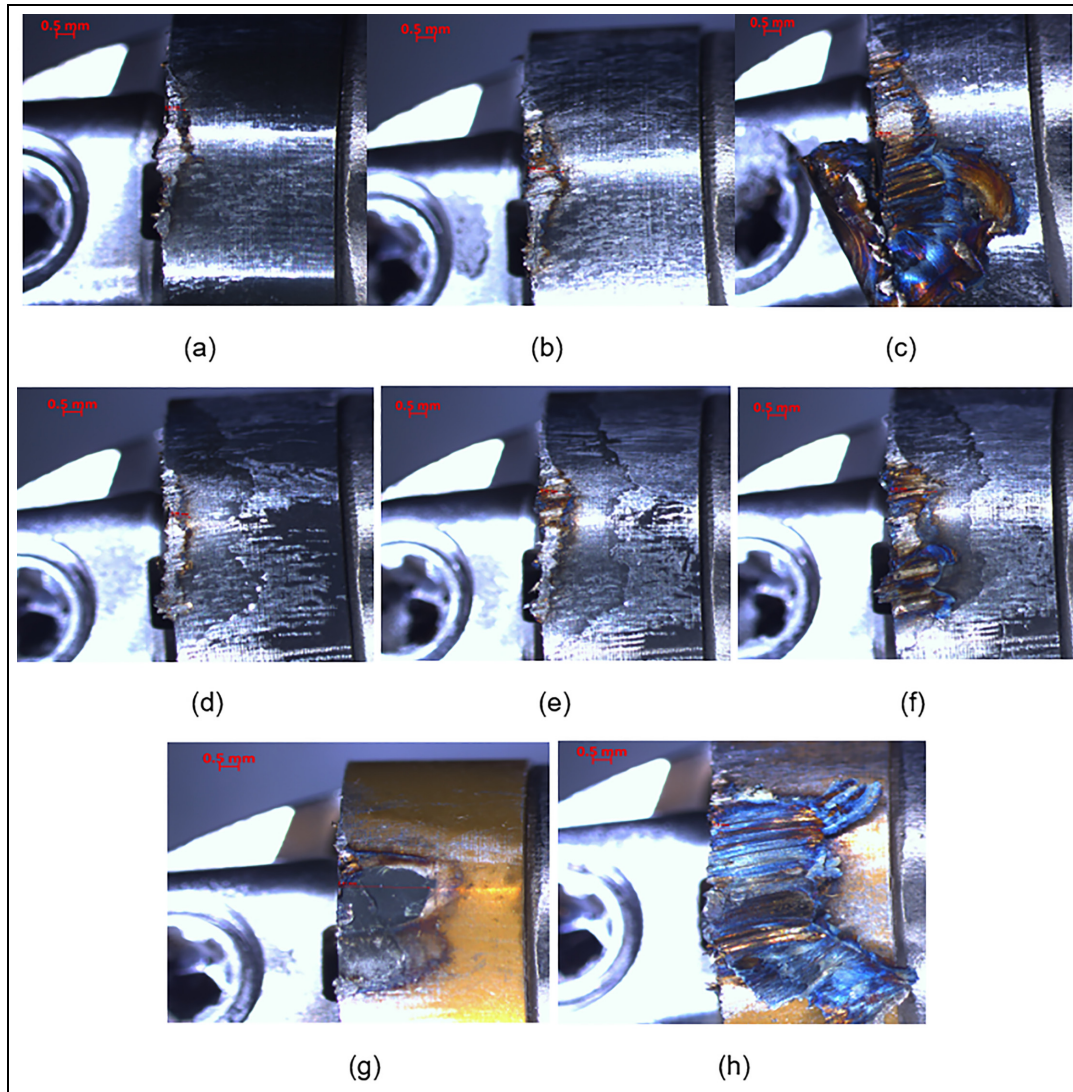
Figure 7. Flank wear visible (a–c) 1000 m/min-Bar-Section-4.1-4-3-insert-Uncoated-insert-3 flank face the material removed is 101.80 cm^3 , flank wear visible (d–f) 1000 m/min-Bar-Section-4.1-4-3-insert-Coating-A-insert-4 flank face the material removed is 101.80 cm^3 , flank wear visible (g and h) 1000 m/min-Bar-Section-4.1-4-2-insert-Coating-B-insert-1 flank face the material removed is 67.86 cm^3 .

This was also apparent with the Coating B in Figure 7(h), because of isolated craters forming on the flank face. The isolated craters are likely as a result of the Coating B being removed via thermomechanical wear from the SiAlON substrate and diffusion wear taking place at temperatures in excess of 1000°C . At cutting temperatures over 1000°C the silicon nitride in the SiAlON milling inserts has a strong affinity for the iron in the workpiece material. This strong affinity between the silicon nitride and the iron initiates solid solution

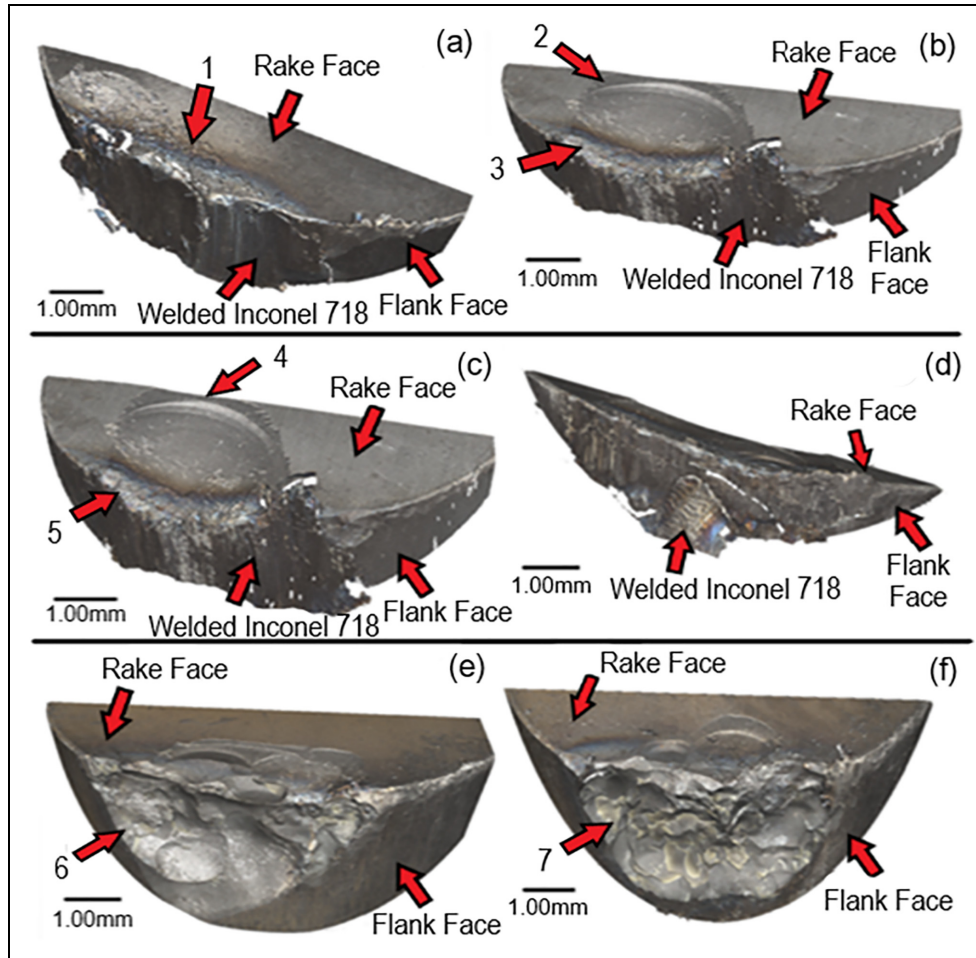
Figure 8. Tests at 700 m/min, 0.1 mm/rev, 1.0 mm (ap), non-contact 3D profilometer (focus variation type) scan: insert-Uncoated-insert-1 & 3 (a and b) the material removed is 135.716 cm³, insert-Coating-A-insert-1 & 3 (c and d) the material removed is 67.858 cm³, insert-Coating-B-insert-2 & 4 (e and f) the material removed is 135.716 cm³.

The non-contact 3D profilometer (focus variation type) scan of the three different types of inserts are shown in Figures 8 to 11. Figure 8 highlights the types of primary and secondary wear mechanisms which the uncoated, Coating A and Coating B inserts sustained when facing milling bar sections (1-1-1-4) of Inconel 718 at a cutting speed of 700 m/min. Secondary wear mechanisms such as oxidative wear are visible on the rake face (Region 1 in Figure 8) and abrasive wear is visible on the cutting edge of the rake face for the uncoated and Coating A inserts (Regions 3 and 5 in Figure 8). Flaking and chipping are evident on the rake

face for the uncoated and Coating A inserts (Regions 2 and 4 in Figure 8). The flaking and chipping take place due to the change in cutting edge as result of abrasive wear, which causes the contact pressures in the chip/tool interface to increase to a point that it causes the SiAlON ceramic microstructure to shear along the grain boundaries. The shearing effect along the grain boundaries causes a wave like multilayer topography to form as can be seen on the rake face of the Coating B inserts (Regions 6 and 8 in Figure 9). Primary wear mechanisms such as crater wear are visible on the flank face of the Coating B inserts (Regions 6 and 7 in Figure 8). During the machining process, as the three types of inserts sustain more wear on the flank and rake faces and remove more metal, the level of vibrations begin to increase. Once the coatings delaminate and flake off the inserts, a cutting surface with different coating thicknesses on both the rake and flank faces of the Coating

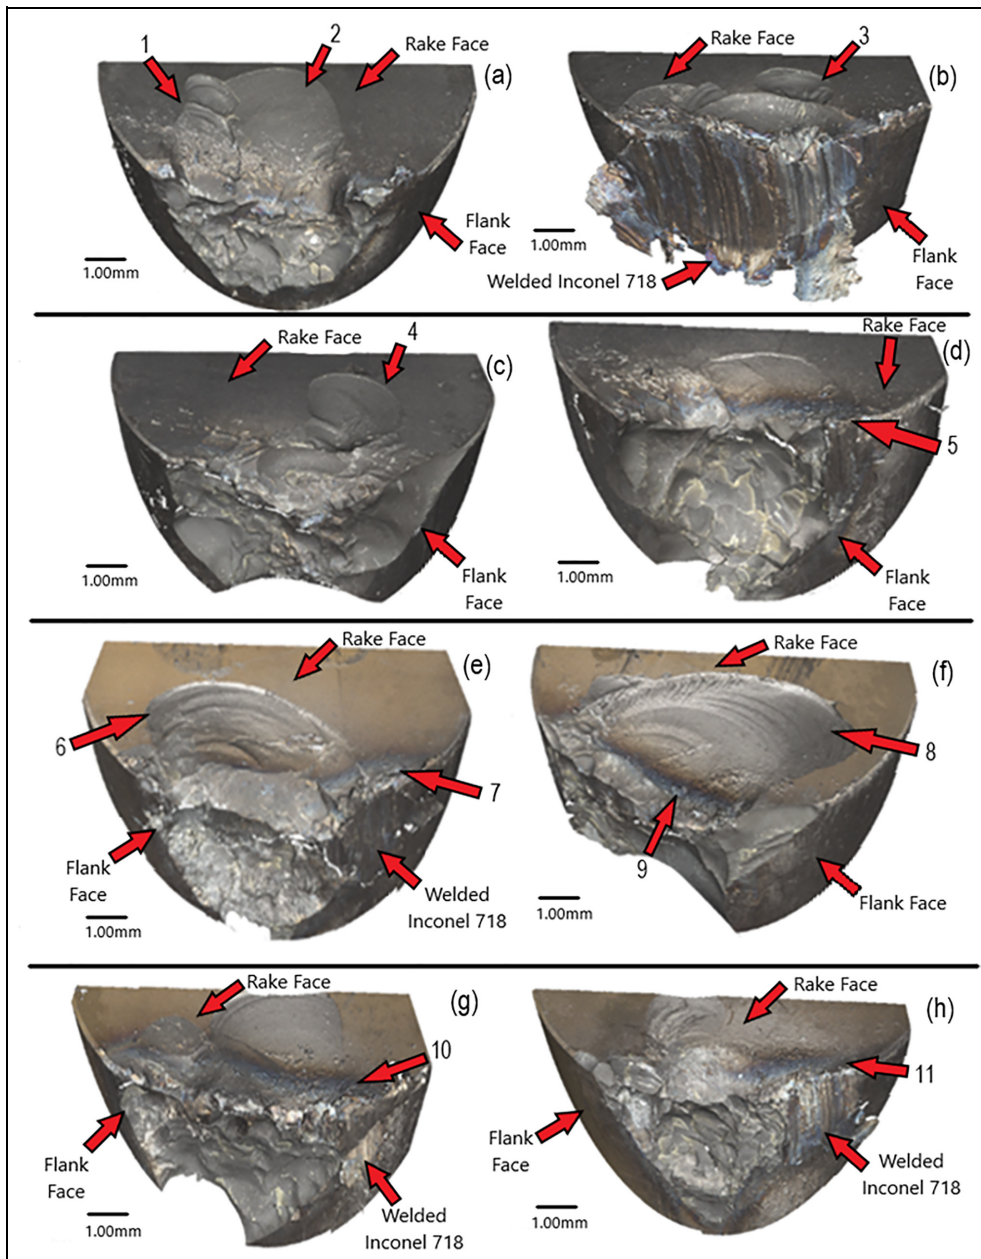
Figure 9. Tests at 800 m/min, 0.1 mm/rev, 1.0 mm (ap), non-contact 3D profilometer (focus variation type) scan: (insert-Uncoated-insert-2 & 3 (a and b) the material removed is 169.645 cm³, insert-Coating-A-insert-2 & 3 (c and d) the material removed is 169.645 cm³, insert-Coating-B-insert-2 & 3 (e and f) the material removed is 135.716 cm³, insert-Coating-B-RP-insert-2 & 3 (g and h) the material removed is 101.787 cm³.

Figure 9 highlights the types of wear which the inserts sustained when facing milling bar sections (2-1-2-5) of Inconel 718 at a cutting speed of 800 m/min. Once again flaking and chipping are evident on the rake face for the uncoated and Coating A inserts (Regions 1, 2, 6 and 8 in Figure 9). The level of insert wear is reflected by the volume of metal that has been removed as bar sections (2-1-2-5) were machined by the uncoated and Coating A inserts.

Isolated chipping and flaking were also evident on the rake face for the uncoated and Coating A inserts (Regions 3 and 4 in Figure 9). The isolated chipping and flaking are likely a result of fluctuating tensile and compressive stresses being distributed across the rake face. Oxidative wear is yet again visible on the rake face for all the inserts (Regions 5, 7, 9, 10 and 11 in Figure 9).

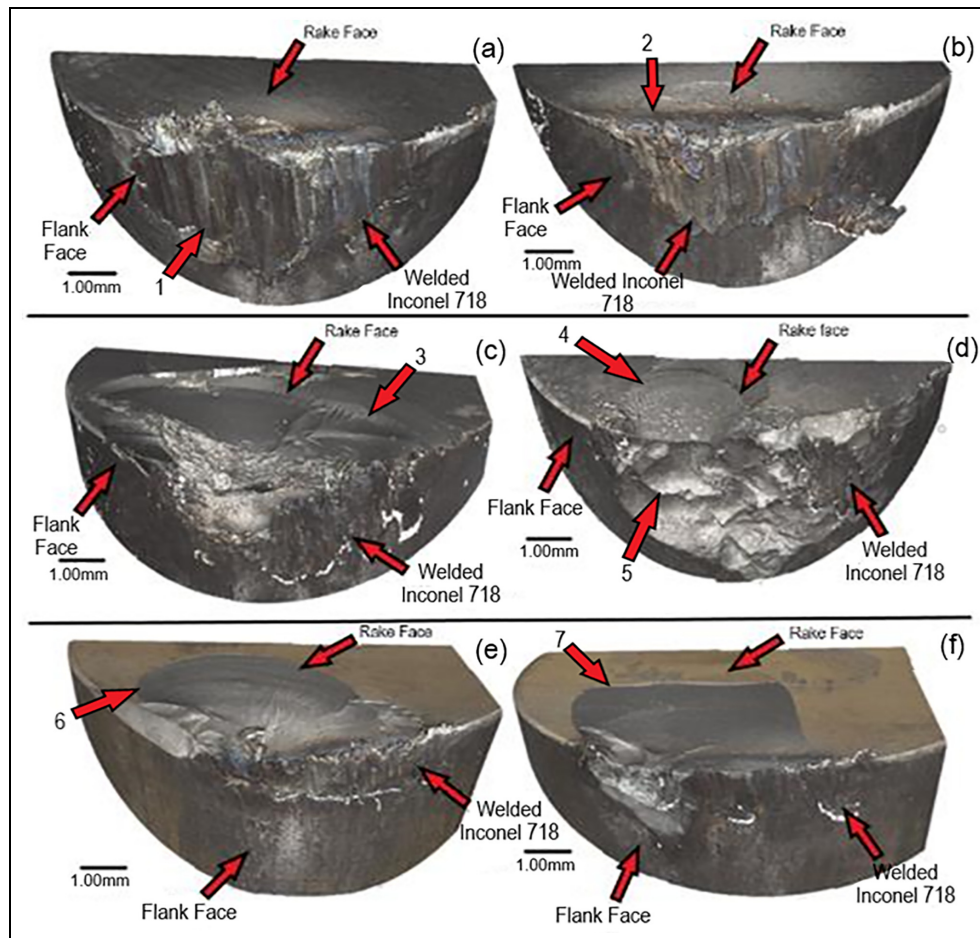
Figure 10. Tests at 900 m/min, 0.1 mm/rev, 1.0 mm (ap), non-contact 3D profilometer (focus-variation type) scan: insert-Uncoated-insert-2 & 4 (a and b) the material removed is 169.645 cm³, insert-Coating-A-insert-2 & 4 (c and d) the material removed is 135.716 cm³, insert-Coating-B-insert-1 & 2 (e and f) the material removed is 67.858 cm³.

As the cutting speed was increase up to 900 and 1000 m/min the type of insert wear mechanisms changed. Figure 10 highlights the types of wear mechanisms which the all the inserts sustained when facing milling

bar sections (3-1-3-5) of Inconel 718 at a cutting speed of 900 m/min. Adhesive wear had been apparent throughout the machining tests, but adhesive wear was more prominent at cutting speeds of 900 and 1000 m/min with the uncoated inserts (Region 1 in Figure 10). This increase in adhesive wear is due to an increase in temperature in the chip/tool interface and the localised welding and fusing of the chip onto the surface of the uncoated inserts. Coating A sustained significant amounts of chipping, flaking and crater wear (Regions 3, 4 and 5 in Figure 10) and Coating B inserts had chipping, flaking and crater wear (Regions 6 and 7 in Figure 10). However, the bilayer coating of Coating B failed after machining bar sections (3-1-3-2). This likely due to titanium nitride (TiN) outer layer oxidising as a result of the increased cutting speed and cutting temperature.

The oxidised surface ablates off the surface of the insert causing the uneven sliding surface contact to exacerbate the flank and rake face wear. The uneven surface contact contributes to high fluctuations in the tensile and compressive stresses in the chip/tool interface and shortens the tool life of the Coating B inserts.

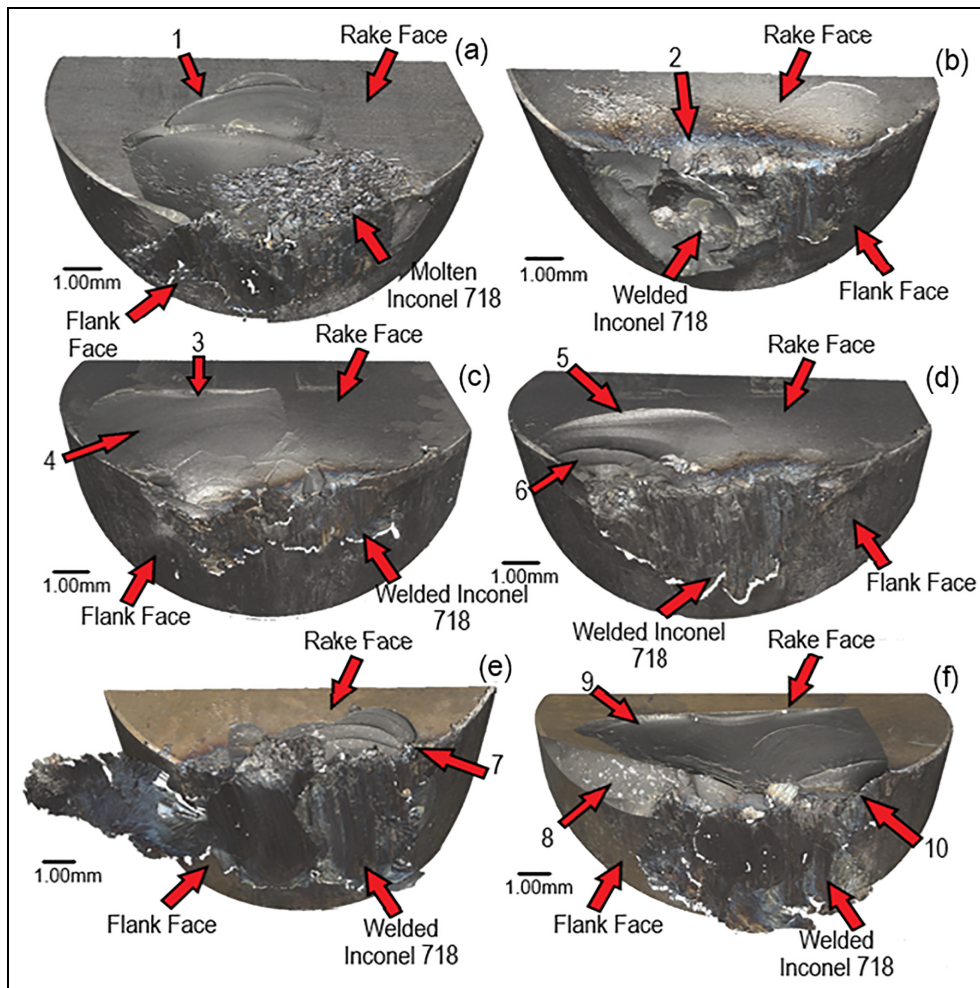
Figure 11. Tests at 1000 m/min, 0.1 mm/rev, 1.0 mm (ap), non-contact 3D profilometer (focus-variation type) scan: insert-Uncoated-insert-2 & 3 (a and b) the material removed is 135.716 cm³, insert-Coating-A-insert-1 & 4 (c and d) the material removed is 135.716 cm³, insert-Coating-B-insert-1 & 4 (e and f) the material removed is 67.858 cm³.

Figure 11 highlights the types of wear which all the inserts sustained when facing milling bar sections (4-1-4-4) at a cutting speed of 1000 m/min. The failures that had been evident for Coating B at a cutting speed of 900 m/min were also evident when the inserts were tested at 1000 m/min. Coating B failed after machining bar sections (4-1-4-2), with the TiN outer coating degrading in the same way that had been experienced in the previous test that were completed at 900 m/min. Flaking, chipping Figure 11 shows that all three types of insert suffer from flaking and chipping (Regions 1, 3, 5, 6, 7 and 9 in Figure 11) with tool fracture

happening with Coating B (Regions 8 and 10 in Figure 11). What must also be noted is how the Coating A inserts improved in wear resistance, in comparison to the uncoated inserts as the cutting speed was increased in cutting speed up to 1000 m/min.

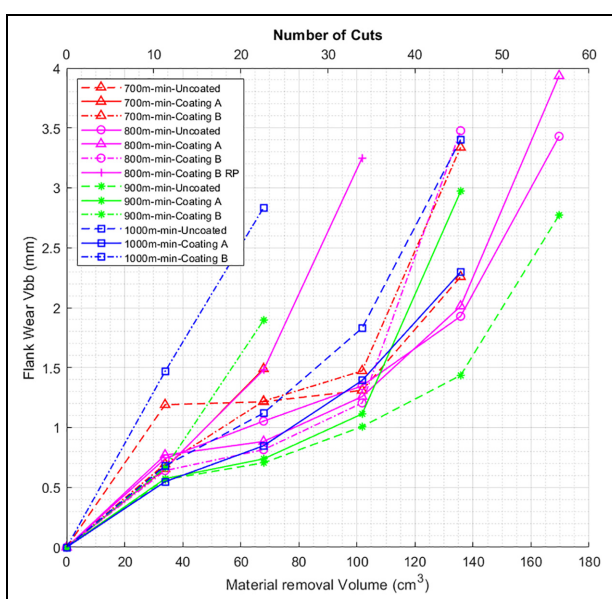
Figure 12. 700, 800, 900, 1000 m/min facing op 1.1-4.5 Uncoated/Coating A/Coating B/Coating B RP.

The tool life curve shown in Figure 12 represents the magnitude of flank wear which each of the three different types of inserts experienced when operated at a cutting speed of 700, 800, 900 and 1000 m/min.

The 1.0mm depth of cut and feed per tooth of 0.1 mm/tooth remained constant throughout the entire machining trial. Over the four sets of cutting speeds, the uncoated CTIS710 milling inserts achieved the best overall wear resistance and resistance to sudden failure. The CVD coated SiAlON ceramic milling inserts have performed well at cutting speeds of 700 and 800 m/min regarding flank wear measurements that were captured from in the earlier sets of test cuts.

When the cutting speed was increased to 900 and 1000 m/min, however, Coating B seemed to suffer from a series of exacerbated wear mechanisms ranging from thermomechanical wear, oxidation, abrasive wear, crater and notch wear, which ultimately led to poor tool life and high tool wear rates. Coating A appeared to perform better when the cutting speed was increased. The increase in cutting performance is likely due to Coating A being removed from the surface of the SiAlON substrate rather easy during the machining of the sections 1 and 2. Once Coating A has subsequently been removed from the surface of the SiAlON, it leaves
