Quinn, J.A., Davidson, J.R., Bajpai, A. et al. (2023) Advanced ultrasonic inspection of thick-section composite structures for in-field asset maintenance. *Polymers*, 15 (15). 3175. ISSN: 2073-4360

# Advanced Ultrasonic Inspection of Thick-Section Composite Structures for In-Field Asset Maintenance

**Abstract:** An investigation into the inspection capabilities of in-field advanced ultrasound detection for use on ultra-thick (20 to 100 mm) glass fibre-reinforced polyester composites is presented. Plates were manufactured using custom moulding techniques, such that delamination flaws were created at calibrated depths. The full matrix capture technique with an on-board total focussing method was used to detect flaws scanned by a 0.5 MHz linear array probe. Flaw through-thickness dimensions were altered to assess the threshold for crack face separation at which delaminations could be identified. Furthermore, part thickness and in-plane flaw dimensions were varied to identify the inspection capability limitations of advanced ultrasonics for thick composites. The results presented in this study demonstrate an inverse relationship between the ability to find delaminations and plate thi

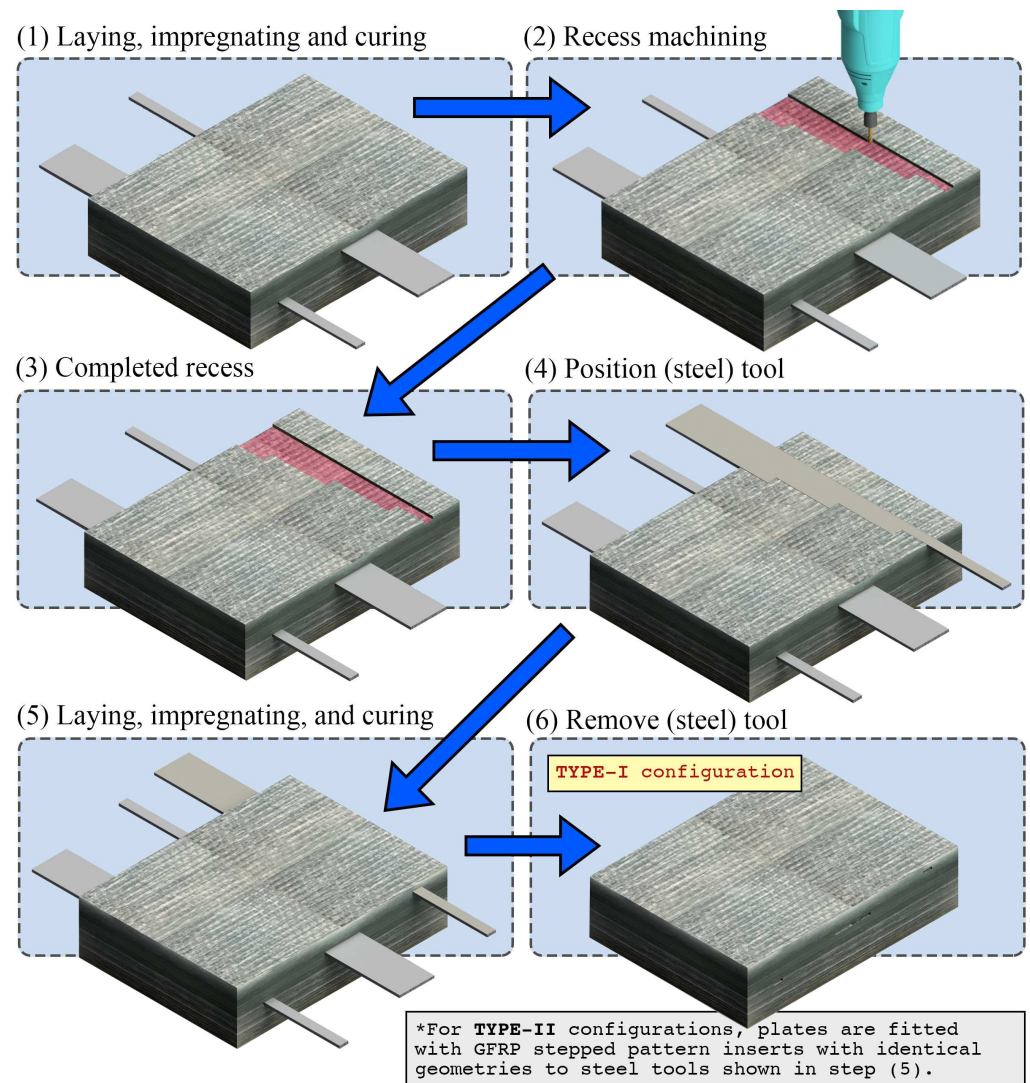
**Figure 1.** Schematic diagram of manufacturing process.

Five variations of the glass FRP plate were manufactured, where the panel thickness was increased from 20 to 100 mm, at fixed intervals of 20 mm. The fabrication process consisted of placing fibre mats warp-on-warp, and impregnating the resin mix using a combination of brushes, plastic wedges, and rollers. The fibre volume fraction ( $V_r$ ) was controlled in each ply by evenly distributing the liquid resin until a fibre volume fraction of approximately 45% was reached, calculated using Equation (1) (transcribed from ASTM D3171-15), where  $M_r$  is the mass ratio of reinforcement in the ply,  $\rho_c$  is the density of the cured composite ( $1.9 \text{ g cm}^{-3}$ ), and  $\rho_r$  is the density of the reinforcement. Artificial cavities that acted as simulated flaws were created at strategically selected depths, relative to the total thickness—for each panel, as shown in Table 1. The intention of these artificially generated flaw cavities was to simulate in-plane delaminations, which may be developed as a consequence of accumulated in-service damage in real structures. Detecting out-of-plane flaws and/or defects derived from manufacturing remains an equally crucial task; however, the in-plane dimensions of these types of features are often much smaller, resulting in a different set of challenges for successful NDT, compared to the scope of the present work. Cavity locations were selected to generate a full range of (absolute and relative) cavity depths whilst including some relative cavity depths in multiple plates. The process of producing artificial cavities in plates is represented schematically in Figure 1. Cavity formation required the lay-up process to be paused at predefined part thicknesses. After the resin was fully hardened, a series of rotary tools and manual files were used to recess a 3 mm deep stepped shape into the (current) top surface of the part. Steel male counterparts, machined in the same stepwise pattern and coated with Loctite Frekote NC770 mould release agent, were then placed into the recesses. The lay-up was resumed until the next target depth was achieved, or until plate completion. Upon completion of the final curing, the steel tools were removed from the plates, resulting in geometrically consistent cavities. A small draft angle was filed into all sharp edges of the steel tools (e.g., a nylon-headed hammer) could be used to lightly tap the tools out with ease. For all plates, precise geometry diagrams (showing all cavity locations/depths) are given in Figure 2.

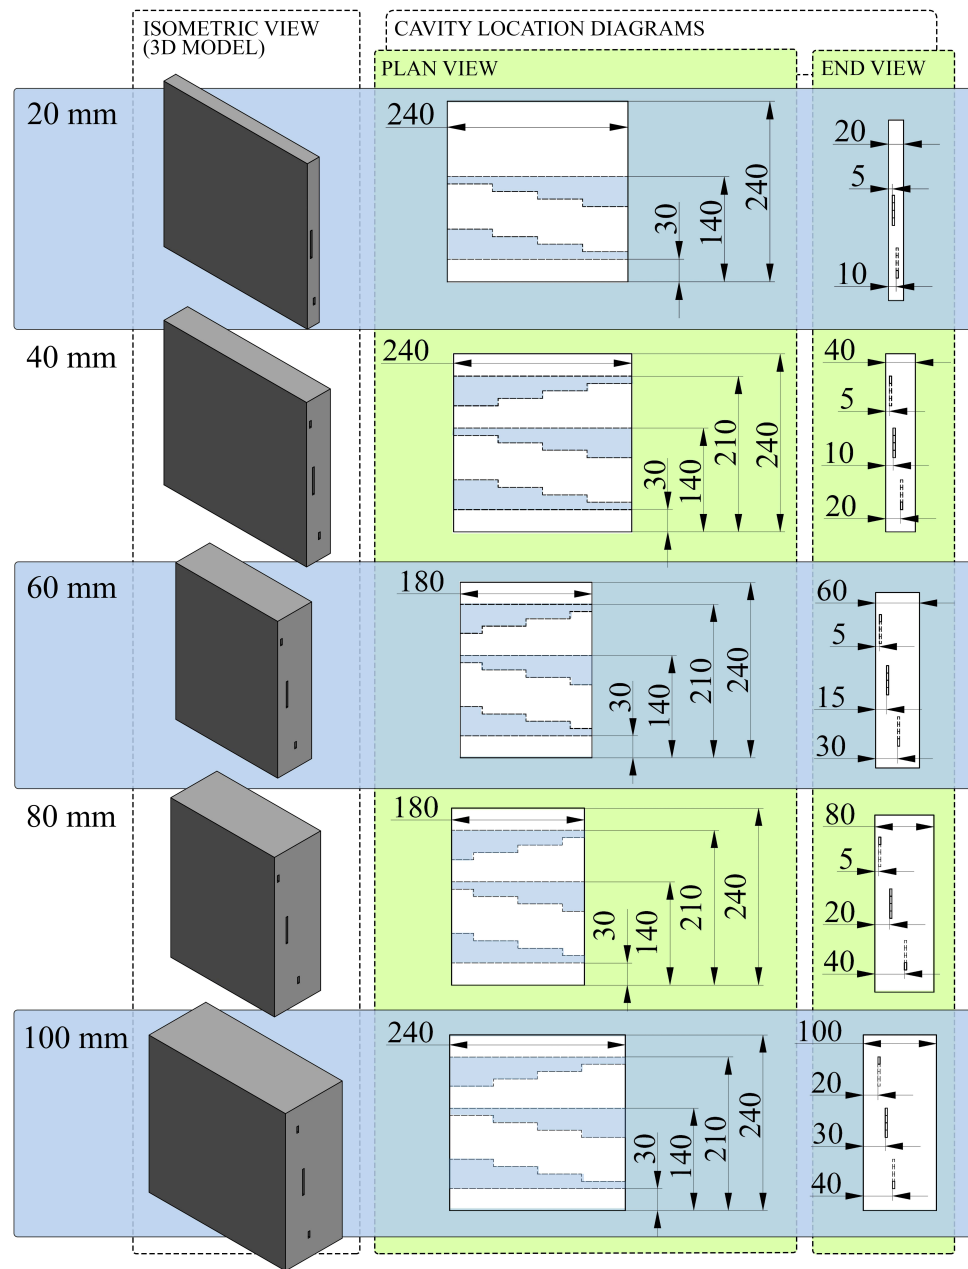
Figure 2. Plate geometry and cavity location diagrams (all dimensions in mm).

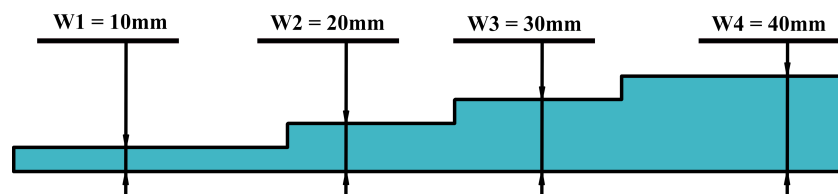
Figure 3. Schematic of the cavity stepwise pattern, including width dimensions.

Three stepped pattern inserts, with identical shapes to that of the steel moulds, were manufactured by the hand lay-up of the same glass FRP system (Figure 3). The in-plane geometry of the glass FRP inserts was machined until a hole-based transition fit (designated 3n14 in ISO 286-1:2010) was achieved—based on sliding inserts within the plate cavities. By utilising glass FRP inserts, the cavity size effect could be explored as an independent variable, with two possible values: no glass FRP insert (3 mm deep cavities), denoted as Type I; and 4-ply glass FRP insert (all-over fixed-transition engineering fit), denoted as Type II. The former acted as a reference case in which UT should be capable of detecting the defects as indicated by existing literature, while the latter simulated delaminations with surface-to-surface contact, resulting from interlaminar shear exhibited after crack formation, without the inclusion of foreign materials such as PTFE.

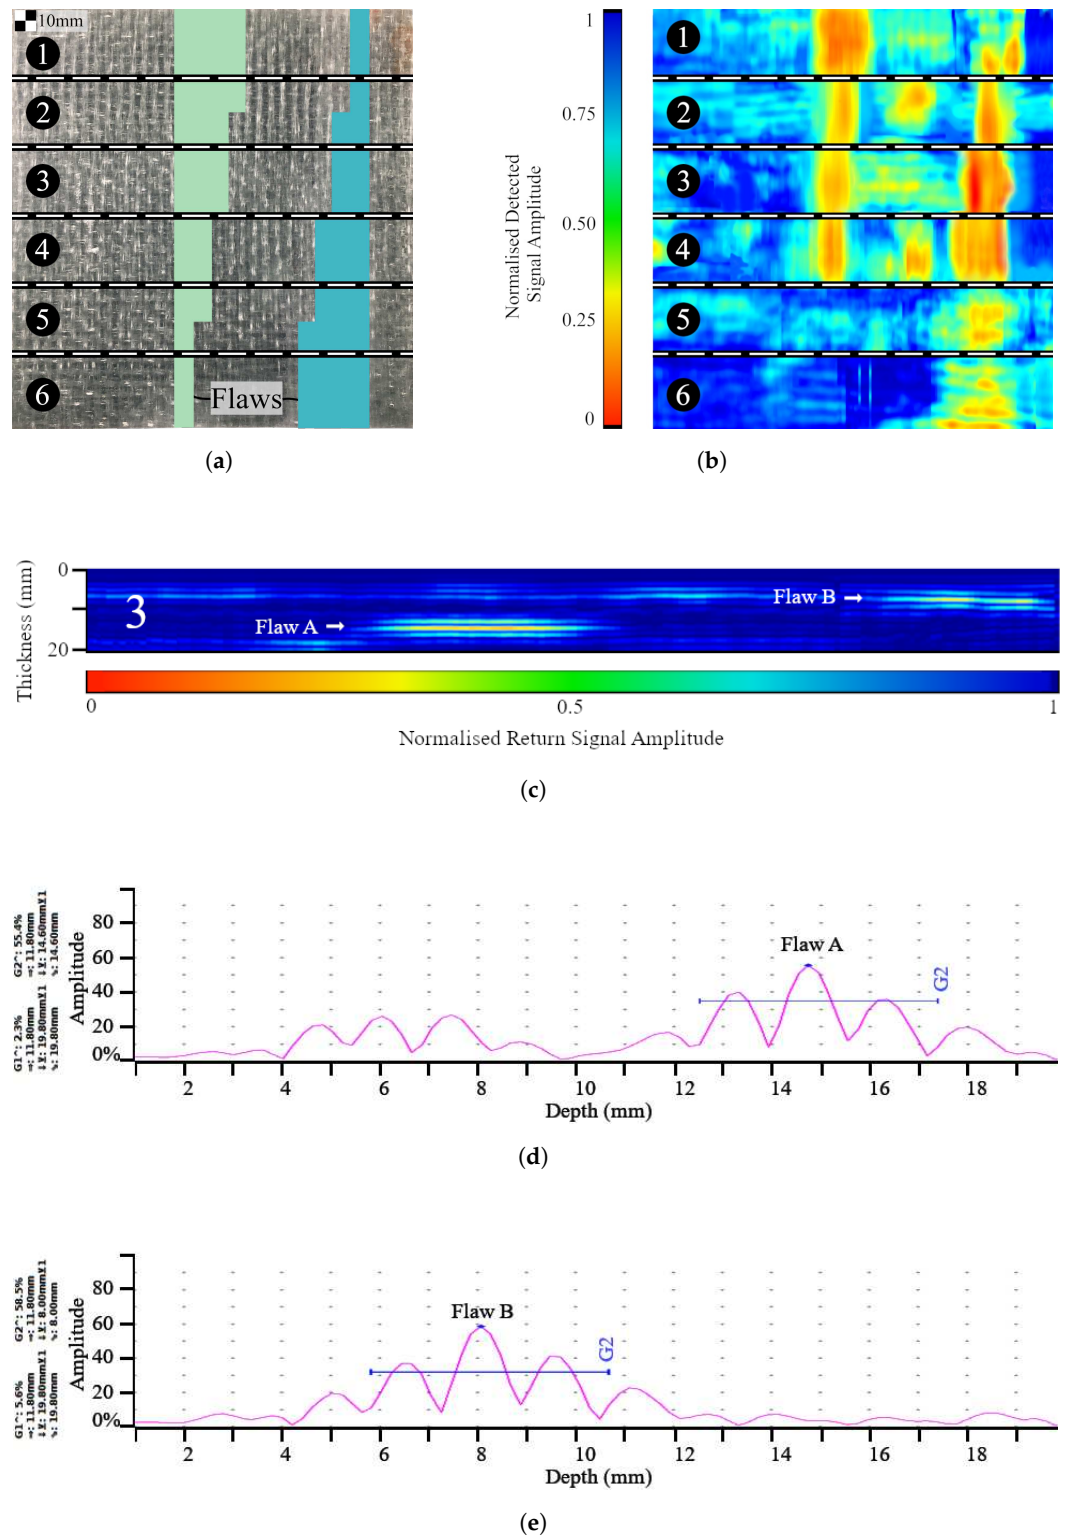
**Figure 4.** Scanning procedure for representative 20 mm plate: (a) Sector locations. (b) C-scans. (c) Sector 3, B-scan. (d) A-scan at Sector 3, flaw A. (e) A-scan at Sector 3, flaw B.

The first specimen (20 mm thick with Type I flaws) is presented as a case study in Figure 4, showing the scanning methodology (Figure 4a), followed by the corresponding C-scan for each encoded sector (Figure 4b). Sector 3 of that specimen was chosen to display a representative encoded B-scan (Figure 4c), and the corresponding A-scans (when the probe was placed directly above each flaw) are included in Figures 4d–e. Uncategorised variations in acoustic impedance, i.e., experimental noise, were observed in some specimens, characterised by high-amplitude peaks in A-scans and subsequent low signal return regions in B and C-scans, as shown in Figure 5. To verify the status of peaks at these locations as noise rather than delaminations, sections of the affected plates were extracted using a diamond-bladed wet saw, polished, and examined using a Zeiss Axioskop 2 microscope (Figure 6, X-Z plane view). Regions where unexpected variations in impedance were observed corresponded to plies, consisting of short reinforcement fibres, increased void content (for example, air bubbles), and less homogeneous resin dispersion, relative to areas of the plate where typical ultrasound responses were observed. Specimens were manually delaminated at this region to observe the X-Y (in-plane) view of the plies, which were revealed as chopped strand mat plies. By contrast, randomly selected plies were delaminated from the remainder of the specimen and were observed as woven roving mat plies. The amplitude of the waveform from a chopped strand mat region can resemble that of delamination, particularly when the former is closer to the probe than the latter (Figure 5). It may be possible to distinguish between causes of impedance gradients by monitoring signal response waveforms on-board during inspection; however, some modern UT detectors may not have this functionality.

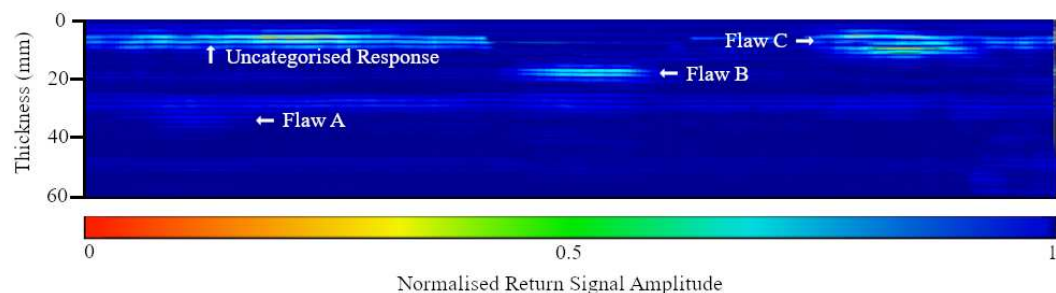
Figure 5. Representative B-scan of the 60 mm specimen.

Furthermore, in-field asset inspection is routinely performed on parts of unknown structural conditions; the ability to detect acoustic features without determining causation could lead to misjudgment of an inherent acoustic feature (for example, a resin-rich zone or chopped strand mat region), as a crack, delamination, dis-bond, or other structural damage. It is, therefore, possible for a benign acoustic feature to obscure a damaged region, for example, flaws A and B in Figure 5 are Type I delaminations (3 mm thick) and are easy to overlook during inspection due to the masking effect of the—previously uncategorised—chopped strand mat/experimental noise region.

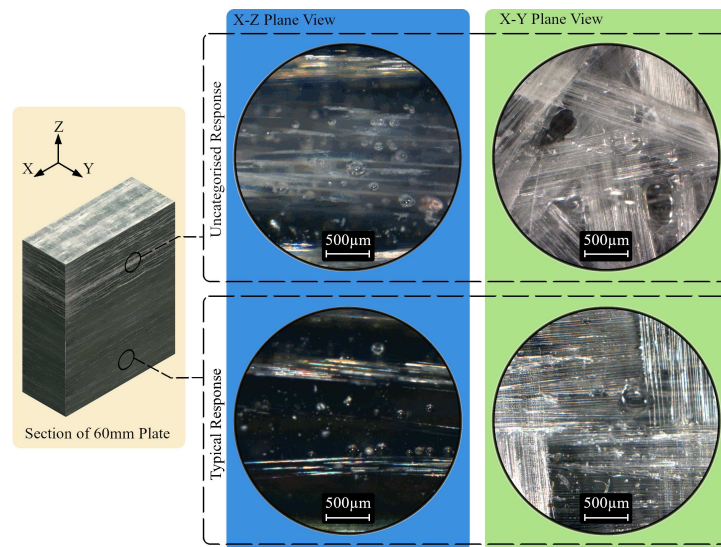
**Figure 6.** Microscopic examination of scan features in a section cut from the 60 mm specimen.

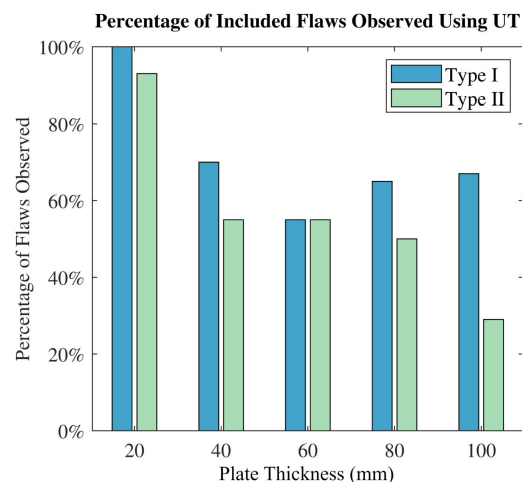
**Figure 7.** Observability of flaws using UT (Type I and Type II).

The ability to find flaws was assessed by comparing the percentage of flaws found as a function of plate depth (Figure 7). The percentage of flaws observed was herein defined as the ratio of the number of flaws that could be seen to the total number of flaws in a given plate.

For both Type I and Type II flaws, an increase in plate thickness correlates with a general decrease in the percentage of flaws detected; for example, in the 20 mm thick plate, 100% of the Type I flaws and 93% of the Type II flaws were identified. This reduces to 66% and 29%, respectively, for the 100 mm thick plate. The relationship between part thickness and the ability to find flaws was expected since the composite was constructed from two materials that had different acoustic properties (glass and polyester); hence, increasing the ply count through-thickness creates more boundaries where the ultrasound waves refract. The drop in the observation of Type I flaws in the 60 mm thick plate was caused by particularly large peak responses from the CSM regions in that plate, which were often positioned between the detector and the flaw, thereby complicating the task of observing the calibrated flaw peaks; it is surmised that without the presence of these CSM plies, more Type I flaws would have been observed. Furthermore, for the ultrasound signal to penetrate a composite at the thicknesses in the present work necessitates ultra-low frequencies, which reduce sensitivity while increasing attenuation and beam spread [60]. Where flaws are small

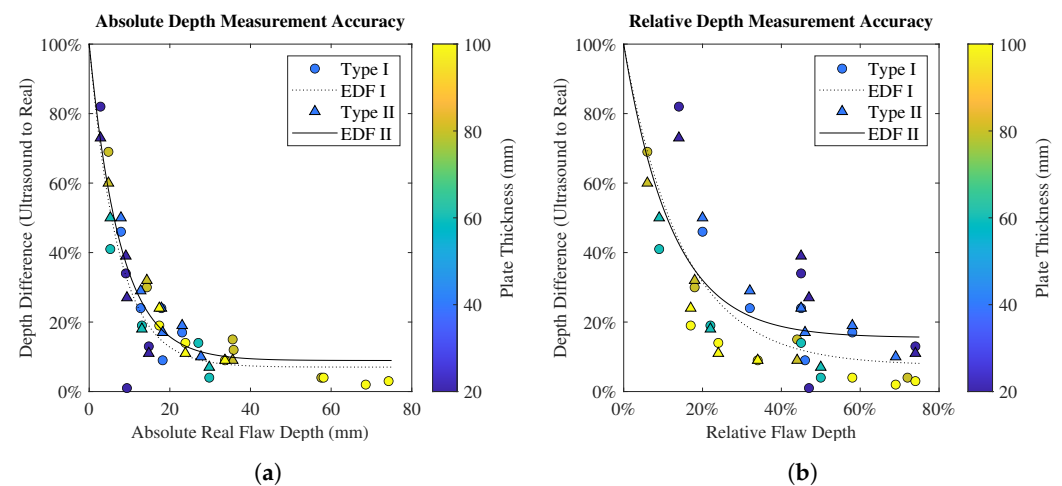
**Figure 8.** Overall flaw depth measurement: (a) Percentage difference between flaw depth measured using UT and real flaw depth as a function of plate thickness, for both Type I and Type II flaws. (b) Percentage difference between flaw depth measured using UT and real flaw depth as a function of plate thickness, for both Type I and Type II flaws.

The present work included a range of real flaw depths, defined as the distance between the external face of the flaw and the probed face (measured with Vernier Calipers). The percentage difference between the flaw depth measured by UT and the real depth is shown in Figure 8a as a function of real, absolute flaw depth. Similarly, the depth difference of the UT measurement as a function of the relative flaw depth is shown in Figure 8b, where the relative flaw depth corresponds to the ratio of the real flaw depth to plate thickness. A least squares optimisation method was used to fit exponential decay function (EDF) trendlines to the data shown in Figure 8; the function is shown in Equation (2), with the parameters A and B listed in Table 2. In order to further probe depth measurement accuracy as a function of plate thickness, the results for all plates are re-plotted in Figure (9).

**Table 2.** EDF trendline parameters for Figure 8.

Figure 8a demonstrates an inverse relationship between real flaw depth and the accuracy of the flaw depth measurement by UT, for both Type I and Type II flaws. The average percentage difference between UT depth measurement and real depth was 22% for Type I and 27% for Type II. The maximum depth at which a flaw could be identified was 74 mm for Type I and 35 mm for Type II. Flaw depth relative to plate thickness is shown in Figure 8b. Irrespective of plate thickness, no flaw can be seen beyond approximately 74% relative thickness, holding for both Type I and Type II flaws.

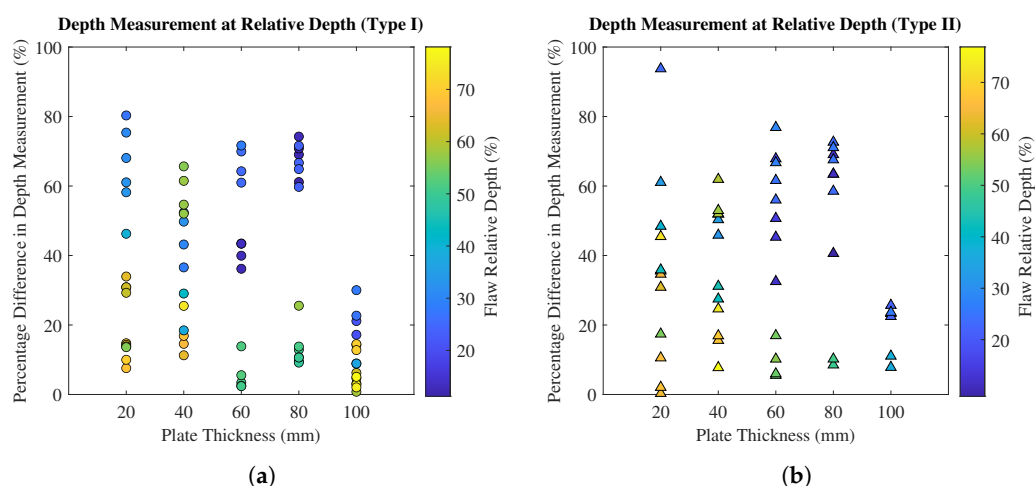
**Figure 9.** Percentage differences of all observable flaw depth measurements as functions of plate thickness: (a) Type I flaws (b) Type II flaws.

Some relative flaw depths (such as 45%) were included in several plates, resulting in a range of data points captured at those relative depths. Colour bar scales are used in Figure 9a (Type I) and Figure 9b (Type II) to highlight the depth measurement accuracies as functions of plate thickness where the range of relative depths is clearly displayed. For similar relative depths, further analysis (Figure 9) shows reduced measurement accuracy when scanning less-thick plates (for both Type I and Type II flaws), further reinforcing the inference of an inverse relationship between plate thickness and flaw depth measurement accuracy. The necessity of low-frequency probes to attain signal penetration when inspecting thick composites is well established, and it is speculated that this is—in part—responsible for the reduction in measurement accuracy at shallow flaw depths. In the present work, the inspection was in the range of 1 to 20 times the sound wavelength (the latter being approximately 5 cm); therefore, the waves may not have had the physical distance necessary to develop fully. Furthermore, it is possible that on-board filtration algorithms are better equipped to distinguish between noise and real features when the cavities are at greater depths, owing to a multitude of factors, including noise attenuation and signal-to-noise ratio. When considering less thick plates, no general trend was observed between the type of flaw and measurement accuracy; however, in thicker plates (above 60 mm or 45% relative), the depth measurements of Type I flaws are more accurate than those of Type II flaws. Furthermore, at these plate thicknesses, the percentage of Type II flaws that could be inspected drops significantly compared to Type I (Figure 7).

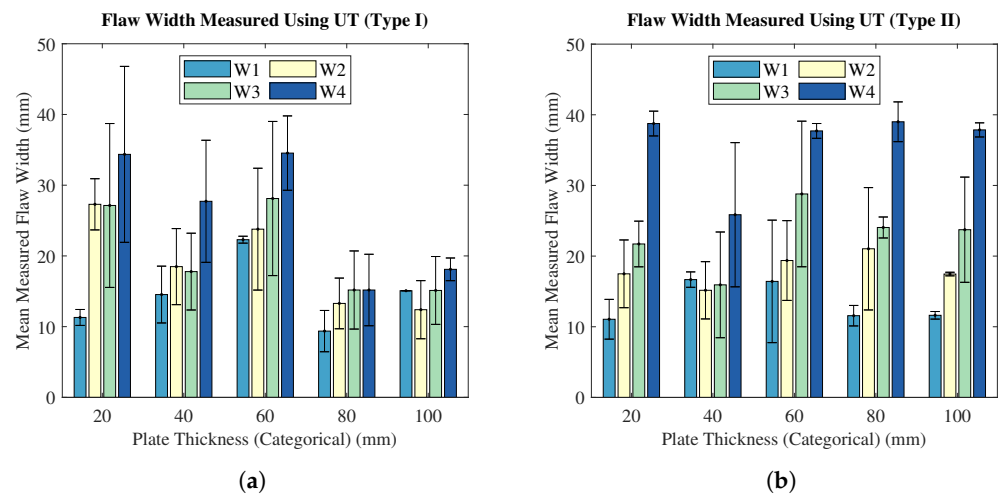
**Figure 10.** Average UT-measured flaw widths (with standard deviations) at each known flaw width, as a function of plate thickness: (a) Type I flaws. (b) Type II flaws.

The in-plane flaw dimension analysis was completed to evaluate the accuracy of UT as a method for determining the size of a delamination-style flaw in the lamina plane. Figure 10 shows the absolute measured flaw width as a function of plate thickness, whilst Figure 11 displays the accuracy of the width measurement by UT as a function of flaw depth. The accuracy of width dimensioning is defined as the percentage difference between the UT measurement and the known actual flaw width.

Examining Figure 10, no trend exists between the UT-measured flaw width and plate thickness, for both flaw types. The standard deviations of width measurements vary considerably across the test matrix, reinforcing the general inaccuracy of the technique for in-plane dimensioning. Furthermore, the analysis of width measurement accuracy in Figure 11 displays a lack of relationship between in-plane measurement accuracy and flaw depth. Generally, Type II flaws were more accurately measured than Type I flaws; however, there is no statistical significance. Additionally, there were fewer Type II flaws identified than Type I, especially at larger plate thicknesses; therefore, the direct comparison of Type I and Type II is ill-advised in this respect.

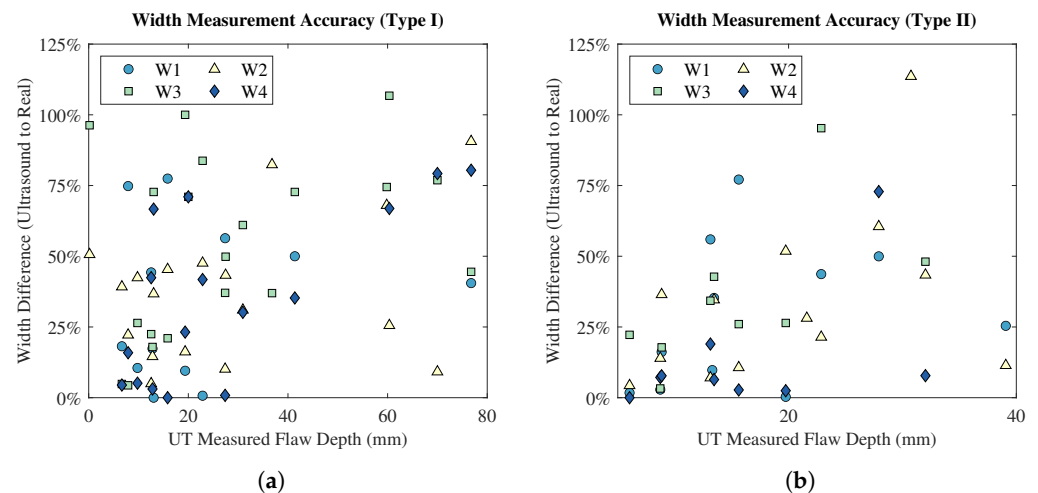
**Figure 11.** Percentage differences between UT-measured flaw widths and the known, actual flaw widths as functions of UT-measured flaw depth: (a) Type I flaws. (b) Type II flaws.
