John, E., Boxall, J., Collins, R. et al. (2024) Experimental investigation of the fatigue strength and leakage failure mode of corroded cast iron water pipes. In: Alvisi, S., Franchini, M. and Marsili, V., (eds.) Engineering Proceedings. The 3rd International Joint Conference on Water Distribution Systems Analysis & Computing and Control for the Water Industry (WDSA/CCWI 2024), 01-04 Jul 2024, Ferrara, Italy. MDPI. Article no: 20. ISSN: 2673-4591.

Experimental Investigation of the Fatigue Strength and Leakage Failure Mode of Corroded Cast Iron Water Pipes[†]

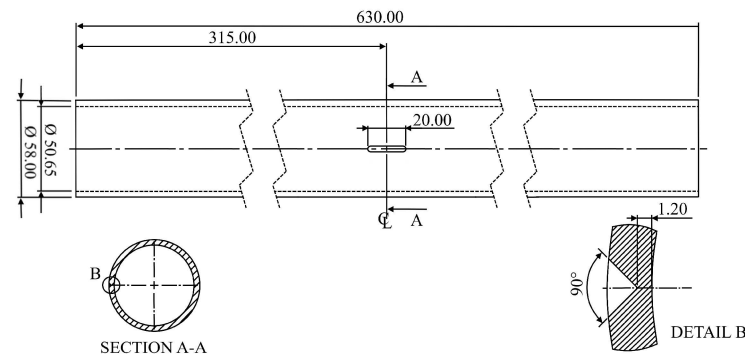
Figure 1. Fatigue specimen design featuring an axially aligned pit, root radius ~ 0.2 mm. Not to scale.

To isolate the effect of fatigue load type, the pipe material and pit geometry were kept constant during all fatigue tests by producing specimens from new BS416-2 pipes [5] and adding artificial pits. Internal water pressure loading causes stress acting in the pipe's circumferential direction, whereas bending loading primarily causes axial stress. A non-symmetric pit geometry was used to investigate how the corrosion pit shape interacts with the applied stress direction (see Figure 1).

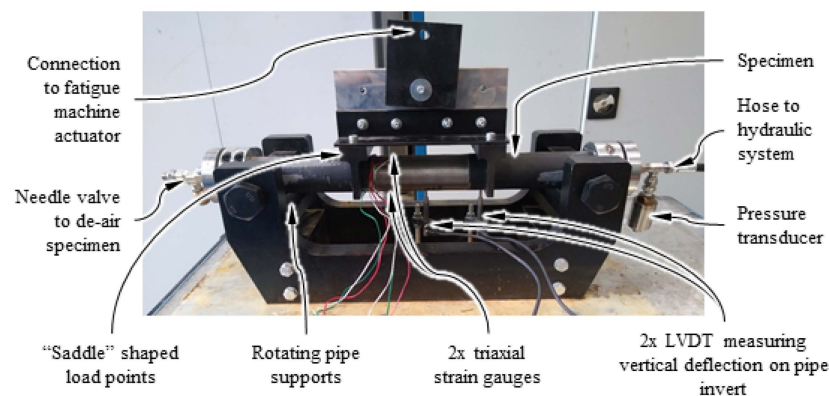
Figure 2. Labelled photograph showing a pipe specimen loaded into the four-point bending apparatus with instrumentation. This photograph was staged outside the fatigue machine for clarity.

Four-point bending was used to give a region of constant moment away from the influence of the load points. The equipment shown in Figure 2 was used to apply the four-point bending load to specimens, and a walter+bai ag LVF-25-ME servo-hydraulic fatigue testing system provided the vertical fatigue load. To provide a constant amplitude internal pressure load, a bespoke hydraulic testing system was built, capable of applying pressure amplitudes up to 9 MPa at a loading frequency of 2 Hz.

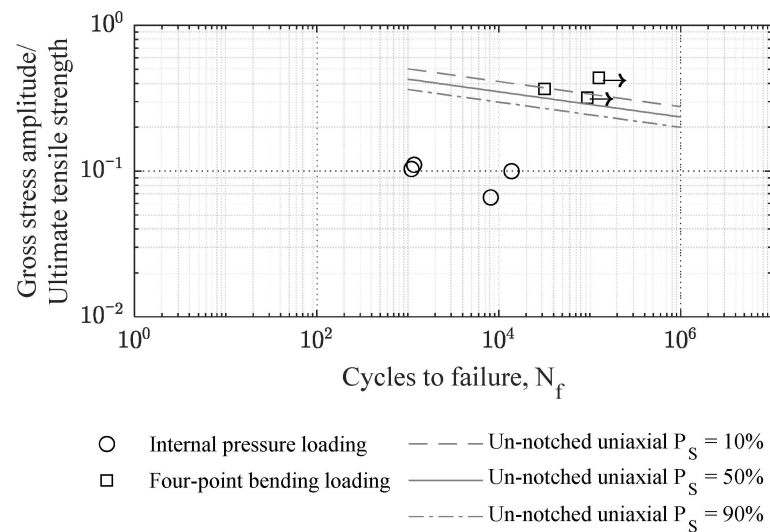
Figure 3. Plot showing the sharp axial notch specimen fatigue test data. The un-notched uniaxial fatigue curve from John et al. [5] is included for reference.

The fatigue results are plotted in Figure 3 with the un-notched uniaxial $R = 0.1$ fatigue curves from John et al. [5] for comparison. An internal pressure scoping test at a lower stress amplitude is included in Figure 3. Only one of the bending fatigue tests failed before 10^5 load cycles. A higher stress amplitude was not possible due to equipment limitations.

Figure 3 shows that, when subject to internal water pressure loading, the presence of the sharp axial notch reduced the fatigue strength of the specimens by 3.4–5.4 times relative to un-notched uniaxial loading. When four-point bending loading was applied to the same specimen design, the fatigue strength was slightly greater than the un-notched uniaxial case. These results show that the direction of the applied fatigue stress relative to an irregular corrosion pit significantly affects the detrimental effect of the corrosion pit, meaning the damage caused by a pit is a function of the pit's geometry and the loading applied to the pipe. Condition assessments of corroded GCI water pipes must consider both the three-dimensional shape of the corrosion pitting and the loading experienced by the pipe to give a true assessment of the damage caused by a given corrosion pit.

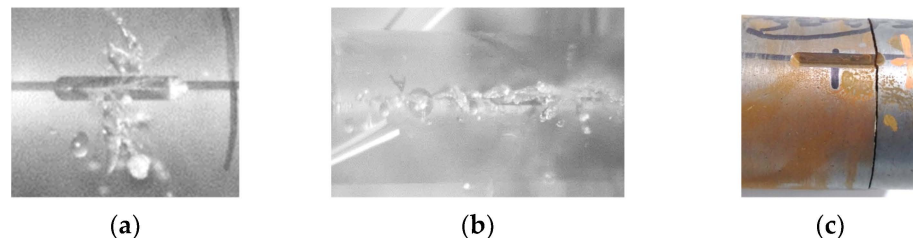
Figure 4. Images showing specimen failure modes: (a) A leaking axial crack contained within the pit; (b) a leaking axial crack extending beyond the pit; (c) a circumferential crack post-test.

All specimens subject to internal pressure fatigue loading developed an axially aligned crack at the root of the pit that allowed water loss (Figure 4a). For the two specimens that failed after $\sim 10^3$ load cycles, the crack leaked for ~ 100 load cycles and then grew beyond the notch in a single load cycle, resulting in a leaking crack >100 mm long (Figure 4b). One pipe that failed after $\sim 10^4$ load cycles leaked for ~ 200 load cycles without the crack growing beyond the pit, while the other leaked for ~ 2000 load cycles without the crack growing. These two tests were stopped automatically because of pressure load drop.

The only four-point bending fatigue specimen that failed developed a circumferential crack during a single load cycle located at one end of the pit (Figure 4c). This failure did not trigger the high-speed camera due to a lighting issue. Gradual pressure drops were detected for the internal pressure loading specimens that coincided with leakage. No pressure drop was detected for the failed four-point bending fatigue specimen, indicating that no leakage occurred before the full-circumferential crack formed.
