Working Paper 255

ERGONOMIC STANDARDS FOR PEDESTRIAN AREAS
FOR DISABLED PEOPLE

Results from Observation Work

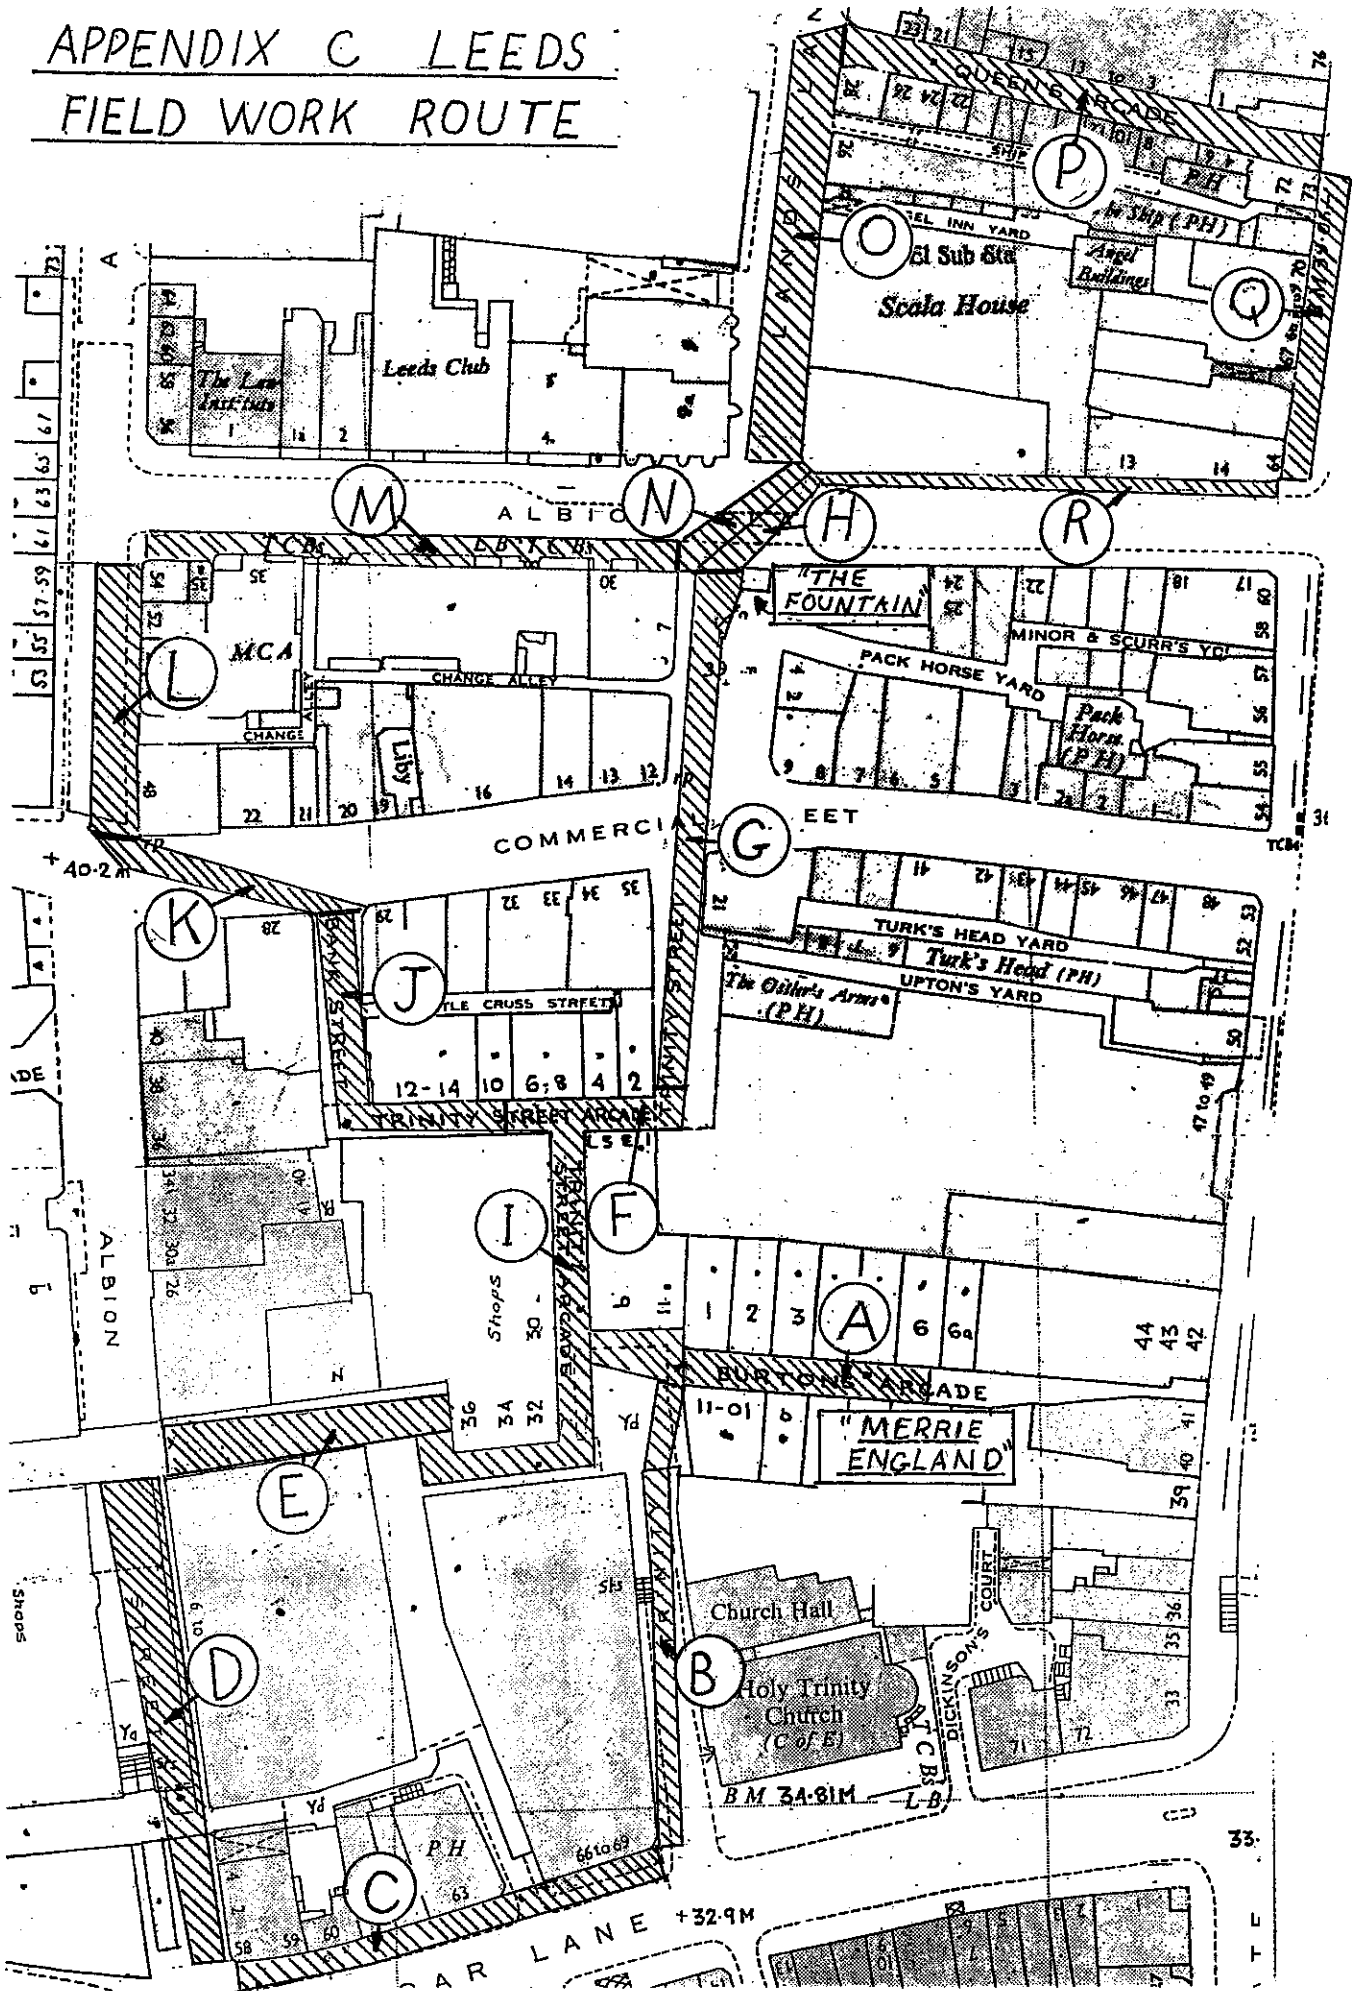
APPENDIX C LEEDS FIELD WORK ROUTE

A - end of first route section H - end of long route N - end of short route
