Nguyen, T-T., Tan, K-H. and Burgess, I.W. (2015) Behaviour of composite slab-beam systems at elevated temperatures: Experimental and numerical investigation. *Engineering Structures*, 82. 199 - 213. ISSN: 0141-0296

Behaviour of Composite Slab-Beam Systems at Elevated Temperatures: Experimental and Numerical Investigation

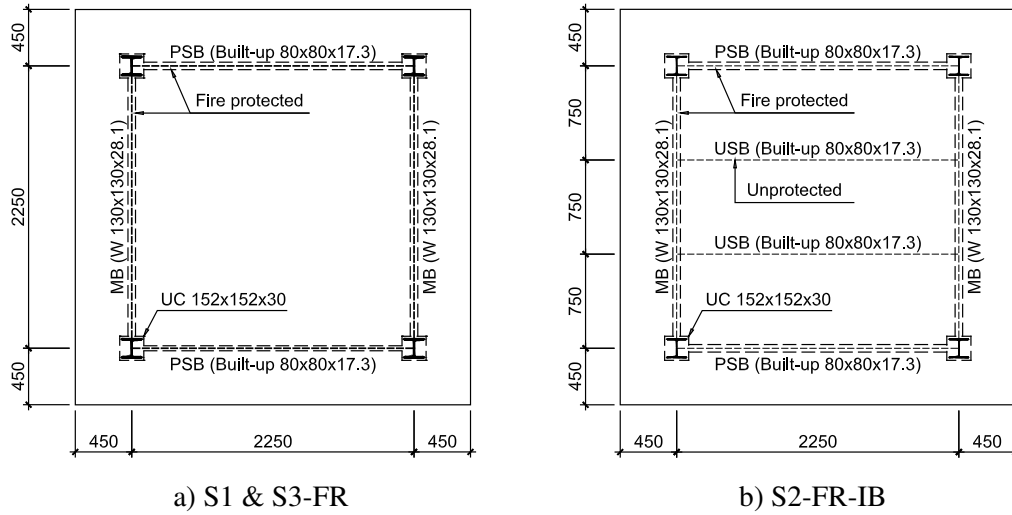
Fig. 1 Structural layout of the specimens

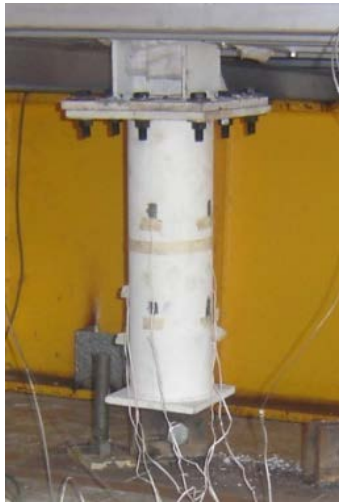
Fig. 4 Supporting columns

The parts of the specimens totally enclosed within the furnace were connected to four fire-protected supporting columns of circular cross-section, using eight M20 bolts to ensure rigid connection between the two parts. These columns were located below and outside the furnace, and connected to the strong floor by hinged connections (Fig. 4). These pin-ended columns allowed the specimen to move horizontally without any restraint, caused no additional bending moments in the slabs, and simplified the test setup.

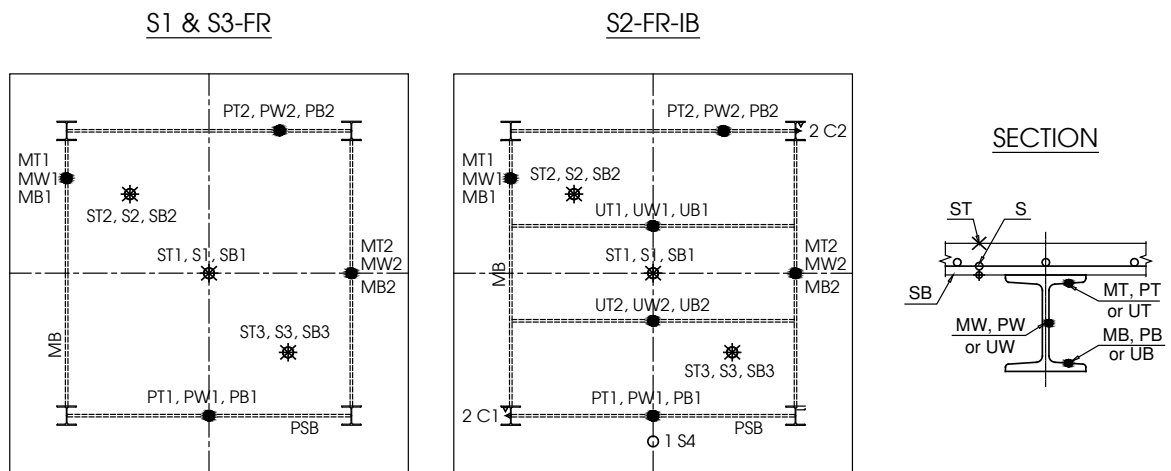
Fig. 7 Arrangement of thermocouples

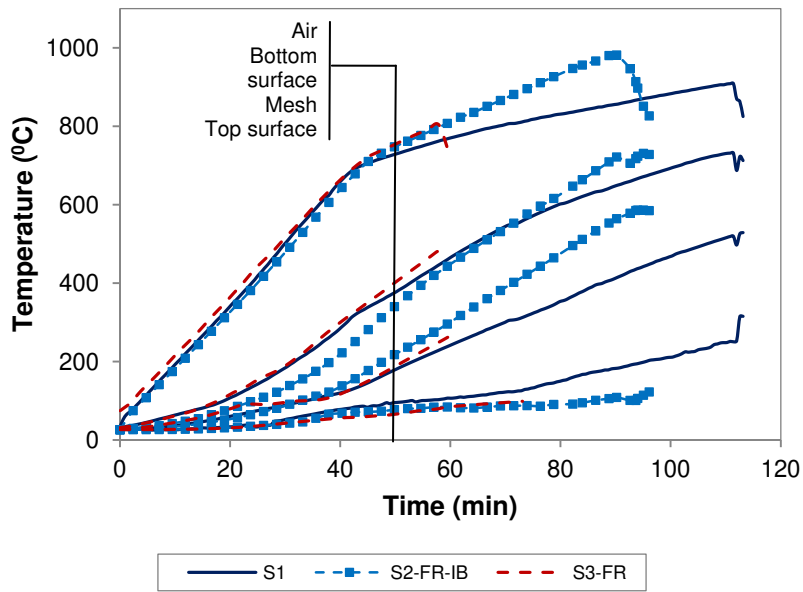
Fig. 8 Air temperature and temperature distributions over slab thickness

As expected, the temperatures at the slab bottom surface were also consistent among the three tests. However, the temperatures at the mesh and the slab top surface diverged towards the end of the tests, since these temperatures depended not only on the air temperature, but also on the development of through-depth cracks in the concrete. As the slab deflection increased, concrete cracks dispersed differently for the different specimens. On the other hand, the temperatures at the mesh level and the slab's unexposed surface increased slowly, progressing only from 23°C to 120°C within the first 40min. This is because of moisture release from inside the concrete slabs, which slowed down the temperature increase rate during the initial stage. When the free water in the concrete had almost evaporated, the concrete temperatures increased at a greater rate.

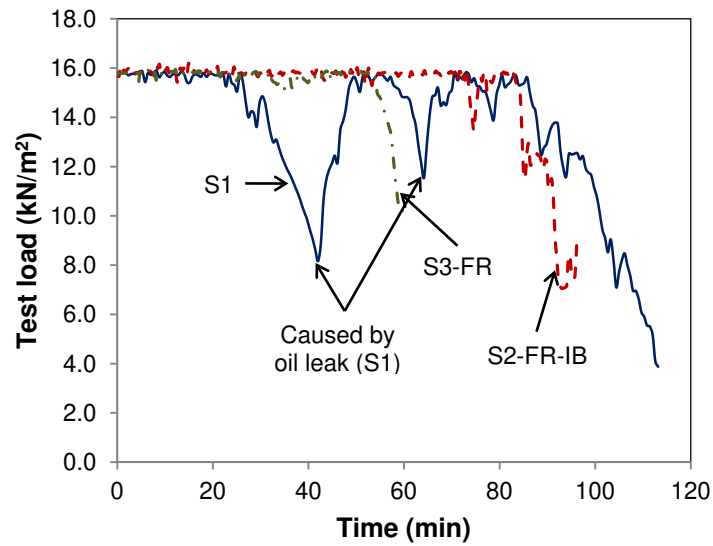
Fig. 9 Load – time relationship

The relationships between applied load and time are shown in Fig. 9. The designated constant level of applied load for all specimens was 15.8kN/m². Unfortunately, in S1 it was not possible to maintain a constant load level during the heating phase, because of an oil leak during the test. Load had to be reapplied manually to keep it constant. In S2-FR-IB and S3-FR the load was maintained as expected.

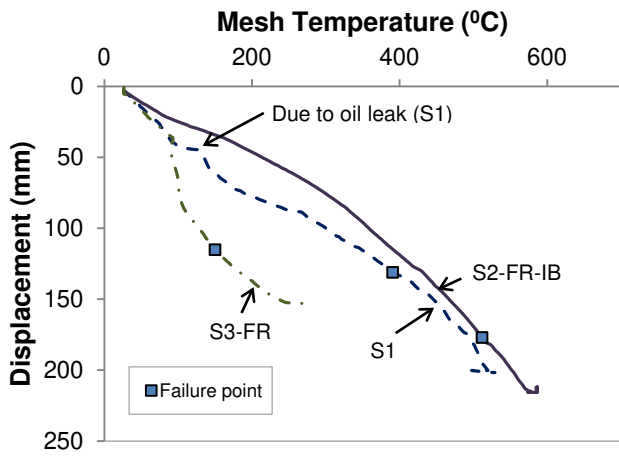
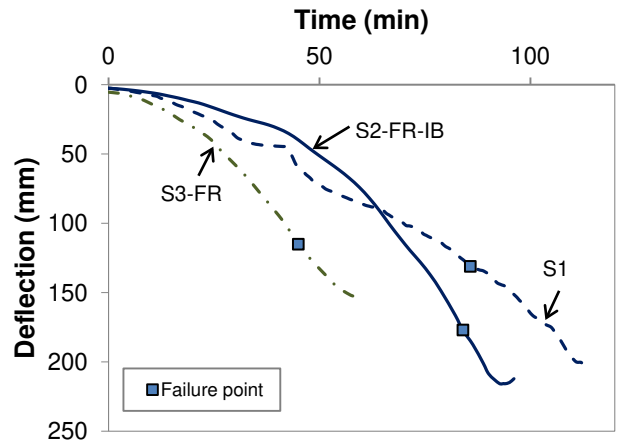
a) Deflection vs. Mesh temperature

b) Deflection vs. Time

Fig. 10 Mid-span slab deflection vs. Mesh temperature and Time

Fig. 10 shows comparisons of the mid-span slab deflections, plotted against mesh temperature and time, together with the corresponding failure points. The maximum slab deflections were 131mm, 177mm and 115mm for S1, S2-FR-IB and S3-FR respectively; however, the failure times were very similar, at 86min for S1 and 84min for S2-FR-IB. S3-FR failed very early, at only 45min of heating due to 'brittle' failure as explained in Section 3.5.

Because of the oil leak, S1 experienced a deflection rebound between 30min and 50min of heating. Although the mechanical load reduced significantly during this period, from 15.8kN/m² to 8.16kN/m², the deflection stayed constant. This indicates that thermal effects

(thermal bowing and thermal expansion) were the main factors in controlling the structural response under fire conditions, rather than mechanical load.

As shown in Fig. 10(a), when the mesh temperature was below 100°C S1 and S3-FR experienced similar deflections. This means that at small deflection (below 42 mm), rotational continuity was maintained by the reinforcement over the supporting protected edge beams. Above this temperature, slab S3-FR experienced larger deflection than S1, due to the restraint beam system on top of slab S3-FR. This caused wide cracks to form over the main beams at a very early point, 20min after the start of heating, while these cracks only appeared in S1 after 30min. This demonstrates that the presence of rotational edge-restraint counteracts the increase in the mesh temperature.

As shown in Fig. 10(a), S2-FR-IB failed at a deflection of 177mm when the mesh temperature had reached 512°C. The corresponding values were 131mm at 391°C and

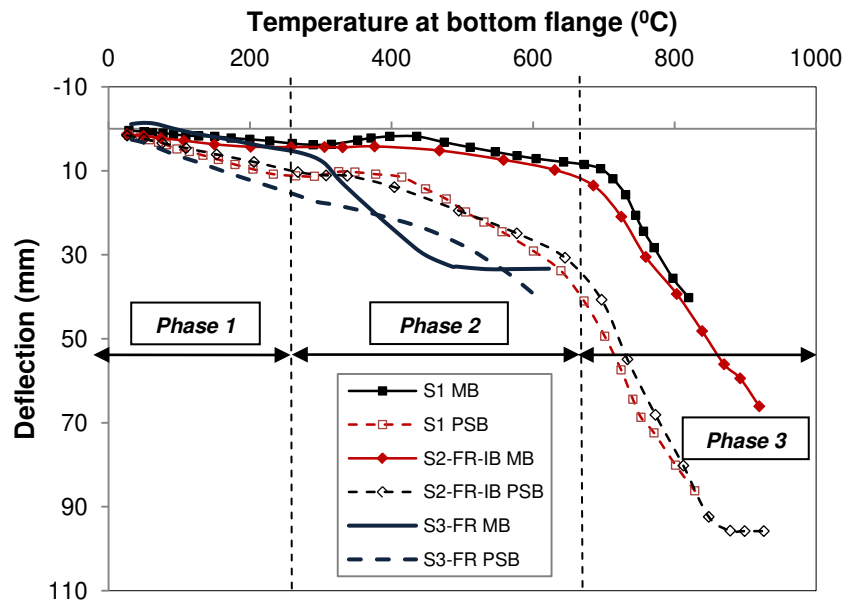
Fig. 12 Mid-span deflection of main beam (MB) and protected secondary beam (PSB)

However, in S3-FR the deflection-temperature curve for the main beam did not follow this trend. After Phase 1, the main beam of S3-FR showed significant deflection. This was because in S3-FR severe cracks appeared at a very early stage (just 20min after the start of heating) directly above the main beam. Thus composite action between the main beam and the slab could not be maintained, leading to inaccurate measurement of beam deflections, which were obtained from the concrete slab placed directly above the main beam. In contrast, the part of the concrete slab directly above the beams in S1 and S2-FR-IB, as well as that above the protected secondary beams in S3-FR, was fully composite with the beams. Therefore these recorded results are reliable.

Comparisons of beam deflection between S1 and S3-FR are shown in Fig. 12. It should be noted that the outstands of S1 were able to curl upwards freely, but in S3-FR this was not possible due to external restraint. It can be seen that the rotational restraint has no effect on the vertical displacement of the main beams. On the other hand, the PSB deflections of S3-FR were greater than those of S1. This may be attributed to the additional mechanical load of the outstands applied to the protected secondary beams of S3-FR due to external restraint.

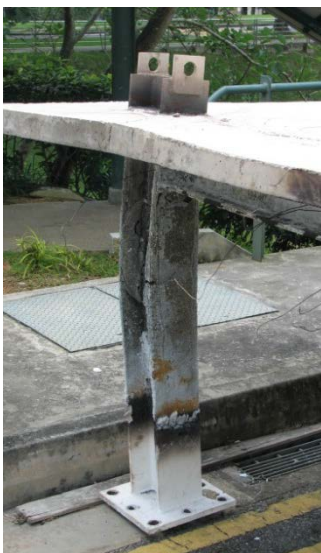
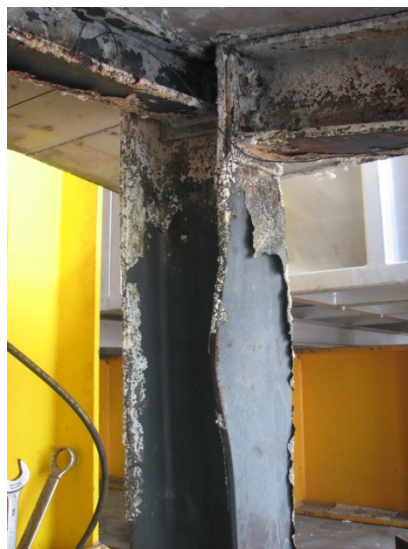
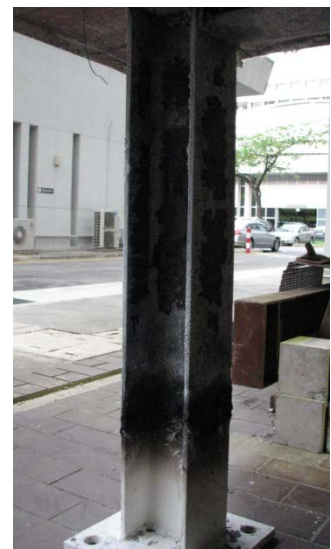
Fig. 13 Deformed shapes of columns after tests

Fig. 13 shows the deformed shapes of the protected steel columns after cooling. They indicate that the columns were subjected to biaxial bending due to pulling-in of the edge beam ends at large deflections. Buckling of the column flanges was observed in S2-FR-IB, but was not detected in S1 and S3-FR. This is possibly because in S2-FR-IB, there was greater mobilization of TMA due to unprotected interior beams. This caused greater biaxial bending in the main beams. These bending moments induced greater compression forces for parts of the columns.

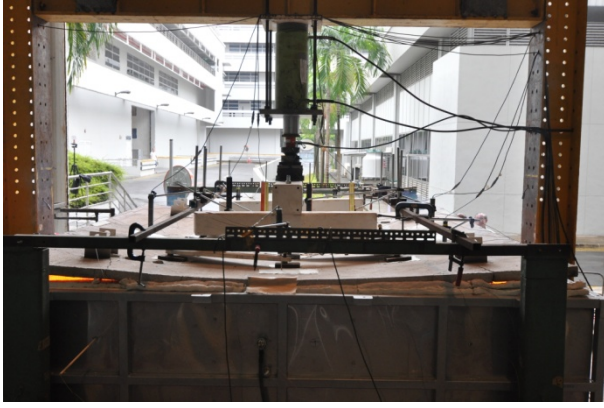
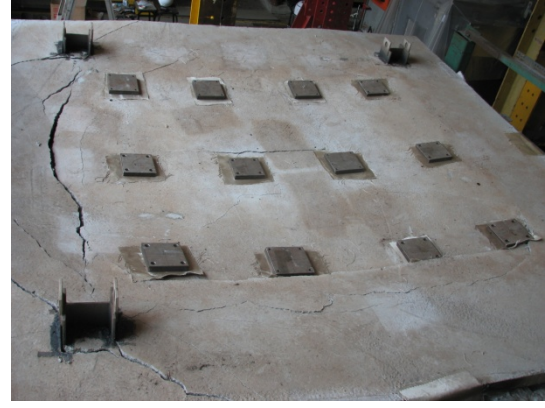
a) Folding mechanism

b) Failure mode

Fig. 17 Failure mode of S1

In S1, concrete cracking occurred around the column locations; however the test was continued, since there was no obvious indication of failure. After 72min of heating, a single-curvature folding mechanism at the slab mid-span, including the formation of plastic hinges

in the protected secondary beams, was observed and is shown in Fig. 17(a). At this stage, when the beam temperature had already reached 692°C, the residual bending resistance of the protected secondary beams (calculated as a composite beam) at the mid-span section was 22.2kNm, which was smaller than the applied bending moment of 32.0kNm due to the mechanical load of 15.64kN/m² and difference in temperatures of the beam top and bottom fibres. After 86min of heating there was a loud sound caused by fracture of reinforcement. Two full-depth cracks were observed; one close to a main beam and the other directly above a protected secondary beam (Fig. 17(b)). Heating was stopped at this point, and no controlled cooling was conducted.

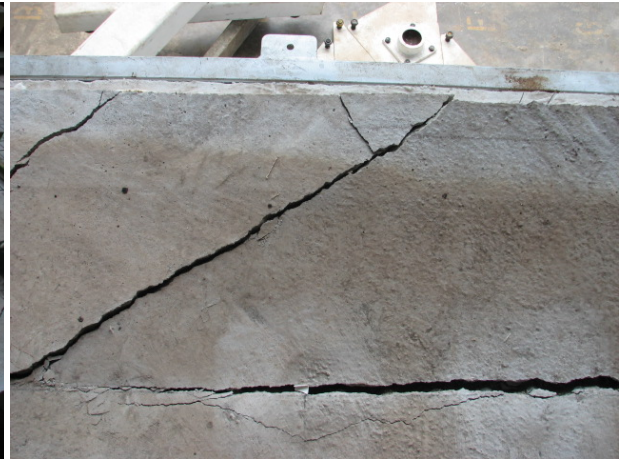
a) Crack pattern

b) Fracture of reinforcement

Fig. 18 Failure mode of S2-FR-IB

Test S2-FR-IB ended when fracture of reinforcement occurred and full-depth cracks appeared close to the edge beams, as shown in Fig. 18(a). However, no folding mechanism was observed. This may be due to the presence of interior beams and the rotational restraint beams on top of the slab, which prevented single-curvature folding.

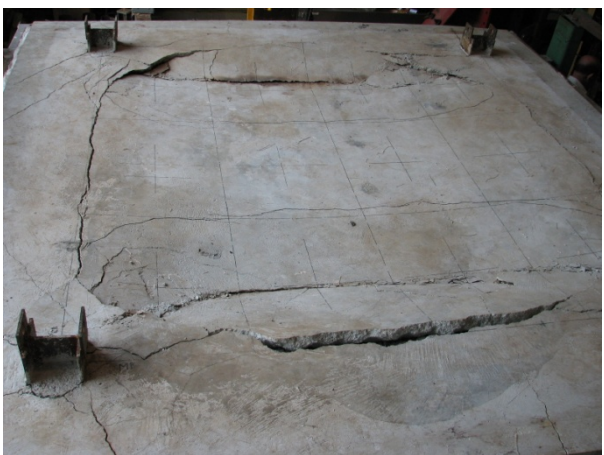
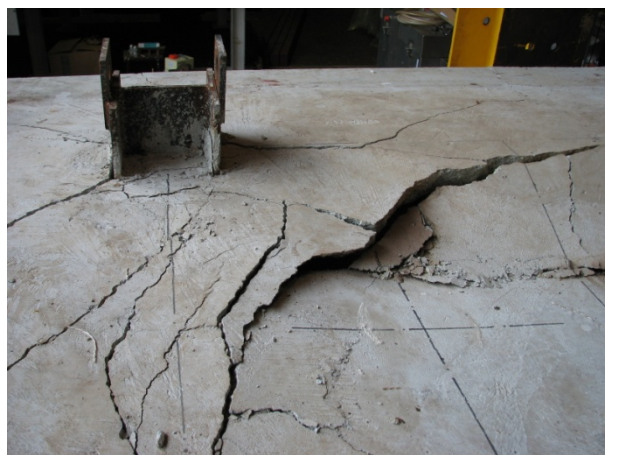
a) Crack pattern

b) Compressive ring failure

Fig. 19 Failure mode of S3-FR

In S3-FR, a compression ring formed after 28min of heating with the appearance of curved cracks at the four corners (Fig. 19(a)). However, at 45min three full-depth cracks appeared suddenly; one at the slab corner near the steel column, and two above the main beams. These cracks led to a 'brittle' failure of the compression ring and caused 'run-away' behaviour in the slab. The supporting compression ring could no longer be maintained, and therefore TMA was not able to develop further.

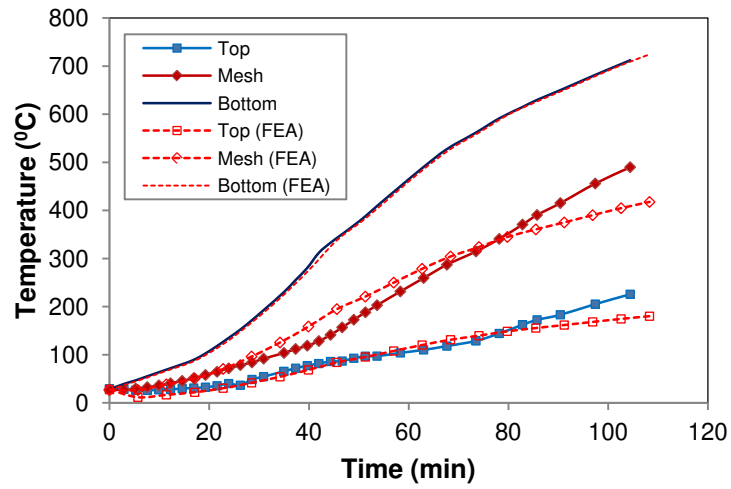
a) Temperature distribution of slab

b) Deflection comparison

Fig. 21 Comparisons between simulation and test for S1

Figs. 21-23 provide comparisons of temperature distribution and deflections of the slab and beams between the FE analyses and the experimental results. With a thermal gradient of $10^{\circ}\text{C}/\text{mm}$ the predicted temperatures were very close to the recorded ones, except for the mesh temperature in S3-FR (Fig. 23(a)). This is because, in S3-FR, severe cracks appeared over the perimeter of protected beams, rapidly leading to significant heat loss. As a result, the recorded mesh temperature increased at a lower rate after the cracks had appeared. The mesh temperature in S3-FR only increased from 91°C (after 22.5min of heating) after cracks appeared to 150°C (after 45min of heating).

As shown in Figs. 21(b)-23(b), generally the numerical predictions match well with the test results. The discrepancies in the slab deflection curves between the predicted and experimental results after the mesh temperature reached 200°C for S1, and 100°C for S3-FR, are attributed to two reasons. Firstly, as the deflection increased, cracks in the concrete slabs developed, leading to significant heat loss. However, the numerical model can not simulate this phenomenon, resulting in greater prediction of mesh temperature. Secondly, the numerical model cannot predict concrete spalling, which had a significant effect on the slab behaviour. In S2-FR-IB the cracks were not as severe as those in S1 and S3-FR, and so the prediction for this test is considerably better.

The results in terms of beam deflections versus temperature (Figs. 21(b)-23(b)) show that in general the model predicts the beam behaviour very well. For the main beam of S3-FR, although the trend was similar, the comparison is poorer because severe cracks appeared directly above the main beam top flange, leading to greater inaccuracy in the measurements.

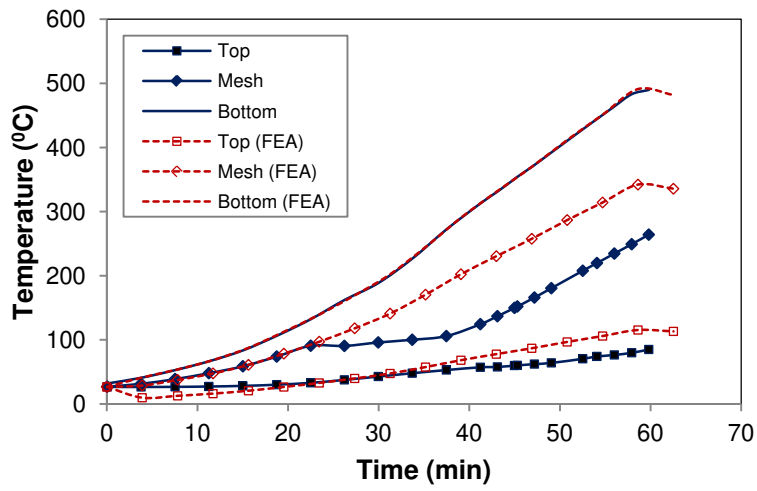
a) Temperature distribution of slab

b) Deflection comparison

Fig. 23 Comparisons between simulation and test for S3-FR

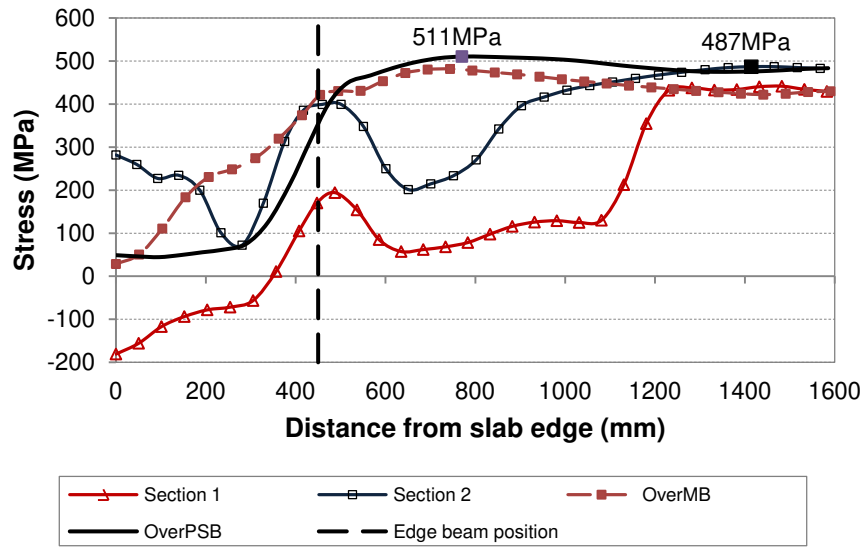
a) Stress distributions in reinforcement across the sections

b) Principal stress distribution in concrete top surface of the slab and in the beams

Fig. 24 Numerical results of S1 at failure – 85.8 min

Figs. 24-26 show the stress distributions across the sections and at the top surfaces of the slabs at failure. In these figures, 'Section 1' denotes the mid-span section perpendicular to the protected secondary beams, 'Section 2' denotes the mid-span section perpendicular to the main beams, 'OverMB' is the cross-section above a main beam, and 'OverPSB' is the cross-section above a protected secondary beam. The positions of these sections are indicated in Figs. 24(b)-26(b).

It can be seen that, for S1 at 85.6min, the highest tensile stress in the reinforcing mesh across a protected secondary edge beam is higher than that across the mid-span section (511MPa compared to 487MPa on Section 2). For S2-FR-IB at 84.0min, the maximum tensile stress of 377MPa is located above the main beam, while the maximum stress in the reinforcement across the slab mid-span (Section 1) is 330MPa. For S3-FR, the maximum tensile stress of 659MPa is found at the slab mid-span (Section 2), followed by that above the protected secondary beam (638MPa). Therefore, on the basis of numerical simulations, in S1 and S2-FR-IB the fracture of reinforcement above the edge beams would occur first, before the fracture of reinforcement at the mid-span of the slabs. This observed failure mode in the model concurs with experimental observations. In S3-FR predicted failure is due to fracture of reinforcement at the slab mid-span; however, in the actual test, the failure mode was due to failure of the compression ring. As shown in Table 4, the equivalent plastic strains in uniaxial compression (PEEQ) at the slab top surfaces at its corners are 0.0057, 0.0031 and 0.0051, for

The interior beams also considerably affect the magnitude of stress in the mesh reinforcement, as well as its distribution, and this may have led to differences in the failure modes of the floor assemblies. As can be seen in Figs. 24(a)-26(a), in the case of S2-FR-IB the maximum tensile stress in the reinforcement across the mid-span cross sections was only 330MPa, which is smaller than the reinforcement stress above the edge beams. In contrast, the corresponding values were 487MPa and 659MPa, for S1 and S3-FR respectively; these are both greater than the reinforcement stress above the edge beams. Consequently, the failure mode may change from reinforcement fracture at mid-span (for cases without interior beams) to reinforcement fracture in the vicinity of edge beams (for cases with interior beams).

The difference in the stress distributions can be clearly identified in Figs. 24(b)-26(b). For S2-FR-IB, the tensile stresses caused by TMA in the reinforcement above the interior beams are reduced, partly because of the superposed compressive stresses caused by sagging bending of the T-flange composite interior beams. For S1 and S3-FR with no interior beams, the tensile stresses are continuous with the maximum values at the centres of the slabs.

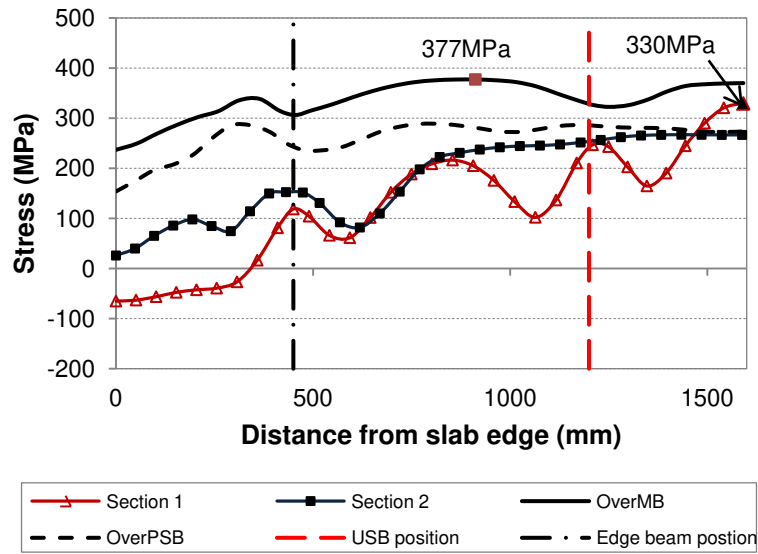
a) Stress distributions in reinforcement across the sections

b) Principal stress distribution in concrete top surface of the slab and in the beams

Fig. 25 Numerical results of S2-FR-IB at failure – 84.0 min

115mm at 150°C, for S1 and S3-FR respectively. On the other hand, Table 3 indicates that S2-FR-IB had the greatest enhancement factor, at 2.55 compared to 1.96 for S1 and 1.54 for S3-FR. This enhancement factor is defined in this paper as the ratio of the test failure load to the small-deflection yield-line failure load at the same mesh temperature. It is obvious that continuity of reinforcement over supporting beams, and the presence of interior beams, have significantly reduced the slab deflection and enhanced the slab's load-bearing capacity. The enhanced capacity is greatly assisted by the tensile forces created in the interior beams, as observed in Fig. 25(b).

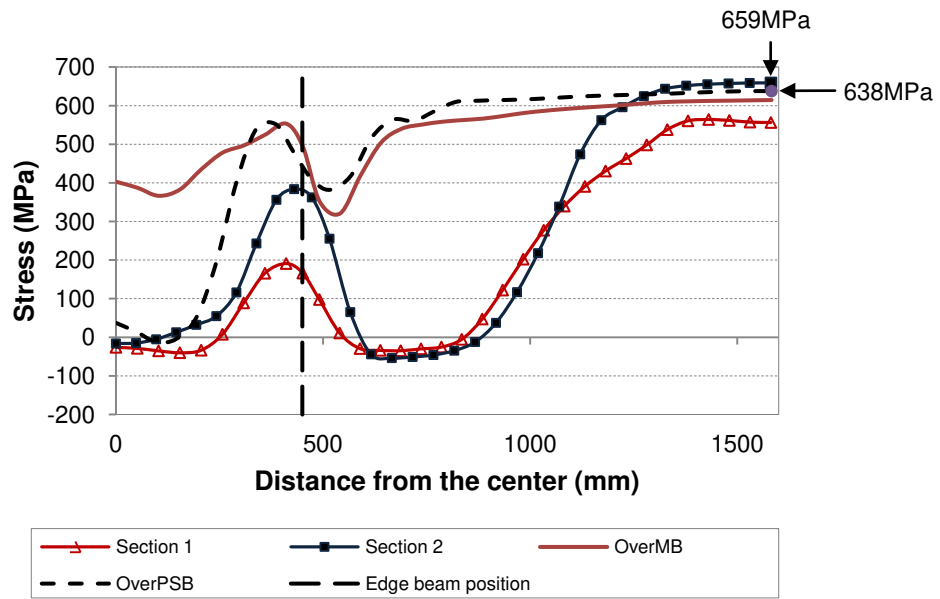
a) Stress distributions in reinforcement across the sections

b) Principal stress distribution in concrete top surface of the slab and in the beams

Fig. 26 Numerical results of S3-FR at failure – 45.0 min
