Lewis, S.R., Lewis, R. and Fletcher, D.I. (2015) Assessment of laser cladding as an option for repairing/enhancing rails. *Wear* , 330. 581 - 591. ISSN 0043-1648

ASSESSMENT OF LASER CLADDING AS AN OPTION FOR REPAIRING/ENHANCING RAILS

S.R. Lewis^α, R. Lewis, D.I. Fletcher

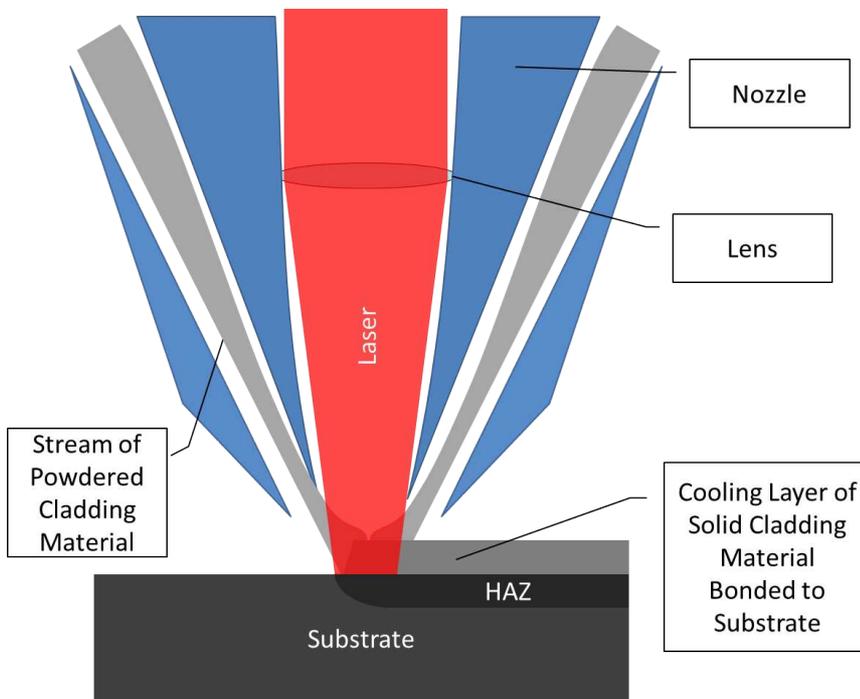
Figure 1 Schematic of one-step laser cladding process

Figure 1 shows a schematic of the one-step process where the laser beam is focused on and scanned across the surface of the metal to be clad. The high heat input of the laser creates a thin melt pool on the surface of the substrate material. Simultaneously a powder consisting of atomized cladding metal is fired into this melt pool. As the powder passes through the laser it is also melted and fuses with the melt pool on the surface of the substrate material. This creates a single track of clad on the surface. Individual tracks are then created side-by-side to clad whole surfaces. An inert gas is used to deliver the powder to the substrate surface. This gas has two functions; to deliver the powder at high speed to the melt pool and also to shroud the particles so that they will not react with the surrounding atmosphere when they are heated by the laser. The high thermal energy input of the laser not only melts the powder but will also heat the substrate material. As the laser passes the substrate will start to cool at a fast rate. This high rate of cooling is due to the greater volume of substrate compared to the cladding. This heating and rapid cooling of the substrate causes changes in its microstructure throughout a certain depth of the bulk material. These changes in microstructure will vary with material type and heating and cooling rates. This layer of modified microstructure sits immediately below the interface between the cladding and substrate and is known as the heat affected zone, HAZ, as shown in Figure 1. Residual stresses are also introduced into the cladding and substrate due to: differences in thermal expansions between the clad and bulk materials, temperature gradients created in the material and expansion/ contraction due to microstructural phase transformations in the HAZ [2]. The thickness and weld quality of the cladding layer is controlled by adjusting the operating parameters of the laser cladding equipment. More information of process parameters such as

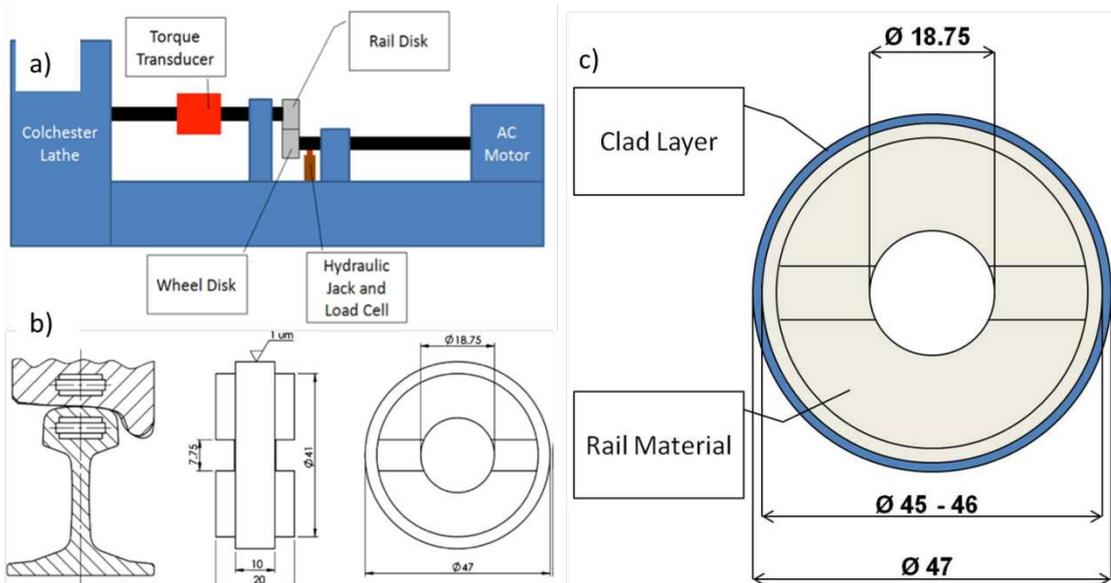
This study was carried out using The Sheffield University Rolling Sliding (SUROS) rig [1]. Figure 2 shows a schematic of the SUROS rig and typical discs used. For these tests the lathe was run at 400 rpm with 1% creep in the contact and contact load of 7.14 kN which gives a maximum contact pressure of 1500 MPa when applied to a 260 grade rail disc. These are standard wear and RCF settings for SUROS testing [9].

Figure 2 a) Schematic of SUROS rig b) Extraction and dimensions of SUROS specimens c) Schematic of laser clad SUROS specimen. All dimensions in mm.

Each SUROS specimen was purposely manufactured undersized to a diameter of either 45 or 46 mm. The clad layer then restored the specimen to a diameter of 47 mm. Clad layers are typically laid in 1 mm thicknesses. Thus the 45 mm discs had 2 layers of clad material and the 46 mm discs had 1 clad layer. Figure 2c) shows a schematic of a laser clad SUROS specimen.

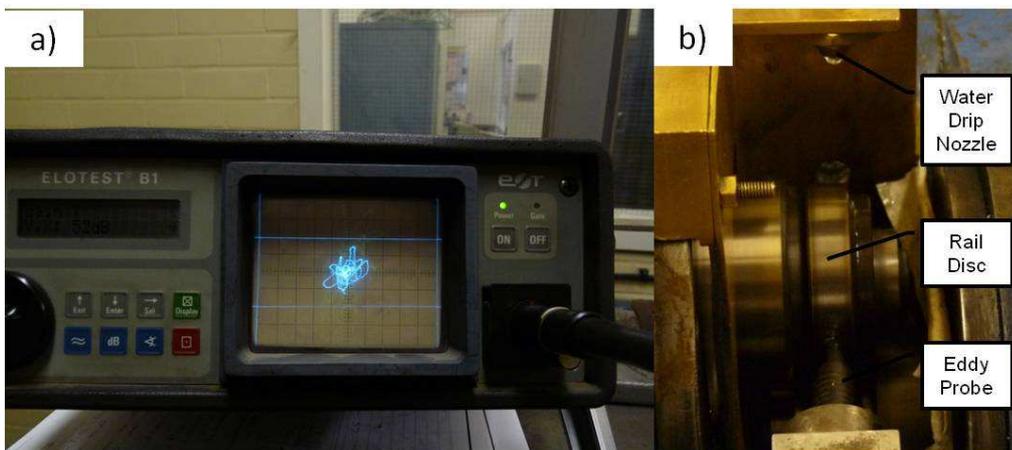
For the RCF tests an Ellotest B1 Eddy Current Crack detector was used. A differential eddy current probe was connected to the detector unit and held 0.3mm from the surface of the rail disc. An RCF failure definition was set using a calibration disc with wire eroded reference cracks in its surface as used in [14]. As the calibration disc was rotated in front of the eddy current probe a signal of fixed size was displayed on the detector screen. The size of this reference signal was used to define the point where the RCF cracks in the test specimens were of sufficient length for failure to be defined see Figure 3.

Figure 3 a) Picture of Eddy Current Crack Detector b) Differential eddy current probe offset 0.3mm from rail disc surface.

Circulating eddy currents can be induced in any electrically conductive material and magnetic material when in close proximity to a wire coil which itself is subject to an alternating current, due to fluctuations in the magnetic field surrounding the coil. These undisturbed eddy currents in turn will affect the impedance of the coil and hence the voltage across it. If a flaw in the conducting material (such as a crack) disturbs the eddy currents this will change the amount which the impedance in the coil is affected. Hence monitoring the voltage across the coil can indicate the presence of a crack [14].

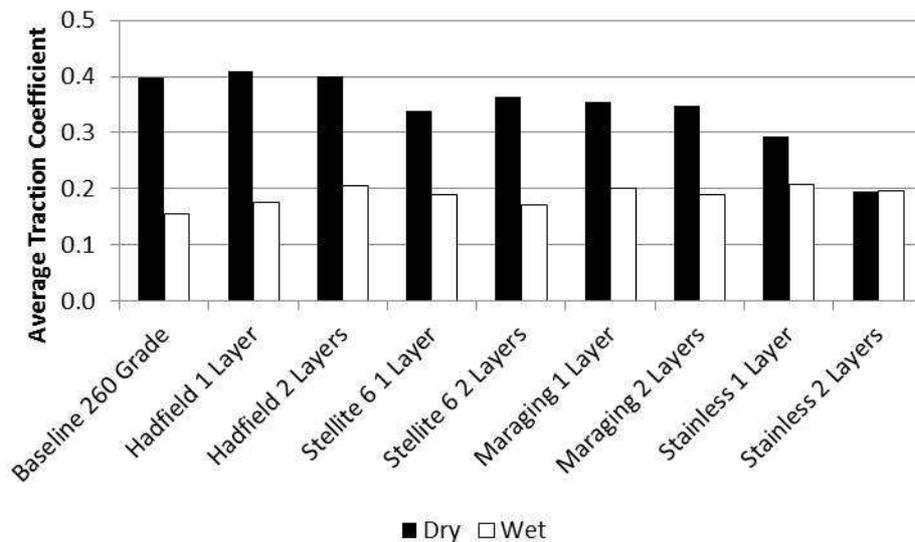
Figure 4 Average traction coefficients yielded during the friction tests.

Figure 4 shows that the Hadfield samples gave traction coefficients of 0.4. This was the same as the 260 grade baseline. All other samples were below this value the highest of these being Maraging with an average traction coefficient of 0.36. Stellite gave an average of 0.35. Stainless steel showed the lowest traction coefficient with an average of 0.25, but also showed the highest variation in traction level. Under wet conditions the baseline traction coefficient was the lowest at 0.15 with reduced variation between the other materials.

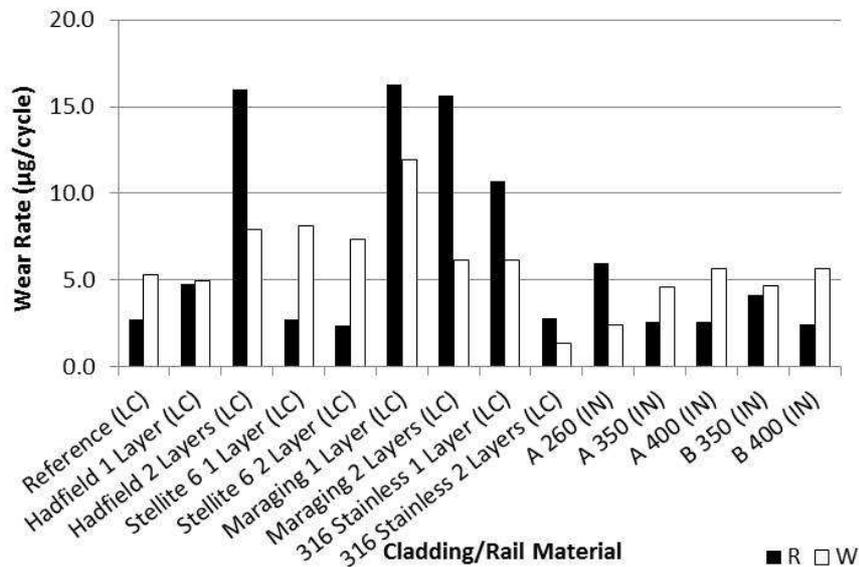
Figure 5 shows wear rates of both the wheel and clad rail along with wear data from the INNTRACK project [10]. Both sets of test were conducted under the same conditions of 5000 dry cycles, 1% slip and 1500 MPa. In the INNTRACK project premium rail grades from two different manufacturers (A and B) were tested in comparison with the standard 260 grade rail. For the laser cladding tests the only consistent wear rates are shown by the Stellite samples which also show the lowest rail wear rate with an average of 2.55 $\mu\text{g}/\text{cycle}$. This compares favourably with the 2.77 $\mu\text{g}/\text{cycle}$ given by the reference sample. However, higher wheel wear was seen with the satellite samples compared to the baseline case. The highest rail wear rates were seen with the Maraging samples with an average wear rate of 15.95 $\mu\text{g}/\text{cycle}$. The Stainless and Hadfield steel samples showed the least consistency in wear rates. As these materials are known to work-harden this could indicate that the materials are still in their soft state and more test cycles would be needed for steady state wear to be achieved. For the laser cladding tests overall wheel wear is increased with the use harder rail materials. The INNTRACK data also shows that wheel wear tends to increase as the hardness of the rail is increased. The Stellite 6 tests showed comparable rail wear with the INNTRACK data with Stellite showing an average of 2.55 $\mu\text{g}/\text{cycle}$ compared to the

premium rails (Manufacturer A 350, 400 and Manufacturer B 350, 400) tested in the INNOTRACK project showing an average of 2.94 $\mu\text{g}/\text{cycle}$. However, wheel wear in the Stellite tests was higher averaging 7.74 $\mu\text{g}/\text{cycle}$ compared to an average of 5.15 $\mu\text{g}/\text{cycle}$ for wheel tested with premium rail in the INNOTRACK project.

Figure 5 Wear rates of the clad discs after 5000 dry cycles. R indicates wear rate of the rail disc, W indicates wear rate of wheel disc LC indicates data from current laser cladding tests, IN indicates data from the INNOTRACK project.

The Stellite rail sample seems to show a similar wear mechanism to the Hadfield sample although with less abrasion. This is evidenced in Figure 5 where the wear rate of the Stellite 1 layer sample is lower than the corresponding Hadfield sample. The Stellite wheel wear is similar to the Hadfield wheel wear with a high amount of delamination and signs of three-body-abrasion.

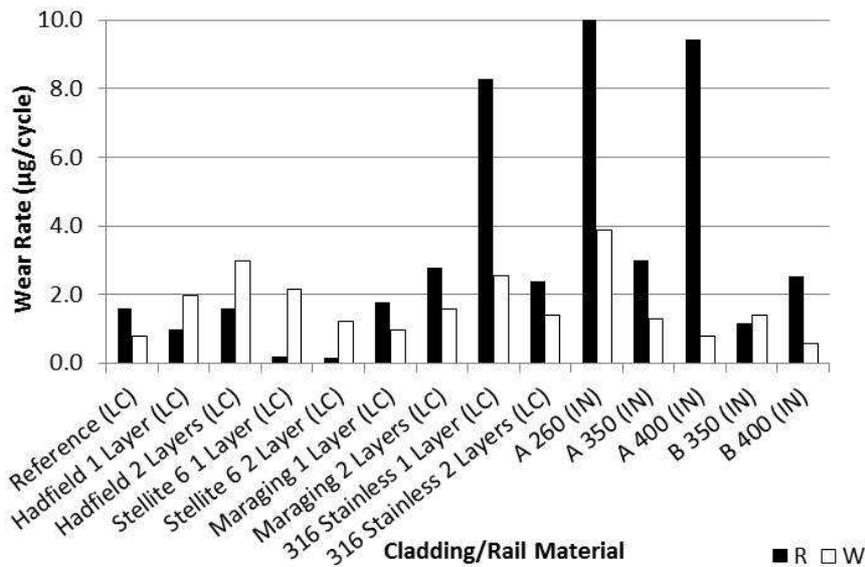
Figure 6 shows wear rates under wet conditions. Note that a wear rate of 51.0 $\mu\text{g}/\text{cycle}$ was measured for the 260 grade rail sample tested in the INNOTRACK project. However, as this value was much greater than any of the other wear rates measured, the scale on the y-axis of Figure 6 has been altered for easier comparison of the remaining values.

Stellite again showed the lowest and most consistent rail wear rates with an average rail wear rate of 0.18 $\mu\text{g}/\text{cycle}$ compared with 1.59 $\mu\text{g}/\text{cycle}$ for the reference sample. Hadfield also showed a lower average rail wear rate than the baseline at 1.29 $\mu\text{g}/\text{cycle}$ although there was less consistency shown between both Hadfield samples. The least consistency in wear rates and the highest wear rates were seen with the Maraging and Stainless steel samples.

Figure 6 Wear rates of the clad discs after 5000 wet cycles.

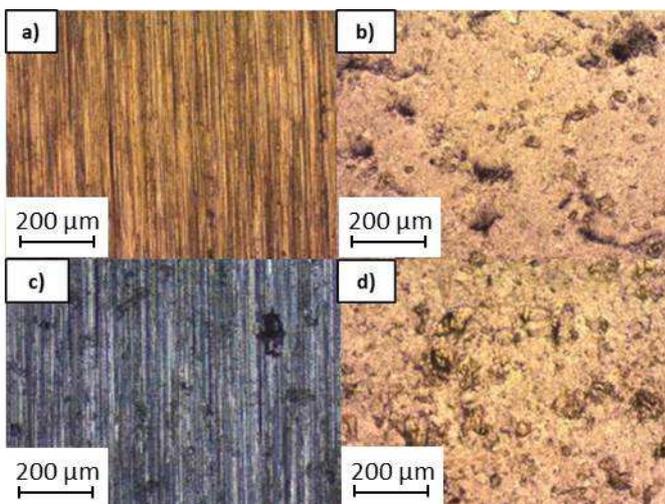
Figure 7 Surface images of the reference wear specimens a) rail before test b) rail after 5000 dry cycles c) wheel before test d) wheel after 5000 dry cycles

With all of the surface images shown in Figure 7Figure 11 the machining grooves can be seen on the new discs (images a and c). Figure 7 b and d show typical wear surfaces with evidence of material flow and ratcheting which has led to pitting of the surface material.

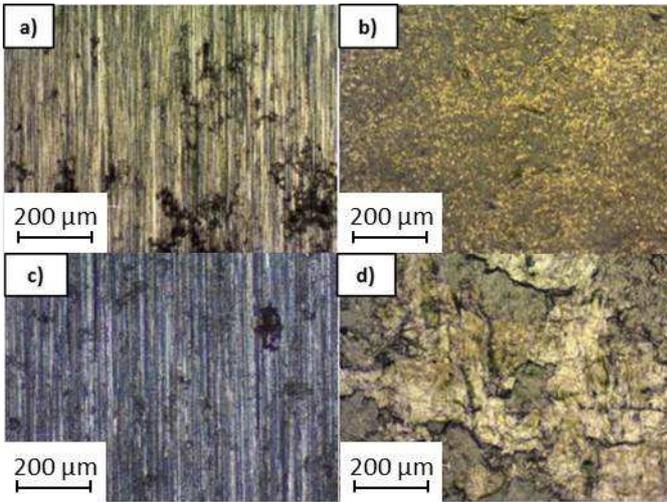
Figure 8 Surface images of the 1 layer Hadfield wear specimens a) rail before test b) rail after 5000 dry cycles c) wheel before test d) wheel after 5000 dry cycles

Figure 8 b and d show different wear mechanisms to the reference sample shown in Figure 7. There seems to be lower deformation on the Hadfield rail disc compared to the reference rail disc with no evidence of ratcheting. There does however, seem to be more abrasive wear on the Hadfield rail sample with no adhesive wear. The wheel disc used with the Hadfield sample shown in Figure 8d) shows more severe surface damage compared to the reference wheel disc. The Wheel disc used with the Hadfield sample also shows a lot of delamination and abrasive scoring caused by three-body-abrasion due to wheel debris.

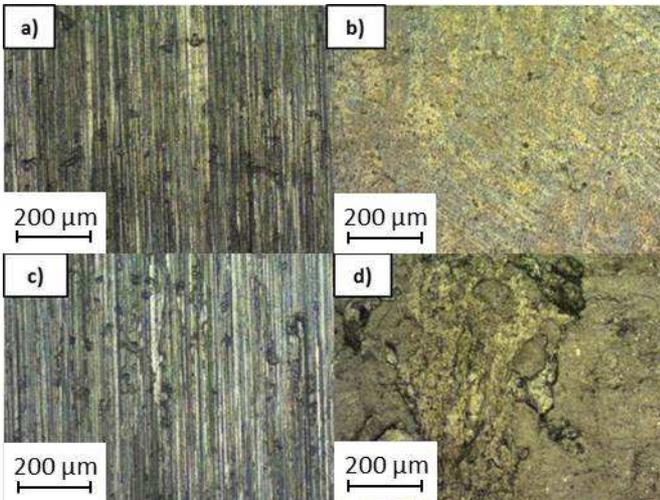
Figure 9 Surface images of the 1 layer Stellite wear specimens a) rail before test b) rail after 5000 dry cycles c) wheel before test d) wheel after 5000 dry cycles

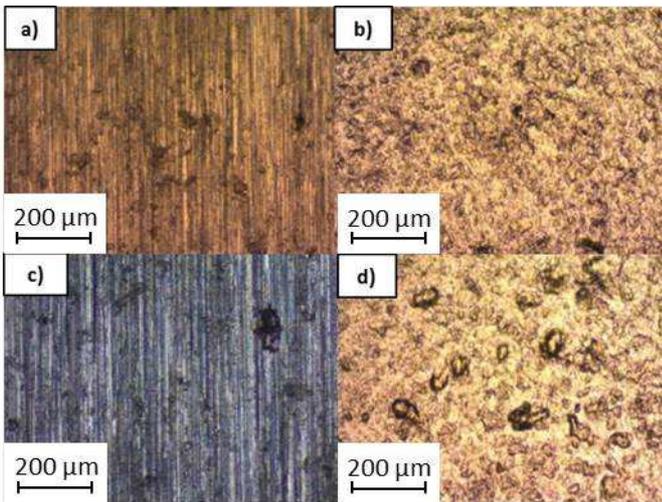
Figure 10 Surface images of the 1 layer Maraging wear specimens a) rail before test b) rail after 5000 dry cycles c) wheel before test d) wheel after 5000 dry cycles

There is not much material flow on the surface of the Maraging rail sample compared to the reference sample. Instead there are signs of adhesive wear with some pitting. The wear surface does appear similar to the reference sample and the Maraging hardness was also similar to the reference sample as shown in Figure 13. The wheel wear is also comparable with the reference sample.

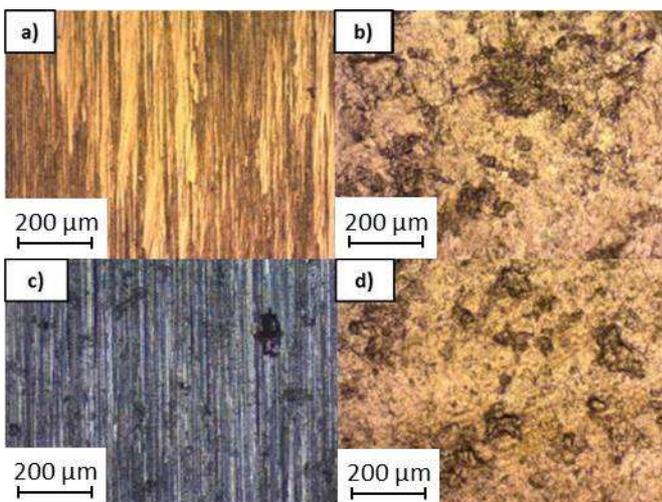
Figure 11 Surface images of the 1 layer Stainless wear specimens a) rail before test b) rail after 5000 dry cycles c) wheel before test d) wheel after 5000 dry cycles

Figure 11 shows very severe wear on both the wheel and rail Stainless sample surfaces. There are signs of high amounts of material flow. Large chunks of material loosened by ratcheting have been removed by adhesive wear. Figure 13 shows that Stainless had the lowest hardness tested which would explain the high material flow. Figure 5 also shows that the Stainless samples showed the highest wear rates further supporting observations from the surface pictures.

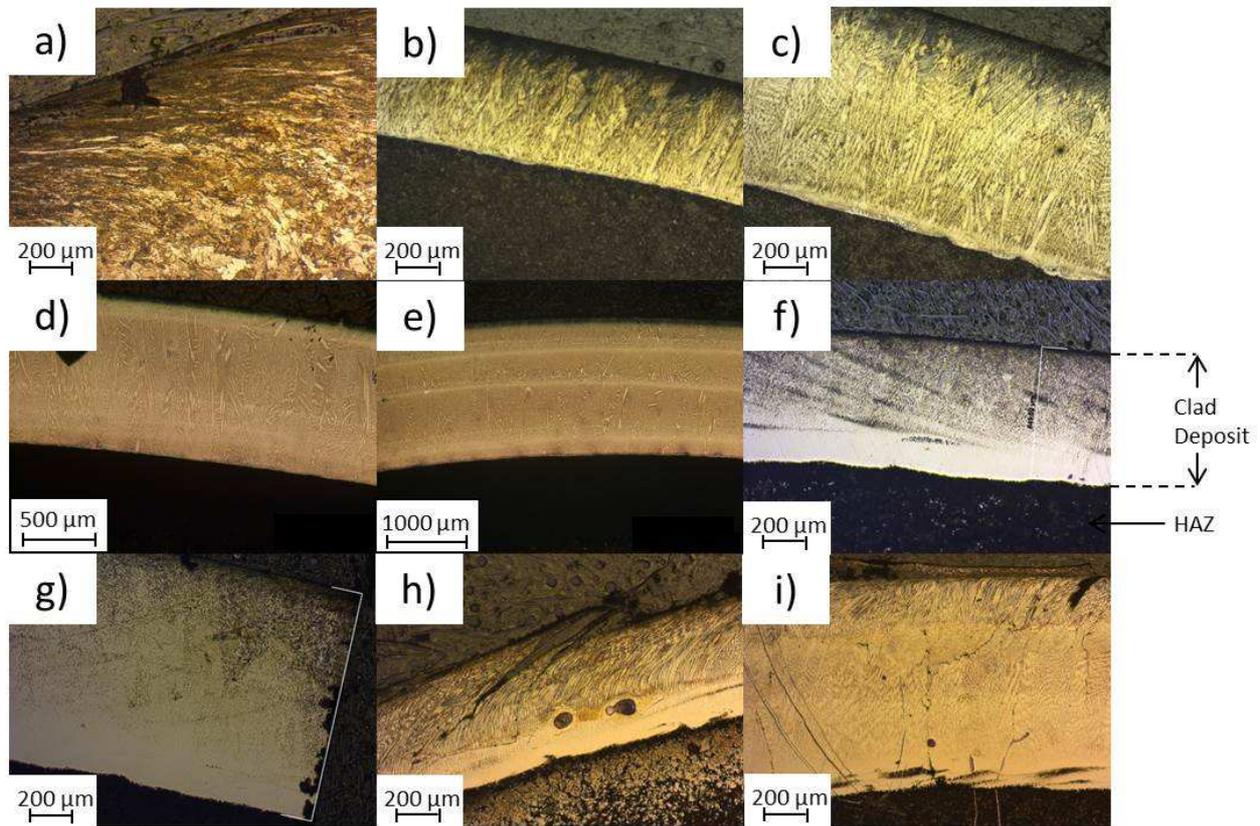
Figure 12 Etched sectioned SUROS specimens from wear testing a) unclad 260 grade reference rail disc b) 1 layer Hadfield clad c) 2 layer Hadfield clad d) Untested 1 layer Stellite 6 clad e) 2 layer Stellite 6 clad f) 1 layer Maraging clad g) 2 layer Maraging clad h) 1 layer Stainless clad i) 2 layer Stainless clad.

The boundary between the clad layers and the HAZ can be clearly seen in Figure 12. The bond between the clad and the HAZ is relatively smooth in the; Hadfield, Stellite and Maraging samples, with no inclusions or lack of bonding. In these samples no porosity or cracking was seen in the clad/deposit. The Stainless samples on the other hand show extensive cracking and delamination with some porosity in the deposit. It is not clear however, if the cracking in these samples was a result of testing or due to a lack of optimisation during the cladding process. The turbulent boundary between the deposit and the HAZ seems to suggest that the high damage in the stainless samples is more down to a manufacturing error rather than a weakness of the material.

Figure 13 shows the relationship between deposit hardness and the depth of plastic deformation in each of the samples. Depth of plastic deformation was measured visually from the sectioned and etched samples. Visual inspection is not as accurate as Electron Backscatter Diffraction, EBSD when measuring the depth of plastic deformation. However, the EBSD technique was not available to the authors at the time of writing.

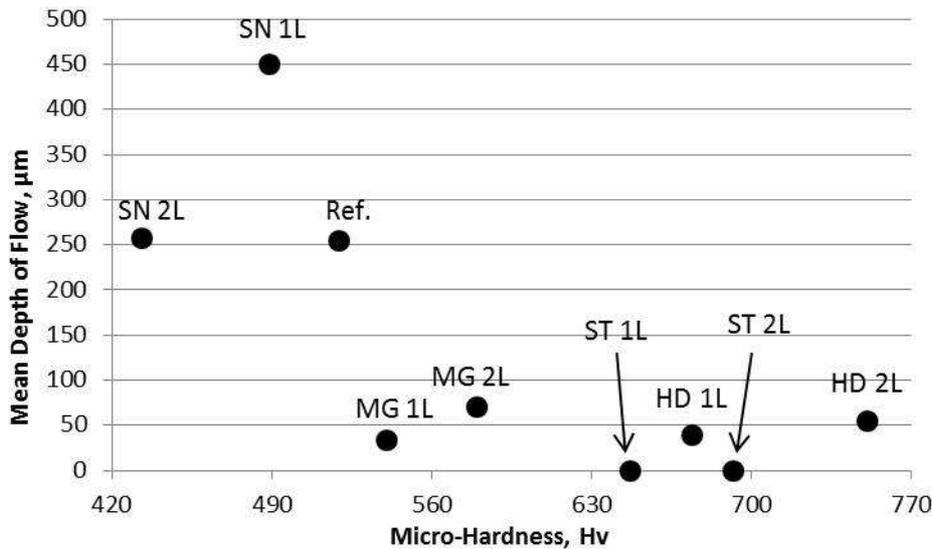
Figure 13 Relationship between each sample's sectioned hardness taken near the surface and the depth of plastic deformation.

It can be seen in Figure 13 that there seems to be an inverse relationship between deposit hardness and depth of plastic deformation.

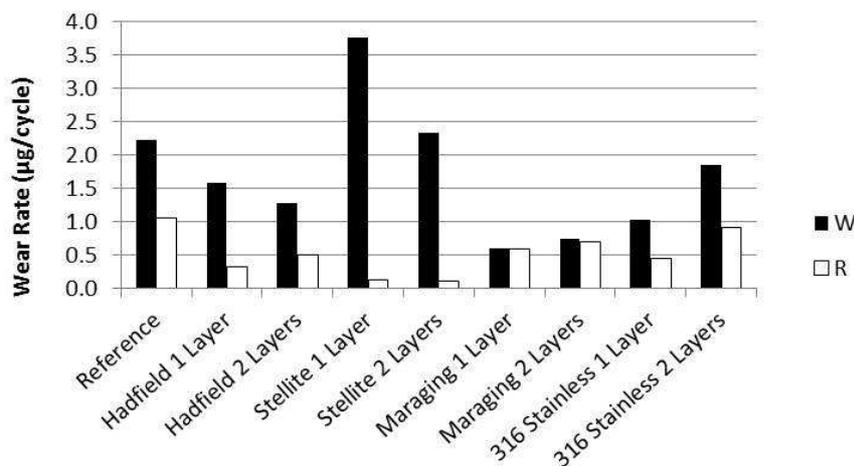
Wear was measured during the wet part of the RCF tests and is illustrated in Figure 14. The discs had not been subject to enough cycles in the dry part of the RCF tests for the wear to stabilise.

Figure 14 Wear rates of RCF samples under wet conditions.

The biggest discrepancy between wheel and rail wear rate is again seen with both the Stellite 6 samples. The wheel wear for the Stellite samples is an average of 36% higher than the reference wheel wear rate. In the RCF tests the Maraging samples both showed almost equal wear rates between the wheel and rail. In the wear tests the Maraging were the only samples with wheel wear lower than that of the rail under wet conditions.

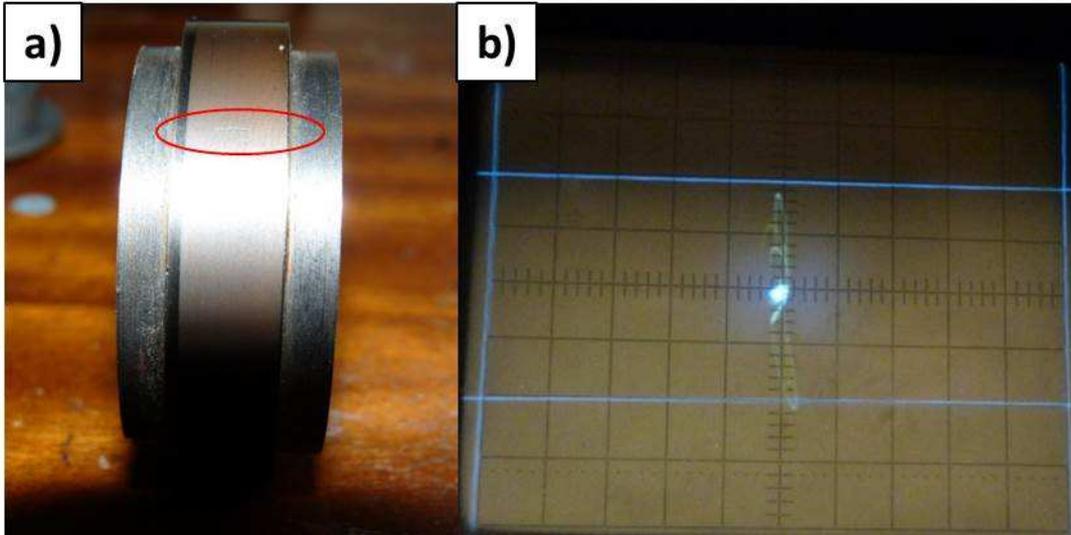
The RCF tests consisted of 500 dry cycles to generate a plastically deformed surface layer in the discs. This is then followed by a test with distilled water dripped onto the surface of the discs at a rate of 1 drop per second. This wet section of the test was limited to 50,000 cycles (see Section 2 for explanation). Figure 15b shows the B1 output signal from the reference disc with artificial crack (Figure 15a). The two horizontal gates are positioned at the edges of the reference signal. Failure during the RCF tests was defined when these gates were breached by the signal from a test disc.

Figure 15 a) Reference disc with artificial crack b) Reference signal on B1 detector.

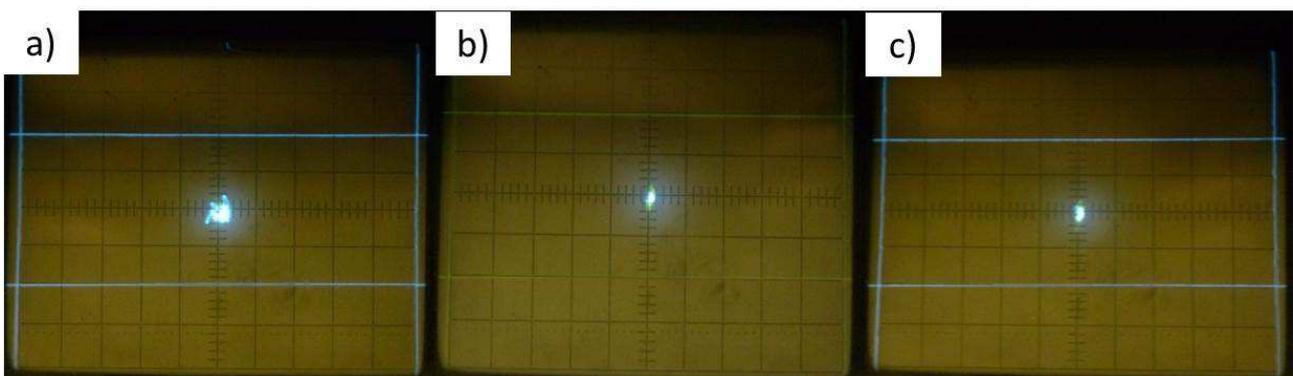
Figure 16 shows the eddy current detector signal for the 1 layer Stellite sample during the wet section of the test. This is one of the samples which did not fail before the 50,000 cycle mark. There is only a slight change in the signal at the end of the test.

Figure 16 Eddy Current Detector signal Stellite 1 layer rail disc a) 200 cycles b) 30,000 c) no failure 50,000 cycles.

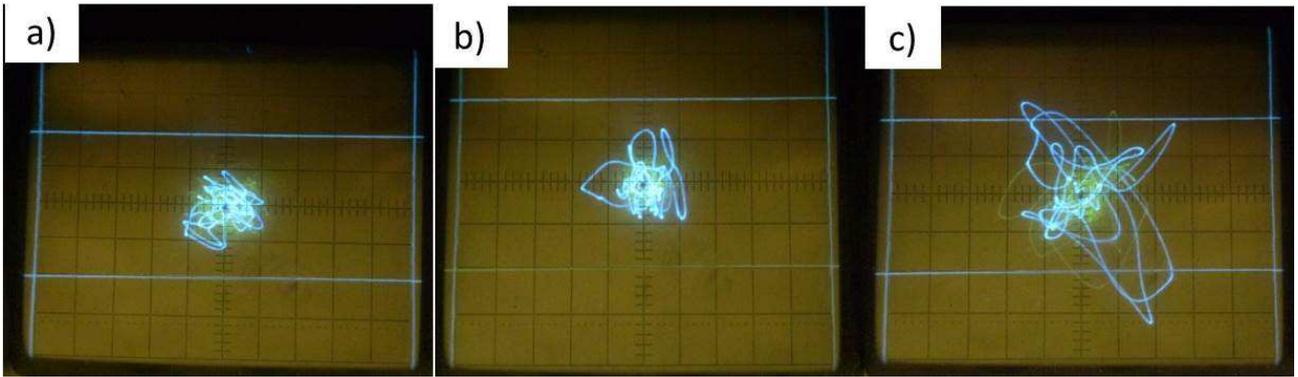
Figure 17 shows the eddy current detector signal for the reference 260 grade sample during the wet section of the test. This sample failed at approximately 15,000 cycles.

Figure 17 Eddy Current Detector signal 260 grade reference rail disc a) 100 cycles b) 10,000 c) failure at approximately 15,000 cycles.

Only two of the rail discs failed during the RCF tests. These were the reference 260 grade rail and the two layer 316 Stainless clad sample. The reference disc failed at approximately 15,000 cycles matching what was seen in [11]. The 2 layer 316 stainless sample failed at approximately 28,000 and even though it was the only clad specimen to fail before the 50,000 cycle mark it still showed almost double the RCF life of the unclad 260 grade rail. Because the 1 layer 316 Stainless sample was showing signs of failure before the 50,000 cycle mark, it can be concluded that the 316 Stainless Steel samples had the lowest RCF life of all the clad samples. Sub-surface analysis of the Stainless sample did show cracks in the two layer sample, however, no cracks were seen in the 1 layer sample and hence the detection by the eddy current detector may have been triggered by some other defect in the deposit. It is not possible to rank the remaining 3 specimens (Hadfield, Stellite 6 and Maraging) because none of them showed any signs of failure before the 50,000 cycle point at which the test was stopped. The discs also showed no or little plastic deformation meaning that the discs could have run for many more cycles than the 50,000 limit. When a material is subjected to a rolling sliding contact and the loading exceeds the materials ratcheting threshold the material will accumulate plastic strain near the surface with each cycle. Eventually the materials ductility is exhausted and cracks, usually starting at the surface, can nucleate in this plastically deformed layer [15]. The cracks will then grow downward into the material driven by repeated contact stresses. If these cracks are not truncated by a sufficient wear rate then these cracks will keep growing downward into the rail eventually leading to failure [17].

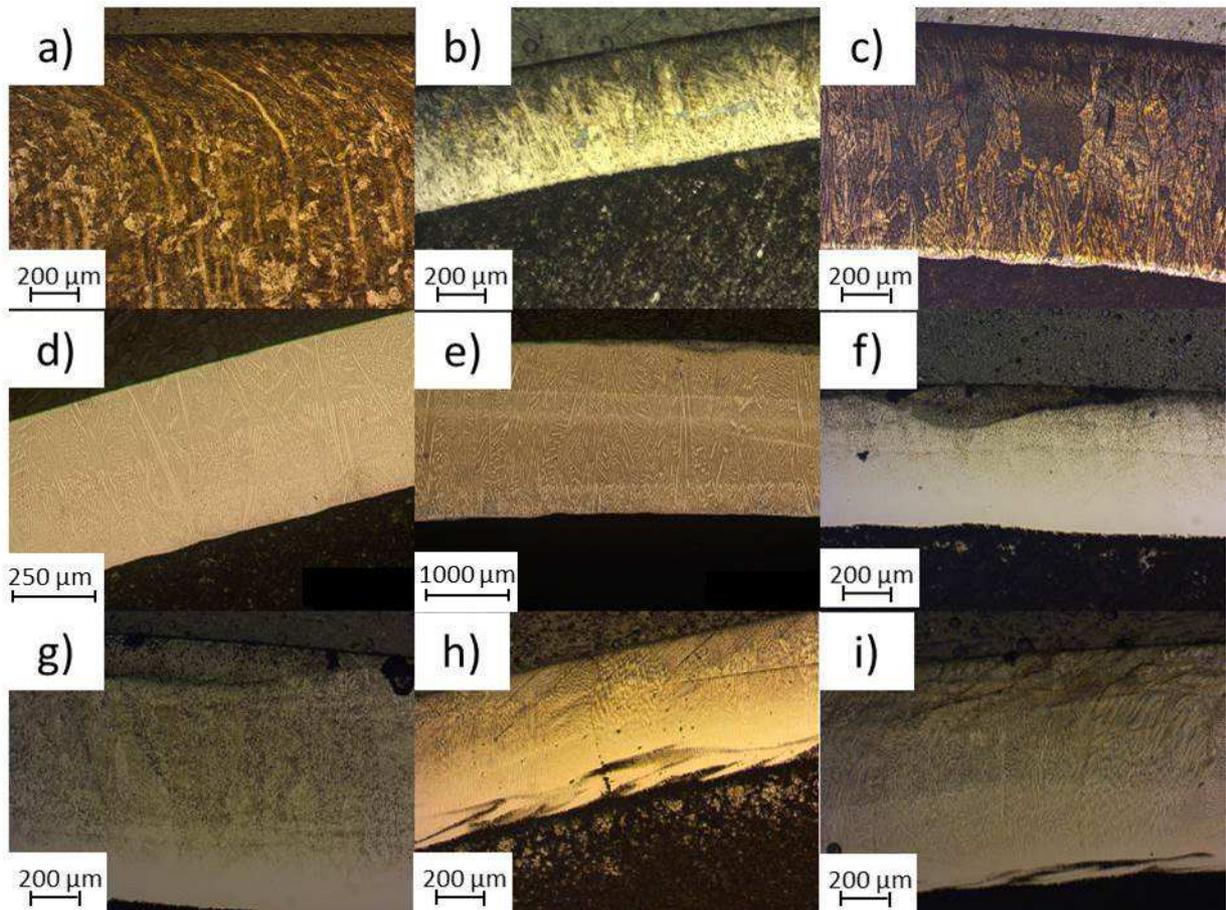
Figure 18 Etched sectioned SUROS specimens from RCF tests a) unclad 260 grade reference rail disc b) 1 layer Hadfield clad c) 2 layer Hadfield clad d) 1 layer Stellite 6 clad e) 2 layer Stellite 6 clad f) 1 layer Maraging clad g) 2 layer Maraging clad h) 1 layer Stainless clad i) 2 layer Stainless clad.

Figure 18 shows that the bond between the clad and the HAZ is relatively smooth in most of the samples with turbulent bonds only seen in the Stainless steel samples. In these samples no porosity or cracking was seen in the clad/deposit. Cracking was only seen at the surface of the two layer Stainless sample.

The clad RCF samples show much shallower deformation compared to the wear specimens. This would be expected as the RCF specimens have only been subject to 500 dry cycles. Whereas the wear specimens were subject to 5000 dry cycles. Under dry running the higher friction at the surface will cause higher sub-surface shear stress to occur usually above the materials yield stress causing plastic deformation in the material. Under wet conditions the friction is reduced and hence the shear stress leading to less deformation. This can be seen in all of the clad samples. However, the opposite seems to have occurred in the reference samples with the RCF sample showing greater depth of deformation compared to the wear sample. It is not possible to calculate an estimated rate of plastic deformation (i.e. μm below the surface per cycle) under dry and wet conditions individually. This is because in both the wear and RCF tests the specimens were sectioned after being subject to both dry and wet cycling. It is therefore assumed that even though the rate of plastic deformation is slower in wet conditions; the reference RCF specimen was subject to far more test cycles than the reference wear specimen and hence a greater extent of deformation compared to the reference RCF specimen. The reason that the opposite behaviour was seen in the clad specimens is that they are much harder than the reference specimens and hence will deform at a much lower rate.

The low amount of plastic deformation in the clad RCF specimens also explains why no cracks were seen in all but one of the specimens. Generally RCF cracks in rolling contacts initiate in the plastically deformed layer of the rail material as its limit of ductility is reached, see Figure 12h. Crack growth is then driven by cyclic stressing as the contact moves over the area containing the crack [15]. Table 1 shows the optically measured depth of deformation for both the wear and RCF specimens. It can be seen that there is little to no deformation in the clad RCF specimens. This explains why no RCF cracks were seen in all but one of the clad RCF specimens as conditions for crack nucleation were not generated.
