Fois, N., Watson, M., Stringer, J. et al. (1 more author) (2015) An investigation of the relationship between wear and contact force for abradable materials. Proceedings of the Institution of Mechanical Engineers, Part J: Journal of Engineering Tribology , 229 (2). pp. 136-150. ISSN 1350-6501

An Investigation of the Relationship between Wear and Contact Force for Abradable Materials

N. Fois, J. Stringer, M.B. Marshall

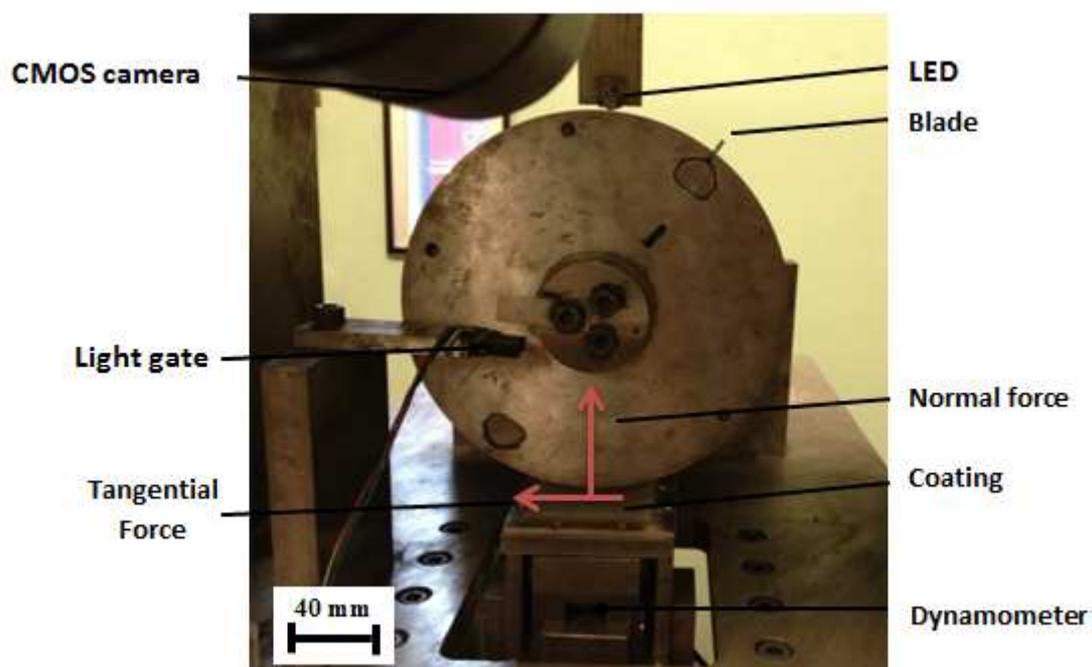
Figure 1. Front Image of the test rig

in an aero-engine [1, 2]. A summary of the test rig is now presented, with specific details given of the changes made for the present study. The test rig is based around a bench-mounted machine tool spindle, which has a maximum rotational speed of 21000 r/min. The spindle is composed of a metal disc, which contains a removable blade specimen along with a dummy blade 180° opposed to it for balancing. An electrical Z-axis microscope stage, mounted below the coating, allows incursions between 0.1-2000 $\mu\text{m/s}$ at intervals of 0.1 $\mu\text{m/s}$ to occur between the blade and coating. The incursion is set at the start of a test using a programmable stage controller. A stroboscopic imaging set-up, described below, is used to image the blade tip during the programmed incursion. Additionally, in this series of experiments, a dynamometer plate is also used to measure the force associated with a blade strike. Through a combination of these two systems, the blade tip can be measured on a pass-by-pass basis, along with the contact force. The temperature of the coating has also been measured during the tests using a laser pyrometer. Figure 1 shows an image of the front of the test rig.

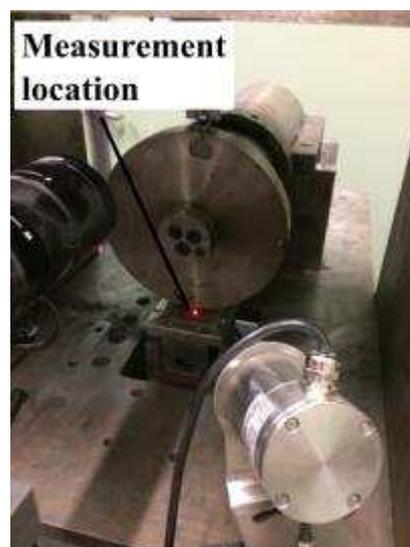
Figure 2. Temperature sensor.

As shown in Figure 2, the coating temperature is measured during an incursion using a pyrometer (Micro-epsilon, Koenigbacher, Germany). The pyrometer is an infrared sensor with a spectral range 2.3 μm , capable of measuring temperatures from 150 °C to 1000 °C. The coating temperature has been measured at a single point on the surface of the abradable material where the blade strikes, and average temperatures determined for the different incursion conditions investigated.

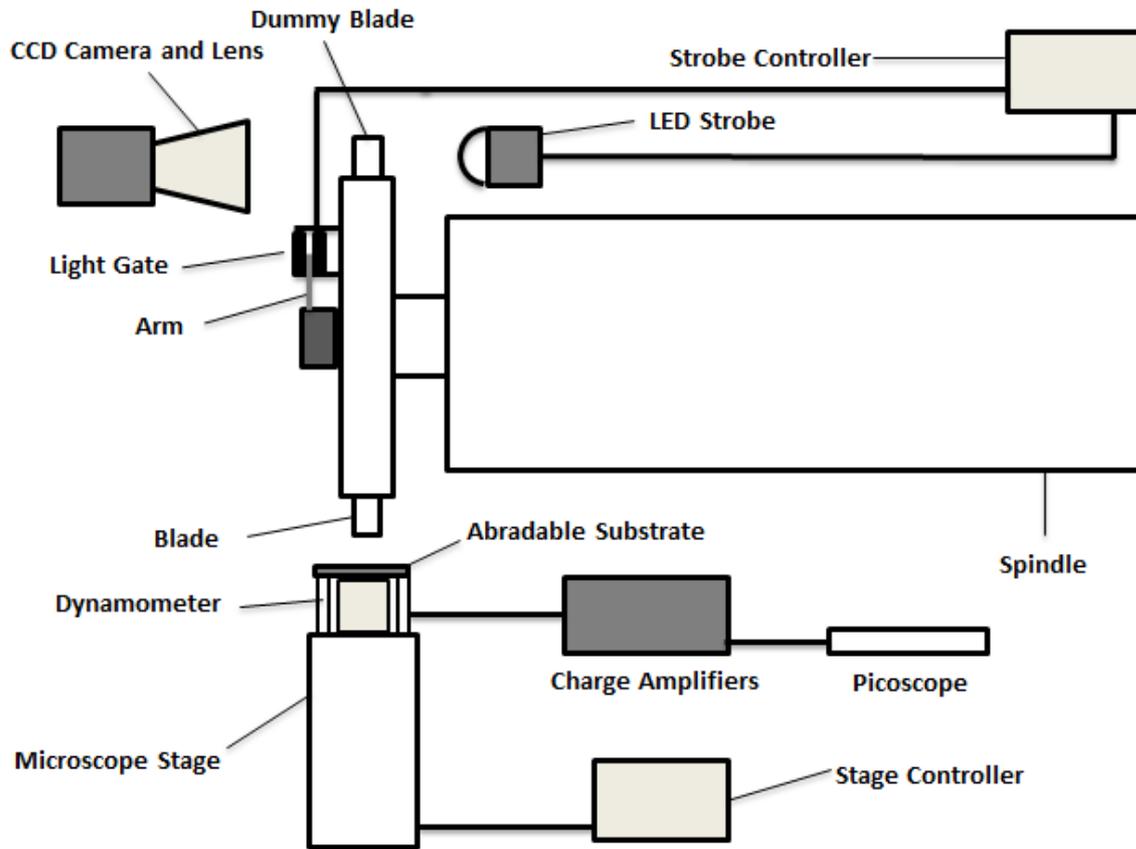
Figure 3. Schematic block diagram of the test rig.

The normal and the tangential contact force were measured using the dynamometer. The dynamometer was inserted below the abradable coating in order to measure the contact force during each test. As mentioned previously, the digital oscilloscope was used to capture the force output from the dynamometer. The z-axis microscope stage, the camera image acquisition, and the force measurement were controlled via Labview (National Instruments, Labview 2009). In this way, blade tip images and force measurements were captured at known times in the programmed incursion, ensuring synchronisation with respect to the two different data sets. This approach allowed measurements of blade wear or adhesion to be investigated in the context of incursion rate and contact force. Figure 3 shows a schematic diagram of the test rig.

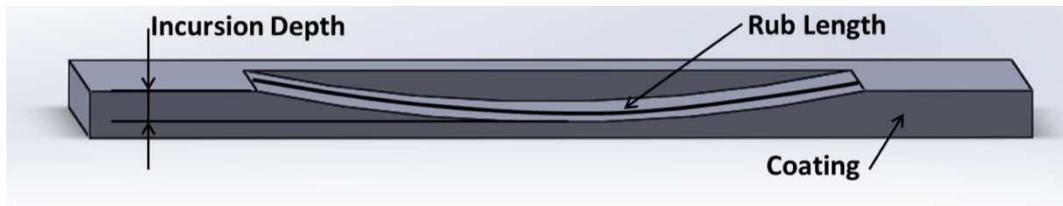
Figure 4. Schematic diagram of the abraded test sample.

It should also be noted that the range of incursion speeds was selected based on the incursion per pass, which is defined as the axial depth of material removed by the blade during a single strike of the coating. Figure 4 shows a schematic diagram of the coating section at the end of a test, where the total incursion depth and abraded surface are highlighted.

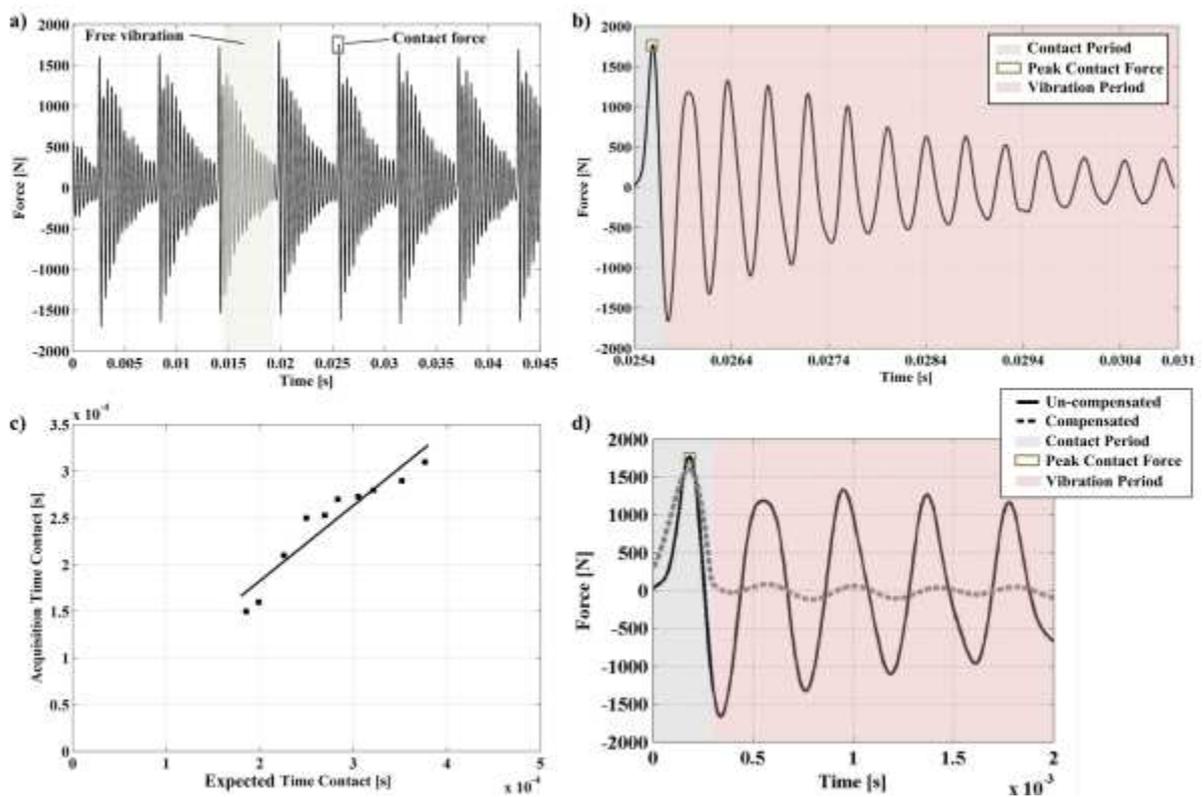
Figure 5. Force measurement (normal component) and analysis: a) recorded for multiple blade strikes; b) single blade strike recorded at time of 0.0254 s; c) expected vs. theoretical contact duration; d) dynamically compensated and un-compensated force measurements.

The dynamometer produced an electrical signal proportional to the applied force; this value was then amplified by the charge amplifier, before being recorded using the digital oscilloscope. Figure 5a shows a typical force signal recorded for a series of blade strikes on the abradable material. As shown in the figure, a given strike is comprised of a major peak, followed by a period of free vibration prior to the blade re-striking the substrate. Figure 5b shows a single strike on the coating. Highlighted on the figure is the expected contact time based on the blade speed and length of the arc of contact at this point in the incursion. The next stage of the analysis involved investigating the dynamic behaviour of the force measurement system to determine whether compensation was required. As a first step, the contact duration was measured at different points in the incursion and compared against the theoretical value (Figure 5c). As shown in the figure, correlation between the measured and

calculated values was good, and indicates that the blade strike has been correctly identified [18]. Following on from this, modal analysis of the system was performed using an impulse hammer (PCB 086C01, sensitivity 11.65 mV/N, PCB Piezotronic, Inc. USA), accelerometer (PCB 352B10, Sensivity 1.02 mV/m/s², PCB Piezotronic, Inc. USA) and National Instruments data acquisition system (NI USB-4431, 24 bit resolution), and the frequency response function (FRF) of the measurement system was acquired. The inverse transfer function was then used to apply dynamic compensation to the measured force signal [12, 19]. Additionally, accelerometric compensation [20] was also applied to the system, with the specific aim of investigating inertial effects in both the blade contact and free vibration components of the measurement. The compensated and un-compensated measurements are shown in Figure 5d. As shown in the figure, the component of the measurement representing the blade contact did not change (within the accuracy of the FRF and acceleration measurements) with compensation applied, indicating that it is not required in this case.

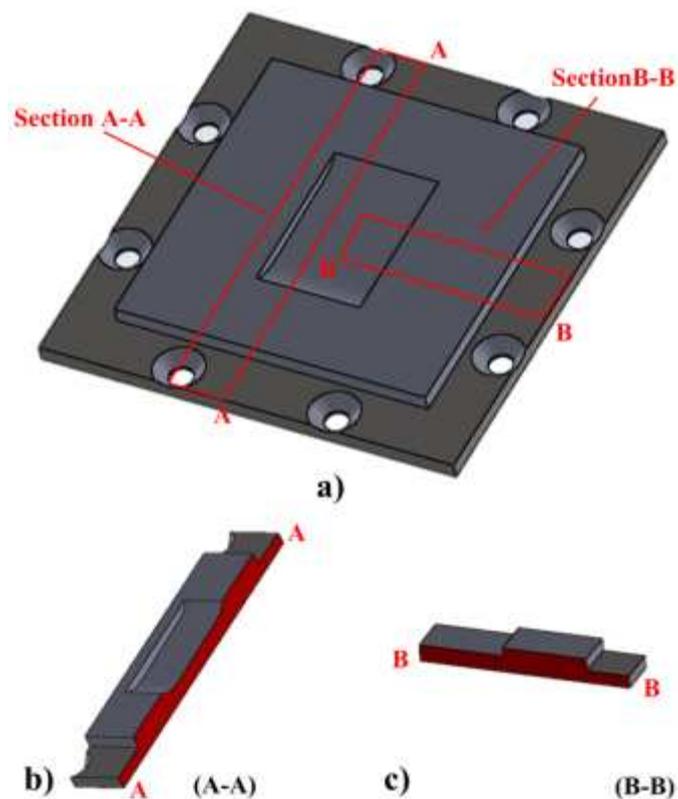
Figure 6. Section of abradable coating: a) coating; b) longitudinal section; c) transverse section.

In order to analyse the structure of the abradable material, the samples were sectioned in both the longitudinal and transverse directions with respect to the blade strike (Figure 6). The samples were mounted and inserted in a vacuum bell for resin impregnation with epoxy resin. This was performed in order to infiltrate any porosity and clearly distinguish between the different features of the coating. Post-impregnation, the samples were placed inside an oven for two hours at 50 °C in order to solidify. Optical Microscopy (Carl Zeiss Axio Scope.A1) was performed at magnifications of x5 and x10.

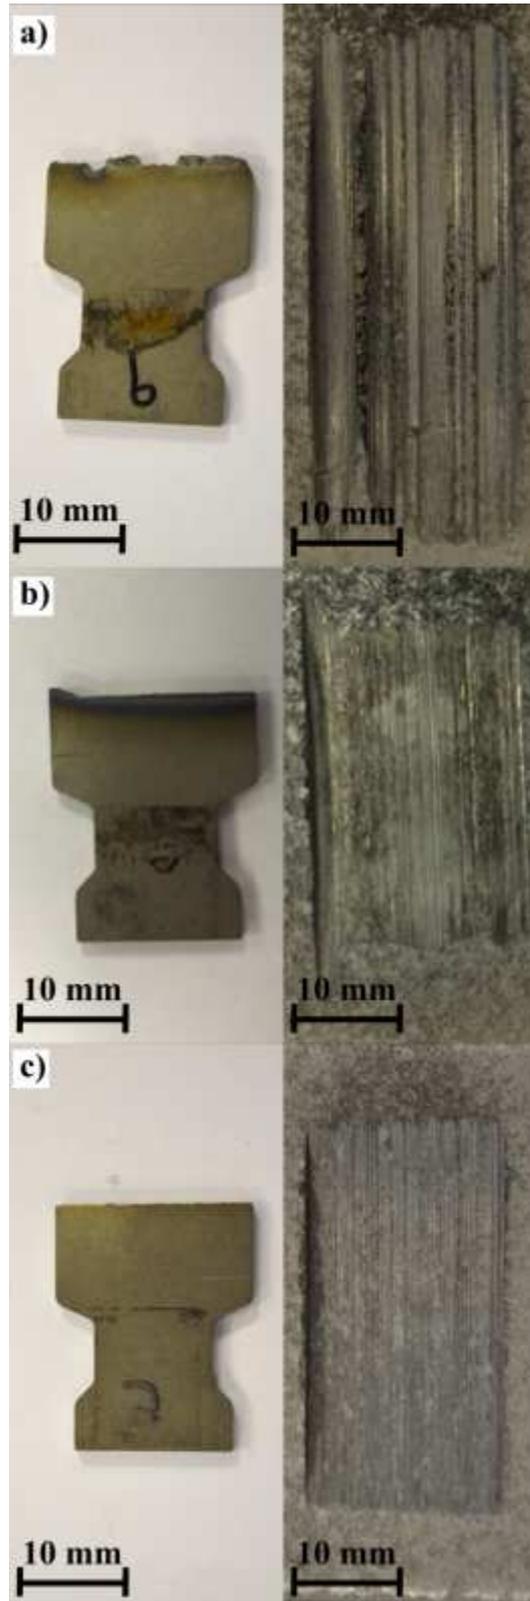
Figure 7. Image of the blade and abradable test specimen post-test for a) an incursion rate of $0.02 \mu\text{m}\cdot\text{pass}^{-1}$ (Test 1); b) an incursion rate of $0.06 \mu\text{m}\cdot\text{pass}^{-1}$ (Test 3); c) an incursion rate of $2 \mu\text{m}\cdot\text{pass}^{-1}$ (Test 8).

Figure 7a shows a typical result from a test with high levels of adhesion, in this case performed at an incursion rate of 0.02 μm·pass⁻¹ (Test 1). As shown in the image, there is significant adhesive transfer to the blade tip, and also an area of wear accompanied by thermal damage. The adhesive transfer to the blade has resulted in grooving of the coating, with the major peak in the groove pattern corresponding to the location of thermal damage on the blade.

Similarly Figure 7c shows the blade and abradable material post-test at an incursion rate of $2 \mu\text{m pass}^{-1}$. At this high incursion rate, the blade was observed to cut the abradable material well, resulting in a lightly grooved surface with a dull appearance. This type of surface is typical of cases where cutting of the abradable material by the blade is reported. As shown, there is also no damage to the blade, with minimal blade wear. At the intermediate incursion rates the wear mechanism was observed to progress from adhesive transfer from the abradable material to the blade, through to clean cutting of the abradable material. Through observing the substrates post-test, this transition was observed to occur at an incursion rate $0.06 \mu\text{m}\cdot\text{pass}^{-1}$ (Test 3), with the corresponding test samples shown in Figure 7b. It is also interesting to note that at low incursion rates where thermal damage and adhesion has been evident, temperatures measured (Table 1) are significantly higher than those when cutting dominates, and that as a general trend temperature is relatively constant once cutting is established.

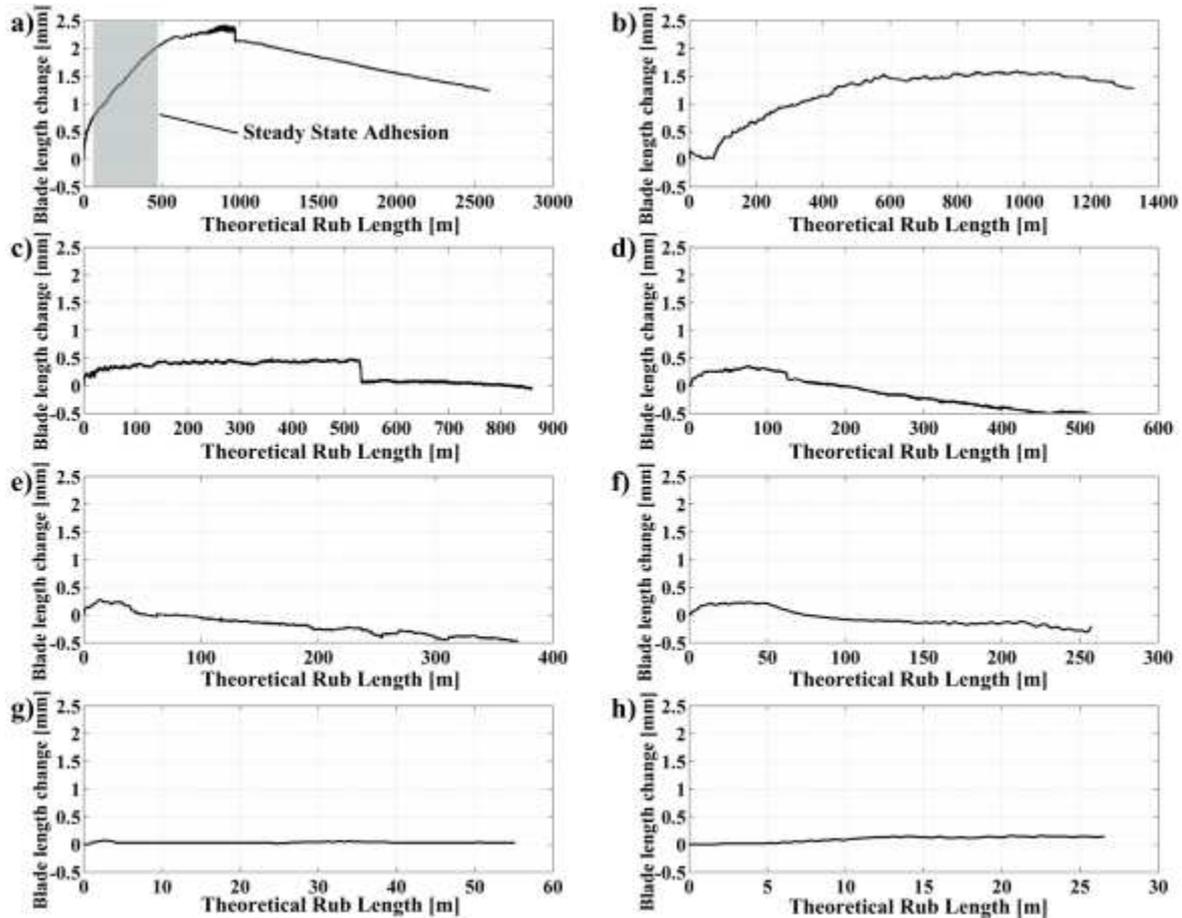
Fig.8. Blade length change expressed in terms of theoretical rub length at incursion rate of: a) $0.02 \mu\text{m}\cdot\text{pass}^{-1}$; b) $0.04 \mu\text{m}\cdot\text{pass}^{-1}$; c) $0.06 \mu\text{m}\cdot\text{pass}^{-1}$; d) $0.1 \mu\text{m}\cdot\text{pass}^{-1}$; e) $0.14 \mu\text{m}\cdot\text{pass}^{-1}$; f) $0.2 \mu\text{m}\cdot\text{pass}^{-1}$; g) $1 \mu\text{m}\cdot\text{pass}^{-1}$; h) $2 \mu\text{m}\cdot\text{pass}^{-1}$.

As shown in the figure, at the lowest incursion rate ($0.02 \mu\text{m}\text{ pass}^{-1}$) significant adhesive transfer from the coating to the blade tip occurs, with the adhered material ultimately partially breaking away. The growth, break away and in some cases re-initiation of adhesion has been previously reported [2], and the result shown here is consistent with this study. Progressively, as the incursion rate increases, the level of adhesive transfer reduces. This is evident when comparing Figures 8a,b and c, which show the transfer at incursion rates of 0.02, 0.04, and 0.06 micrometers per pass (Test 1, 2, and 3 respectively). As shown in Figure 8c, at an incursion rate of 0.06 microns per pass adhesion initially occurs, breaks away and fails to re-initiate resulting in a cut-like appearance on the abrasable surface (Figure 7b). It is also interesting to note in this case that whilst a small amount of blade wear is reported at the end of the test, inspection of the blade tip shows wear mixed with small amounts of residual adhesion, indicating the co-existence of the two mechanisms. Following on from this, as shown in Figure 8d at an incursion rate of 0.1 micrometers per pass (Test 4), initial adhesion

is minimal with a cutting mechanism now dominant. As shown in Figures 8e, f, g, and h, which show the blade length change at incursion rates of 0.14, 0.2, 1 and 2 micrometers per pass respectively (Tests 5, 6, 7 and 8), the cutting mechanism is maintained with minimal blade wear recorded with increasing incursion rate.

As shown in Table 3, where material adheres to the blade tip rub length is significantly increased, as evidenced by the increased arc of contact on the abradable sample for the low incursion rate test (Figure 8a). However, it should be noted that the maximum length may occur at different points along the blade face during the rub, and in particular in cases where break away of adhered material occurs. Therefore, this actual rub length can only serve as an estimate of the maximum value. Conversely, at all but the most adhesive condition, and in

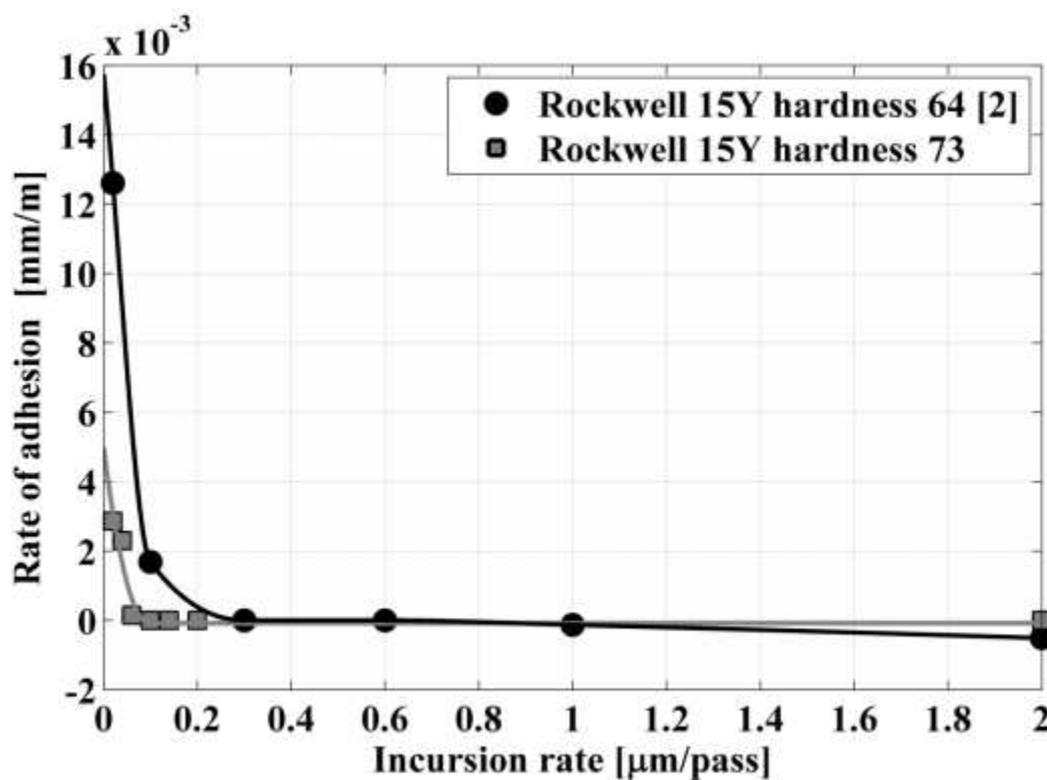
Figure 9. Adhesion rate with respect to incursion rate.

Adhesive transfer of abradable materials can be characterised by a period of initial growth, followed by a steady-state adhesion. The adhesion rate in the steady state period is calculated as the rate of change of blade length with respect to theoretical rub length [2]. Figure 8a shows an example of the region of steady-state adhesion (grey area), as measured for Test 1 at 0.02 micrometers per pass. A similar analysis was performed for all of the incursion rates investigated, and the adhesion rate was found to rapidly drop as incursion rate increased (Figure 9). Also included in the figure is data recorded in a previous study [2], where a similar relationship was observed to this series of tests. It should be noted in the comparative data that the negative adhesion rate at an incursion rate of 2 micrometres per pass corresponds to blade wear, and that in general the softer coating was characterised by a higher rate of adhesion.

The close relationship between material behaviour, wear and cutting force is again highlighted by Figures 9 and 13, which show the adhesion rate and force ratio respectively as a function of incursion rate. These results indicate a sliding scale, whereas incursion rate increases, the material cuts more efficiently, resulting in reducing adhesion and an increasing force ratio. This result is highlighted by the microstructures shown in Figures 15 and 17, where a transition in material behaviour is observed with incursion rate. The results from this study also show that at an incursion rate of 0.06 micrometers per pass, cutting begins to dominate for this coating. The force ratio defined is an indication of the mechanical behaviour of the blade / abradable system, and ultimately how the abradable dislocates, and has the potential to be used in the modelling of this system, in much the same way as cutting force ratios are used for turning, milling, and grinding.

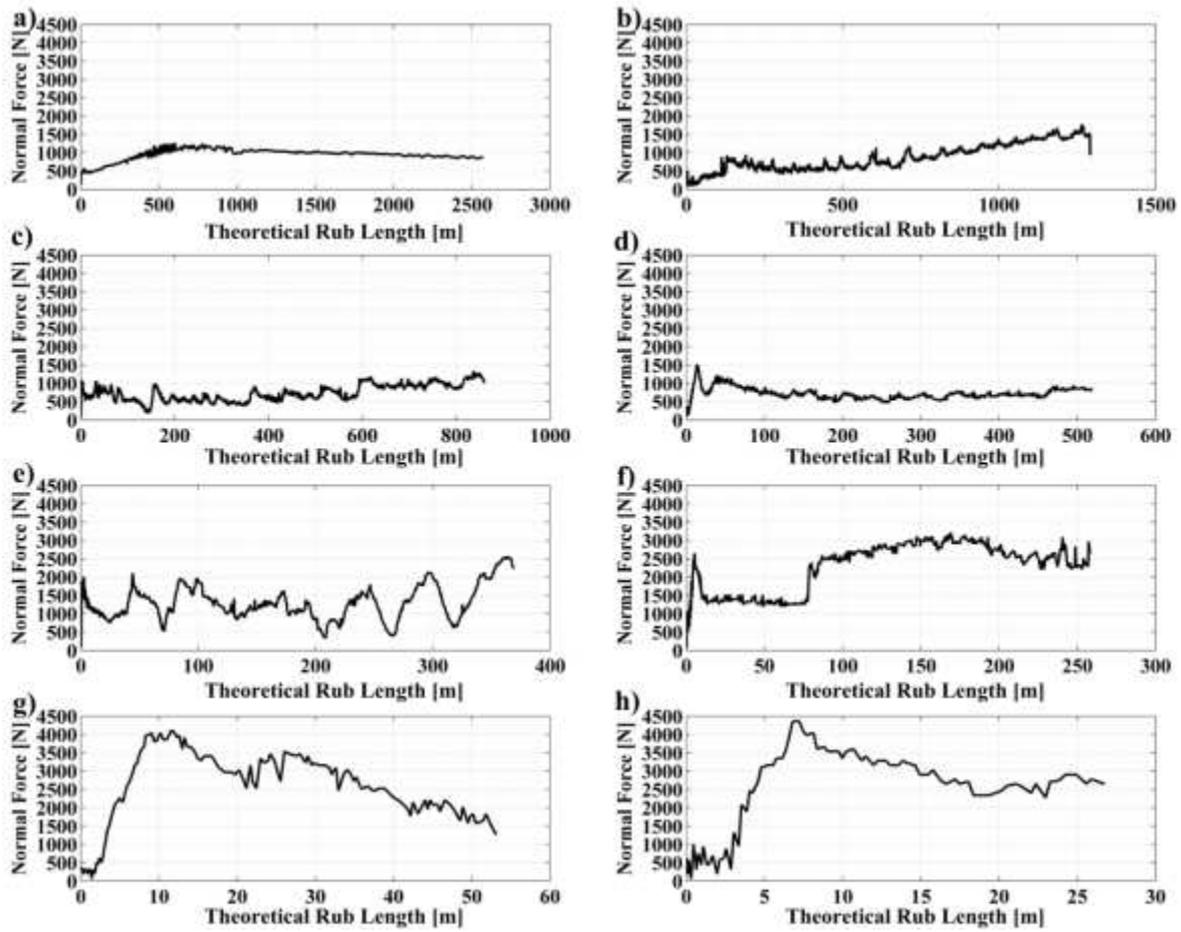
Figure 10. Normal force measurement at incursion rates of: a) $0.02 \mu\text{m}\cdot\text{pass}^{-1}$; b) $0.04 \mu\text{m}\cdot\text{pass}^{-1}$; c) $0.06 \mu\text{m}\cdot\text{pass}^{-1}$; d) $0.1 \mu\text{m}\cdot\text{pass}^{-1}$; e) $0.14 \mu\text{m}\cdot\text{pass}^{-1}$; f) $0.2 \mu\text{m}\cdot\text{pass}^{-1}$; g) $1 \mu\text{m}\cdot\text{pass}^{-1}$; h) $2 \mu\text{m}\cdot\text{pass}^{-1}$.

function of rub length. Figures 10 and 11 show the normal and tangential forces respectively at low, intermediate and high incursion rates.

As shown by both Figures 10 and 11, the normal and tangential forces were subject to significant variation throughout a given test, over the range of incursion conditions investigated. In some cases cutting forces were observed to rise to a maximum, before remaining at a more steady state value for the remainder of the test (eg. Test 1, Figures 10a and 11a respectively). The observed variation in cutting force is expected, particularly when considered in the context of the blade length measurements. As shown in Figure 8, over the range of incursion rates tested, the observed length change showed continuous variation over the rub length. It is also interesting to note that in the case of Test 1 carried out at an incursion rate of $0.02 \mu\text{m}\cdot\text{pass}^{-1}$, the normal force recorded (Figure 10a) shows a similar trend to the result for blade length change shown in Figure 8a. A similar comparison can also be made with respect to the tangential force (Figure 11a), however in this case whilst observable, the trend is less pronounced. In general, both tangential and normal forces were also observed to increase with incursion rate.

rate. It is also interesting to note that when investigating an area corresponding to thermal damage on the blade, significant solidification was present and blade material has been transferred to the coating. At these conditions the ratio of tangential to normal force is also low, implying a low resistance to tangential motion. This result is in keeping with consolidation as opposed to cutting of the abradable material, along with a low friction melt layer at the surface. The fact adhesion has taken place, and in the case of this test that the blade length change and force curves are similar in form (Figure 8a, 10a, and 11a respectively), supports this view.

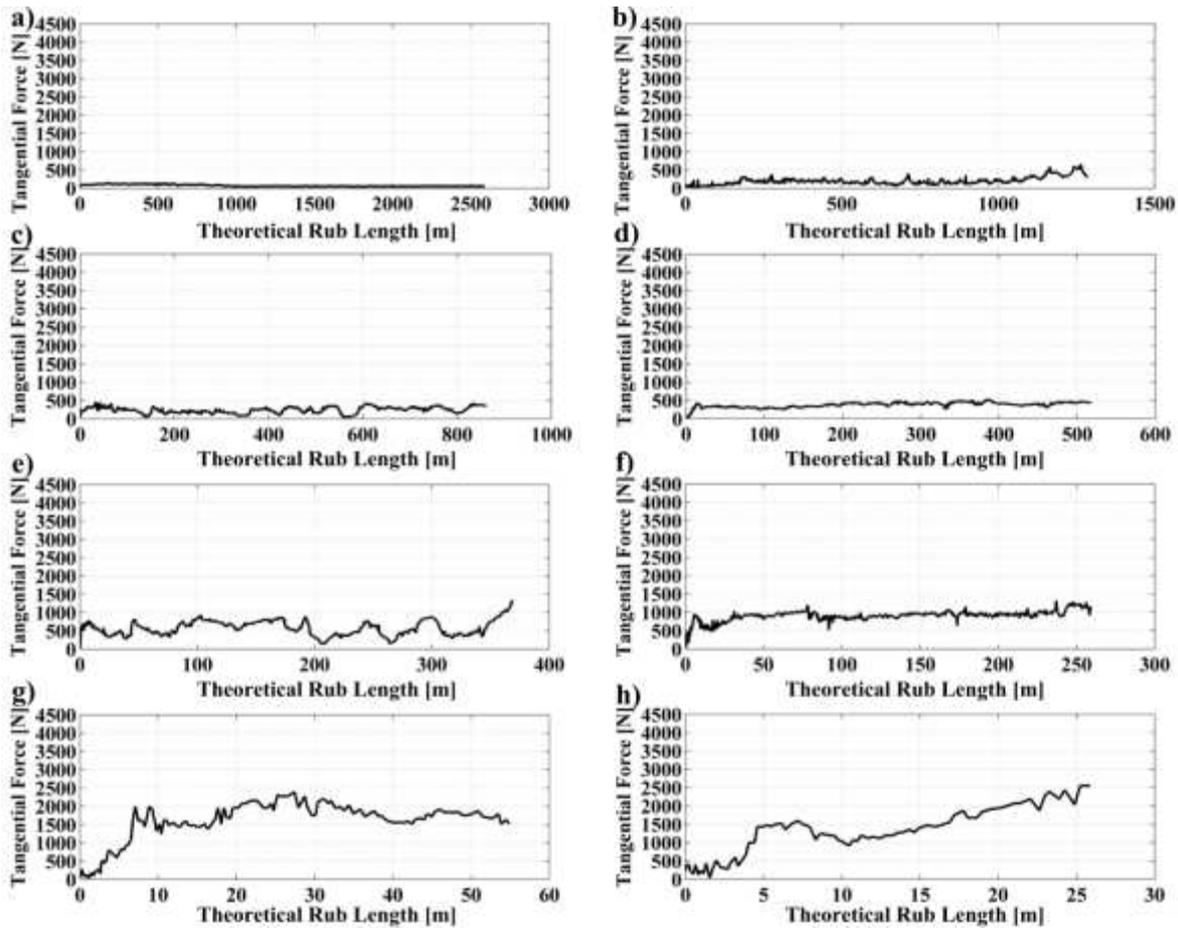
Figure 11. Tangential force measurements at incursion rates of: a) $0.02 \mu\text{m}\cdot\text{pass}^{-1}$; b) $0.04 \mu\text{m}\cdot\text{pass}^{-1}$; c) $0.06 \mu\text{m}\cdot\text{pass}^{-1}$; d) $0.1 \mu\text{m}\cdot\text{pass}^{-1}$; e) $0.14 \mu\text{m}\cdot\text{pass}^{-1}$; f) $0.2 \mu\text{m}\cdot\text{pass}^{-1}$; g) $1 \mu\text{m}\cdot\text{pass}^{-1}$; h) $2 \mu\text{m}\cdot\text{pass}^{-1}$

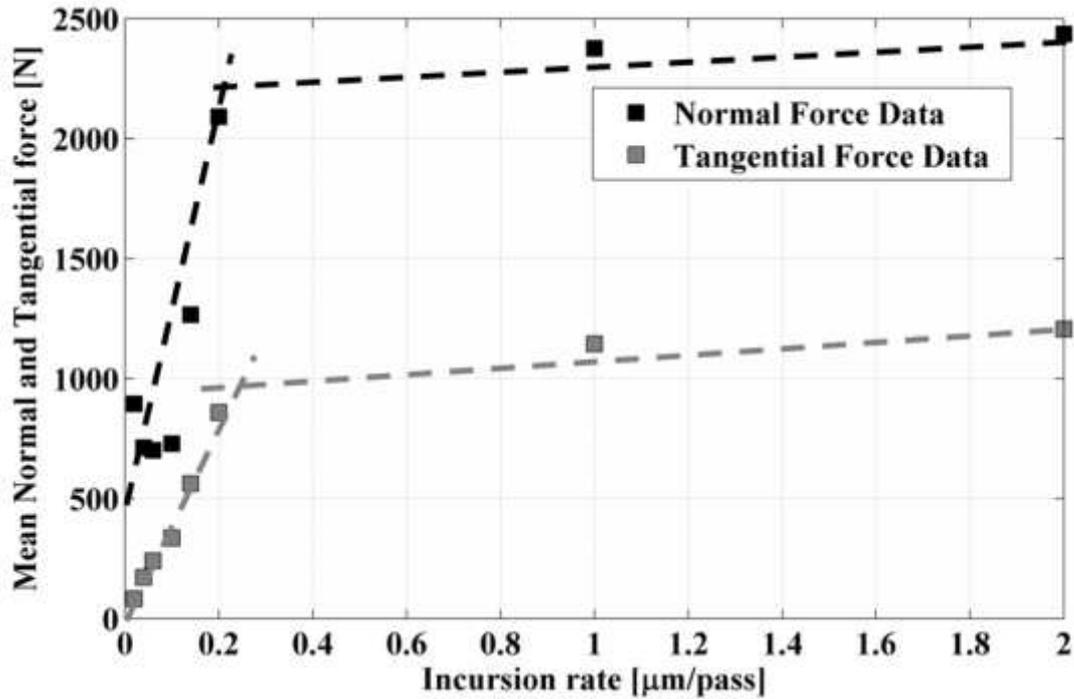
Figure 12. Average contact forces vs incursion rate.

Figure 12 shows the average normal and tangential forces as a function of incursion rate over the duration of a given test. Clearly due to the limitation of incursion depth, the overall rub length is different at each incursion condition. However, as demonstrated by Wang [9] in respect to a similar test platform, steady-state thermal conditions are quickly reached, and are done so within the range of rub lengths investigated in this study. Whilst significant variation in the two force components occurs during a test, both components show a similar average trend with respect to incursion rate. In both cases, force increases rapidly with incursion rate, before plateauing off and only showing a slow rate of increase at higher values of incursion rate. This result suggests that the material behaviour varies, and is different at high and low incursion rates. This point can be further explored by plotting the force ratio as a function of incursion rate (Figure 13). As shown in the figure, a transition point appears to occur in the force ratio at an incursion rate of 0.06 micrometers per pass. Indeed, the incursion rate is the same value at which the wear mechanism was observed to transition from adhesion to cutting, with Figure 13 appearing inverse in form when compared to the plot of adhesion rate as shown in Figure 9. At higher incursion rates, the measured force ratio is also similar to those found in orthogonal cutting of brittle materials [21, 22] and it is interesting to note that this corresponds to a well cut surface on the abradable material.

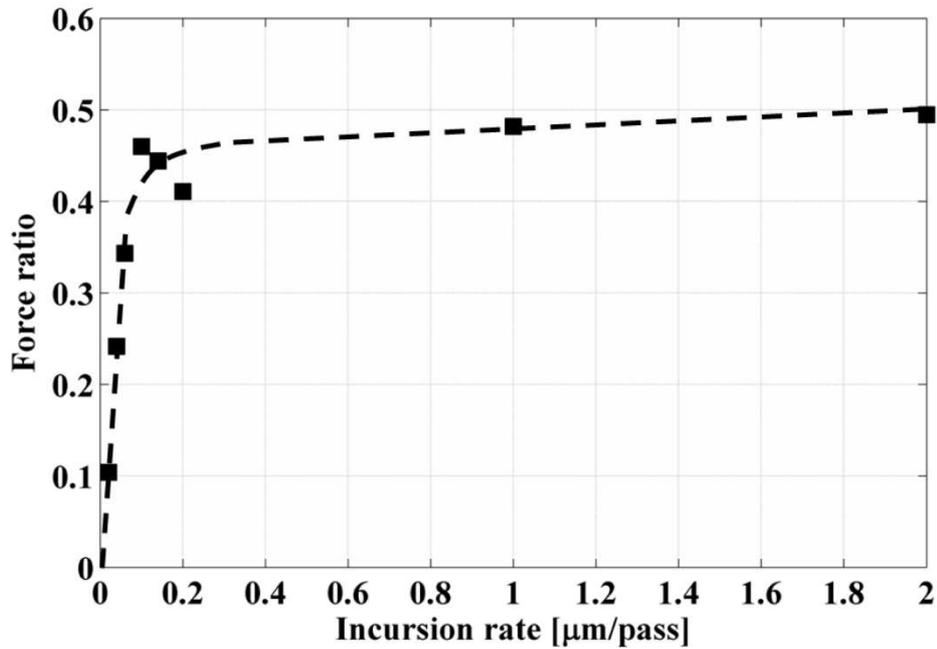
Figure 13. Force ratio vs incursion rate.

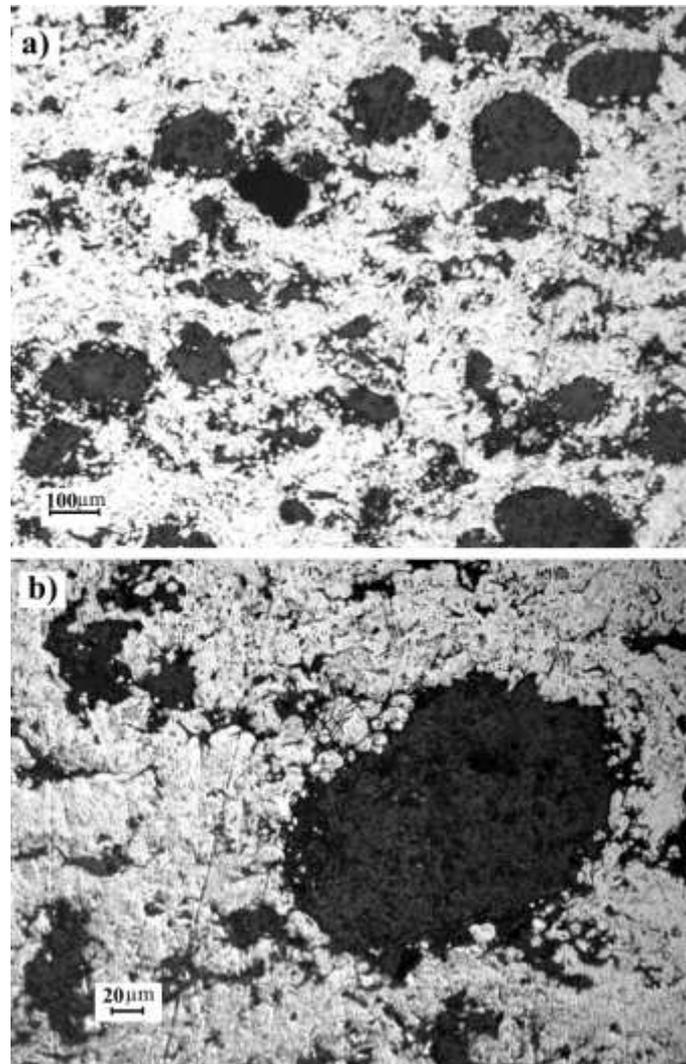
Figure 14. (a) microstructure of the AlSi-hBN (abradable material); (b) further magnification highlighting the presence of porosity (dark black) and lamellar hexagonal boron nitride.

In order to further investigate material behaviour, the abraded surface of the coating samples was sectioned. As discussed, this was performed in both the longitudinal and transverse direction with respect to the blade strike. Once prepared, the samples were inspected using an optical microscope. Figure 14a shows the microstructure of the coating; AlSi metal (white) and hexagonal boron nitride solid lubricant (dark grey) are visible, along with the porosity present in the coating (black). A further image at higher magnification is shown in Figure 14b, where the dark grey, lamellar, hexagonal boron nitride is clearly visible. The successful identification of the porosity in the coating also correlates well with that observed in previous studies [14], validating the sample preparation approach followed.

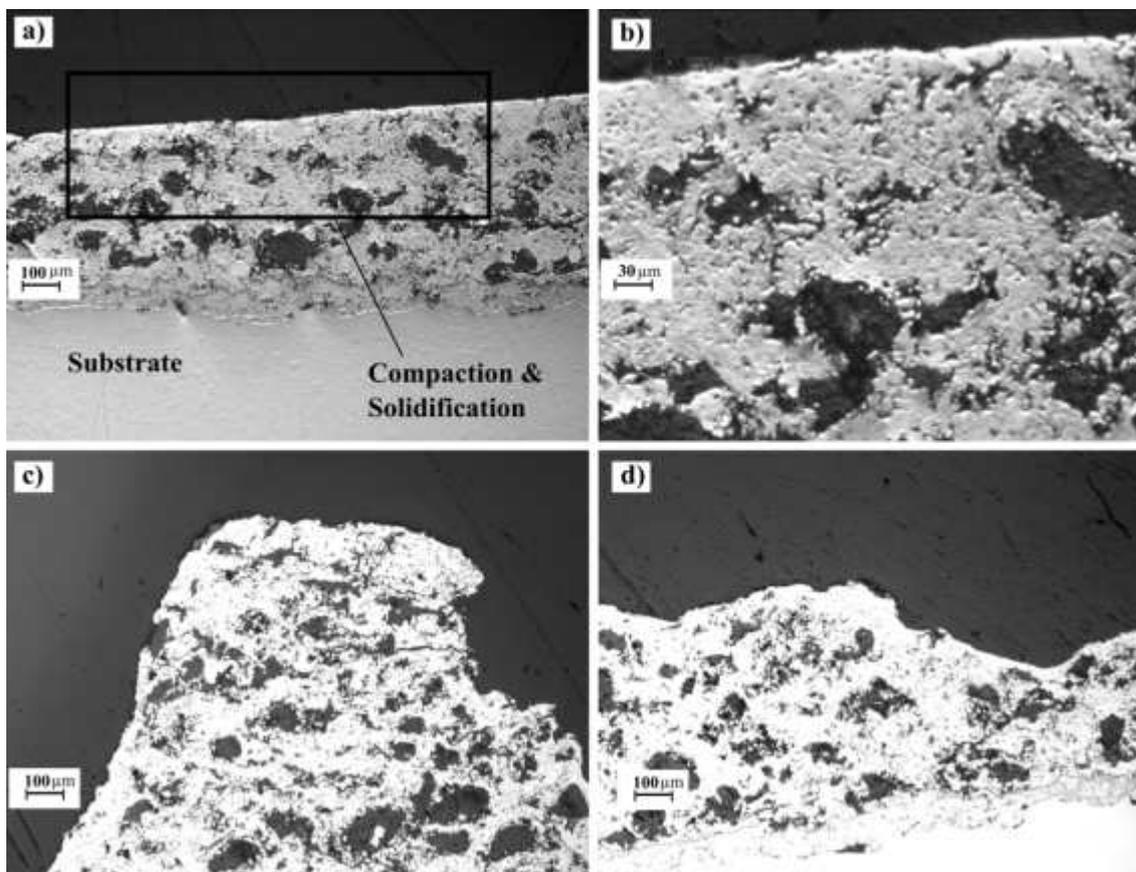
Figure 15. Section showing the microstructure of sub-surface at an incursion rate of $0.02 \mu\text{m}\cdot\text{pass}^{-1}$: a) longitudinal section; b) zoom of longitudinal section; c) transverse section corresponding to a groove peak; d) transverse section corresponding to a groove trough.

Figure 15 shows longitudinal and transverse sections of the coating at an incursion rate of 0.02 micrometers per pass (Test 1). As shown by the longitudinal section in Figure 15a-b, significant compaction and solidification of the coating has occurred. This is shown by the distorted, fragmented hexagonal boron nitride phase in the near-surface, along with the more continuous AlSi phase at the surface itself. In particular, the solidified, continuous AlSi layer at the surface suggests melt wear of the coating, and represents a significant difference when compared to the as sprayed sample in Figure 16. It is also interesting to note that, as discussed, the highest temperatures were also recorded at this incursion rate (Table 1). The transverse section shown in Figure 15c has been taken at the location of the groove highlighted in Figure 7, which corresponded to thermal damage on the blade. As shown in the figure, compaction is significant, again evidenced by the nature of the boron nitride layer, with a large solidified layer also present. Conversely Figure 15d shows a transverse section taken from the trough of the groove as shown in the figure, compaction is similar to the peak of the groove, but solidification is reduced as evidenced by the increased hexagonal boron nitride phase in the near surface. On the corresponding point on the blade to the trough, no thermal damage was evident.

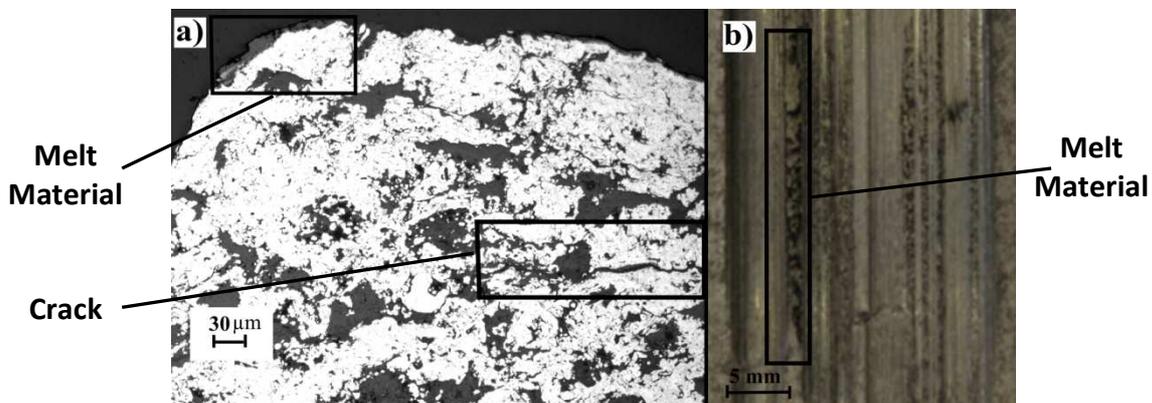
Figure 16. a) higher magnification image of groove region; b) coating after the test with melt material on the groove.

Figure 16 shows a high magnification image of the sectioned groove, along with the corresponding image of the coating surface. As shown in Figure 16a, material transfer appears to have occurred between the blade and the coating, with a corresponding dull area of transferred titanium present on the surface of the specimen (Figure 16b). This observation correlates well with the report of thermal damage at the corresponding point on the blade, and suggests that temperatures were locally hotter at this point on the coating when compared to other regions in the contact patch. Further, a crack is also evident on the coating, and is running perpendicular to the incursion and blade strike axes.

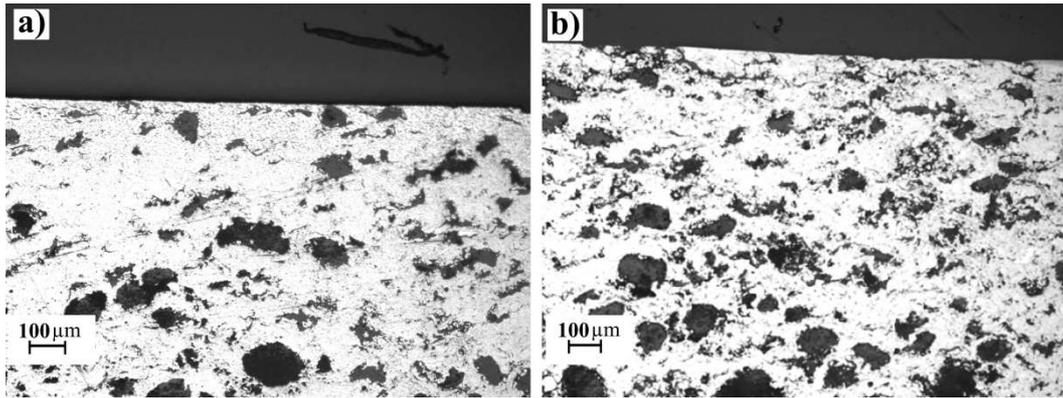
Figure 17. Section showing the microstructure on the longitudinal axis at an incursion rate: a) $0.2 \mu\text{m}\cdot\text{pass}^{-1}$; b) $2 \mu\text{m}\cdot\text{pass}^{-1}$.

Figure 17, shows the microstructure of the coating at incursion rates of 0.2 and 2 micrometers per pass (Test 6 and 8 respectively). In these cases good cutting was observed for the abradable material, and is reflected in the microstructure. As shown in the figure, as the incursion rate is increased consolidation is minimal, with the intact hexagonal boron nitride phase remaining at the surface and little or no evidence of a solidified layer. This is particularly evident at the incursion rate of 2 micrometers per pass. In general, for both of these results the coating in the region close to the surface is smooth and well fractured, indicating an efficient cutting mechanism. However, the fact that minor consolidation is present at 0.2 micrometers per pass, does imply that an increase in cutting efficiency does occur with increasing incursion rate.

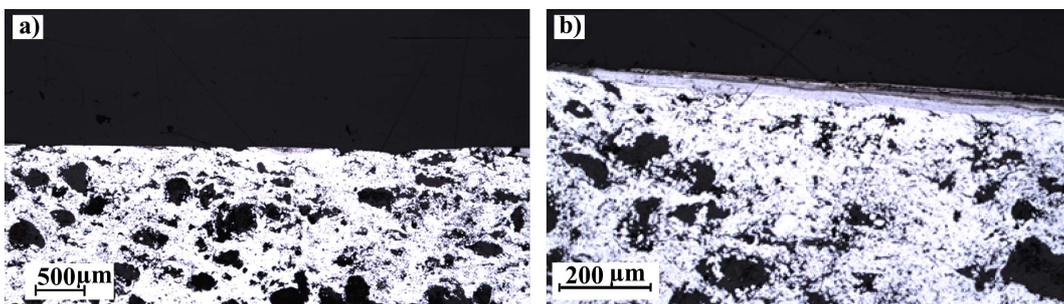
Figure 18. Section showing the microstructure on the longitudinal axis at an incursion rate $0.06 \mu\text{m}\cdot\text{pass}^{-1}$: a) low magnification, b) high magnification.

Figure 18, shows the microstructure of the coating at an incursion rate of 0.06 micrometers per pass (Test 3). As shown in the figure, the coating is beginning to be well cut, with the solidified layer minimal, and the hexagonal boron nitride phase starting to occur intact at or close to the surface. This suggests that at or around this incursion rate, the material removal mechanism is transitioning, with a good cutting and dislocation of the abrasible material becoming dominant.
