von der Tann, L, Ingram, P, Devriendt, M et al. (2015) Case Study of Barrette Retaining Wall, Kent, UK. In: Winter, MG, Smith, DM, Eldred, PJ and Toll, DG, (eds.) Proceedings of the XVI ECSMGE Geotechnical Engineering for Infrastructure and Development. XVI ECSMGE Geotechnical Engineering for Infrastructure and Development, 13-17 Sep 2015, Edinburgh, UK. ICE Publishing, pp. 1003-1008. ISBN: 978-0-7277-6067-8.

Case Study of Barrette Retaining Wall, Kent, UK

ABSTRACT This paper presents a case history of a retaining wall designed by Arup and constructed in Kent, UK, between 1996 and 1998, as part of a highway cutting. The design methodology which was applied for this novel wall type is introduced, and measured horizontal displacements are presented and discussed. The design requirements specified that the wall had to be capable of supporting up to 8.8 m of retained height and was not to be propped or anchored. To attain sufficient bending stiffness, Arup introduced a series of discrete barrettes perpendicular to the excavation. Arches of sprayed concrete retain the soil between the barrettes above dredge level. The barrettes were designed applying the general design principles for

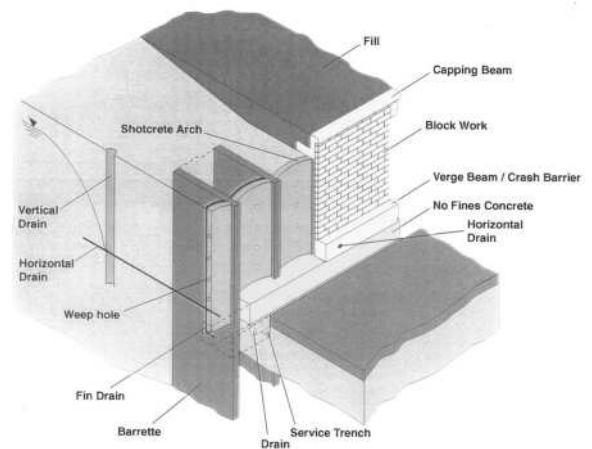
Figure 1. Isometric view of the wall and the drainage system.

Maximum allowable wall deflections of 20mm horizontal movement at verge level and 1:200 tilt above verge level, following construction of a non-structural facing wall, were specified by KCC in order to minimize the risk of future damage to the block work. In order to ensure that these limits were not exceeded, a permanent drainage system was provided, consisting of fin drains behind the sprayed concrete arches and vertical drains located 6m behind the wall facing, at the end of the barrettes. The water level behind the shotcrete is controlled with intersecting horizontal drains which discharge through the verge beam into the highway drainage system. The general arrangement and the back of wall drainage system is shown in Figure 1.

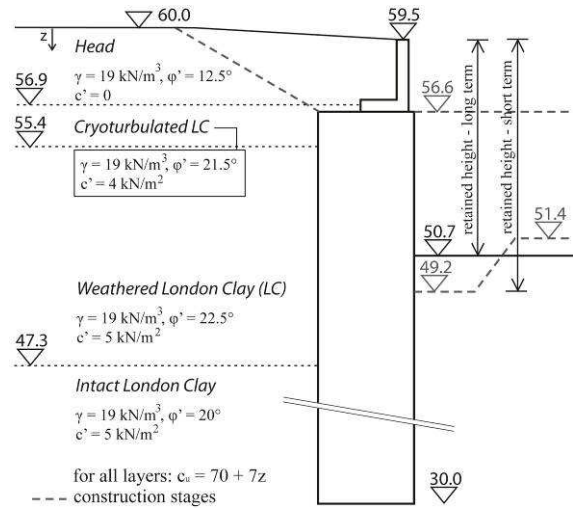
Figure 2. Wall section of maximum retained height: cross section and geology

The section considered in this paper, including the geology and basic design parameters is shown in Figure 2. The wall in this section is fully embedded in London Clay (LC).

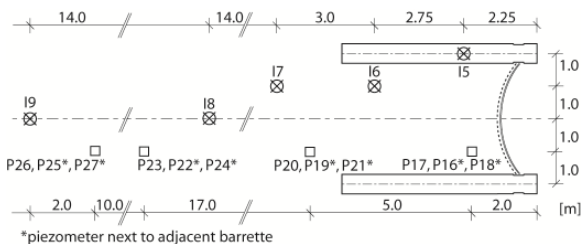
Figure 3. Installed instrumentation at critical wall section.

both behind and in front of the wall using vibrating wire pressure transducers which were installed in standpipes. Figure 3 shows the location of inclinometers and piezometers installed at the wall section in plan. Magnetic extensometers were installed in conjunction with the inclinometer tubes.

It can be seen from comparison of the deflected profiles of the wall at the end of construction and some 15 years later that only minor movements of the wall have occurred in the interim. At the top of the wall, increases in deformation of 2mm in I5, in the barrette, and 3mm in I6, between the barrettes (see Figure 3), have been recorded.

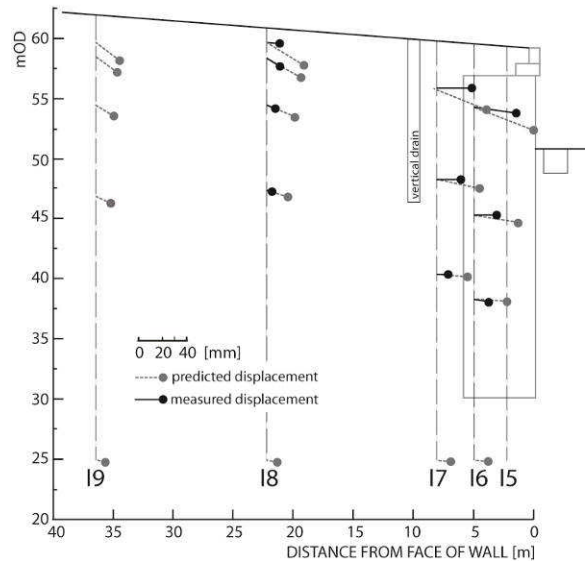
Figure 4. Predicted and measured displacements at end of construction (April 1998).

In Figure 4, observed movements after completion of construction are compared to movements predicted from the original undrained model. The analyses conducted in SAFE showed movement of the inclinometer toes which, for the inclinometer readings, are assumed to be fixed. As there was no independent monitoring of the top of the inclinometers, it cannot be verified if toe movement actually occurred.

Even though the displacements had been over-predicted in the original analysis for the short as well as in the long-term (Figures 4, 6), horizontal strain in the soil behind the wall, calculated as $(d_{16}-d_{18})/17\text{m}$, with d_{16} : deformation at inclinometer I6, level +55 mOD, was similar for predicted and measured values (short-term measured: 0.14%, short-term predicted: 0.12%, long-term measured: 0.14%, long-term predicted: 0.15%). It must be noted that taking into account the system accuracy of inclinometers there is some uncertainty in these values and they

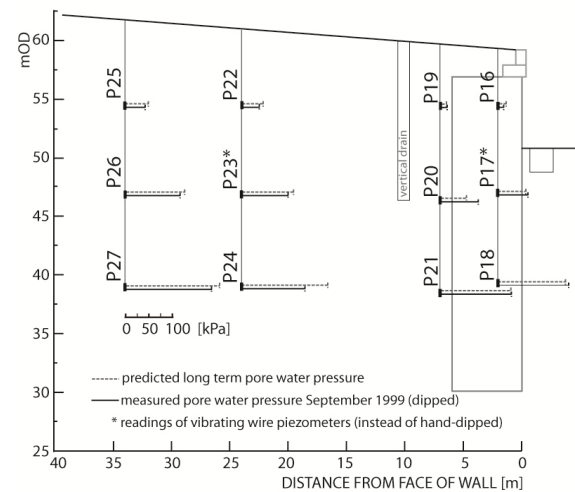
Figure 5. Long term prediction of pore water pressures and measured values 1 year after completion of construction (April 1999).

Water levels one year after completion of construction in the serviceable piezometer were found to be close to the expected long-term levels, indicating that the installed drainage system was operating efficiently (Figure 5). Compared to the plotted values, until 2003 an increase in P20 and a decrease in P21 were recorded, with all other piezometers being stable.

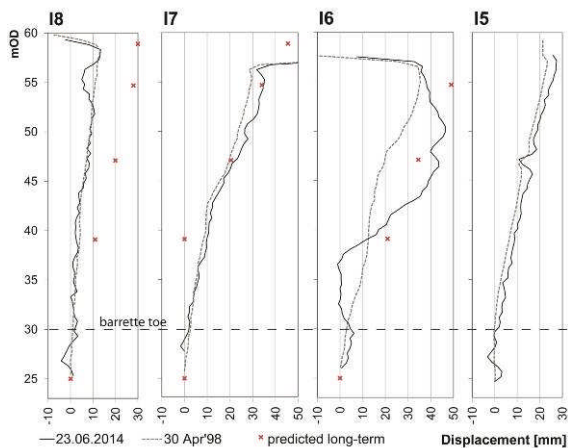
Figure 6. Horizontal displacements at end of construction, recent readings and long-term prediction.

In June 2014, inclinometers I5-I8 were read again. Deformations of these inclinometers at end of construction as well as the new readings are shown in Figure 6. It has to be noted that I5, in the barrette, was commissioned about 6 months later than I6-I8 and consequently did not record all movements during construction.

Horizontal long-term deformations as predicted in the original analysis are plotted alongside the new readings in Figure 6. The plotted displacements are reduced by the predicted toe movements which were 20mm for I6 and 16mm for I7 as well as I8.

Inclinometer I5, in the barrette, shows a kink at around +47 mOD. This is probably due to an inconsistency in the inclinometer tube as it appears in the prior readings and also is apparent in the checksums of the recent measurements, suggesting false readings around this level. Between +25 and +28 mOD, deformation of the inclinometer tube possibly indicates squeezing of the ground below the barrette. Both features are apparent in the B-axis as well, which is not plotted here. However, the recorded movements are very small ($\pm 3\text{mm}$) and further evidence would be required to verify this conclusion.

Inclinometer I6 which is located 5m behind the wall face, adjacent to a barrette, shows backwards movement between +32 and +37 mOD compared to the reading in 1998. This could possibly be due to a bias shift. However, shifting the data to match the prior reading at this level would increase the post construction movement at the top of the wall to 12 mm, which does not seem plausible given the negligible displacement of I5 and I7 in the same period. Between +37 and +57 mOD I6 bulges in the direction of the wall face. Both, the bulge and the backward movement at lower levels seem to show local effects between the barrettes, as they don't appear 3m further back, in I7. In I8, 16m behind the wall face, no additional movements have occurred since construction was completed.

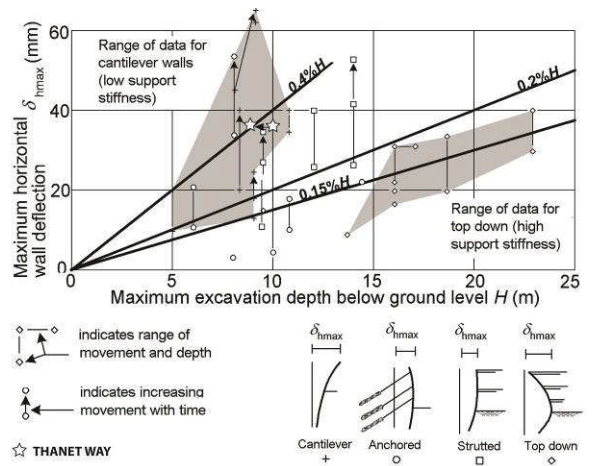
Figure 7. Comparison of barrette wall with case studies after CIRIA C580 Figure A2.1.

In order to demonstrate the performance of this barrette wall in the context of other case studies, the maximum horizontal wall deflection vs maximum excavated depth below ground level has been plotted against case history data given in Ciria C580 (Figure 7). The Thanet Way wall performance is within the range of data for other cantilever walls and is close to the line where deflection is equal to 0.4% of excavated height. It is important to note that unlike other cantilever walls this wall remained as an unpropped cantilever wall after construction and has no long-term propping from the final structure.
