# Failure mechanisms in DP600 steel: initiation, evolution and fracture

H. Ghadbeigi<sup>a\*</sup>, C. Pinna<sup>a</sup>, S. Celotto<sup>b</sup>

## Abstract

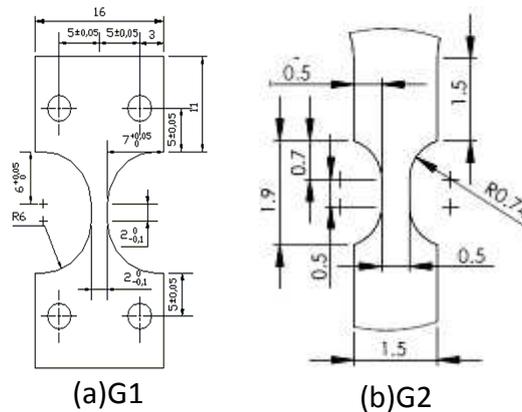
The test specimens are shown in Fig. 1 that takes into account the load capacity of the tensile stage. Specimens with the gauge geometry of Fig. 1-a (denoted G1) were used to study the local deformation and damage initiation mechanisms as well as the strain distribution at the scale of the microstructure. The damage evolution mechanisms were investigated using a slightly different gauge geometry (G2) shown in Fig.1-b. The gauge profile of both geometries was machined using electro-discharge wire erosion in order to minimise the local plastic deformation due to the conventional machining processes. For the specimens with the Fig. 1-a geometry, prior to the tensile testing, one of the broad surfaces was mechanically polished and etched in a 2% Nital solution to reveal the microstructure. The tests were then carried out with the loading direction parallel to the rolling direction (RD) according to the procedure developed by the authors in [9] using a 5kN Deben tensile test stage inside the chamber of a CamScan SEM using a crosshead speed of 0.1mm/min. Micrographs of the deforming microstructure were taken at magnifications of 3000X and 9000X. The local deformation within the ferrite and martensite phases was quantified using

Fig. 1 (a) tensile specimen geometry designed to investigate local deformation and damage initiation mechanisms and (b) the gauge geometry used to study damage evolution mechanisms. All dimensions are in millimetres

Tensile tests using specimens with the gauge geometry of G2 (Fig. 1-b) was used to investigate damage evolution mechanisms. The tests were stopped at different strain levels in the post-uniform elongation stage and close to the final fracture. The specimens were sectioned and metallographically prepared along their mid-width plane. The through thickness strain was calculated using the thickness of the specimens in the centre of the neck measured from the optical micrographs of the mid-width plane. The previously described etching procedure was then used to reveal the microstructure of the specimens at this plane and the deformed microstructure of the material was scrutinized using a high resolution FEG-SEM in order to identify the damage evolution mechanisms at each strain level.

Special gauge geometry was designed to study the final stages of damage evolution and fracture propagation during the tensile experiments (Fig. 1b). The rate of damage and fracture propagation in the standard tensile specimen geometry was so fast that it was not possible to capture intermediate stages of damage evolution in the studied material. This could be related to the stress state within the material and the effect of stress triaxiality. Consequently, the gauge geometry was modified in such a way to reduce the damage propagation rate at the centre of the neck. The modified specimen geometry made it possible to capture the intermediate stages of damage propagation and investigate the effect of microstructural constituents on the final stages of deformation. Fig. 10 shows that

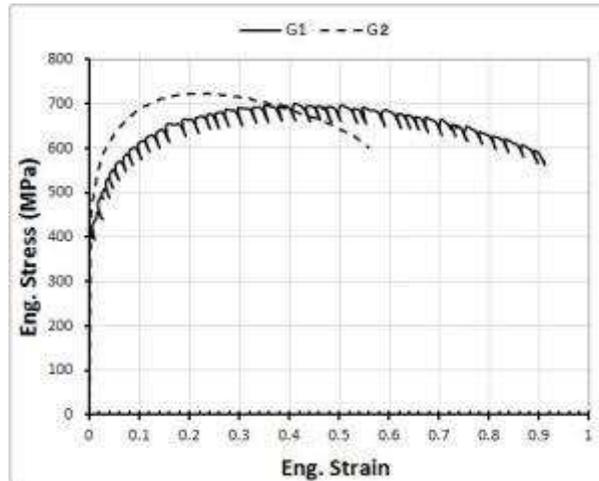
The engineering stress-strain curves have been determined using the load and displacement data measured at the grip section of the G1 and G2 specimens. The curves are plotted in Fig. 2 wherein the solid and broken lines represent the stress-strain data for the specimens with the 2 mm and 0.5 mm gauge lengths, respectively. The intermittent decreases in stress values for the G1 curve are due to the relaxation of the specimen during intervals used to take images for subsequent DIC analysis. It should be noted that the large post uniform elongation is the result of the specimen geometry. The uniform plastic deformation part of the curves is also reduced by the gauge length reduction.

Fig. 2 Engineering stress-strain curves of the material tested with different gauge geometries.

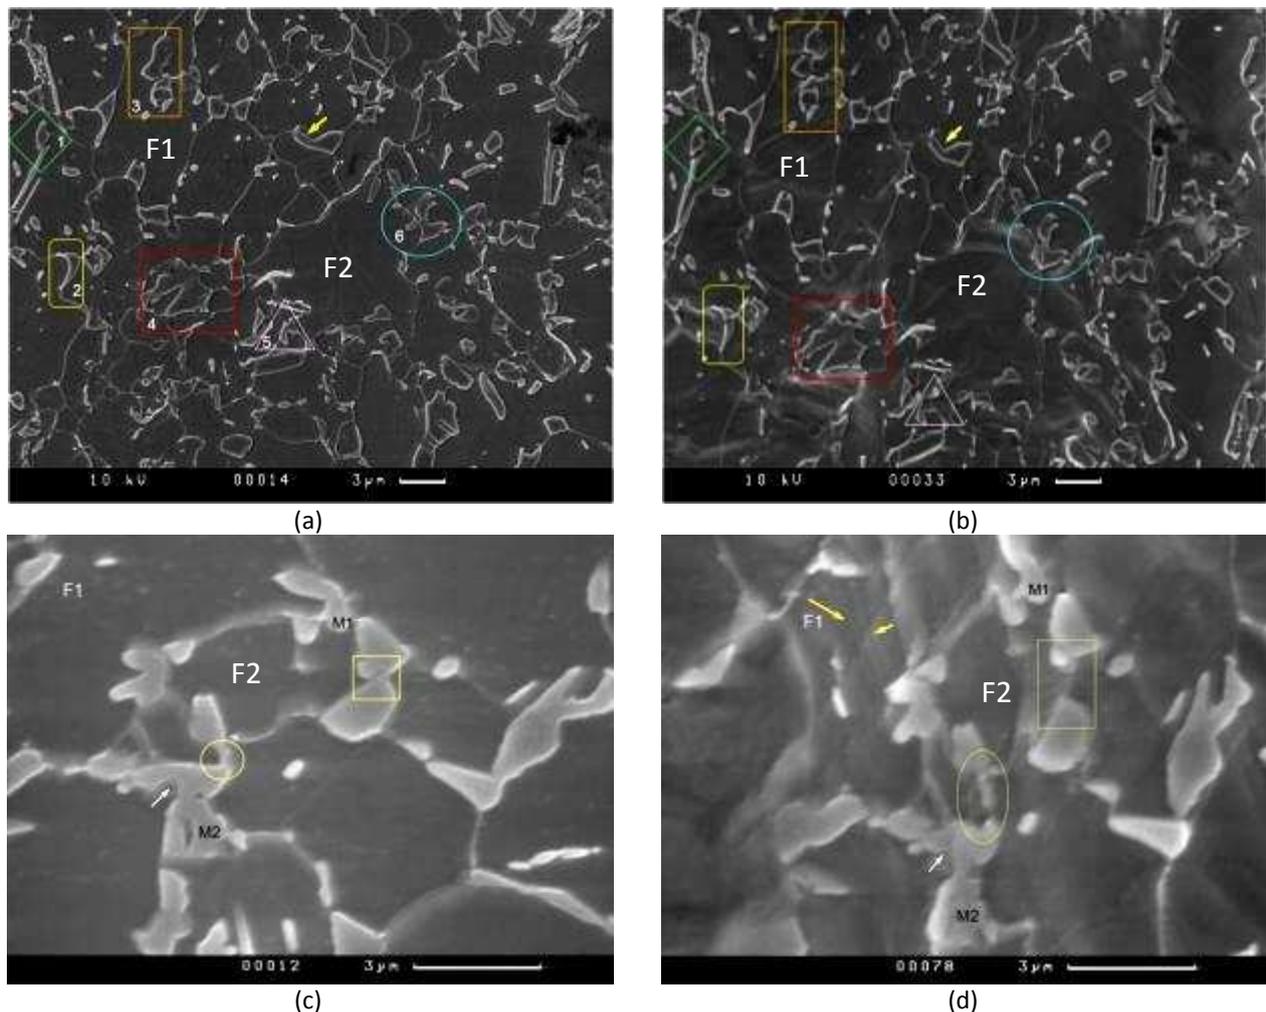
The highlighted areas in Fig. 3 show examples of the different deformation and damage mechanisms observed within the martensite phase. The local displacement of the identified martensite islands with respect to the loading direction indicates that the martensite islands labelled M3 and M6 (Fig. 3a) are elongated in the loading direction (that is vertical in the micrographs) whereas a shear deformation is appeared to take place at the vicinity of martensite islands M1 and M5 by the applied local stresses. A combination of bending and tensile deformation was observed for the martensite island M2 as indicated by the arrow. A comparison of the undeformed and deformed microstructures at higher magnification (Fig. 3-c and d) confirms the identified deformation modes. Furthermore, it shows that the phase boundaries maintained their integrity even up to the point where the martensite islands themselves began to fracture where still no decohesion occurred at the interfaces. This is shown in the encircled martensitic region of Fig. 3c where the boundaries of the deformed and undeformed martensite island are compared and the local elongation measured. A total elongation of about 50% is measured up to the point of fracture (Fig. 3-d) with no

decohesion at the ferrite -martensite (F-M) interface. However, separation of prior austenite grain boundaries, as a well-known damage mechanism in the martensite phase of DP steels[10] , has been observed as highlighted by the square area in Fig. 3c and d.

Fig. 3 (a,c) Undeformed and (b,d) deformed microstructure of the specimens after an applied strain of 88% taken at (a,b) 3000X and (c,d) 9000X magnification. The loading direction is vertical in the micrographs. The micrographs show slip bands formation within the ferrite grains prior to the damage of the highlighted martensite islands

Successive micrographs of the deforming microstructure taken during the tests have been analysed to identify the local deformation and damage mechanisms. Fig. 3 shows micrographs of the undeformed (Fig. 3a, c) and deformed microstructure close to the final fracture (Fig. 3b,d) taken at low and high magnifications. It is found that the local deformation commenced with slip bands formation within the largest ferrite grains (F1 and F2 in the figures). The slip bands then appeared in the smaller grains followed by an increase in the density of the bands (F1 in Fig. 3d). The slip bands then crossed into the neighbouring ferrite grains or martensite rich regions to develop localized deformation bands that ran across several grains within the microstructure. The transfer of slip bands across adjacent grains was found to occur at smaller strain levels when the bands are formed in the same direction. It is presumed that this is related to the crystallographic orientation of the grains and therefore, directions of active slip systems.

It is shown that martensite is clearly a deformable phase within the microstructure of DP-steels (Fig.3, 4 and 9), even when the macroscopic stress applied is tensile. The strain map of Fig. 9b shows that a maximum local strain value of about 80% is measured within the islands close to the phase boundaries. However it is worth noting that an average error of about 16% may exist in the measured strain values in the used DIC technique and SEM micrographs as reported elsewhere [20].

configuration like that observed for regions 2 and 6 in Fig. 3a. However, the smaller martensite islands may undergo larger plastic deformation due to the specific microstructural arrangement around the islands. Fig. 14 shows the lower magnification micrograph of the selected region of Fig. 3c. Here, the smaller islands (e.g. A) are located at the direct vicinity of two small ferrite grains, F2 and F3, while the larger martensite island (B) is enclosed by much larger ferrite grains (F4 and F5). The ferrite grains F2 and F3 are surrounded by several martensite islands and therefore, the volume expansion of the martensite islands during phase transformation may generate a local stress field inside the grains that plastically deforms the whole grain. Due to the subsequent work hardening, the local yield strength of ferrite increases to a value close to that of the neighbouring martensite islands. However, for the larger ferrite grains F4 and F5, the martensitic volume expansion affects a narrow rim along the phase boundaries leading to a much larger yield strength difference between the ferrite grains and martensite islands. Accordingly, at an applied elongation, the local stress field is more uniformly partitioned between the two phases in the ferrite-martensite cluster containing smaller ferrite grains [3] and local stresses are more rapidly transferred to the martensite phase [27]. As a result the martensite island denoted A, might be subjected to a larger local stress field than island B that has a better strain compatibility with the ferrite grains around and that results in a larger plastic deformation in the island (Fig. 9b). The grain size and the martensite volume fraction in the steel are other important factors affecting the global and local ductility of the material and are reported elsewhere [3].

Void formation due to the failure of martensite islands is one of the identified damage initiation mechanisms for DP steels [3, 11, 30]. This may occur as a result of the separation of prior austenite grain boundaries (Fig. 3) and/or crack initiation and propagation through the martensite islands. The segregation of alloying elements such as residual phosphor often occurs at the prior austenite grain boundaries, which increases their brittleness [3]. Additionally the plastic incompatibility between adjacent martensite islands would make these boundaries the likely failure initiation sites. On the other hand, Szewczyk and Gurland [31] reported that the plastic incompatibility increases the average applied stress at the hard phase above the mean stress value in the dual phase alloys. They showed that the local uniaxial stress in martensite can be 3 times larger than the ferrite stress. Therefore at an applied large plastic strain, the martensite phase is subjected to a relatively large local stress, close its yield strength, that will result in a local plastic deformation. Additionally the carbon is heterogeneously distributed in the martensite islands[24], the boundary regions of the martensite islands are prone to failure in a form of crack initiation due to higher carbon concentration and the reduced ductility compared to the interior of the islands. This may explain the fact that cracks formation are mostly observed at the boundary region of the martensite islands as shown in Fig. 4.

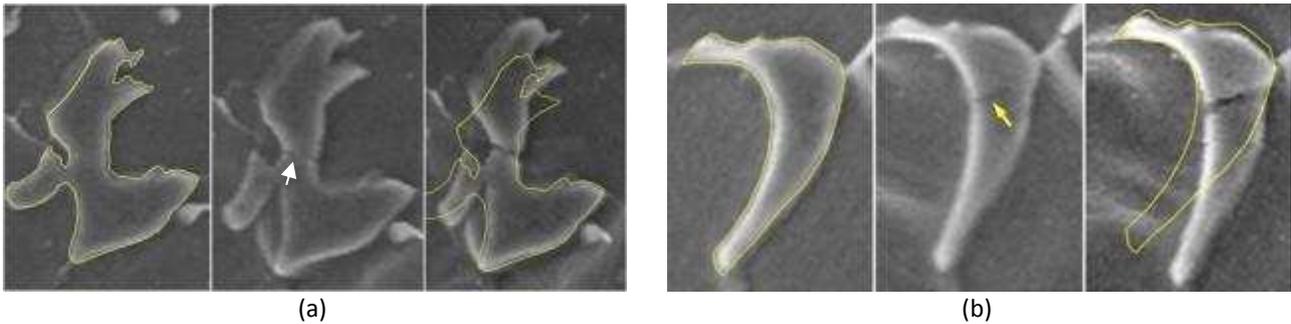
Fig. 4 (a,c) Undeformed and (b,d) deformed microstructure of the specimens after an applied strain of 88% taken at (a,b) 3000X and (c,d) 9000X magnification.

Fig.4-a shows local necking occurring in the martensite island and microcracks initiating from both sides of the narrow central region indicated by the arrow in the middle image. The cracks grew towards the interior of the martensite island and final fracture occurs at a total elongation of 13.5 % in the martensite island. Fig. 4-b shows that the bending mode imposed on the martensite phase also results in crack initiation from the boundary of the island under tension followed by its propagation towards the centre of the island in a direction that is perpendicular to the local principal loading direction. Martensite fracture occurred as the crack passed through the island. The broken islands then moved rigidly within the microstructure from the plastic deformation of the ferrite phase.

Close investigation of the micrographs of the deformed microstructures reveals several of the martensite failure mechanisms in the DP steel studied. Micro-cracks formation in the martensite due to extensive tensile (Fig. 4-a) and bending (Fig. 4-b) deformation is the main local damage initiation mechanism identified. Fig. 4 shows crack initiation and propagation in the martensite phase at several loading steps during the tests. The outline of the undeformed martensite island in Fig. 4 is highlighted and superimposed on the deformed micrographs to show the extent of deformation in that phase.

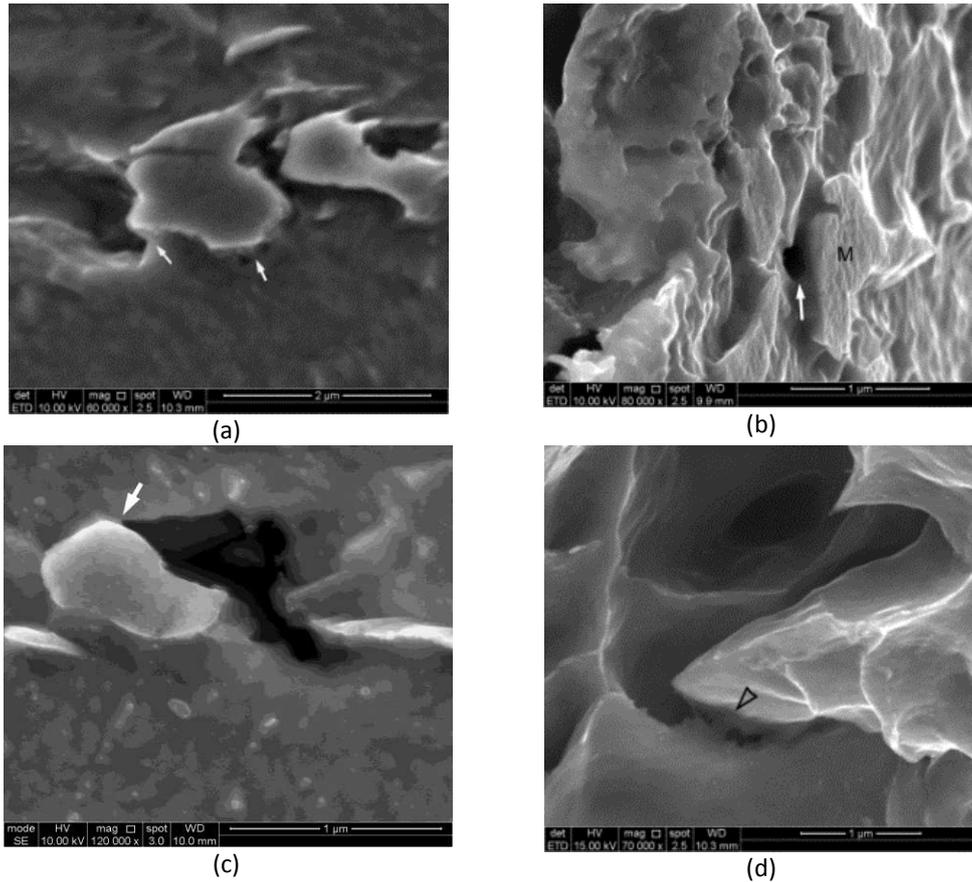
In addition to mechanisms that involve crack initiation and propagation within the martensite islands, failure of the ferrite-martensite (F-M) interface is another damage initiation mechanism that is reported for DP steels [5, 7]. Uggowitzner and Stuwe [19] related this type of failure to the separation of inclusions from the martensite islands close to the interface with ferrite. However, the observations made in the current study like that shown in Fig. 5 revealed that the failure did not occur at the interface itself, instead voids formed within the ferrite phase close to the martensite boundary. Sub-micron voids close to the interface inside the ferrite grains are highlighted by the arrows in Fig. 5a. The voids then elongated through further applied deformation and micro-cracks are formed (Fig. 5b). These then propagate along the interface and martensite islands are separated from the adjacent ferrite grains (Fig. 5c). It should be noted that the crack propagation occurs within the ferrite grain rather than at the interface itself as shown in Fig. 5c and 5d. Fig. 5d shows indeed a martensite island on the fracture surface with some part of the ferrite phase still attached to the island after damage development. It worth noting that, the observed mechanisms are representatives of the microstructural observations in this study. However the statistical analysis of the results is not the subject of the present research.

Fig. 5 The damage initiation mechanism at the vicinity of ferrite-martensite interface includes (a) micro-void initiation within the ferrite phase followed by (b) void growth and (c) tearing off the ferrite region along the interface (d) up to the final fracture where some of the ferrite phase attached to the martensite island

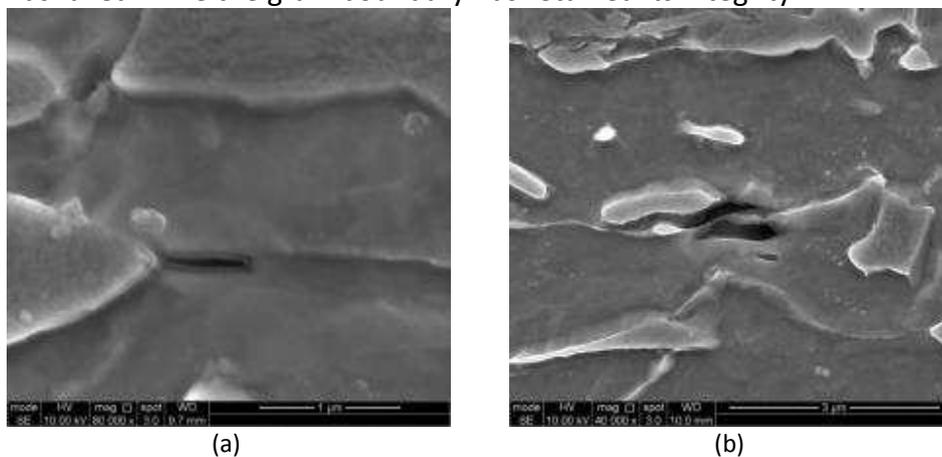
A similar behaviour has been identified for the damage initiation at the vicinity of the ferrite grain boundaries. Fig. 6a shows that damage starts by micro-void formation at the triple junction of the ferrite grains and the martensite phase followed by void elongation along the grain boundary. The fact that the generated crack is growing parallel to the loading direction (i.e. horizontal in the micrograph) and cannot cross the grain boundary implies that the grain boundary shows more resistance to the damage process than the bulk phase itself does. This is also shown in Fig. 6b where the ferrite phase on both sides of the grain boundary has failed while the grain boundary has retained its integrity.

Fig. 6 (a) Void initiation at the triple junction of the grains and (a, b) its growth along the ferrite grain boundary showing that the grain boundary is stronger than the ferrite regions at the vicinity of the boundary

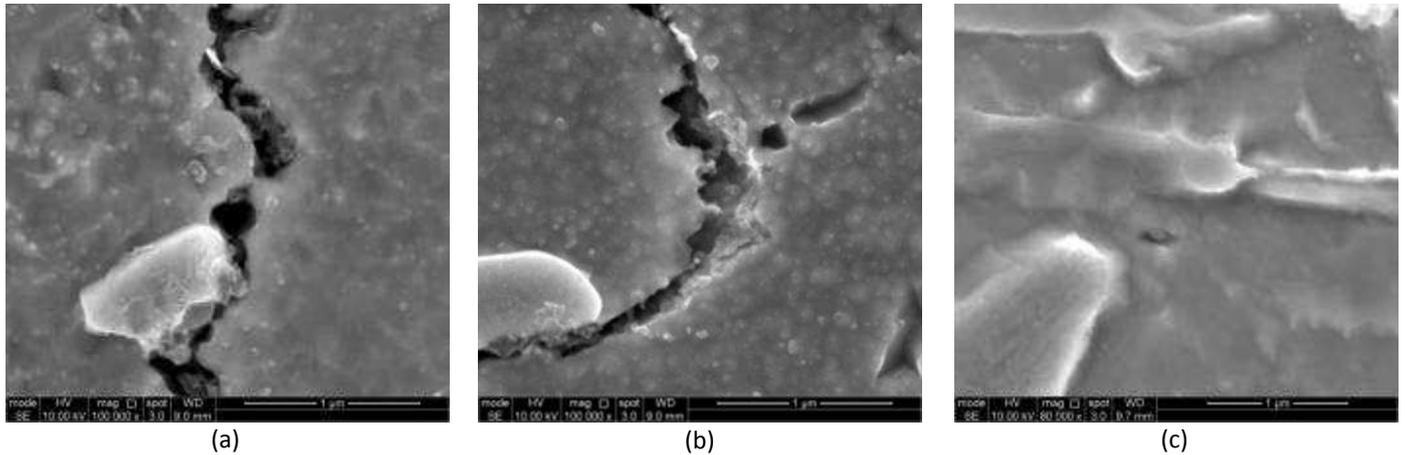
In addition to the identified damage initiation mechanisms at the early stages of the post uniform plastic deformation, sub-micron voids formation is the mechanism that is mostly observed right before the final failure (Fig. 7). Micrographs of Fig. 7a,b show that voids with a size of few hundreds of nano-meters are initiated inside the ferrite phase due to decohesion of fine dispersed carbide particles or Mn-S inclusions from the matrix (Fig. 7c). The latter micrographs show the early stages of voids initiation and coalescence in the ferrite phase.

Fig. 7 Sub-micron void formation within the ferrite phase right before the final failure due to decohesion of carbide particles or Mn-S inclusions

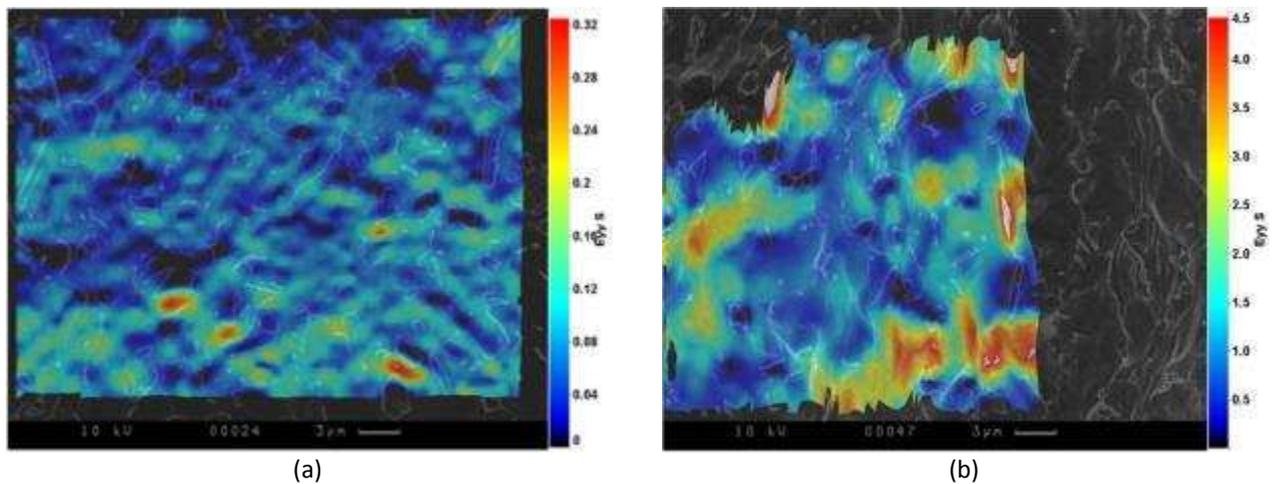
The martensite boundaries are highlighted for better visualization of the deformation within the islands. The maps clearly show that the martensite phase is plastically deformable with a heterogeneous strain distribution within the phase. Fig.9a indicates that the large local strain values of about 20% are measured close to the identified damage initiation sites (shown by the arrows). The local strain values for the identified damage

Fig. 8 Local strain distributions at the applied strain of (a) 14 % and (b) 88% for the micrographs shown in Fig. 3a that shows the deformation evolution in the microstructure

The local deformation of the microstructure has also been quantified using DIC for the micrographs of the deformed specimen taken at low and high magnifications. The technique that was developed to measure strain distributions within the deformed microstructure as well as the local strain values at the onset of damage for the identified mechanisms is explained elsewhere [9, 20]. The distribution of the strain component along the loading direction that is in the vertical direction of the image is shown in Fig. 8. Local strain values as large as 4.5 have been measured within the ferrite phase, although no localized strain bands have been detected within the microstructure, in contrast to the strain map reported for DP1000 in [9]. The strain maps of Fig. 8 show that the largest local strain values measured are within the ferrite grains and that the deformation is much smaller in the vicinity of martensite islands. Therefore the microstructural deformation is restricted by the presence of the martensite rich regions. The images taken at the higher magnification have been analysed to resolve the deformation within the martensite phase. Fig. 9 shows the measured strain distribution within the selected region of microstructure in Fig. 3c close to the yield point (Fig. 9a) and just before the final fracture (Fig. 9b). Although the strain maps show a good correlation has been obtained in most of the analysed area, there are some small regions in the ferrite grains that correlation has not been made due to the lack adequate random pattern within the ferrite phase.

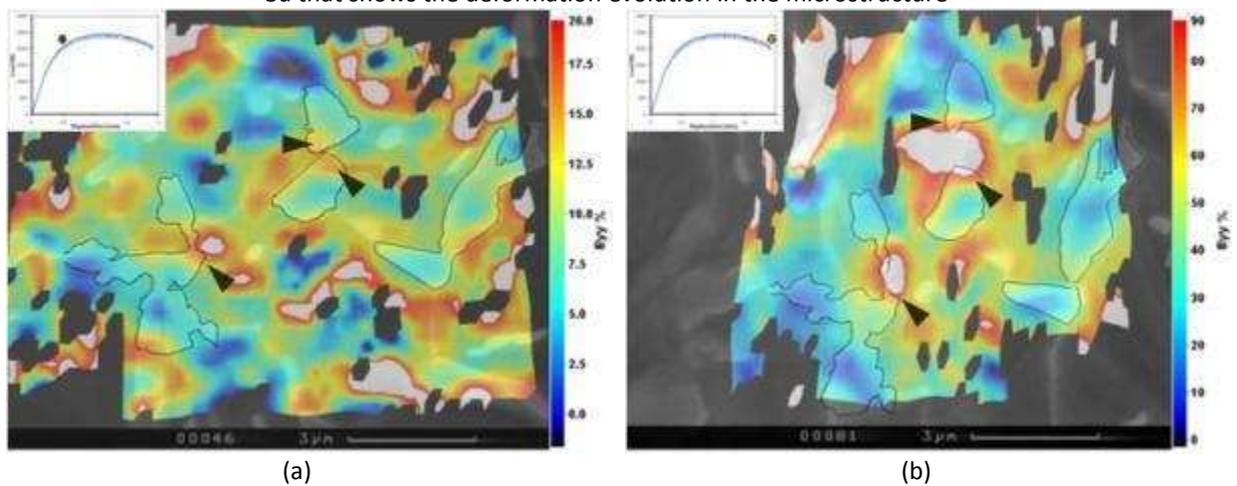
mechanisms have also been determined from the obtained strain maps. It is found that crack initiation occurs at a local strain value of 17% and 5% for the mechanism shown in Figs. 4a and 4b, respectively. The fracture strain of martensite therefore varies significantly as it is dependent upon several factors including the size and geometry of the martensite grains together with the local stress state around the phase.

Fig. 9 Local strain distribution in the martensite islands for the microstructure of Fig. 3c obtained (a) close to the yield point and (b) before the final fracture of the specimen that shows the strain gradient within the highlighted martensite islands together with the local strain values close to the damage initiation sites shown by arrows

While martensite is plastically deformable, the strain maps in Fig. 9 show that there is a heterogeneous strain distribution across the islands with larger strain values close to the phase boundaries than the centre of the islands. This variation of strain values across the martensite islands are plotted in Fig. 15 for the martensite islands A and B (Fig. 14). The plots show that the local deformation is not uniform along the specified line shown with blue colour. Fig. 15a and b show a higher strain value on the left-hand edge of the martensite islands while the local strain value at the right-hand side of the island is lower compared to the centre. The strain values at each individual step in the plots correspond to

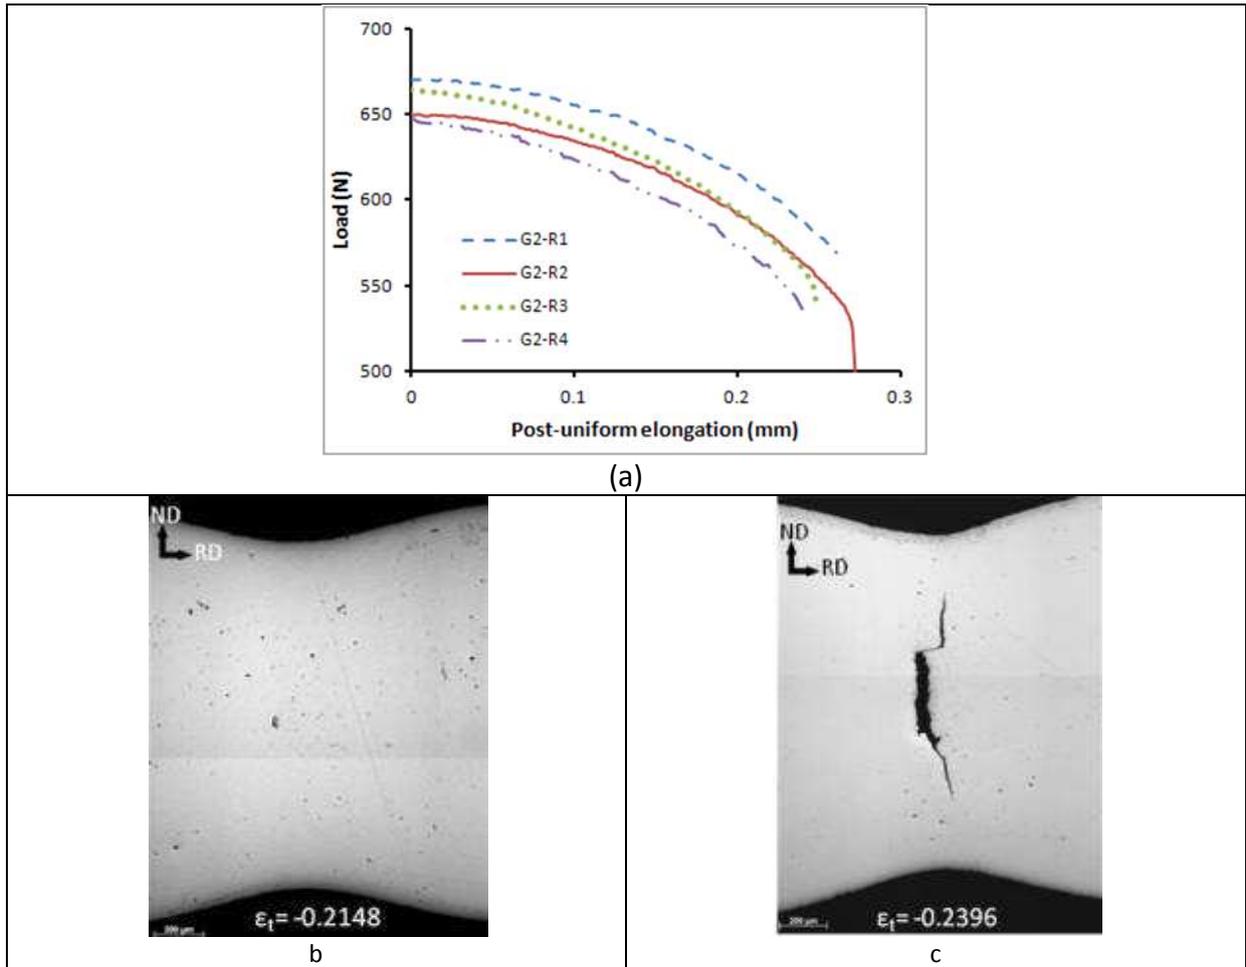
Fig. 10a shows the recorded load-post uniform elongation for the tensile specimens with the G2 gauge geometry. The modified gauge geometry results in a slower damage evolution rate that provides an opportunity to investigate final stages of damage propagation within the material. The solid line in Fig. 10a corresponds to the broken specimen while the curves with broken lines represent the tests interrupted before final fracture.

Fig. 10 (a) Load-post uniform elongation curves for samples with G2 gauge geometry loaded in the rolling direction and Optical micrographs of the mid-width plane of (b) G2-R1 and (c) G2-R3 tensile specimens for the tests stopped before final fracture

Optical micrographs of samples R1 and R3 are shown in Fig. 10b,c together with the through thickness strain values corresponding to each sample. The images show that final fracture starts at the centre of the neck where the voids volume fraction is greatest. The small strain increment between the two steps (R1 and R3) indicates that the damage propagation occurs due to a very rapid voids coalescence followed by crack propagation near centre of the neck that results in final fracture. The material fails perpendicular to the loading direction at the stage shown in Fig. 10b,c with an untypical step that shows the competition between localised variations in microstructural damage intensity with the necking geometry. The position of the final crack had to adjust to plane of greatest stress where the cross-section area was minimal at the neck.

the final failure occurs after voids accumulation at the central region of the neck. The initial failure may occur due to either the coalescence of several growing voids formed at close vicinity or by crack initiation and propagation through ferrite linking the voids formed within a large ferrite grain, Fig. 11. Cracks propagated by following the path of least resistance, which was largely within the ferrite matrix as opposed to the martensite islands. This includes the regions away from the phase boundaries as shown in Fig. 11d. As explained earlier, the area close to the F-M interface has higher hardness [24] and larger dislocation density[21] compared with the grain interior. Therefore, the cracks propagation through the area away from the phase boundaries requires lower fracture energy. Additionally, fracture of martensite islands are also observed in the area close to the edge of the specimen (Fig.12) towards the end of the test, as the stress triaxiality increases within the region of the neck. It is shown that the crack has directly passed through the martensite islands with a sharp crack edge. In contrast to the voids initiated close to the F-M boundaries, those are observed within the ferrite grains are formed due to the decohesion of Mn-S inclusion and possibly very fine carbide particles dispersed in the ferrite grains. It has been reported[21] that a large local deformation gradient is required for the decohesion of fine carbide particles from the ferrite matrix. This may happen towards the end of the test where ferrite grains undergo a large local plastic deformation; hence, providing the required condition for the submicron voids formation.

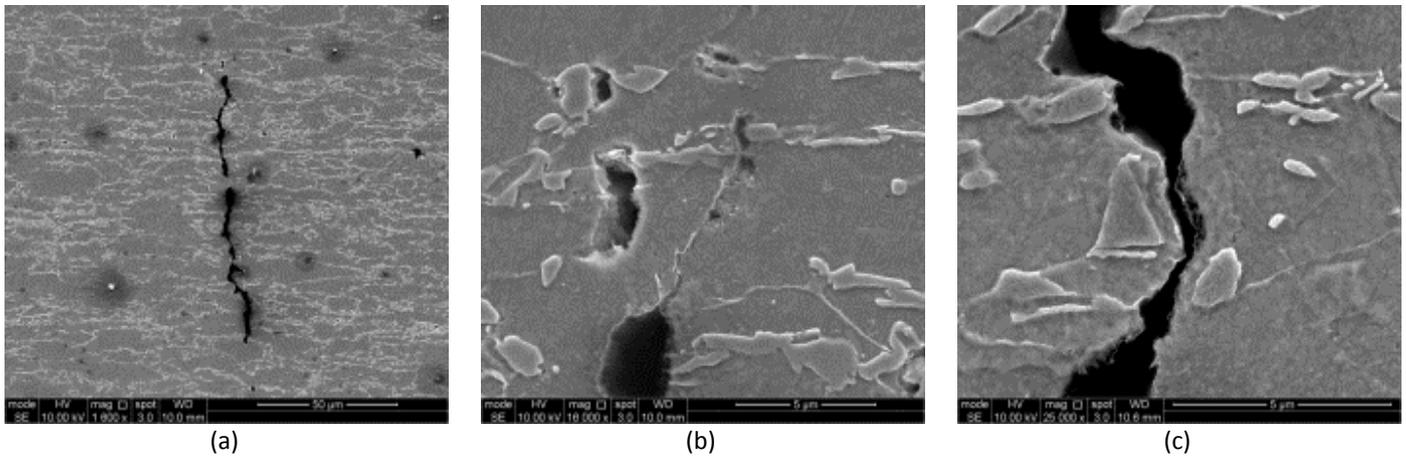
Figure 11 shows how the voids are connected at the mid-width plane of the specimen during the damage evolution. Void coalescence due to the interconnection of growing voids initiated at close proximity from each other (Fig. 11a) is a well-known mechanism of ductile failure. However as the voids initiate apart from each other, damage evolution occurs through micro-crack initiation and its propagation through the ferrite phase between the growing voids (Fig11b). The crack propagation path is affected by the microstructural constituents ahead of the crack tip. Fig. 11c shows that the crack has been deflected to

Fig. 11 High resolution micrographs at the mid-width plane of specimens showing different damage evolution mechanisms including interconnection of voids by crack propagation between the adjacent damage sites

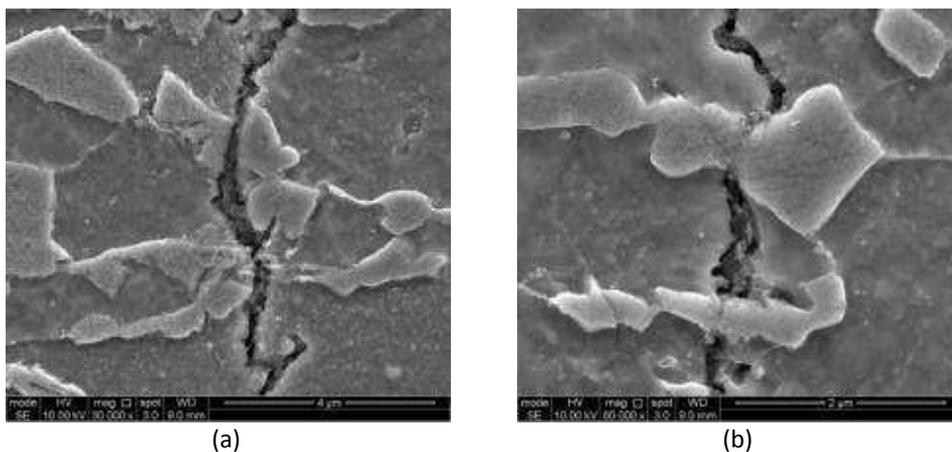
avoid martensite islands located in its path. However, when there is no alternative route for crack propagation, the crack passes through the martensite and can fracture the islands (Fig.12).

Fig. 12 Fracture of martensite islands due to crack propagation during damage evolution

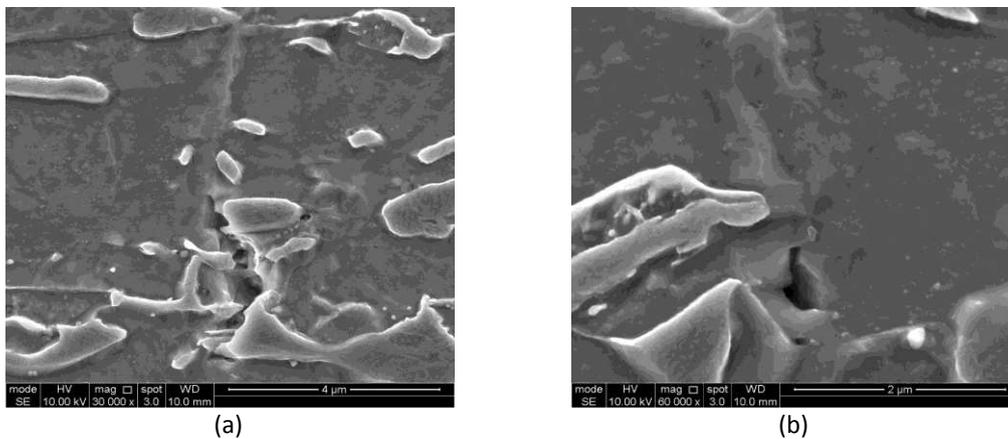
The mechanisms of deformation in ferrite are reported to be closely related to the size and the orientation of the grains as reported in [21]. The in-grain orientation gradient is higher for the smaller ferrite grains surrounded by martensite islands [21]. Additionally, the induced plastic deformation due to the martensitic volume expansion may induce work-hardening within the ferrite grains [24] and thus, increase the dislocation densities adjacent to the F-M interface. Consequently, higher local stresses are required to plastically deform smaller ferrite grains. This may occur after severe plastic deformation within the neighbouring larger grains (F2 in Fig. 4). However, in the larger grains deformation is localized in the form of slip bands at the early stages of deformation (F1 in Fig. 3) and sub-grain structures are formed [3, 23], as shown in Fig. 13. The dislocation density is increased in these substructures and this may facilitate damage initiation and crack propagation in a heavily deformed ferrite grain (Fig. 13).

Fig. 13 Damage initiation and crack propagation along the sub-grain structures in the ferrite phase due to an excessive plastic deformation

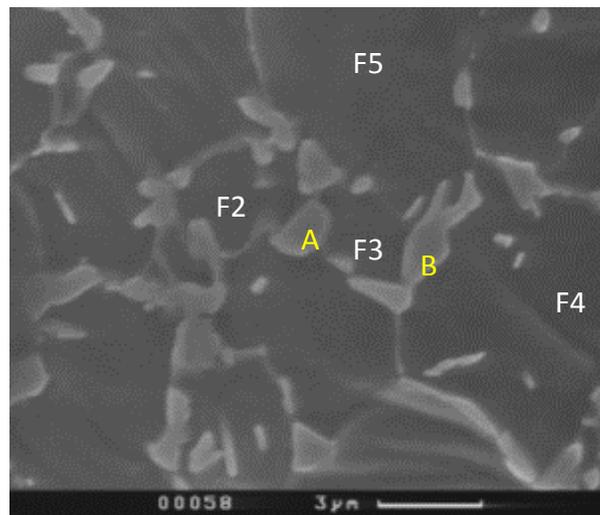
Fig. 14 lower magnification micrograph of Fig. 4 that shows the effect of microstructural configuration on the local deformation mechanism

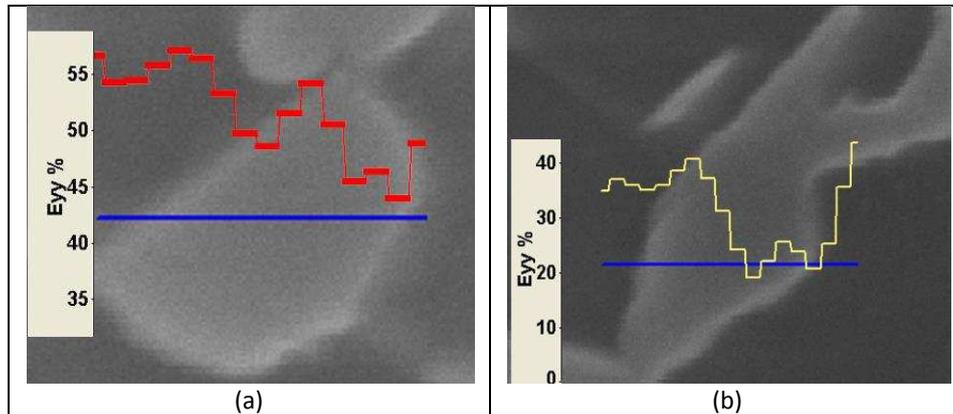
the local deformation of subsets used for DIC analysis. Therefore the flat sections of the plots show the strain values within each individual subset across the predefined line. According to the strain maps of Fig. 9, the deformation gradient within the martensite phase is dependent upon the geometry and size of the individual islands. The local strain values at the F-M interface cannot be independently quantified due to the fact that the displacements of pixels located at the either side of the interface are considered to determine the total strain of a selected subset size that covers the interfacial regions.

Fig. 15 local strain distribution across the martensite island (a) A and (b) B shown in Figure 20 along the specified line (blue line)
