This is a repository copy of *Strengthening of infilled reinforced concrete frames with TRM: Study on the development and testing of textile-based anchors.*

## **Strengthening of Infilled Reinforced Concrete Frames with TRM: Study on the Development and Testing of Textile-based Anchors**

### **Abstract:**

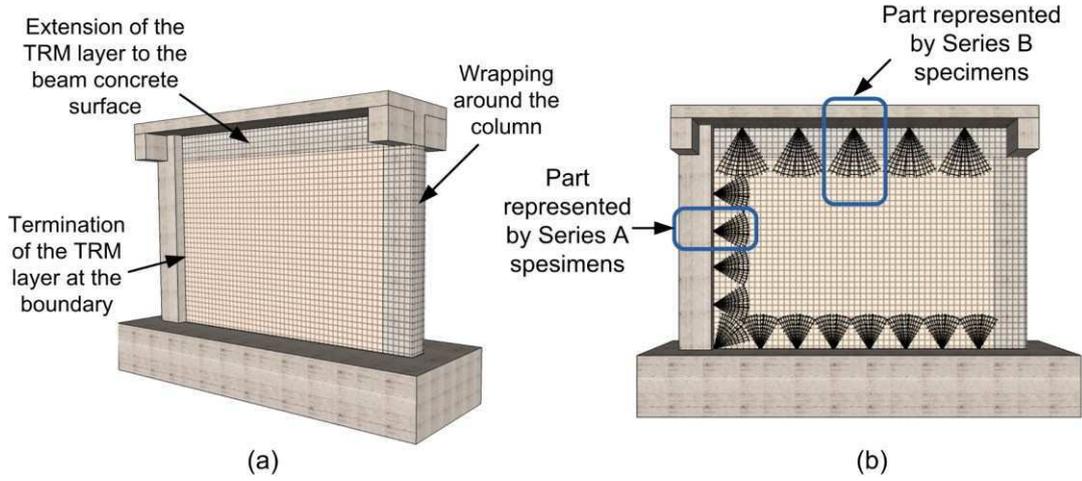
- Fig. 1 (a) TRM-strengthening of infill with different possible boundary conditions. (b) Schematic placement of anchors.
- Fig. 2 Geometry of specimens in (a) Series A and (b) Series B (dimensions in mm).

Key objective of the present study is to examine methods of infill-frame connection for two different cases of boundary conditions, as follows (Fig. 1a):

(i) The thickness of the masonry infill is less than the width of the concrete frame elements. In this case there is a step at the boundary, hence simple extension of the TRM layers from the masonry to the concrete surface is not feasible and the transfer of forces from concrete to masonry has to be achieved through the use of anchors (e.g. left column or bottom slab in Fig. 1b).

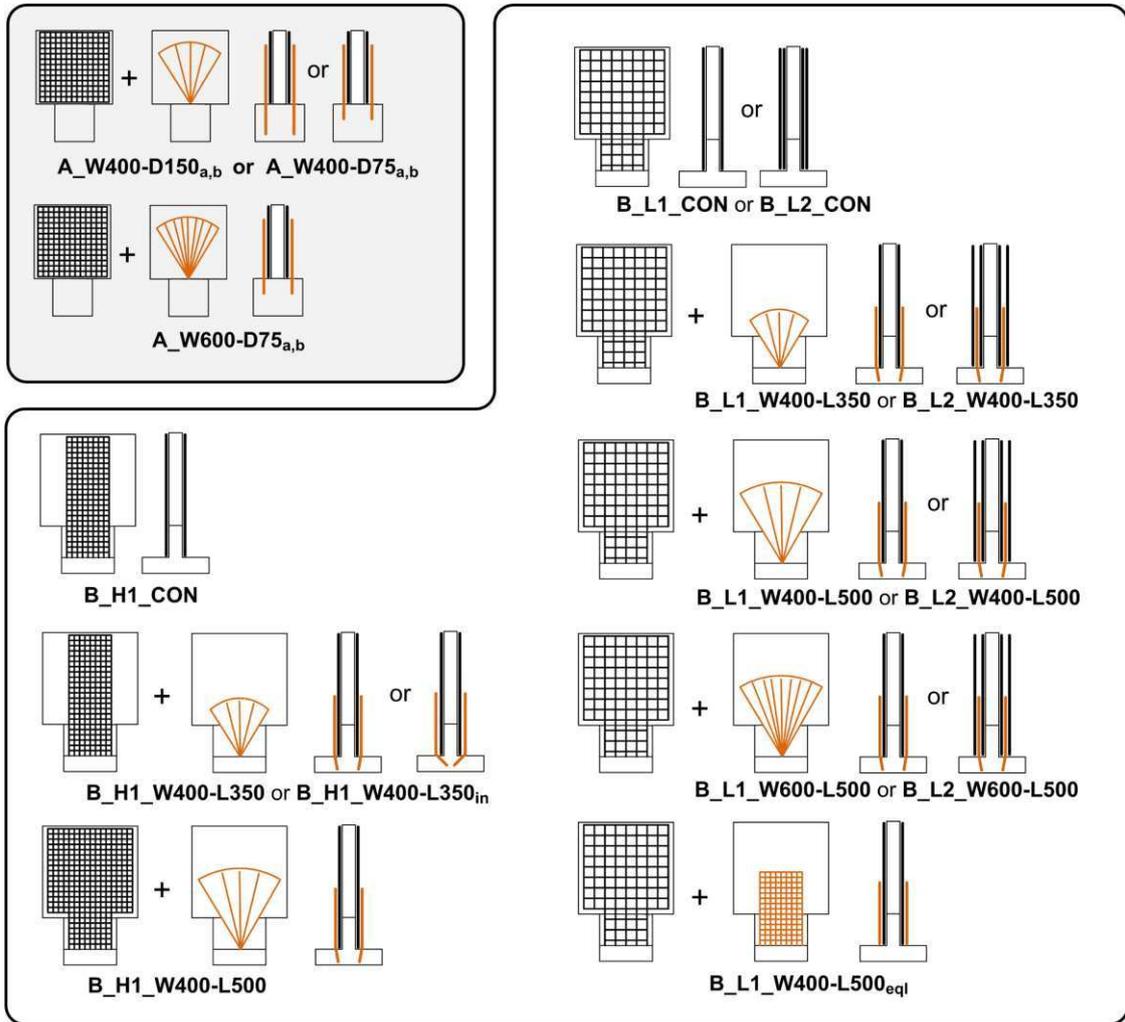
Fig. 3

All specimens tested are summarized in Table 1 and are shown schematically in Fig. 3. The notation given to the specimens of Series A is  $A\_WX-DY_I$ , where:

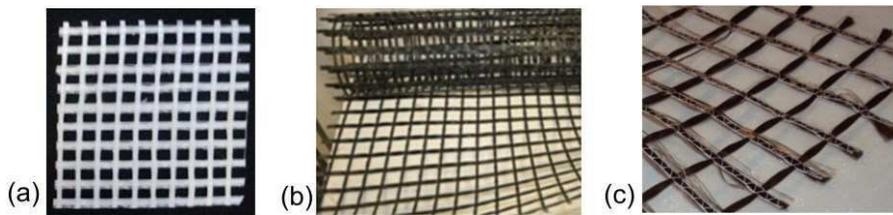
- Fig. 3 Schematic view of specimens tested.
- Fig. 4 Textiles used in this study: (a) Epoxy-coated E-glass with mesh size 10x10 mm; (b) elastomeric polymer-coated E-glass with mesh size 25x25 mm; (c) uncoated basalt textile with mesh size 25x25 mm.

Two different textiles were used as externally bonded reinforcement of the specimens. For all the six specimens of Series A and four specimens of Series B (specimens 7-10) a commercial textile with equal quantity of epoxy-coated E-glass fibers in two orthogonal directions was used (hereafter mentioned as textile H – Fig. 4a). The mesh size and the weight of that textile were 10x10 mm and 610 g/m<sup>2</sup>, respectively. For the rest of the specimens (11-19) a lighter commercial textile (with a larger mesh size) made of elastomeric polymer-coated E-glass with equal quantity of fibers in two orthogonal directions was used (hereafter mentioned as textile L – Fig. 4b). The mesh size and the weight of that textile were 25x25 mm and 405 g/m<sup>2</sup>, respectively.

The anchors developed in this study were custom-made from a commercial textile made of uncoated basalt fiber rovings knitted in two orthogonal directions with equal quantity of fibers in each one (Fig. 4c). The mesh size and the weight of that textile were 25x25 mm and 192 g/m<sup>2</sup>, respectively. The reason for selecting this textile for the anchors was the requirement for an easy to unknit textile, so that the anchors could be produced with minimal

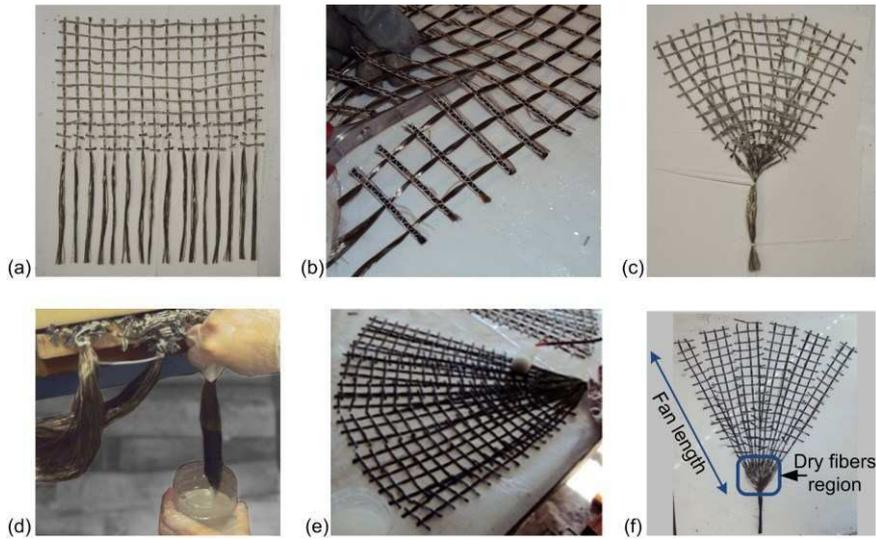
Fig. 5

The anchors were based on the concept of “spikes”, often used in the case of FRP (e.g. Zhang and Smith 2012, Koutas and Triantafillou 2013). The procedure that was followed to form the anchors and prepare them for use on the day of the strengthening is described next. Initially, a part of the basalt textile was cut in the desired dimensions. The width of the textile was equal to either 400 mm or 600 mm and the length was equal to the depth of the hole in which the anchor would be inserted, plus the desired length of the fan that would be shaped at the end of the procedure (350 mm or 500 mm). The second step involved the removal of a certain number of fiber rovings in the direction parallel to the width of the textile (Fig. 5a). This step was necessary in order to form a tow of fibers at one end of the anchor. This tow had a length greater than the depth of the hole in which the anchor would be inserted by about 50 mm. As the main objective of this procedure was to create a textile-based anchor with a fanned part that could be easily applied over a TRM layer and have good bonding conditions, it was important to retain the grid of the textile at the fanned part and to ensure the alignment of the fiber rovings that would be activated in tension. A way to achieve that was by cutting the fiber rovings in the direction parallel to the height of the textile at certain distances (every two or three vertical rovings), thus creating separate grid parts (Fig. 5b). At this stage the anchor comprised a tow of fibers at one end and separate textile grids that could shape a fan at

the remaining part (Fig. 5c). The final step of this procedure was the impregnation with epoxy resin both of the fibers of the tow (Fig. 5d) and of the textile grids (Fig. 5e), followed by a subsequent period of two days for curing. Impregnation of the tow fibers facilitates the insertion of that part of the anchor into the predrilled hole in the concrete. Impregnation of the textile grids provides a stable and easy-to-apply material and increases the stiffness of the fiber rovings, thereby creating better conditions for the mechanical interlock between the textile and the mortar. It is important to note that the tow of fibers at one end of the anchor was impregnated only in a length equal to the depth of the hole, leaving a small portion in the central region of the anchor with dry fibers (Fig. 5f); these were impregnated with epoxy adhesive at a later stage, during the strengthening procedure. Within the framework of this study, the angle of the shaped fan of the anchors was not a parameter under investigation. Taking into consideration the geometric characteristics of all the specimens, this angle was made equal to 45°.

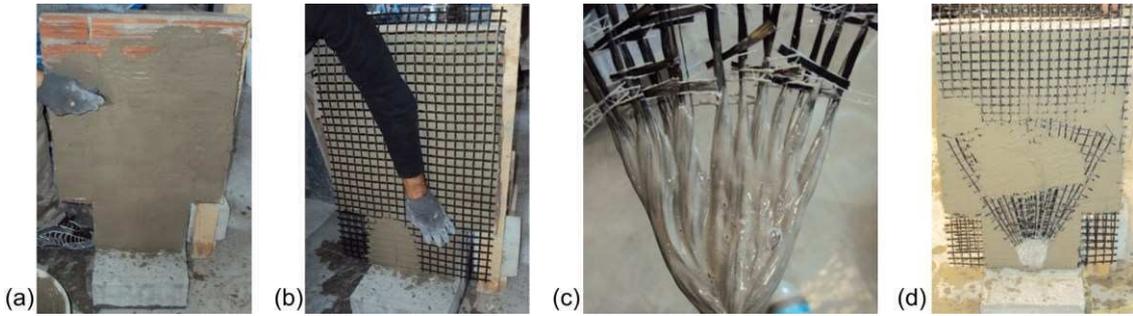
Fig. 6

The application of textile layers and textile-anchors comprised the following steps: (a) drilling holes into the concrete prisms with a diameter of 12 mm and varying depth according to specimen design; (b) removing the dust from the holes and from the surfaces receiving the TRM layers with high air pressure; (c) application of protection to the holes in order to keep them dry and clean during the application of TRM layers; (d) dampening of the surfaces receiving mortar; (e) application of a thin layer of masonry mortar at the joint between the concrete prism and the brick wallette; (f) placement of the wallette on the concrete prism while the masonry mortar at the joint was in a fresh state; (g) application of mortar on both sides of the wallette (and the web of the concrete prism for specimens of Series B – Fig. 6a); (h) bonding of the textile by hand pressure (Fig. 6b); (i) application of mortar at the location of the fanned part of the anchor; (j) filling of the holes with low viscosity epoxy resin; (k) local impregnation of the dry fibers of the anchors with epoxy adhesive (Fig. 6c); (l) placement of the anchors into the holes, bonding of the fan over the first textile layer by hand

pressure and application of mortar on the top of the fan area (Fig. 6d); and (m) application of mortar in between the layers (in case of two layers), while the first layer was in a fresh state, as well as on the top of the last layer. The thickness of each layer was approximately 3 mm, thus resulting in a jacket with thickness of approximately 6 mm on each side of the specimens. At the location of the fan the total thickness was increased by approximately 2 mm.

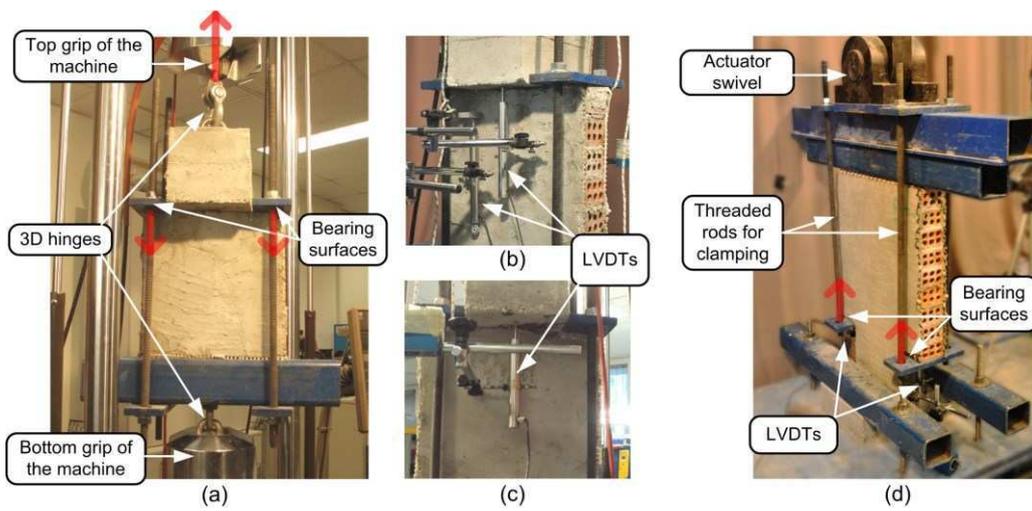
Fig. 7

In the test setup for Series A, each specimen was suspended from the top grip of the testing machine through a steel ring, which was bolted to a threaded rod placed in the center of the concrete prism during casting. The load was applied at the two bearing surfaces of the wallette through a custom made clamping system (Fig. 7a). This system comprised a pair of two steel plates (one placed at the bearing surface and the other placed at the bottom of a stiff steel tube) and a pair of threaded rods. The steel tube at the bottom of the specimen was attached to the bottom grip of the machine through a steel ring, thus allowing the rotation of the specimen. As the concrete prism was allowed to rotate freely in 3D the setup was self-centering, thus resulting in perfectly symmetrical loading of the anchors on the two sides of the specimen.

In addition to the internal LVDT (Linear Variable Differential Transformer) of the actuator, displacement measurements were provided by external LVDTs measuring: (a) the relative displacement between the concrete prism and a fixed reference point (Fig. 7b,c), in order to monitor any deformation of the concrete prism; and (b) the relative displacement between the brick wallette (at a point near the masonry-concrete interface) and the same reference point (Fig. 7b).

In the test setup for Series B, the reinforced concrete prism was fixed at the base of the stiff steel frame through a pair of stiff steel tubes, placed on top of the two flanges of the prism, and two pairs of threaded rods (Fig. 7d). The load was applied at the two bearing surfaces of the wallette through a custom made clamping system, similar to the one used in the test setup of Series A. The swivel of the actuator was attached to a steel plate welded at the center of a steel tube. The actuator was placed at the centerline of the specimen, providing symmetrical loading conditions. Because of the 3D hinge of the actuator, possible geometrical eccentricities or eccentricities induced to the system due to local damage during the experiment, did not affect the nature of loading (pure tensile). Two external LVDTs were mounted to the bottom of the bearing surfaces to monitor the in-plane rotation of the brick wallette.

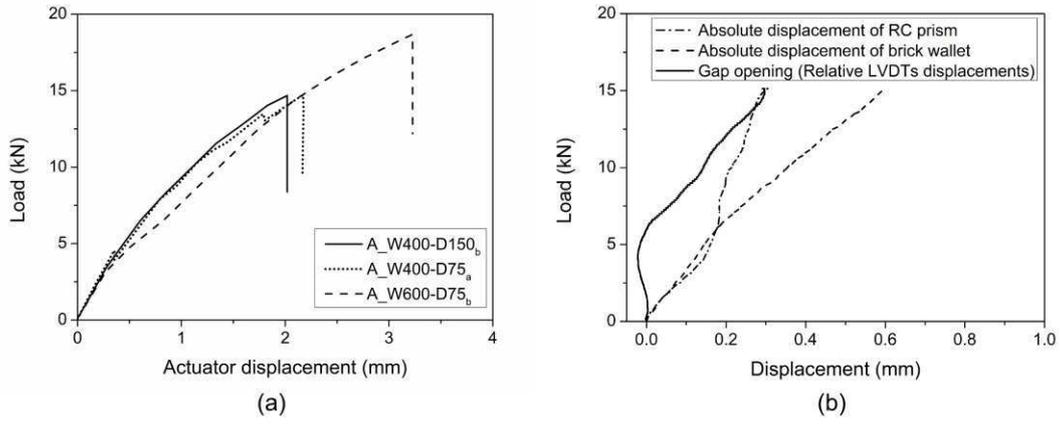
Fig. 8

Figure 8a shows typical load versus actuator displacement curves for specimens in Series A. All specimens in this series failed when one anchor ruptured at the concrete-wallette interface (Fig. 10a), resulting in a sudden load drop. Mean values of the maximum loads for specimens A\_W400-D150<sub>i</sub> (i=a,b), A\_W400-D75<sub>i</sub> (i=a,b) and A\_W600-D75<sub>i</sub> (i=a,b) were 15.05 kN, 13.95 kN and 16.65 kN; all values for the six specimens tested are given in Table 1.

An interesting aspect of the behavior in specimens of Series A may be seen in Fig. 8b, which shows load versus displacement plots for a typical test of the series, that corresponding to specimen A\_W400-D150a (the results for all other specimens were quite similar). The figure illustrates the opening of a “crack”, that is the creation of a gap, at the concrete-wallette interface, at a load approximately equal to 7 kN. Thereafter this gap increases almost linearly, confirming the elastic response of the anchors crossing the interface.

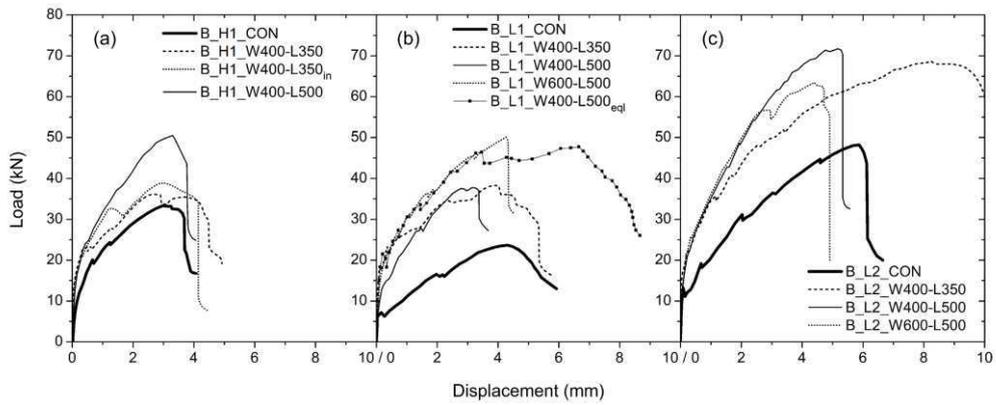
The load versus displacement (average value of two externally mounted LVDTs) curves recorded for all specimens in Series B are shown in Fig. 9. The curves are grouped on the basis of the type of textile (“heavy”, H or “light”, L) and the number of layers (1 or 2). All curves are characterized by an initial linear branch, followed by a second ascending branch of gradually decreasing slope. The point where the initial branch meets the second one indicates “cracking” at the concrete-wallette interface and creation of a gap. Failure modes and failure loads for all tests in Series B are summarized in Table 1.

- Fig. 9 Load versus displacement curves of Series B specimens.
- Fig. 10 (a) Anchor rupture in a specimen of Series A at the concrete-wallette interface; (b) debonding of the anchor at the edge of the fan in specimen B\_H1\_W400-L350; (c) anchor debonding over the concrete and rupture in specimen B\_H1\_W400-L500; (d) rupture of fibers in B\_L2\_CON specimen; (e) anchor debonding (through the mortar

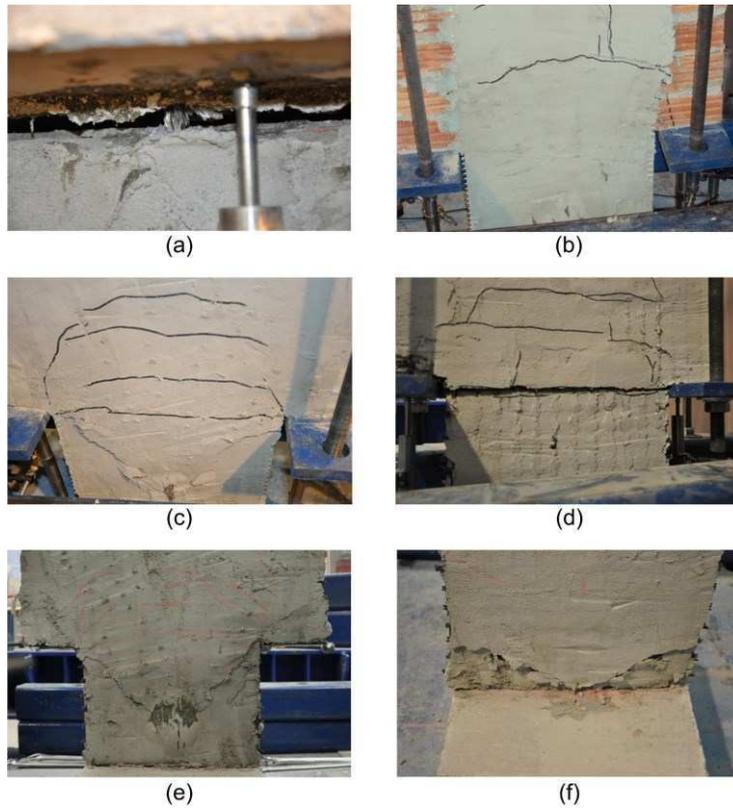
Fig. 10

of the TRM system) over the concrete and rupture in specimen B\_L1\_W600-L500;

(f) anchor debonding over the concrete and rupture in specimen B\_L2\_W400-L500.

concrete-wallette interface and the flange of the concrete slab, that is on top of the concrete, and then ruptured suddenly as a result of the force released due to debonding (Fig. 10c).

and then ruptured suddenly as a result of the force released due to debonding (Fig. 10e). Specimen B\_L2\_W600-L500 failed prematurely, due to local crushing of the masonry in contact with the bearing surfaces of the loading plates, hence its failure load may only be taken as a lower bound of that corresponding to the capacity of the anchored TRM.

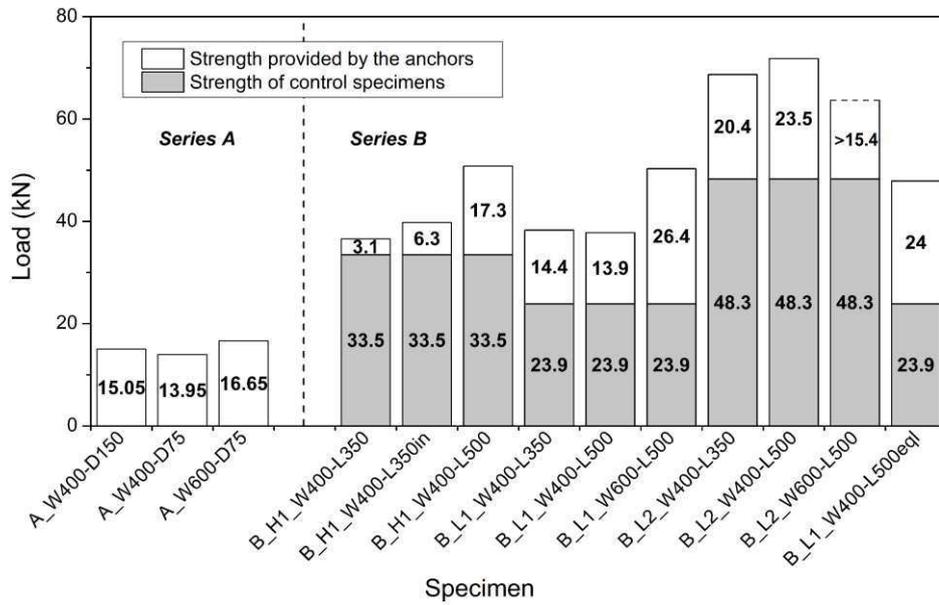
The results from all tests are summarized in Table 1 and in a convenient graphical form in Fig. 11. In this figure, the values of maximum loads sustained by specimens in Series A (average values from two identical specimens) indicate that a reduction in the anchorage depth inside the concrete from 150 mm (A\_W400-D150) to 75 mm (A\_W400-D75) led only to a marginal reduction of the maximum load (by 7%, which may be considered as statistical error) because the failure mode (rupture of the anchors) remained unchanged. Moreover, comparison of the results for specimens A\_W400-D75 and A\_W600-75 indicates that an

As far as the contribution of anchors to the capacity of the specimens is concerned, Fig. 11 illustrates that in all specimens of Series B, except for B\_H1\_W400-L350 and B\_H1\_W400-L350<sub>in</sub>, the anchors (one per side) substantially increased the capacity of tensile force transfer between the brick wallette and the concrete prism. Anchors in the two aforementioned specimens debonded prematurely, while contributing only  $3.1/2 = 1.55$  kN and  $6.3/2 = 3.15$  kN each, in the strength of specimens B\_H1\_W400-L350 and B\_H1\_W400-350<sub>in</sub>, respectively. Their poor performance (early debonding) is attributed to the combination of a relatively short bond length in the masonry and the fact that they were bonded on top of heavy textile, which, when tensioned, produced high interlaminar shear stresses at the interface between the fanned part of the anchors and the textile. Each anchor in B\_H1\_W400-L500, the third specimen in the group of those with the heavy textile, sustained a force equal to  $17.3/2 = 8.65$  kN (Fig. 11), well above the forces carried by B\_H1\_W400-L350 and B\_H1\_W400-350<sub>in</sub>, which, as discussed above, failed by debonding in the masonry.
