Rapid testing on the effect of cracks on solar cells output power performance and thermal operation

Mahmoud Dhimish✉ & Yihua Hu

This work investigates the impact of cracks and fractural defects in solar cells and their cause for output power losses and the development of hotspots. First, an electroluminescence (EL) imaging setup was utilized to test ten solar cells samples with differing crack sizes, varying from 1 to 58%. Our results confirm that minor cracks have no considerable effect upon solar cell output, and they develop no hotspots. However, larger cracks can lead to drastic decreases in the output power, close to –60%. Furthermore, as the crack area increased, there was a further increase in the cell's temperature under standard test conditions. On the contrary, no hotspots were found for the solar cells affected by significant crack areas (crack percentage > 46%) because there were insufficient areas to develop a hotspot. Last, a comparative analysis with solar cells affected by potential induced degradation (PID) was made. We found a strong relationship in the output power losses, and the PID test critically impacted the cells by developing localized hotspots at a temp

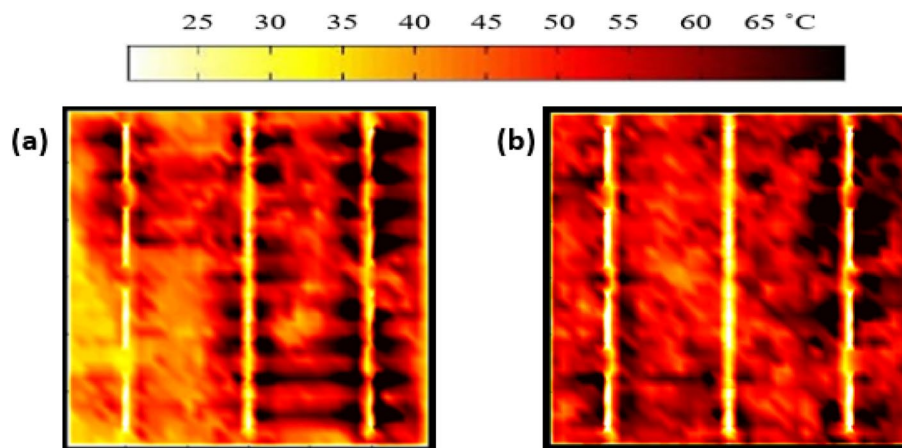
Figure 10. Thermal image of the solar cell samples after the PID test was completed (a) Sample #1, (b) Sample #2.

As we have shown earlier in Table 2, some solar cells do not develop hotspots. In this regard, the PID experiment allows us to confirm another compelling conclusion. We have observed that the solar cell samples subjected to the PID test have developed severe hotspots, as can be seen in Fig. 10. The surface temperature of both cells is approximately 50 °C; these images were taken at STC conditions. In comparison, the worst case of an increase in the cell temperature for cracked cells was observed at nearly 43 °C (Fig. 7) when the cell is affected by a 25% crack percentage. Therefore, unlike solar cracking, a PID can critically influence the thermal performance of affected solar cells.
